# One Medlock Street Development

## Highway Pre-condition Survey

Sweco UK Limited 2888385  
**Project Name** One Medlock Street Development  
**Planning Application Reference** 135419/FO/2022N/A  
**Client** RG Group  
**Author** Jordan Bamber Sweco  
**Date** 11/10/2023  
**Document reference** One Medlock Pre-condition Survey

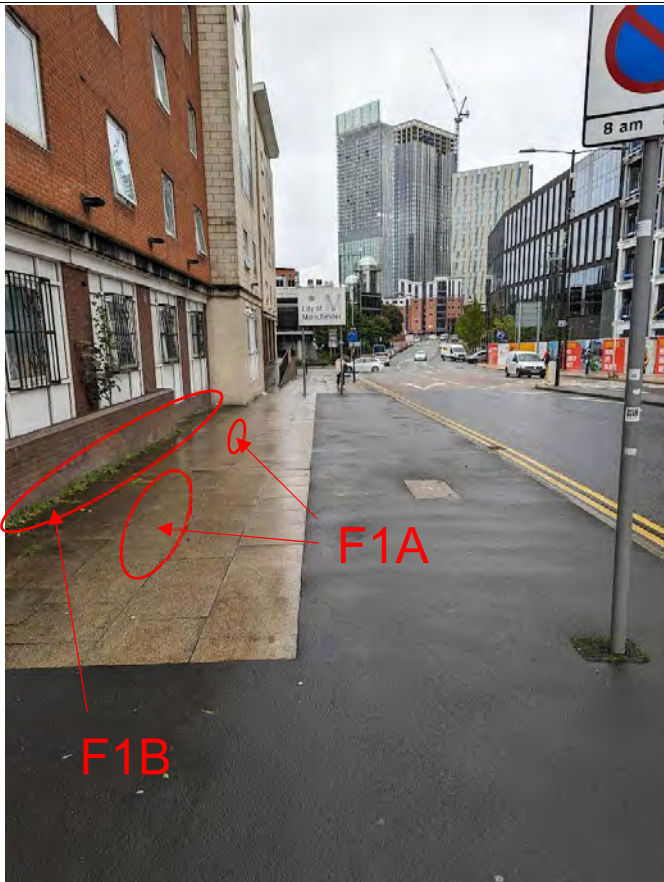
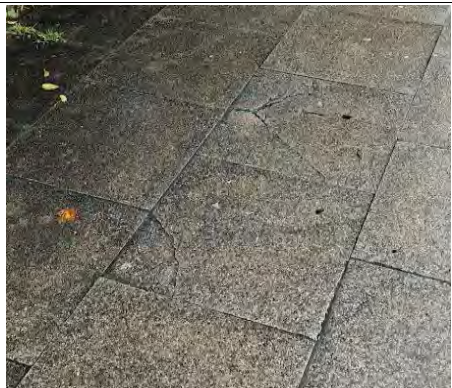
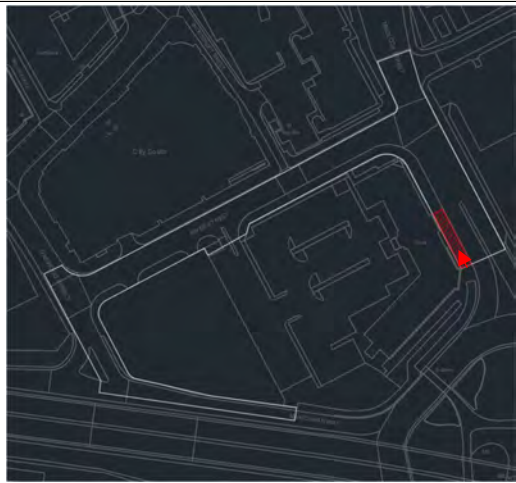
| | <p>Location F1: Grid Reference X=383680 Y=397207</p> | |
| <p>Notes:</p> <p>F1A. Cracked paving slabs.</p> <p>F1B. Overgrown vegetation at paving boundary with building line.</p> | | |

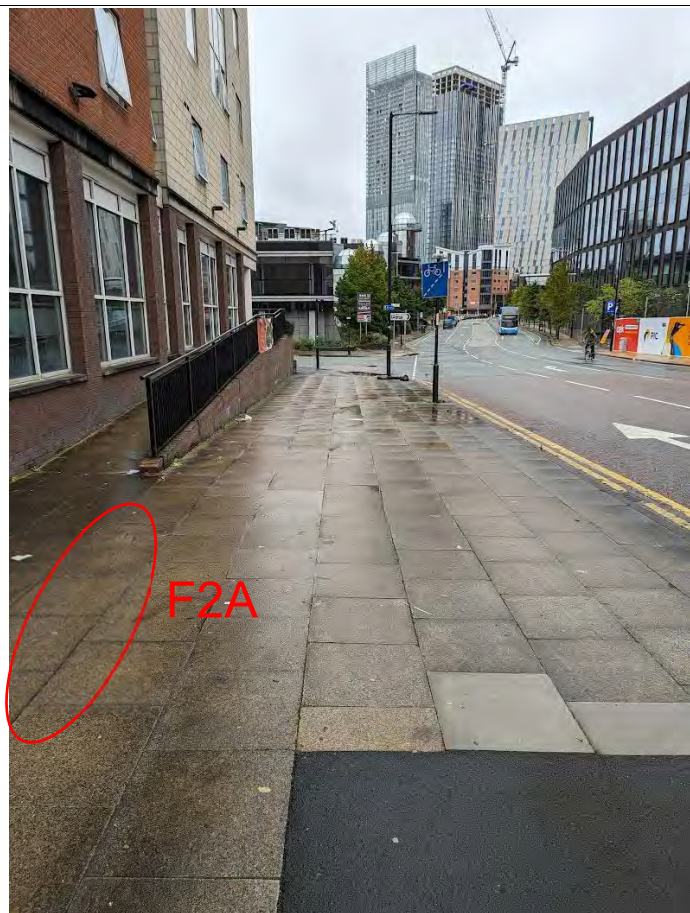
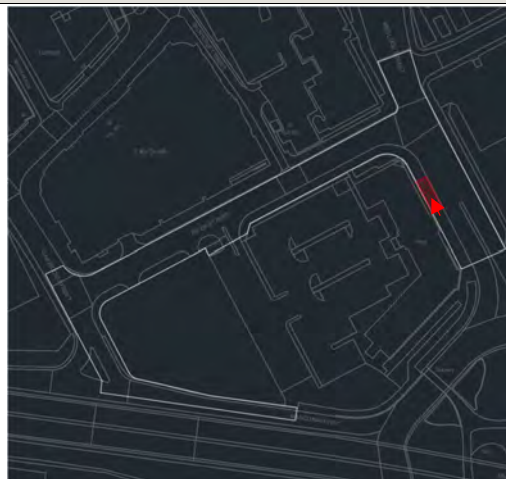
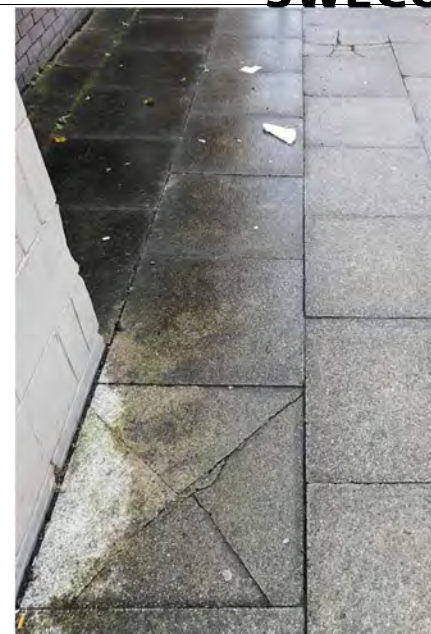
Location F2: Grid Reference X=383671 Y=397225

F2A. Cracked paving slabs

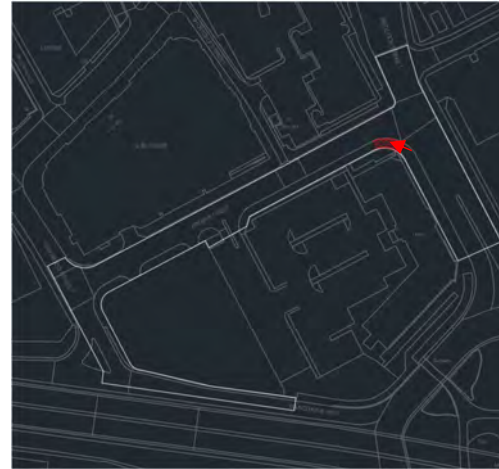
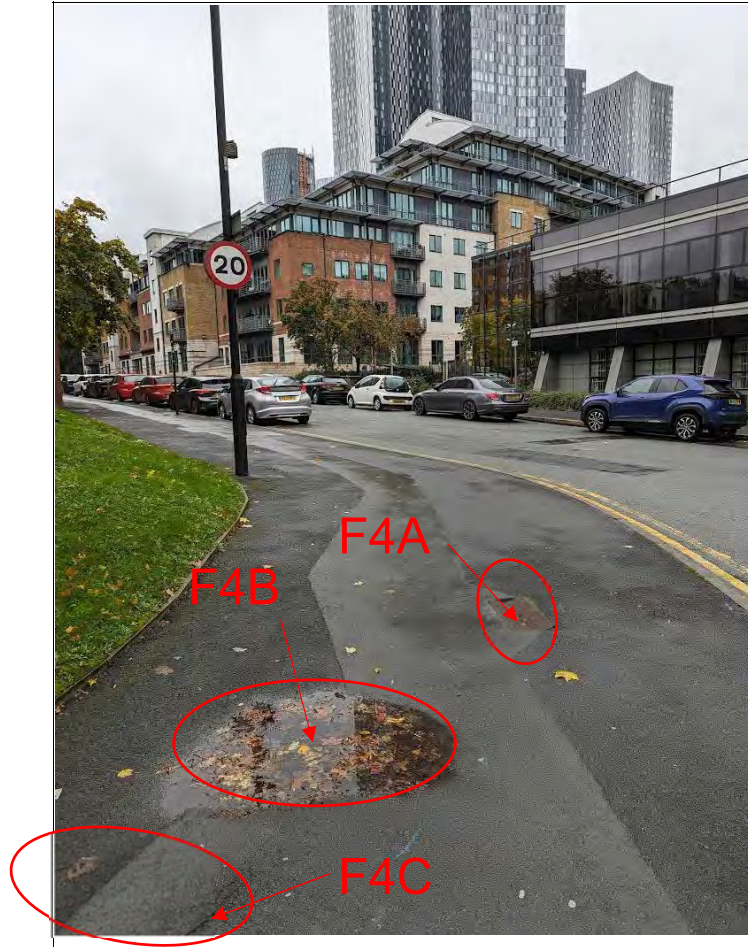
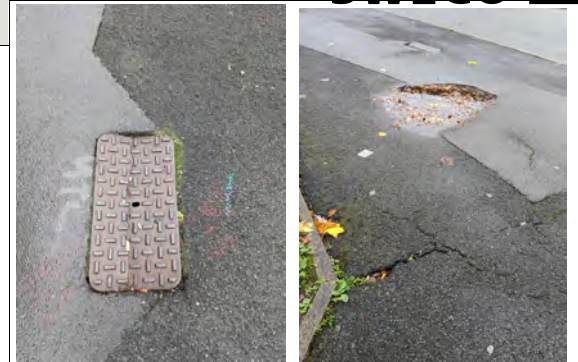
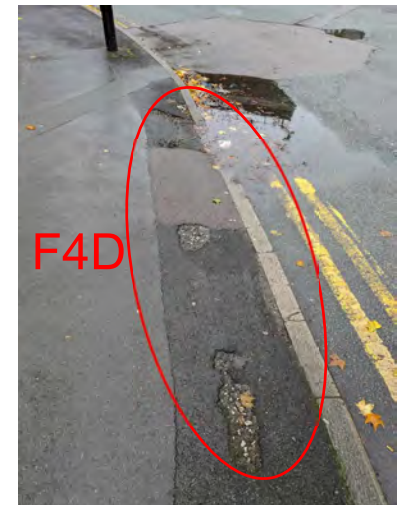
Location F4: Grid Reference X= 383655 Y= 397245

F4A. Shattered utility chamber.

F4B. Footway low spot resulting in ponding of water.

F4C. Asphalt cracking.

F4D. Potholes and cracking of kerb unit.

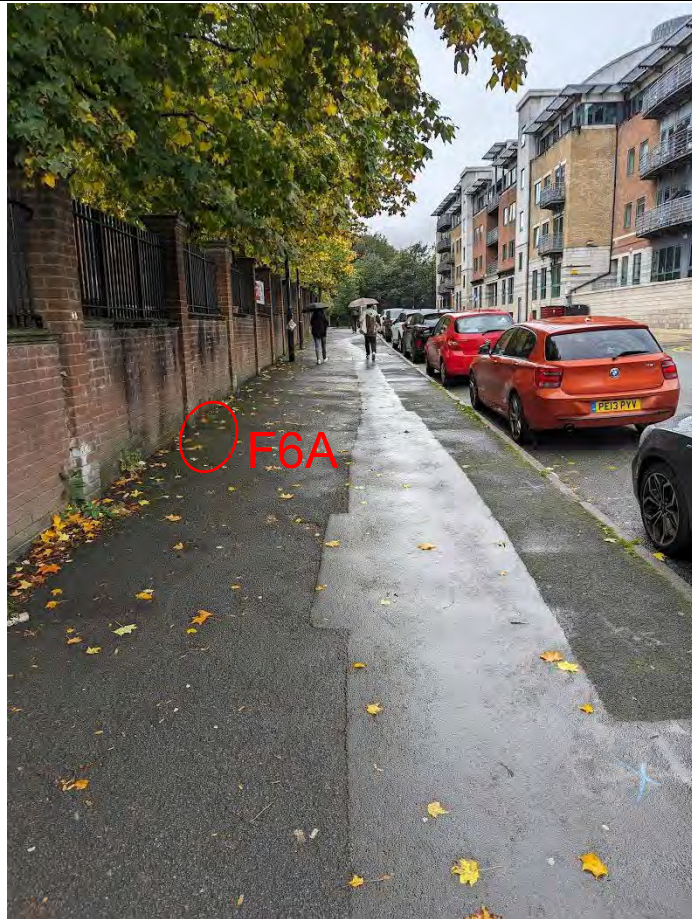
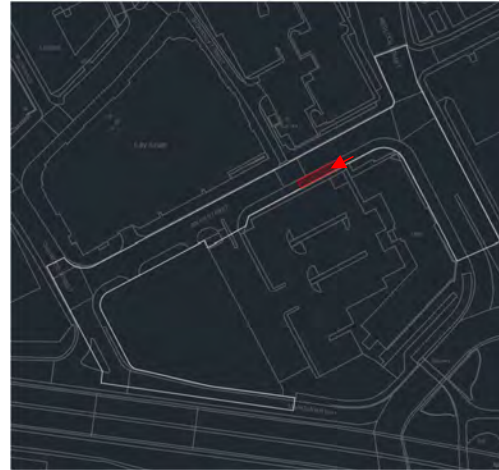
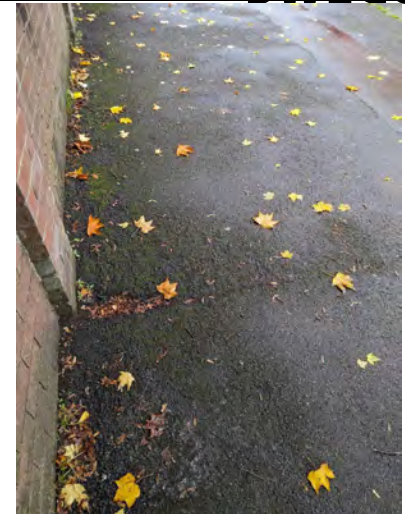
Location F6: Grid Reference X= 383628 Y= 397233

F6A. Asphalt joint failure

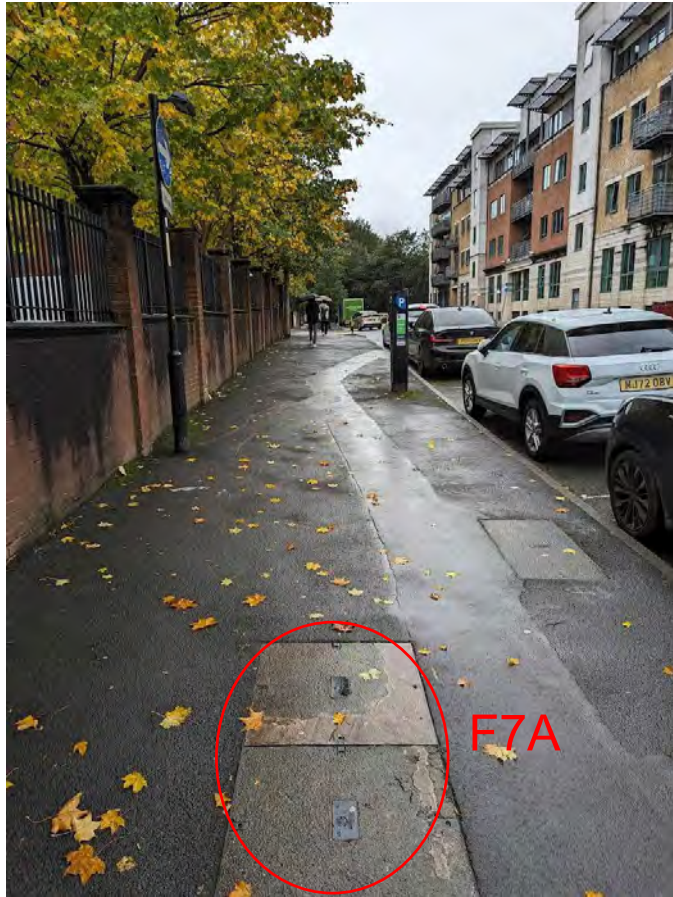
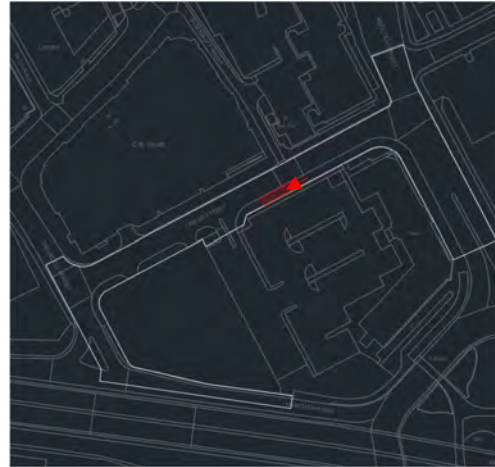
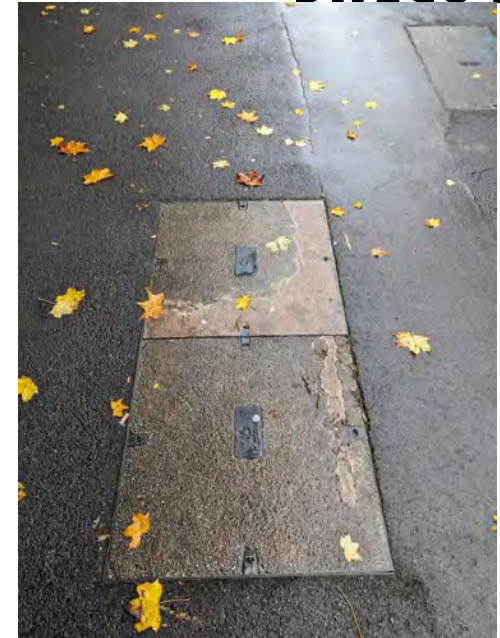
Location F7: Grid Reference X= 383609 Y= 397224

F7A. Degraded inspection chamber lid.

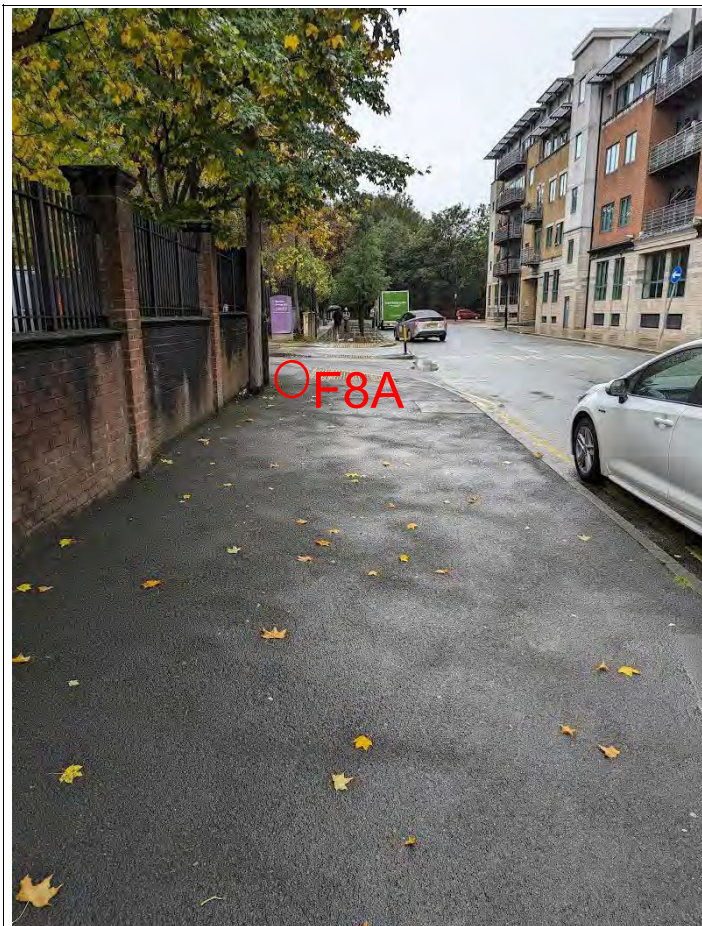
Location F8: Grid Reference X= 383598 Y= 397217

F8A. Scarring in footway from removed bollard.

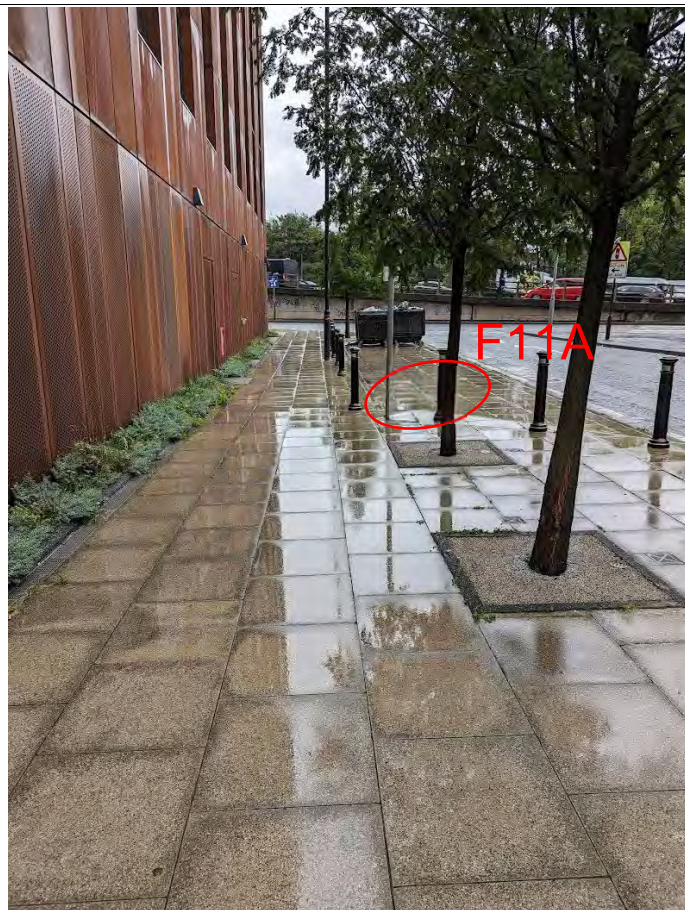
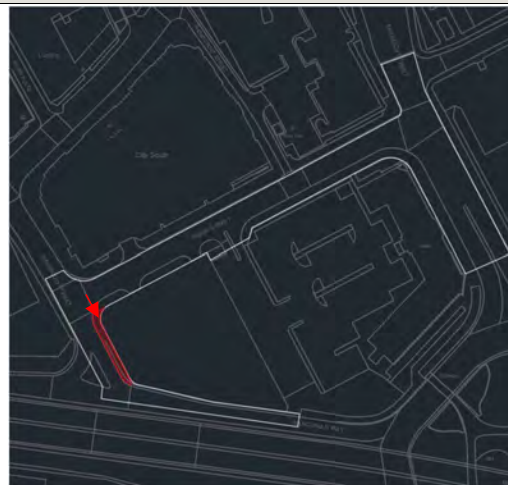
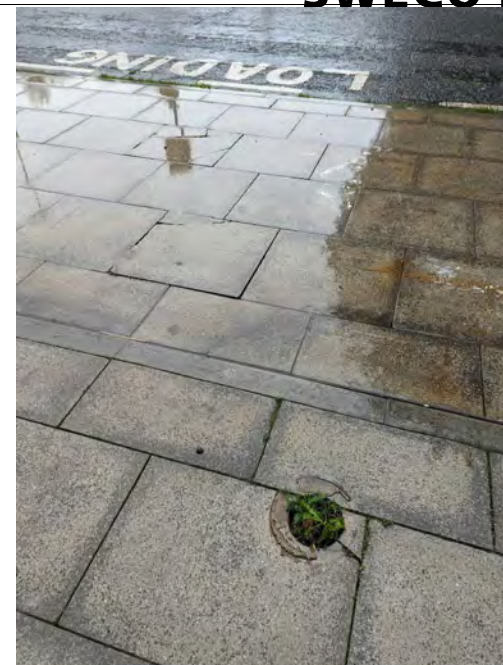
Location F11: Grid Reference X= 383538 Y= 397165

F11A. Cracked paving slabs in vehicle layby

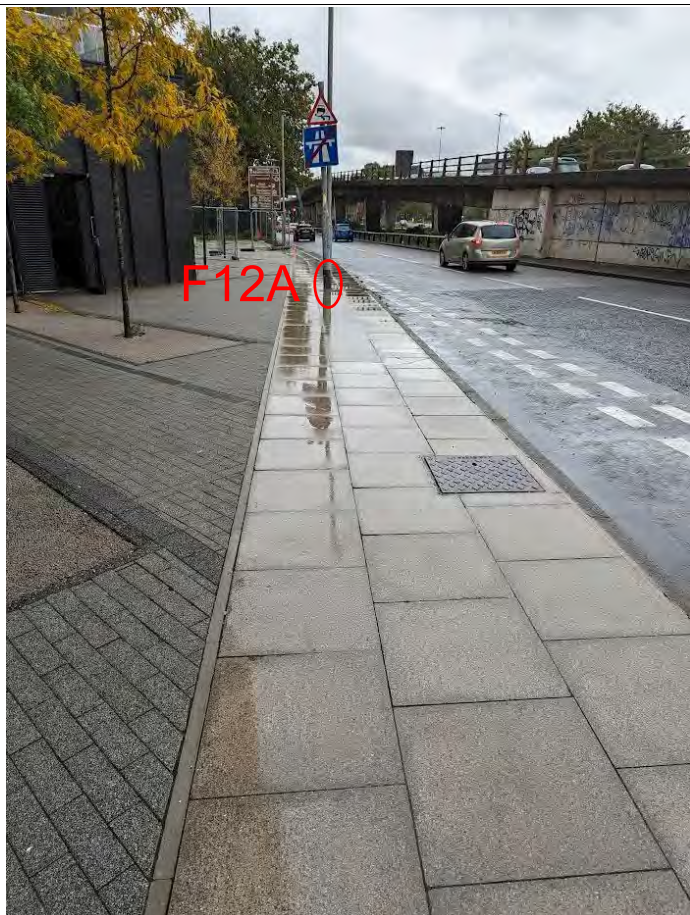
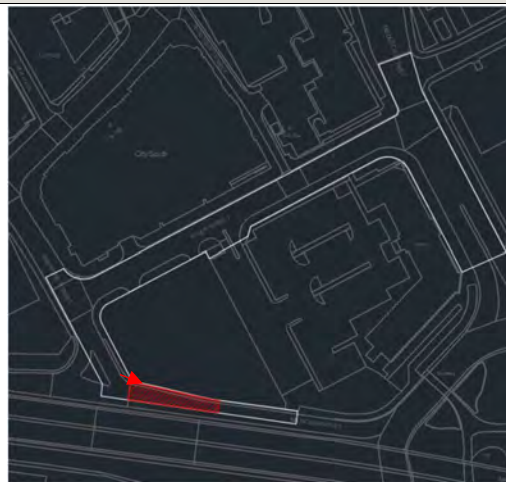
Location F12: Grid Reference X= 383565 Y= 397143

F12A. Damaged sign-post base

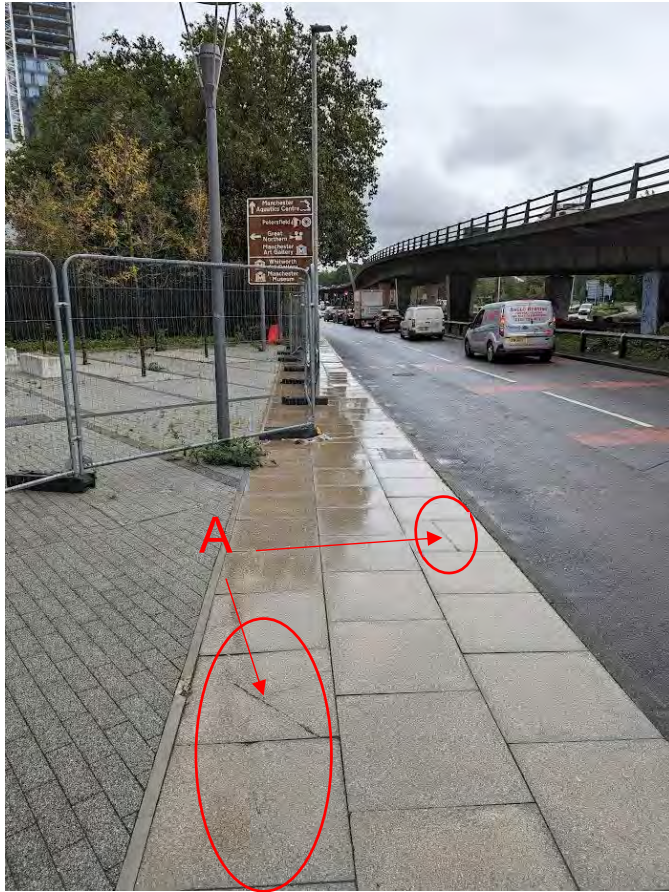
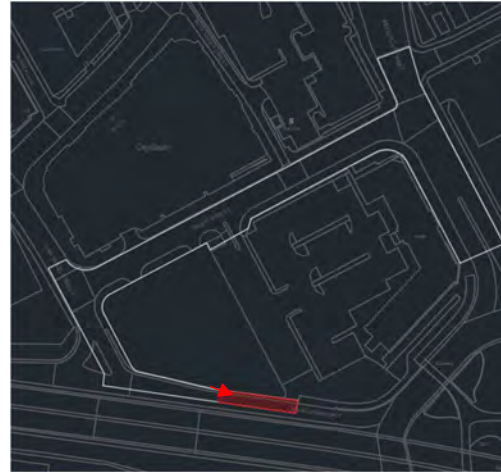
Location F13: Grid Reference X= 383601 Y= 397137

F13A. Cracked paving slabs

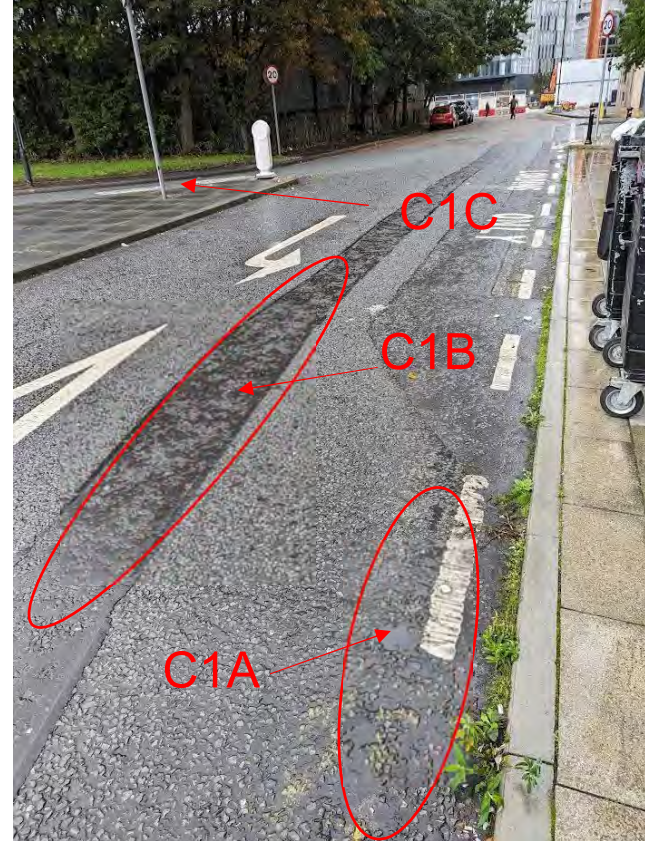
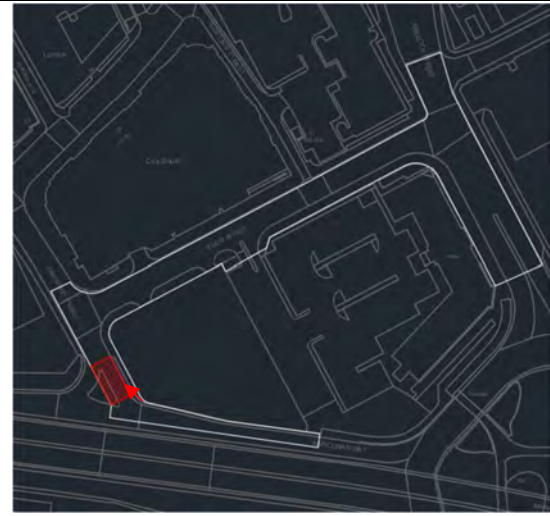
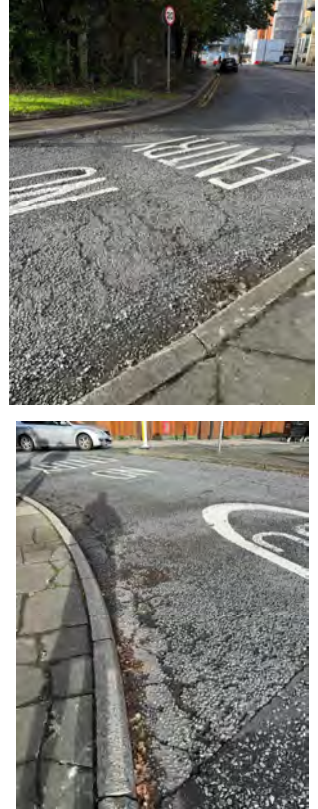
| | <p>Location C1: Grid Reference X= 383536 Y= 397159</p> <p>Notes:</p> <p>C1A. General surface wear.</p> <p>C1B. Visible carriageway trenches.</p> <p>C1C. Cracking and general surface wear on Mancunian Way off slip.</p> | <p>Additional photo taken 13/10/2023 indicating clearer evidence of longitudinal and transverse cracking in this location in dry conditions.</p> |

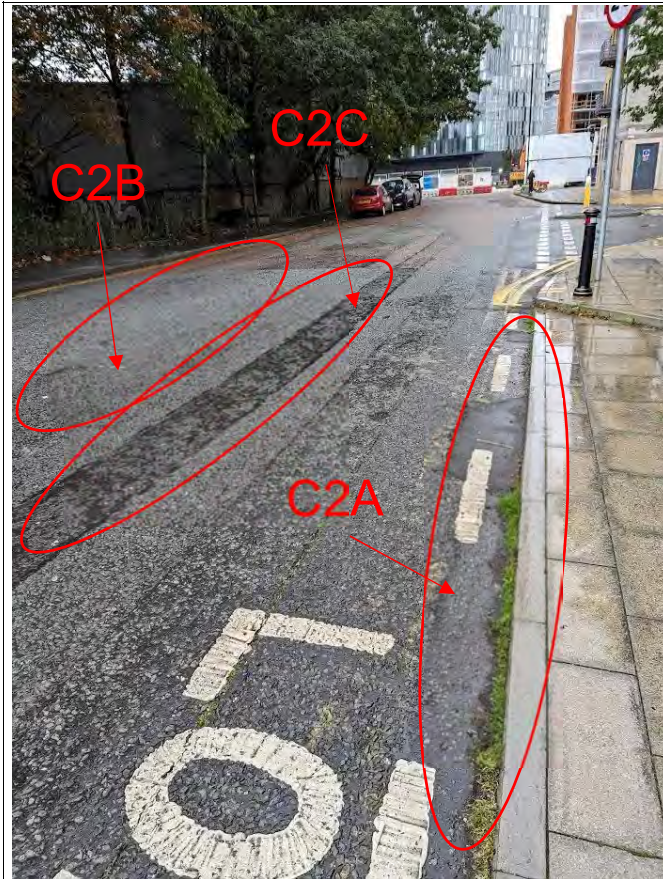
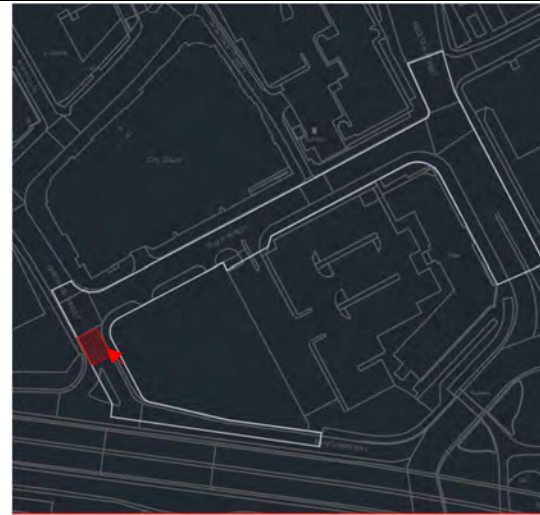
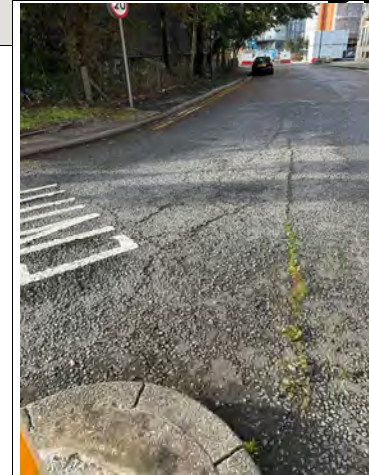
Location C2: Grid Reference X= 383529 Y= 397171

C2A. General surface wear at carriageway edge with evidence of previous patch repairs.

C2B. Longitudinal and transverse cracking.

C2C. Visible carriageway trenches.

Additional photo taken 13/10/2023 indicating clearer evidence of longitudinal and transverse cracking in this location in dry conditions.

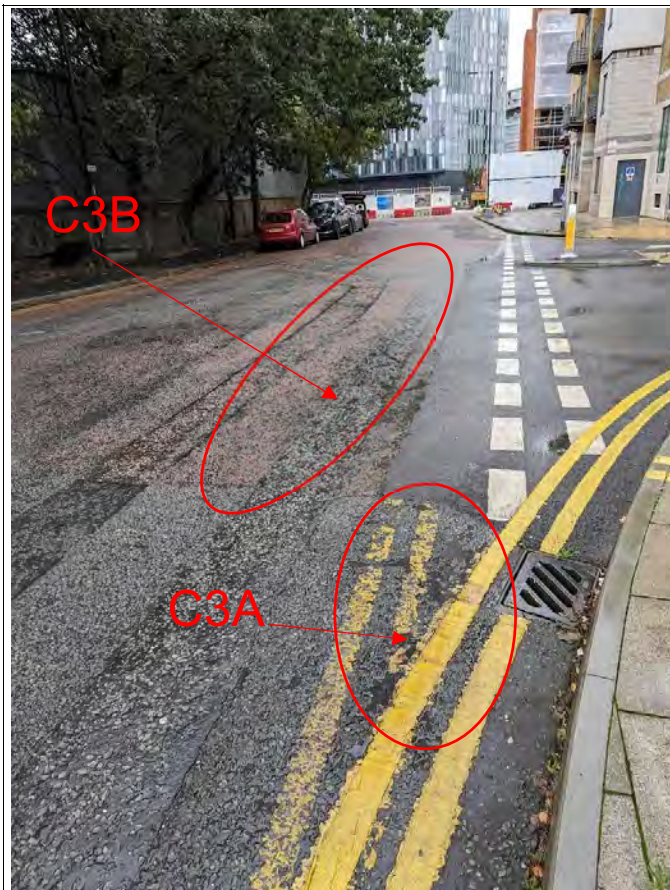
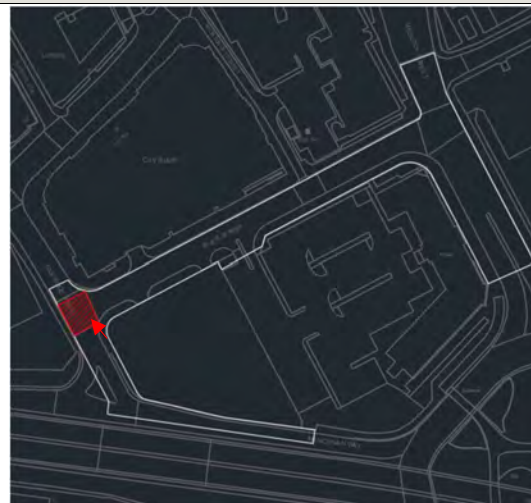
Location C3: Grid Reference X= 383523 Y= 397184

C3A. General surface wear.

C3B. Visible carriageway trenches of contrasting colour surface course.

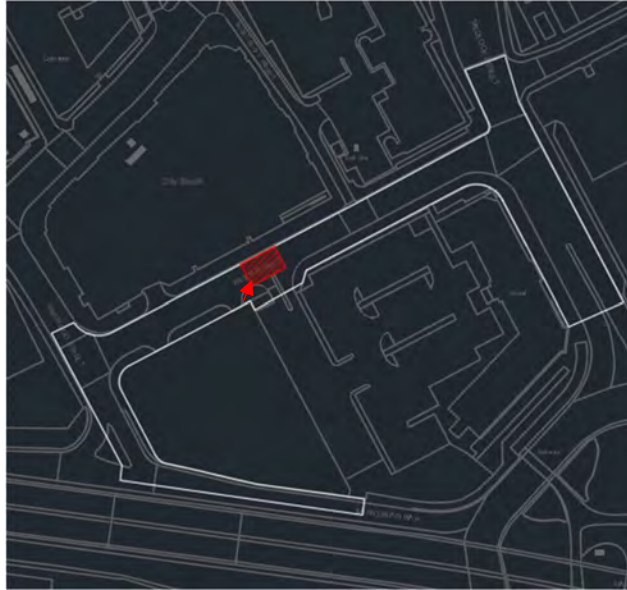
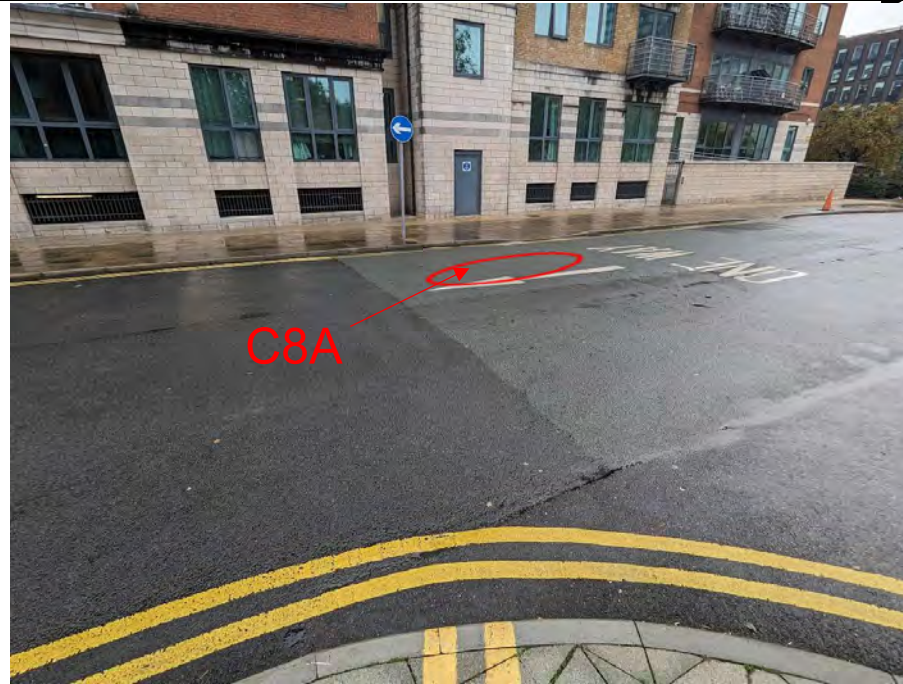
Location C8: Grid Reference X= 383582 Y= 397216

C8A. Longitudinal cracking

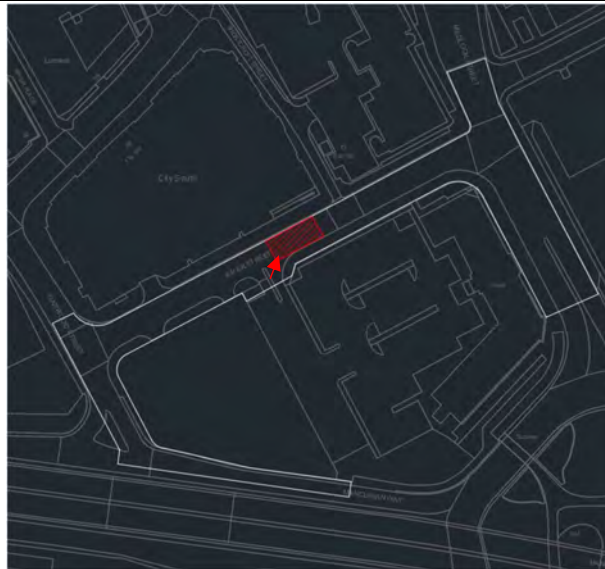
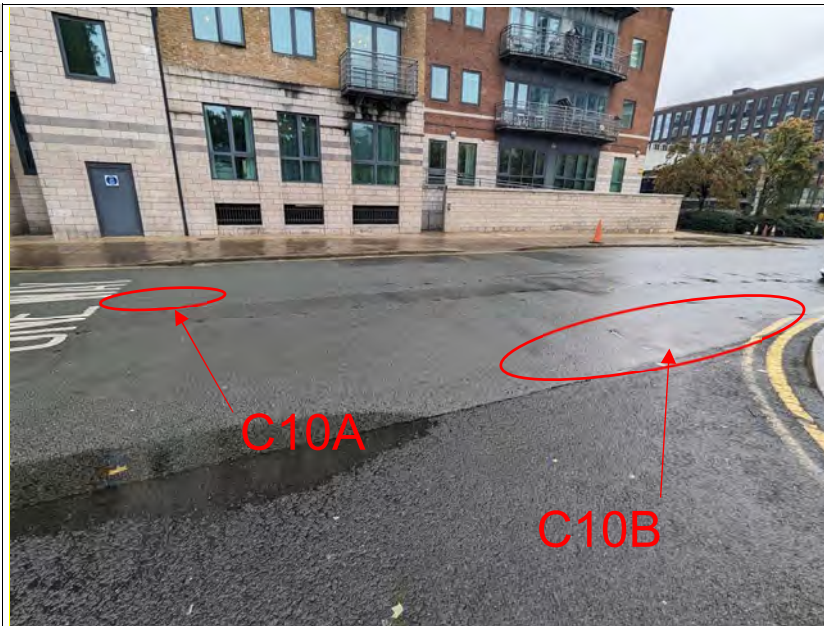
Location C10: Grid Reference X=383597 Y=397223

C10A. Longitudinal Cracking

C10B. General surface wear

C10C. Worn down kerb units

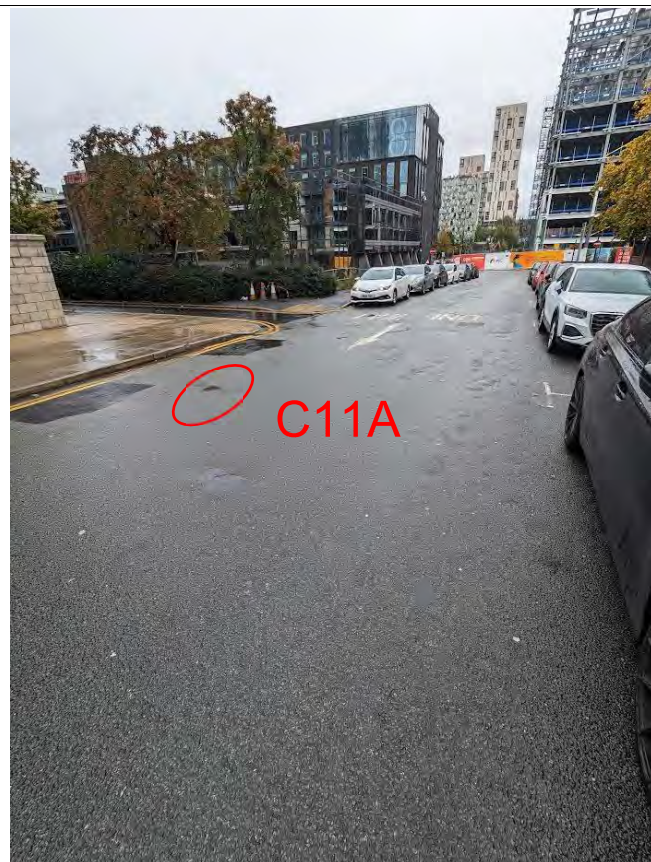
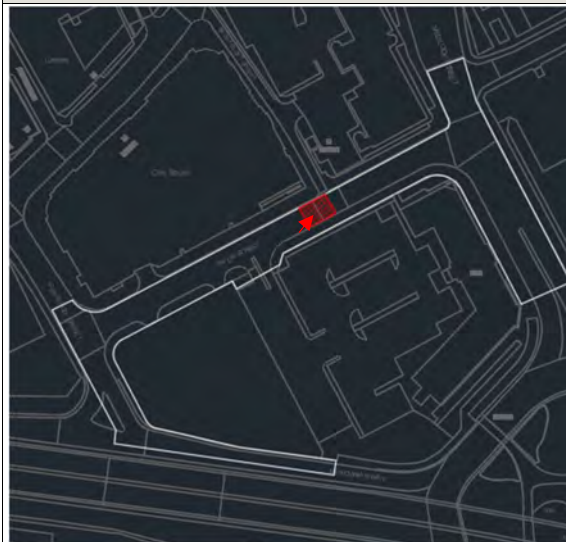
Location C11: Grid Reference X= 383609 Y= 397230

C11A. General surface wear

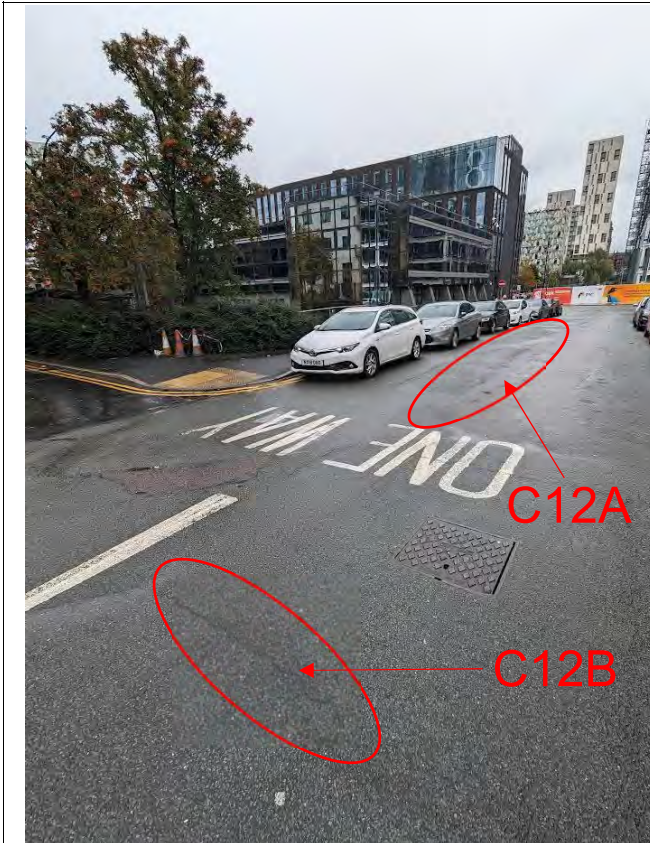
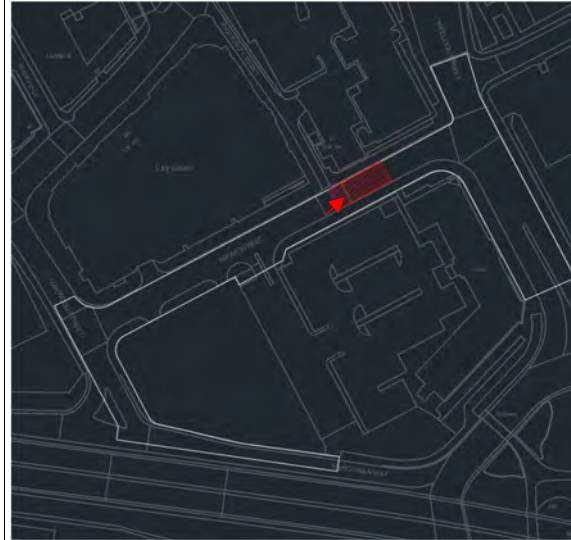
Location C12: Grid Reference X= 383623 Y= 397237

C12A. Longitudinal Cracking with significant surface failure

C12B. Transverse Cracking

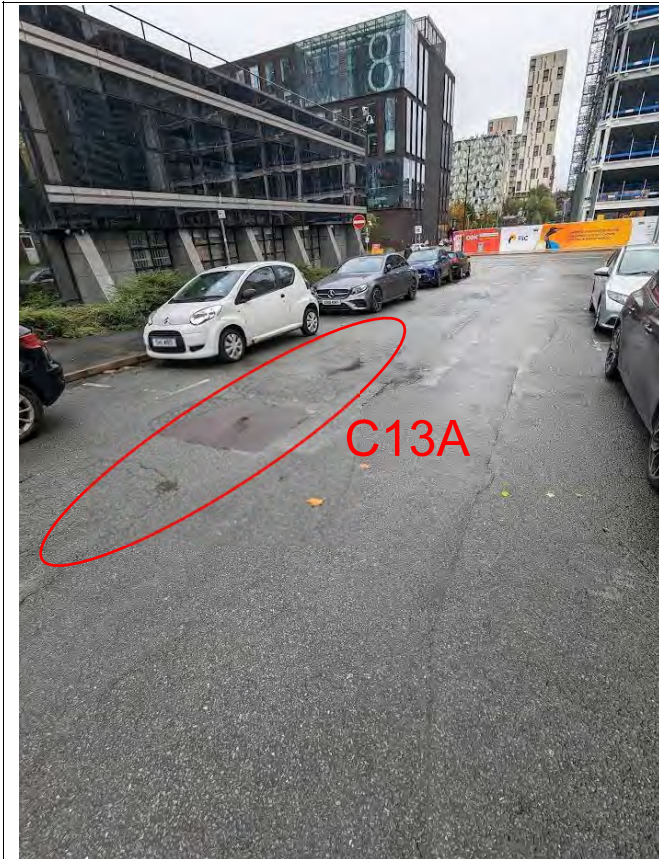
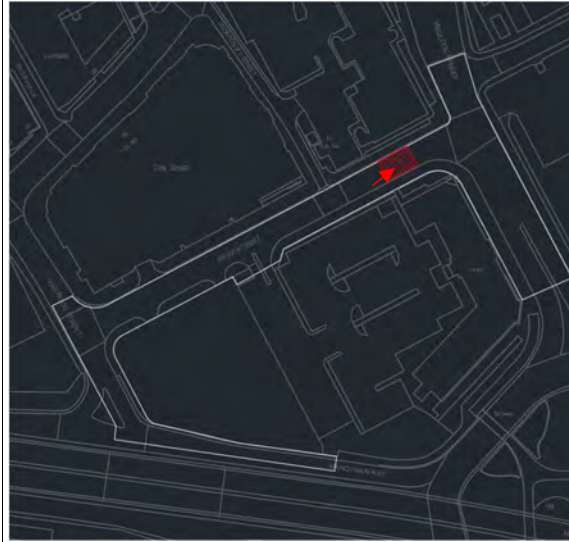
Location C13: Grid Reference X= 383638 Y= 397245

C13A. Longitudinal cracking with significant surface failure

C13B. Kerb units deteriorated

C13C. Debris build up at gully pot

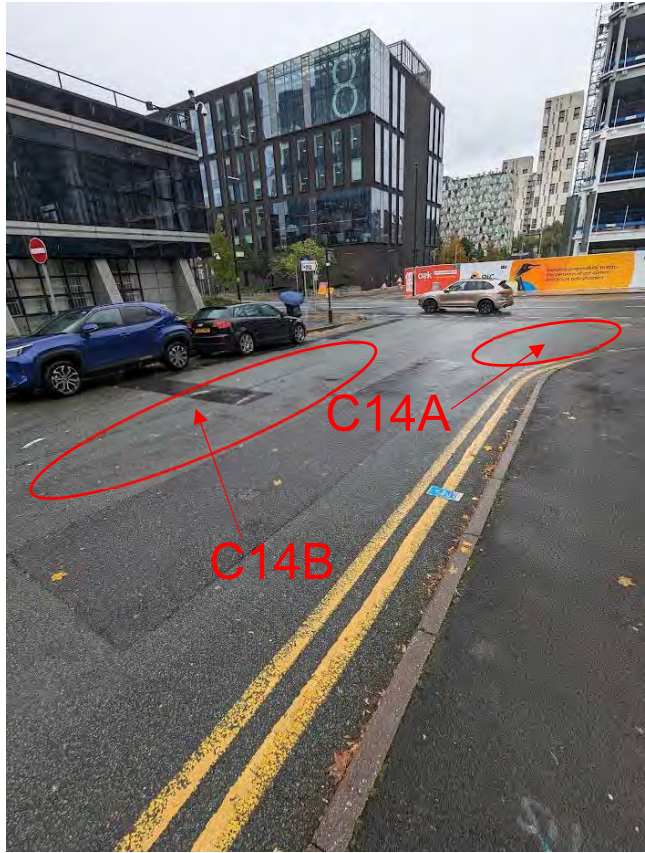
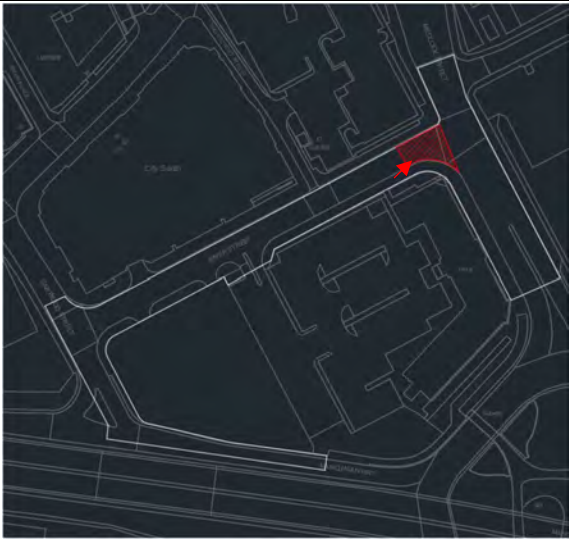
| | <p>Location C14: Grid Reference X= 383651 Y= 397252</p> <p>Notes:</p> <p>C14A. Longitudinal and transverse cracking</p> <p>C14B. Longitudinal cracking with minor surface failure</p> | |

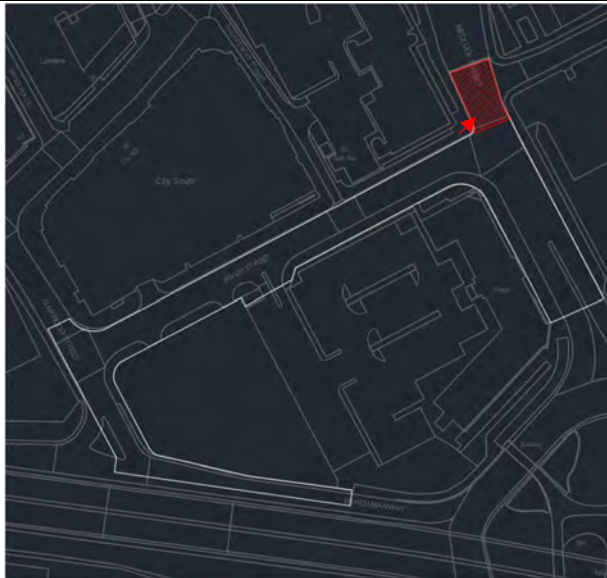
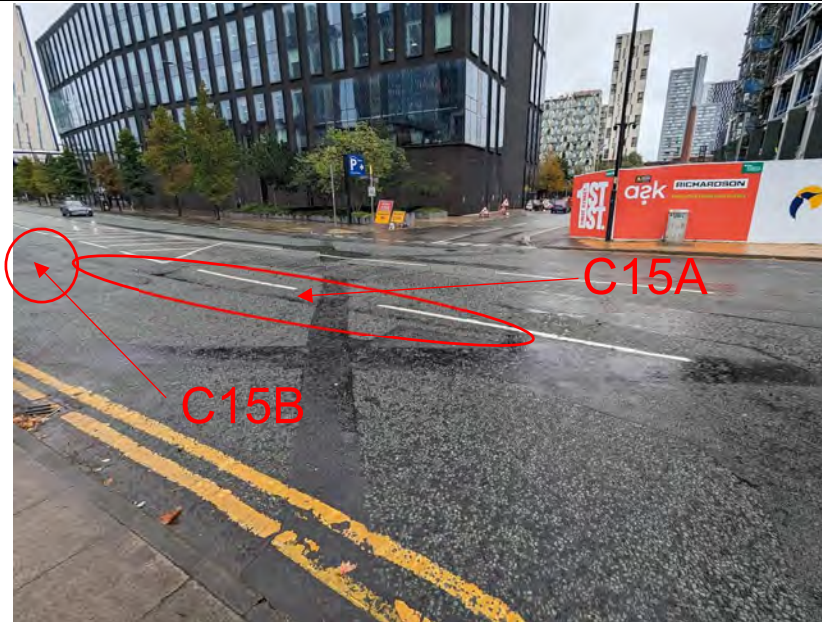
C15A. Longitudinal cracking in right wheel track of lane 1 northbound

C15B. General surface wear

C15C. Debris build up at gully pot

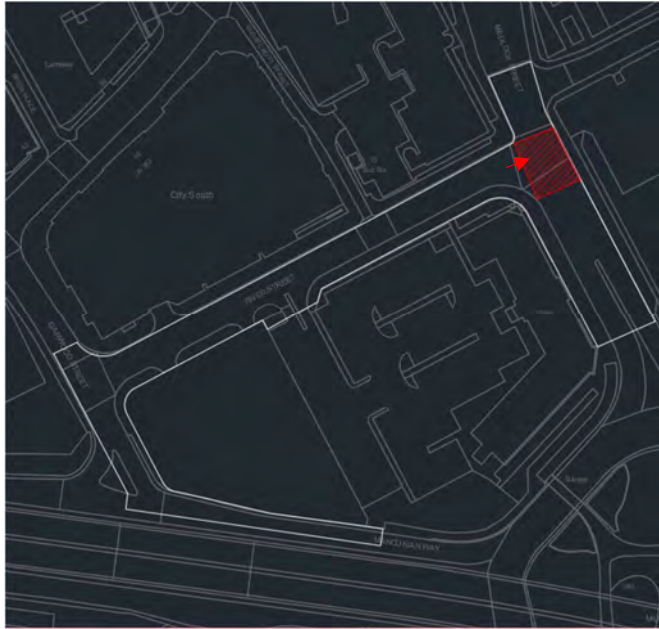
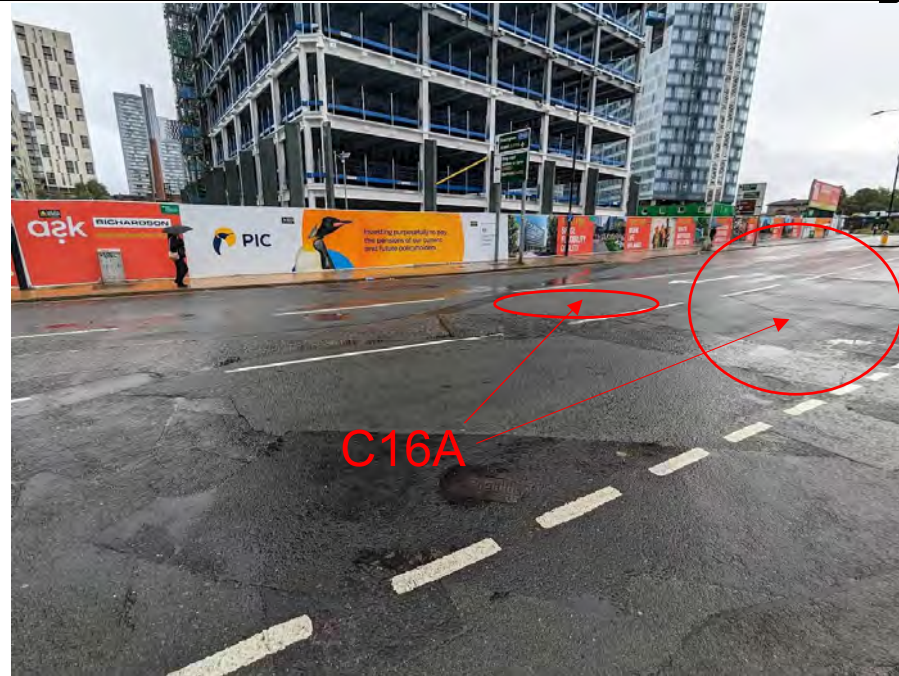
Location C16: Grid Reference X= 383669 Y= 397251

C16A. Transverse cracking across lanes 1 and 2 northbound

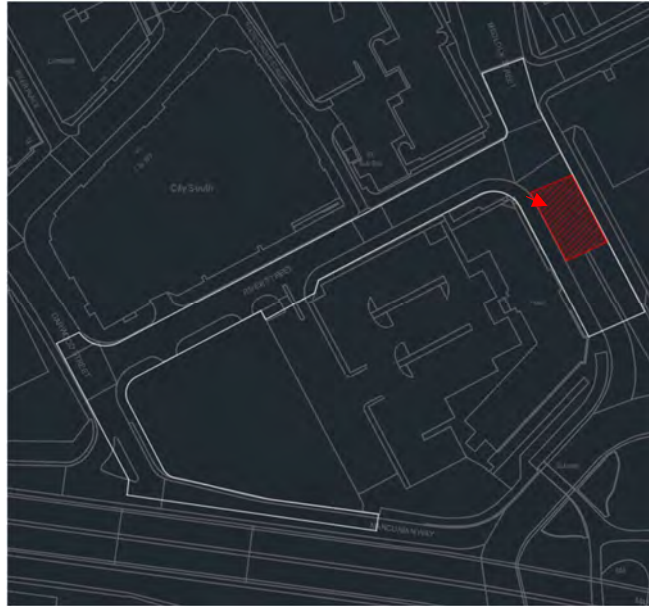
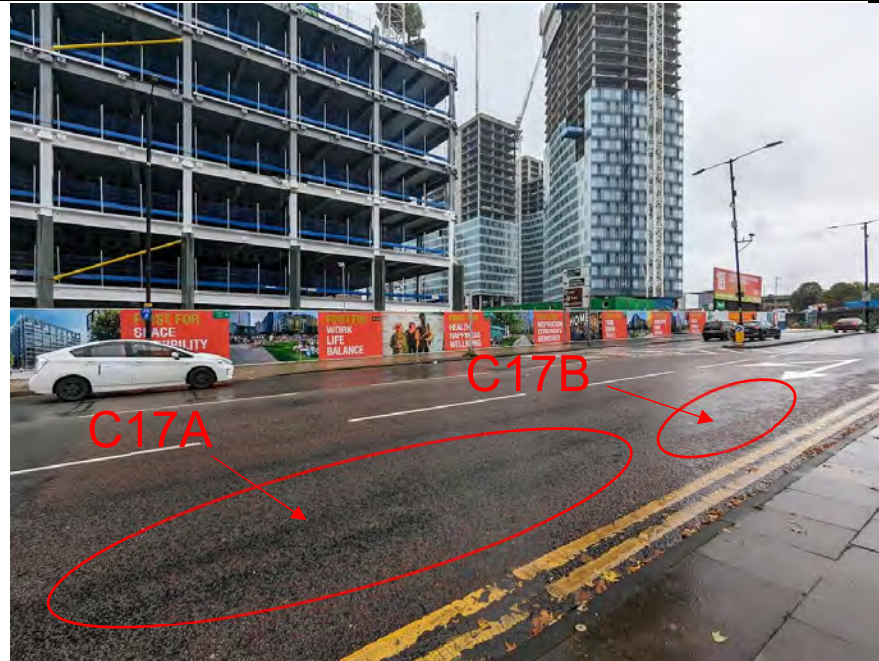
Location C17: Grid Reference X= 383677 Y= 397235

C17A. General surface wear

C17B. Longitudinal Cracking
