**Roof Works, Structural Repair Summary****1830 Warehouse – Essential Repairs (LBC Application No.2)****Science & Industry Museum, Manchester**

Ref: 220627/S Wilkinson

27 Feb 2023

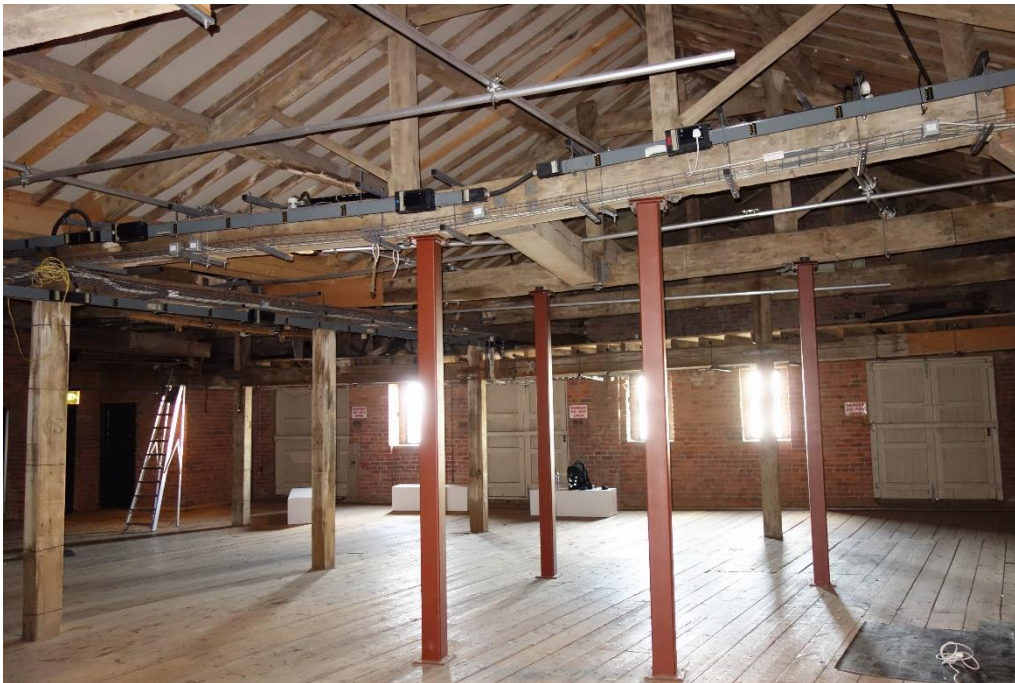
Serious cracking has occurred to the bottom chords of two roof trusses in Bay 2. This has resulted in previous total failure of two chords and installation of long-term propping in the form of steel posts (Photographs 1 & 2) together with partial failure of a second (Photograph 3) which currently has no supplementary support. Refer to Conisbee plan drawing 220627-CON-XX-02-DR-S-1103 for precise locations.

**Photograph 1: General view of propped failed trusses in Bay 2.**

The cause of the damage could be conclusively confirmed but is considered most likely to relate to a combination of historic overloading and some inherent timber defects. The roof trusses have historically had imposed loading applied at various points on the structure for lifting operations in the warehouse. Such loads, if excessive, may alter structural function and load paths within the trusses, resulting in partial failure.

The steel posts currently providing support are not necessarily aligned with structural beams below and risk transferring excessive point loads onto second floor boarding and joists. Whilst the posts provide vertical support, they do not restore the full structural function of the truss. The bottom chord is in tension and acts to resolve lateral thrust created by the roof loads. Whilst the props have acted to prevent collapse of the truss, additional lateral loads have been transferred to the brickwork walls between the bays, which is structurally undesirable.

Repairs are required to properly restore the structural function of the propped trusses and prevent further damage from occurring to the unpropped truss. A further modest benefit would be removal of the steel posts.

Having considered the options, use of external steel plates applied to each side of the bottom chords and bolted through was considered to be the most favourable option. This would restore the structural function of the trusses, whilst keeping loss of historic timber fabric to an absolute minimum. No historic timber would need to be cut out and losses would only occur due to drilling of holes for through bolting. A repair of this type has the further advantage that complex temporary works to maintain structural stability and redirect loading to other parts of the structure would not be required, which also mitigates associated risks. This repair option would remain clearly visible on completion of work but would be generally in keeping with the existing materials and aesthetic.

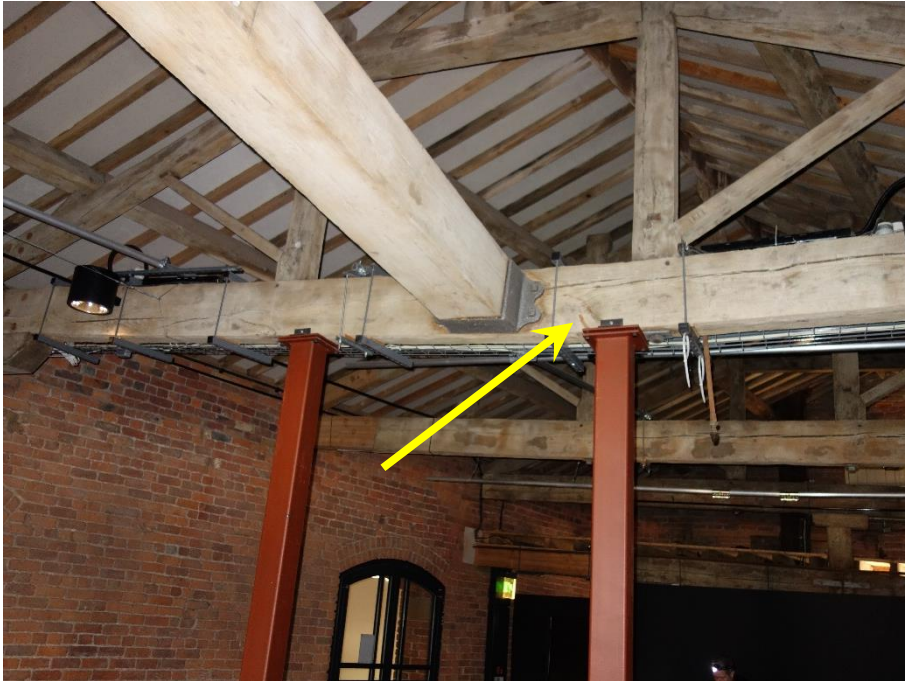
**Photograph 2: Detail view of damaged truss chord. The crack location is arrowed.**

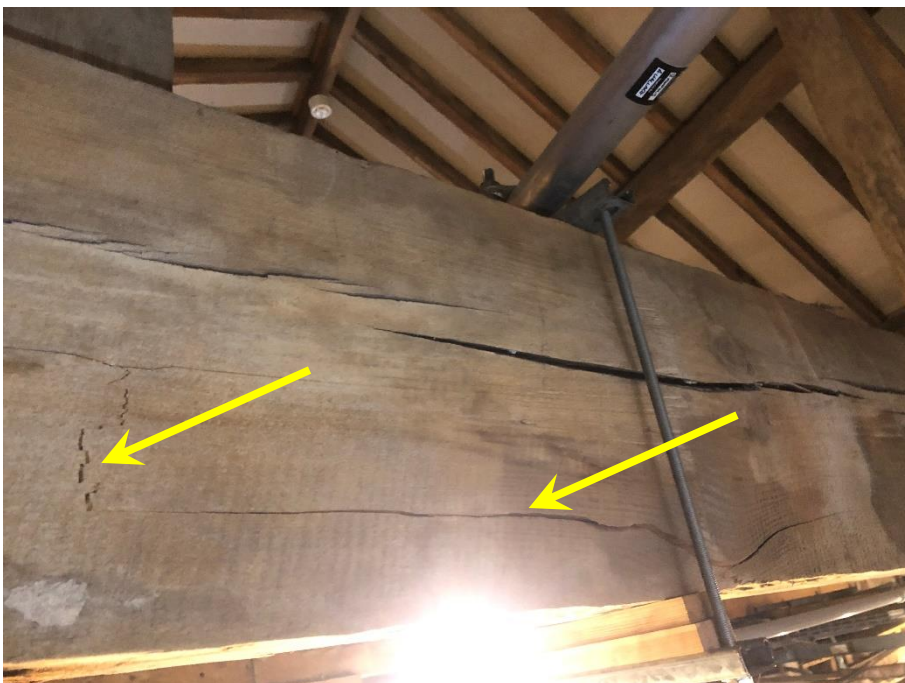
**Photograph 3: Detail view of damage to unpropped truss chord**
