Eagle House, Manchester  
Third Floor Photographic Survey  
May 2023

## 3.0 – Key plan of third floor

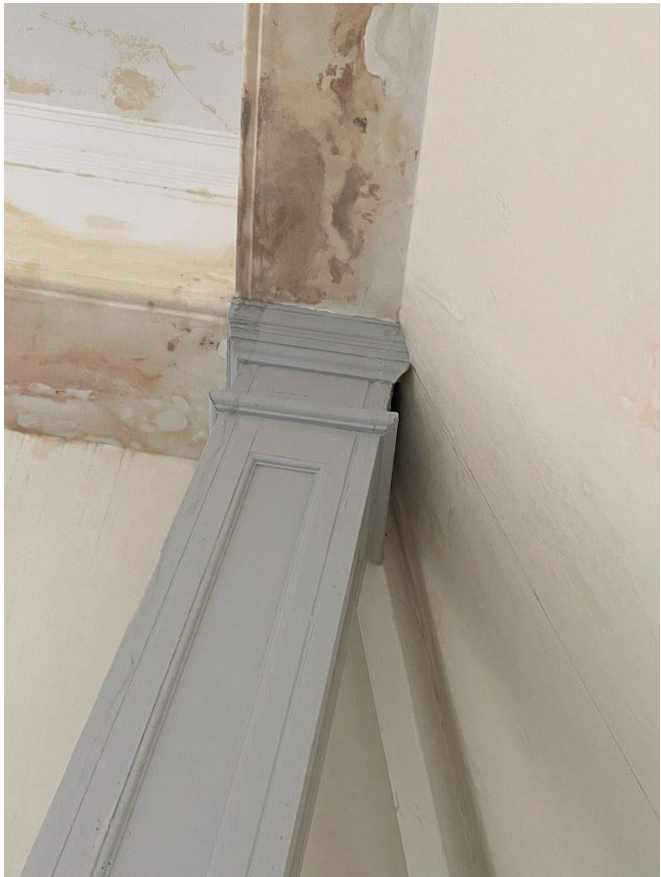
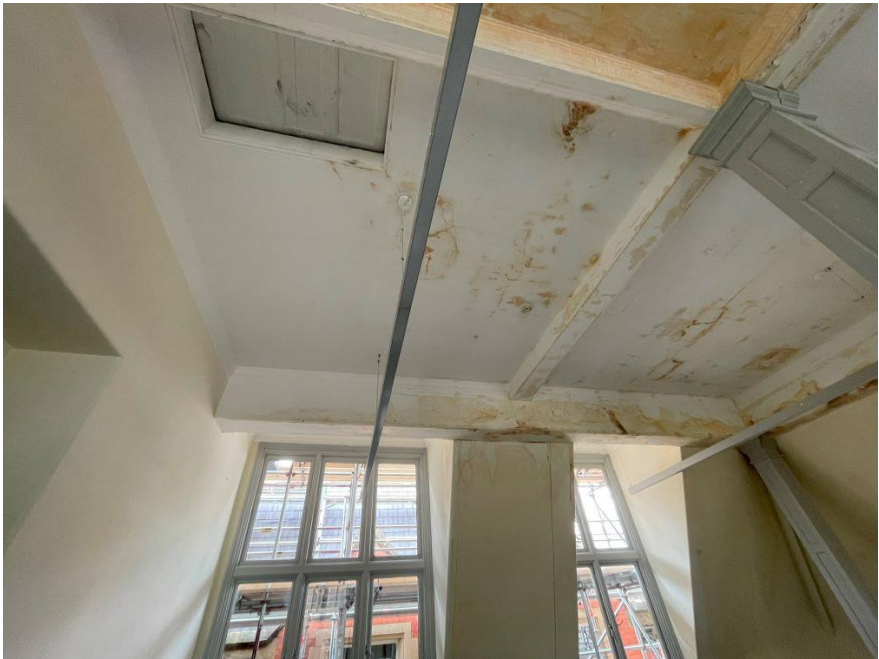
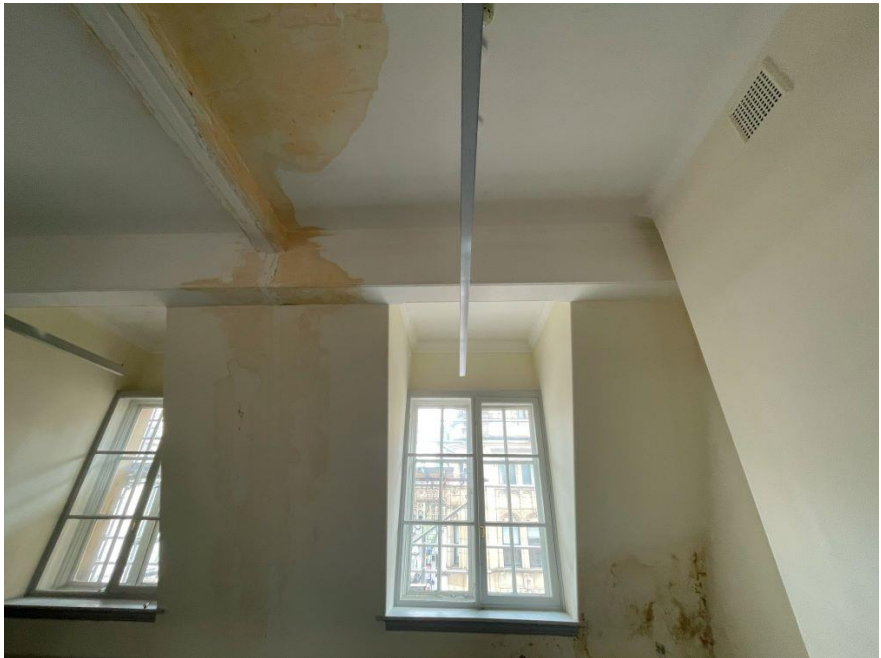
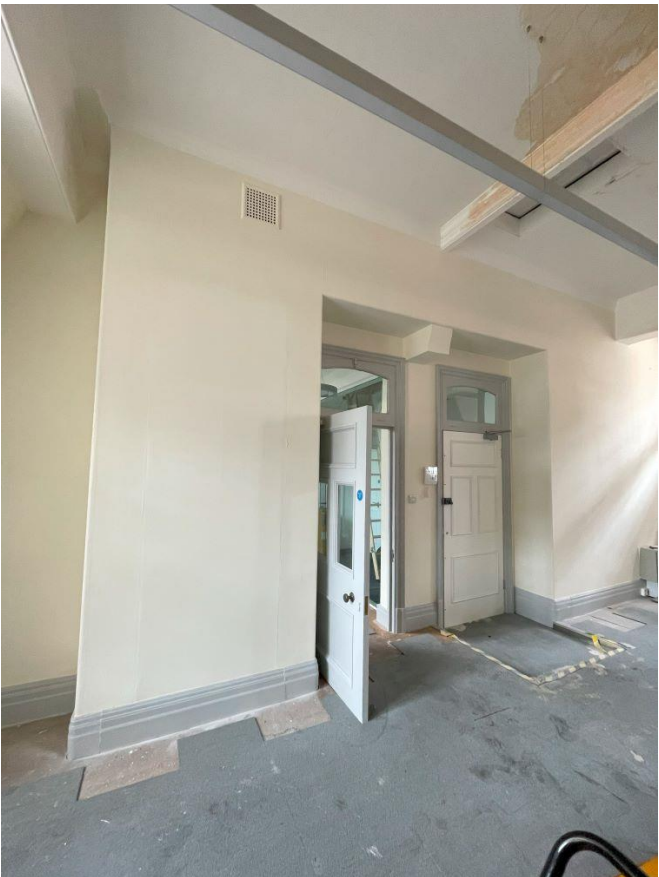
Photographs show columns to perimeter of the space with timber facings, but also show extent of water damage to ceiling and walls

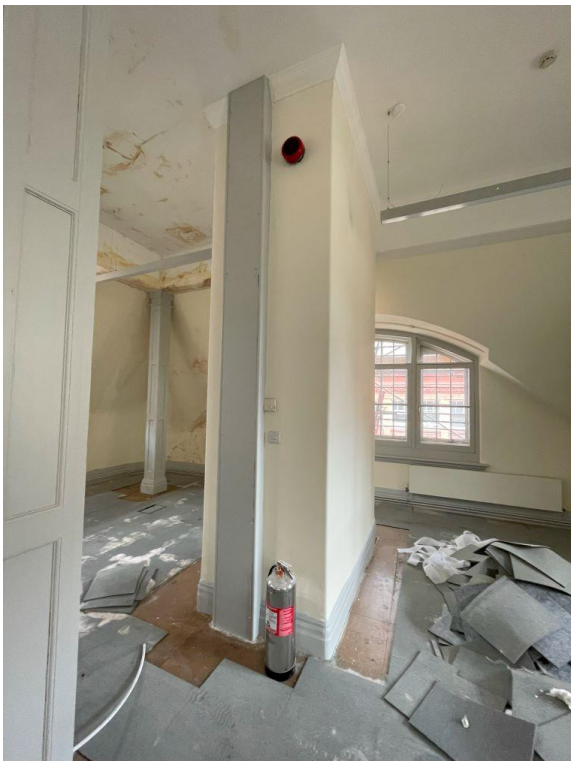
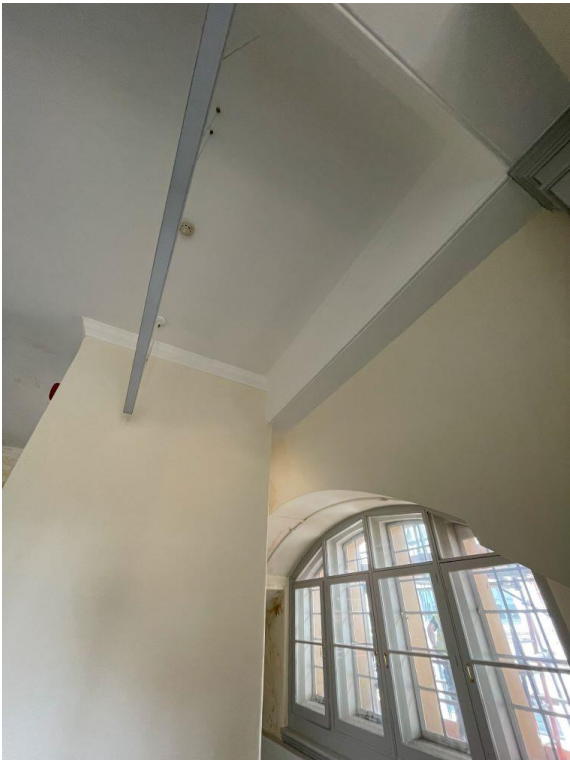
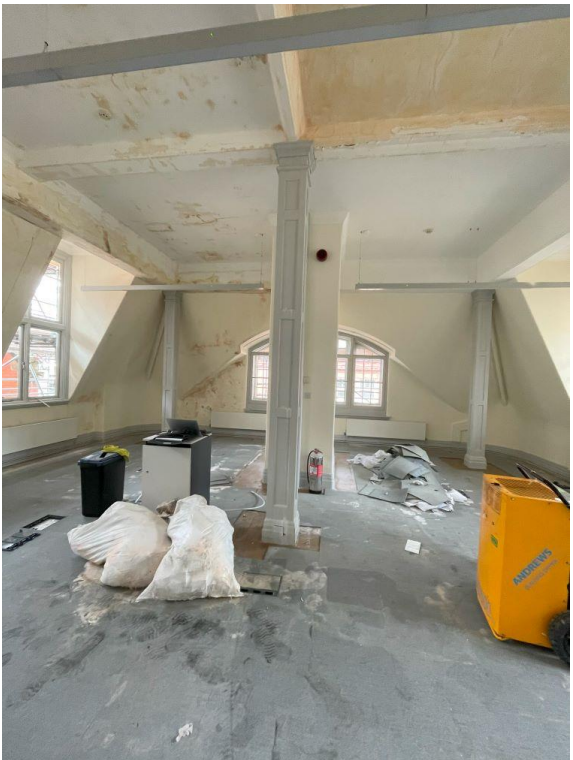
The space to the North end of the third floor is open plan. Many of the ceiling and wall finishes have been badly water damaged

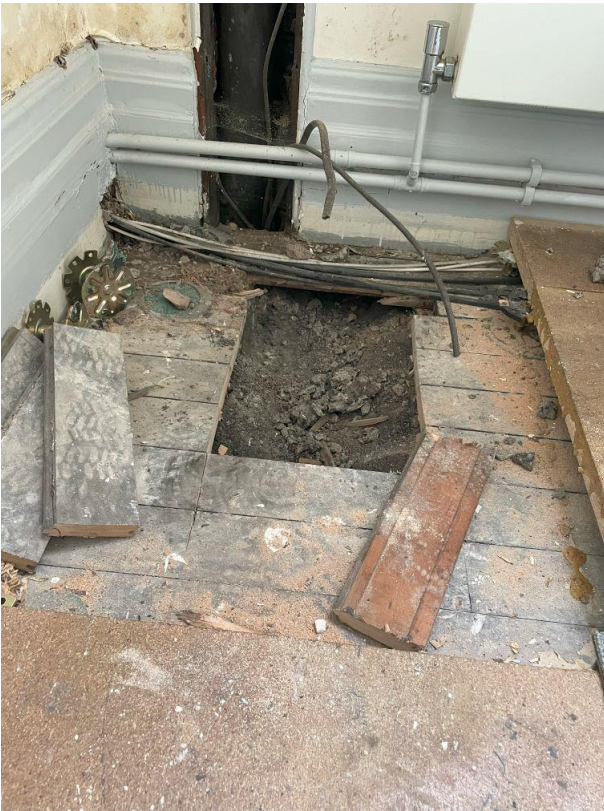
Shallow plywood raised access floor and damage to timber floor
