Phase II Geoenvironmental Site Assessment  
Vine Street, Gorton

Reference: 14-944-R1-2  
Date: January 2022

## **PHASE II GEOENVIRONMENTAL SITE ASSESSMENT**

Land off Vine Street  
Gorton  
Manchester  
M18 8SR

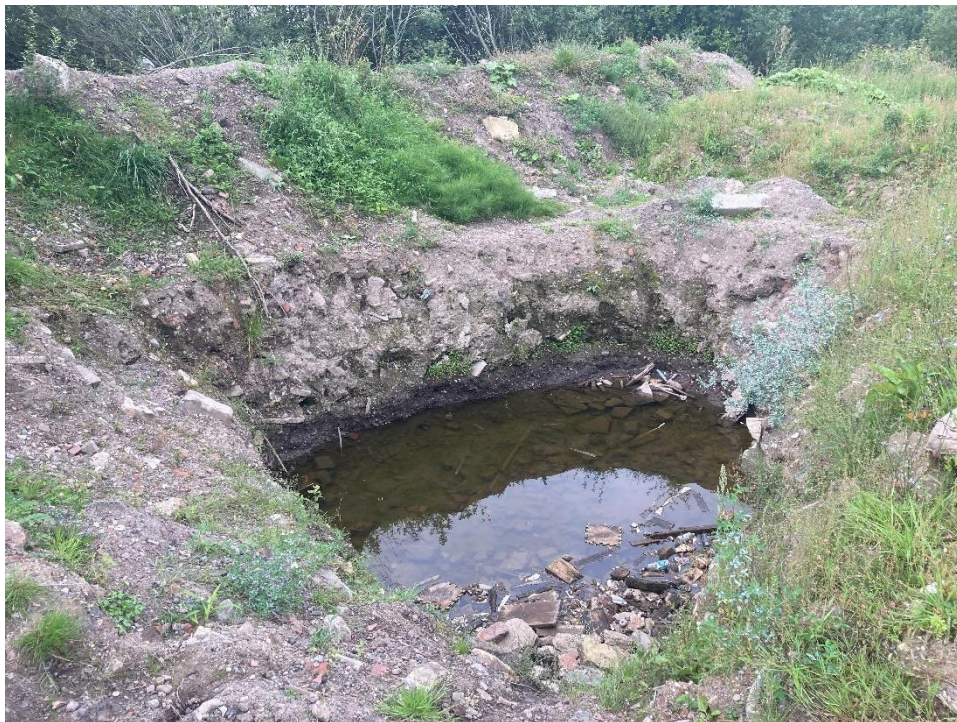
PLATE 2      VIEW OF EXCAVATION WITHIN THE WESTERN SECTOR

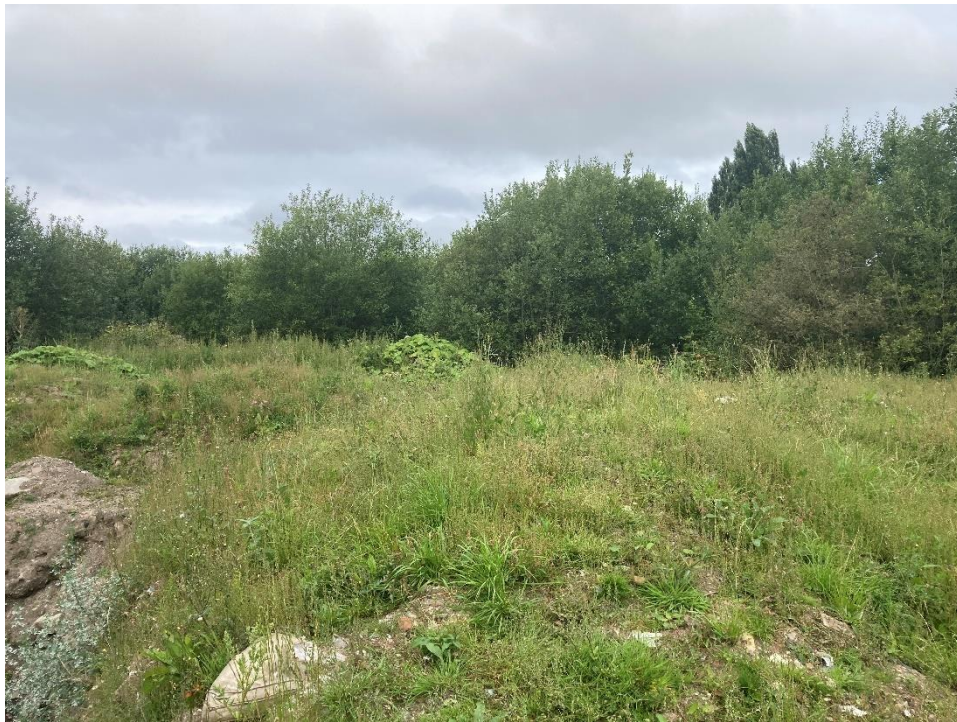
Based on these results, the material within the stockpiles can be removed as non-hazardous.

PLATE 3 VIEW OF WASTE STOCKPILES IN THE WESTERN SECTOR

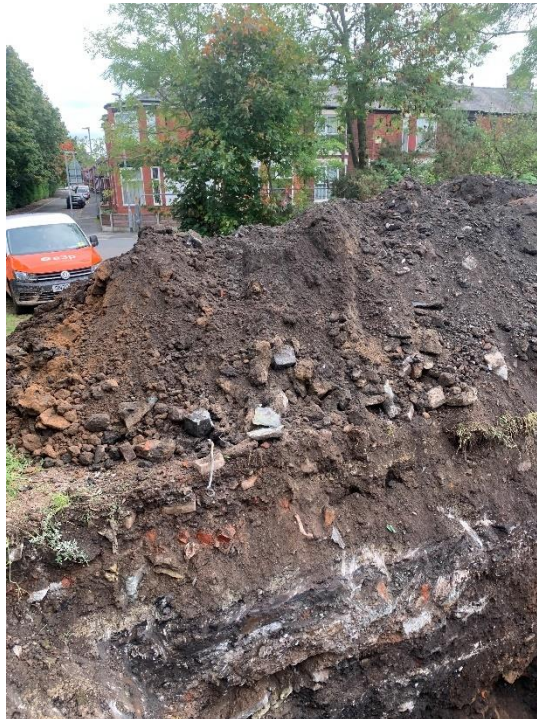
PLATE 4 EXCAVATION FOR CULVERT TRENCH (EASTERN SECTOR)

However, during the enabling works, it is recommended that a watching brief is completed in this area to confirm the presence or absence of the feature.

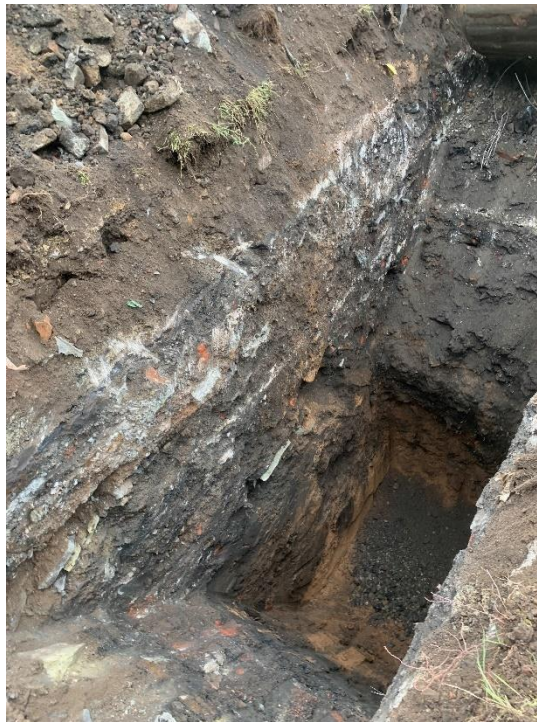
PLATE 5

EXCAVATION FOR CULVERT TRENCH (EASTERN SECTOR)

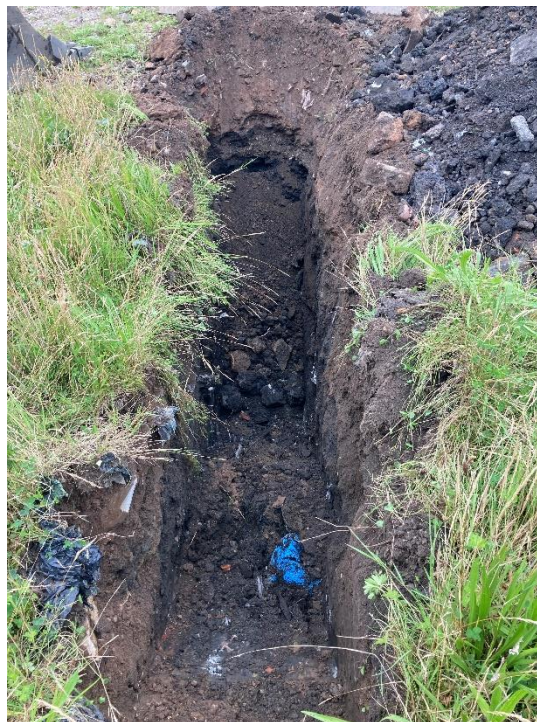
PLATE 6

The sides of the exploratory trial pit excavations appeared to be generally stable during excavation with the exception of TP106, where sidewall collapse was observed and the excavation terminated on a concrete obstruction.

EXAMPLE OF SHALLOW GRANULAR MADE GROUND (TP106)
