CLIENT: The Parish of Our Lady of Mount Carmel Blackley

PROJECT: Our Lady of Mount Carmel, Blackley

Repair Proposal - North Aisle / Abutment Gutter

| PURPOSE OF ISSUE: | | | |
|---|---|---|---|
| MC-BTP-00-ZZ-DR-A-4200_103.A | | | |

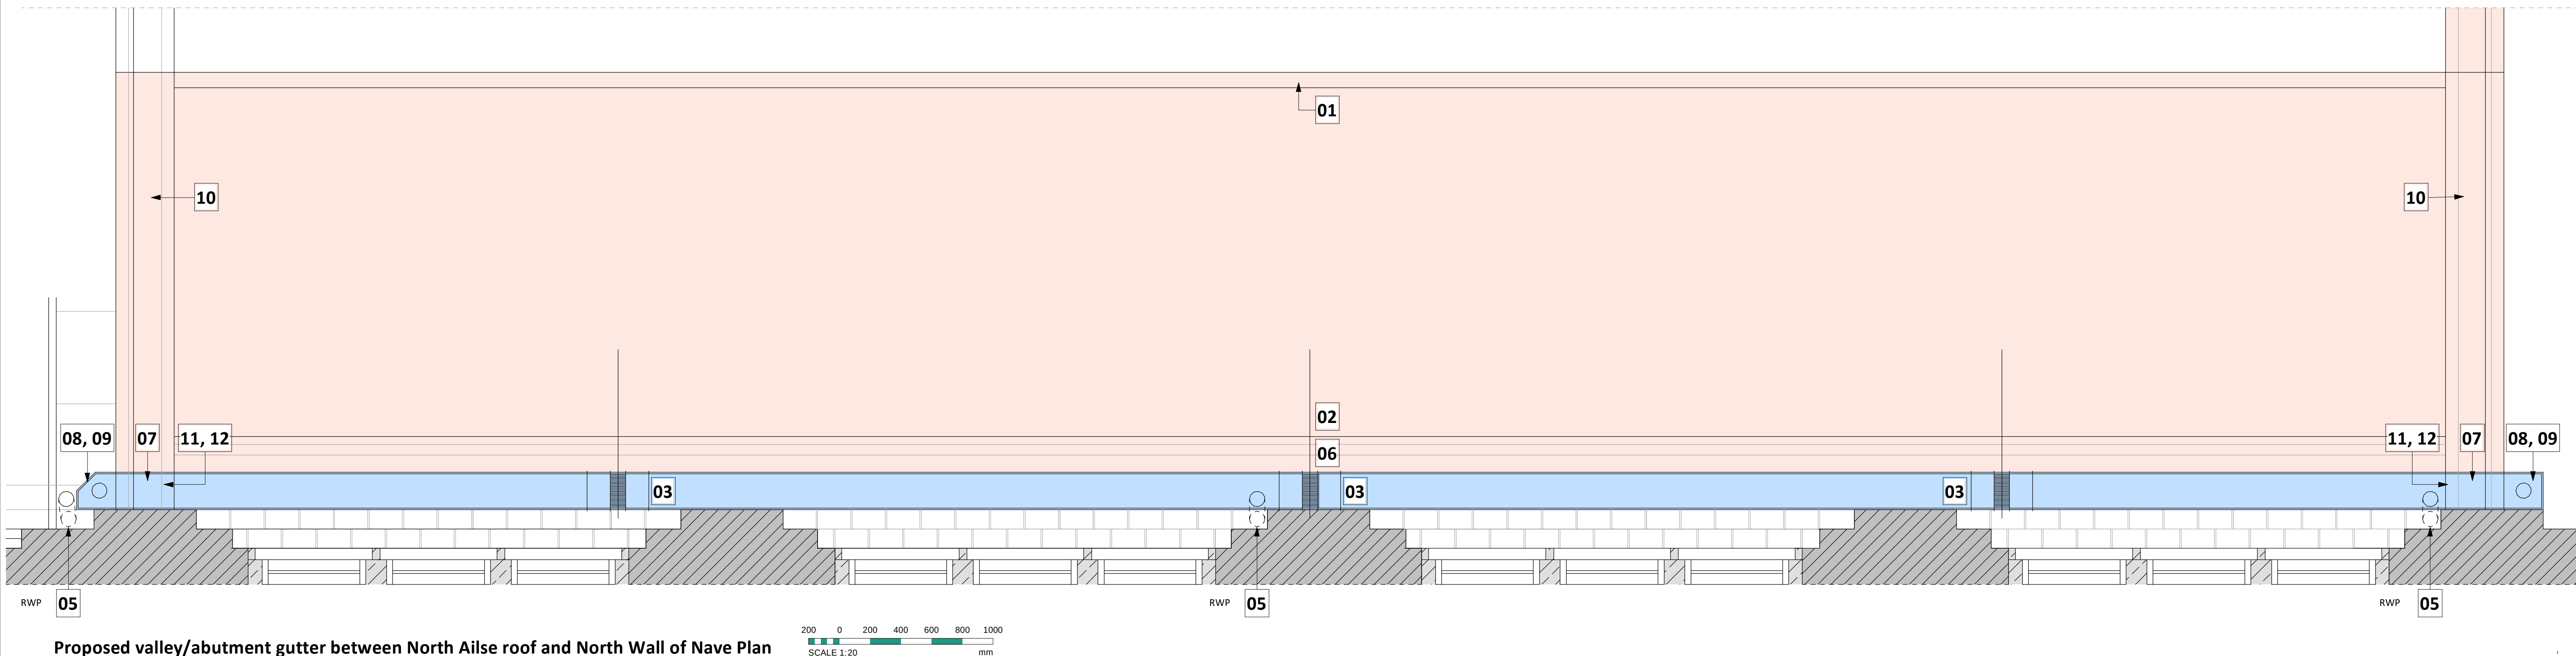
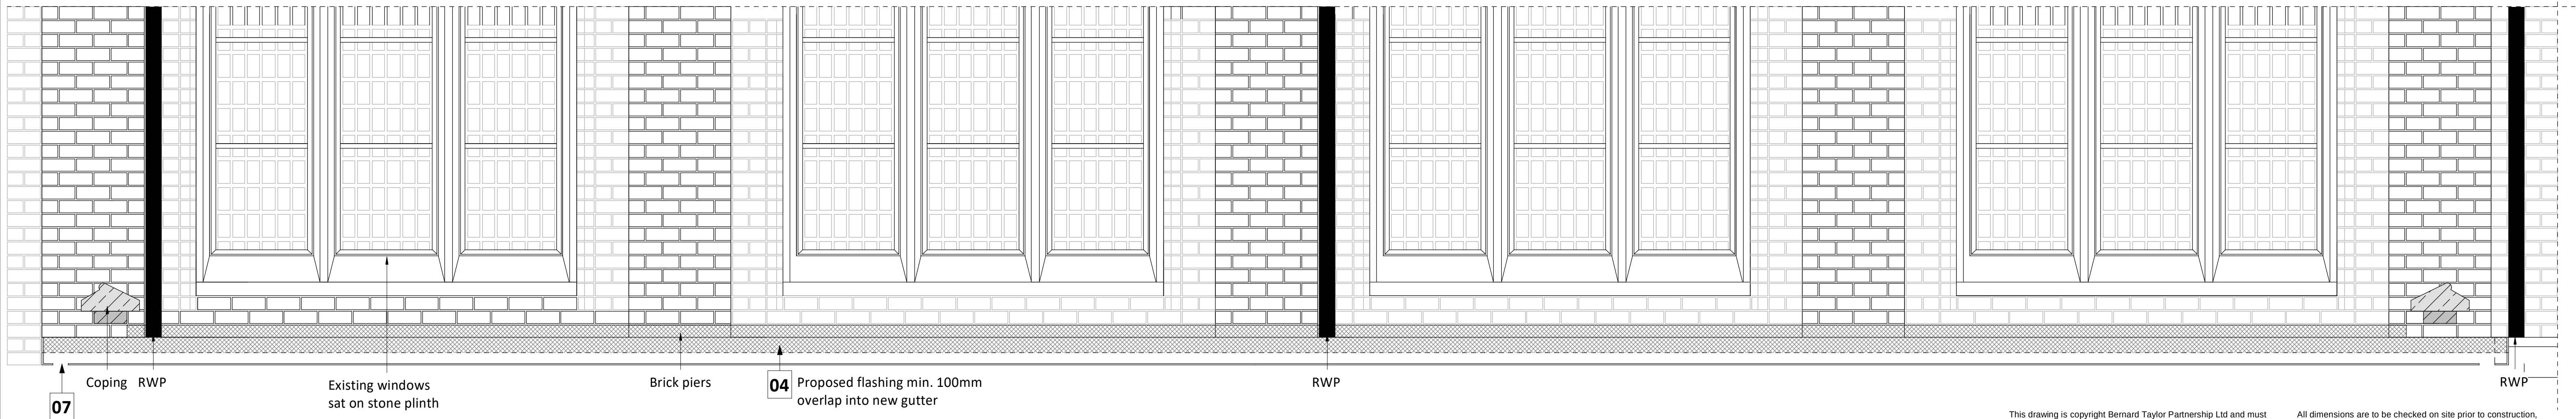
## Sectional Elevation through abutment gutter (Nave North Elevation)

Approximately 15m long cast iron (assumed) sectional trough gutter laid to discharge at each end via a spitter pipe onto the roof areas at the east end onto the flat roof and west (inclined trough) ends. The cast iron gutters are assumed to have failed at the joints in the individual sections and have subsequently been lined in a flexible bituminous sheeting (Red mineral faced felt?).

Red mineral faced felt has been used as a flashing from the Nave north wall dressed underneath the lower plinth cill brick and down into the existing cast iron trough gutter.

The existing trough is assumed to be supported off horizontal bearers from the inclined joists of the North Aisle roof structure (south side). The bearers may have been fixed to provide a nominal fall from the centre of the gutter to the east and west outlets.

Originally, it is likely that the slates would have terminated over the cast iron trough gutter but it appears that this detail has been altered when the roof to the North Aisle was renewed. The presence of a now brittle black sarking felt (BS5747) would suggest that this was likely to have taken place in the 1970's or 80's. It is assumed that at this time, a secondary tilting fillet was introduced a further up the roof slope thereby providing a wider more accessible gutter for maintenance (loft traffic). A lead flashing was then used to weatherproof the exposed sarking board at the junction with the cast iron trough. The gutter was then dressed down into the gutter and was then dressed up and over the new tilting fillet and tacked to the sarking boards which terminate at the first listing batten. The exposed lead which has been the subject of the recent lead theft incidents and has been replaced with a temporary Ubiflex sheet repair.

Over the length of the cast iron gutter 3 no. rainwater pipes from the Nave roof over discharge into the gutter via anti splash shoes just above and partially onto, the plinth cill course to the windows. These are encouraging the growth of moss on the plinth bricks which would suggest the run off is saturating the brickwork in these three locations.

**02** 3no. courses of (REV A) the existing slate roof finish to North Aisle southside to be carefully stripped back to existing substrate/ roof joists. Include for removal of Ubblex temporary repair and for all boarding/ tilting battens at gutter. Assess slates for reuse and sort/ record/ store in safe position. Repair/ renew damaged and rotten areas of boarding/structural timbers as necessary. Lay Proctor's Roofshield breathable underlay in accordance with manufacturer's recommendations, and 50 x 32mm tanalised slating battens to accept re-laid slates in regular courses. Make up any shortfall in reclaimed matching slates, carefully sourced to follow existing in size, texture and edge finish (allow 40%). Minimum slate head lap: 75mm.

**04** At upstand to north wall of Nave, the new gutter is to have a new TCSS flashing with a minimum 100mm lap down into gutter and dressed/wedged into mortar joint below the lower plinth brick to window cills. Joint to be pointed up on completion with compatible coloured mastic to architects approval. Allow for TCSS clips at maximum 450mm centres along loose edge of flashing.

**05** At locations of existing cast iron rainwater pipes, allow for providing TCSS splash plate dressed behind existing anti-splash shoes, up wall no course and dressed into bed joint. Wedge and point as noted elsewhere. Plate to be a minimum of 300mm wide with 50mm upstanding edges to direct water down and into gutter. Allow for clipping leading edges in two locations.

**06** To roof finish, slates on the *first 3 courses* (REV A) are to be re-laid to allow the formation of an inclined TCSS flashing/impact plate over lower 450mm of roof slope. This is to allow for foot traffic for future maintenance access. Flashing to be dressed a minimum 75m down into gutter and secured with clips at maximum 450mm centres along loose edge of flashing. Flashing to be then dressed up over new sarking boards to form the inclined section of impact plate and then over the new tilting fillet/sarking boards before being dressed over the first slating batten. Battens and tilting fillet locations are to be set out and approved by the architect prior to fixing.

07 At each end (east and west) new trough gutter is to be formed to be dressed through projecting raking gables. The existing copings and supporting brickwork is to be carefully dismantled (see below) to allow the installation of the last section of gutter to each end. Once gutter is fixed and tested, the brickwork course over the gutter and below the flat end coping is to be rebuilt off a new 8mm by 200mm stainless steel flat plate lintol prior to the reinstallation of the flat coping and doc/fishing detail.

**10** At east and west end of the North Aisle, south face roof, the existing terracotta raking copings are to be carefully dismantled, cleaned off and set aside for reuse. Clean out well head and prepared for rebedding raking copings. Copings are to be bedded on Icopal Extra Load Alumite DPC undercloak carefully cut back to have 10mm overhang each side of upstanding gable. Re-bed and point up raking copings on 3:1 (sand-cement) mortar colour to match existing.
