Roof Asset Management Programme

Manchester Royal Exchange Condition Survey

Prepared By  
Tom Boon

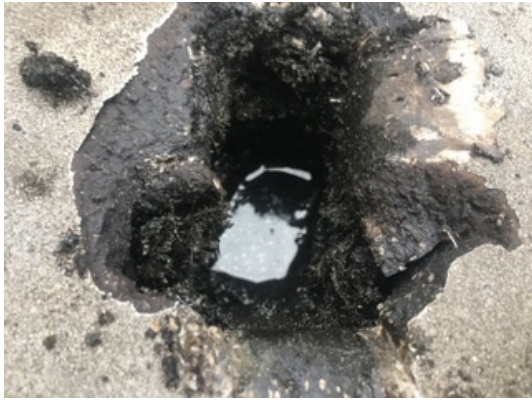
**Photo 1**

Core cut 1, as you can see the water has completely saturated the system this has subsequently degraded the foam glass insulation below leading to slumping and blisters across the whole section. a structural engineer will need to be brought in to determine whether the section is still structurally secure.

Due to the complete saturation of this section, the best solution is to completely strip the old top layer of asphalt and foam glass insulation and replace with a new fully built up system.

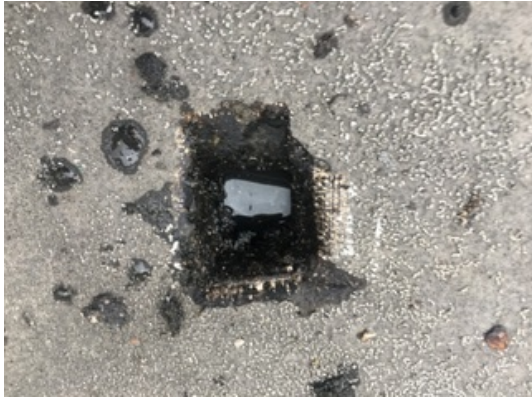
**Photo 2**

Core cut 2, this core was taken at the opposite end of the roof and is also completely saturated below this will need to be addressed ASAP

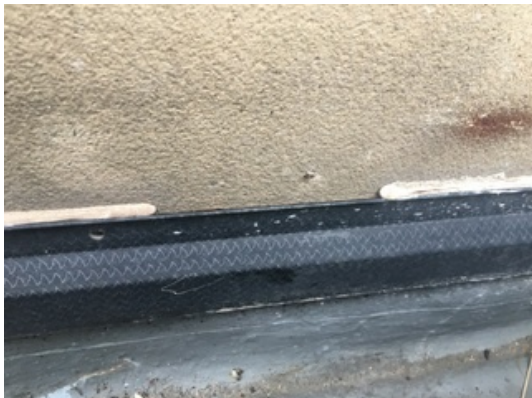
**Photo 3**

I found a number of areas where the sealant has failed along this termination bar

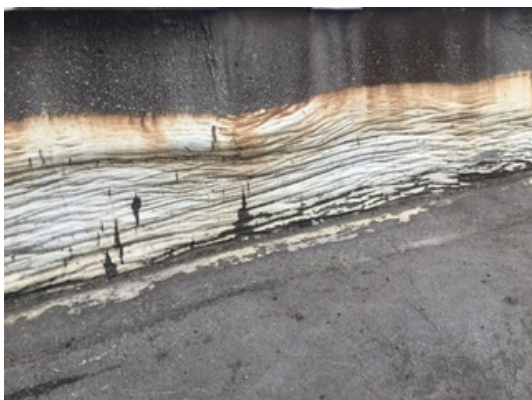
**Photo 4**

The perimeters are also displaying severe slumping of the asphalt leaving large folds in the upstands this will only deteriorate over time and needs to be resolved.

Due to the water ingress and UV damage the asphalt around the perimeter of the wall has severely slumped this will continue to get worse until it fails completely

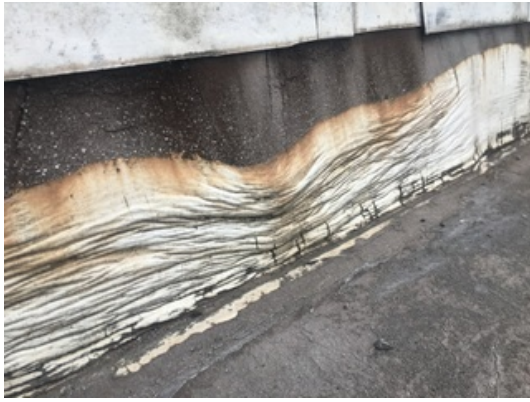
**Photo 5**

Another example of the above

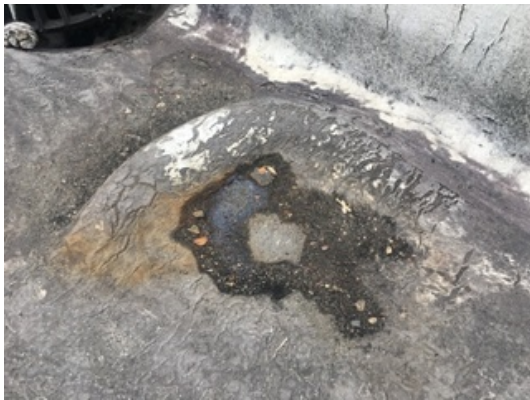
**Photo 6**

I've included a number of images of blisters and failures in the system, these are obvious signs of failures across the asphalt due to UV/water damage.

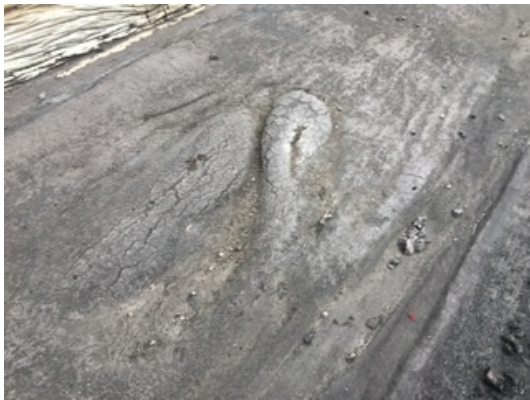
**Photo 7**

Example of a blister in the asphalt

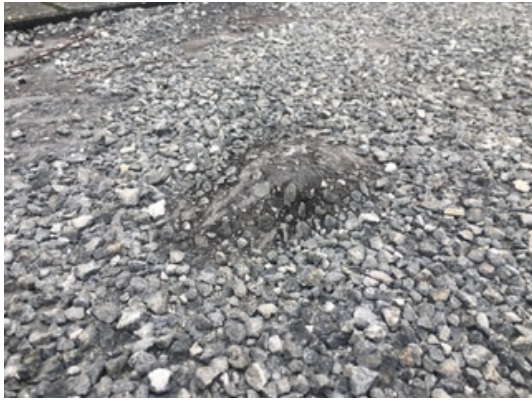
**Photo 9**

Example of a blister in the asphalt, this was found on the main field of the roof which is evidence that water has ingressed across the whole system and will need to be stripped

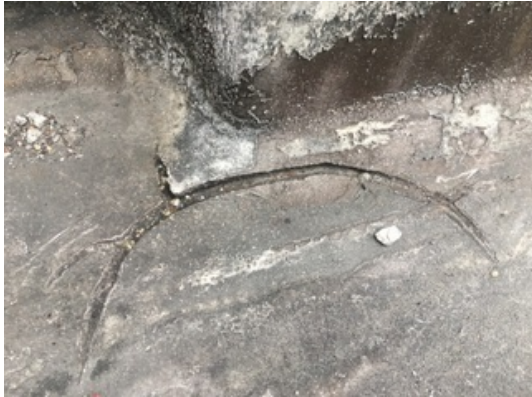
**Photo 10**

Large crack found in the asphalt

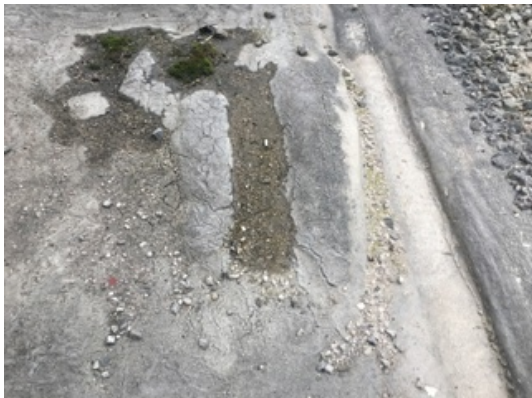
**Photo 11**

Example of a blister/slumping in the asphalt

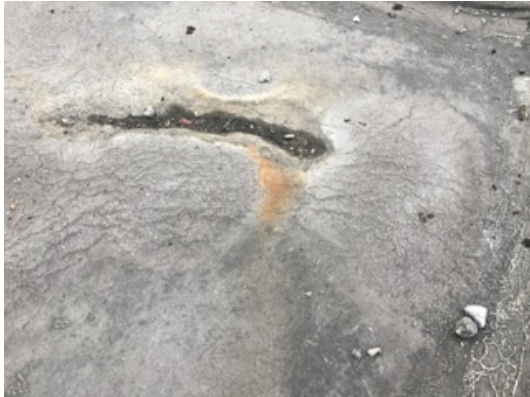
**Photo 14**

two large blisters found in this area

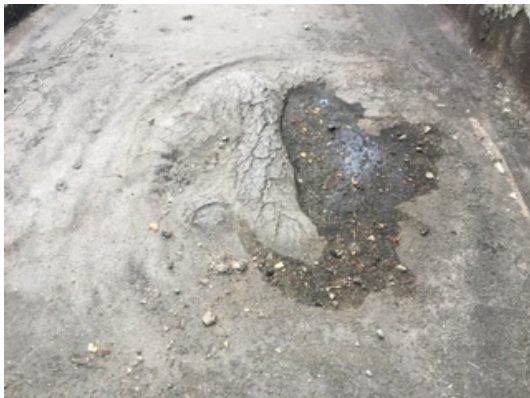
**Photo 15**

Example of a blister in the asphalt

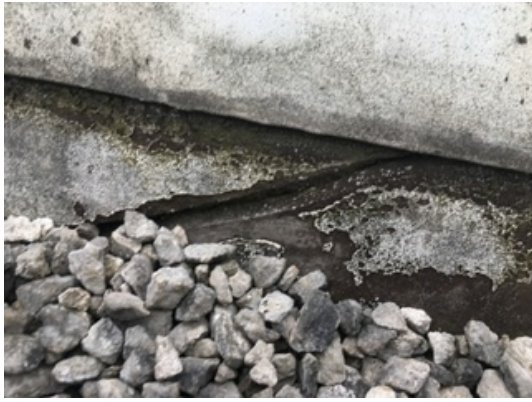
**Photo 1**

I found a number of areas where the asphalt has completely broken down and cracks have formed

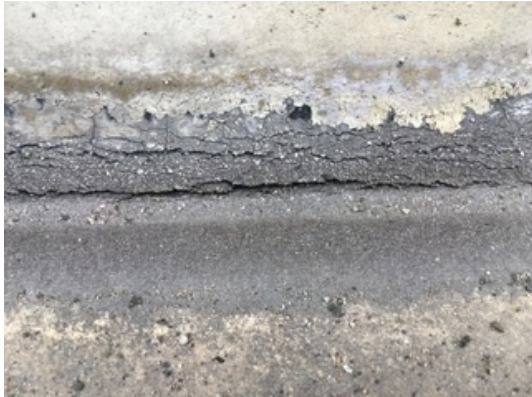
**Photo 2**

Evidence of cracks/slumping around the perimeter

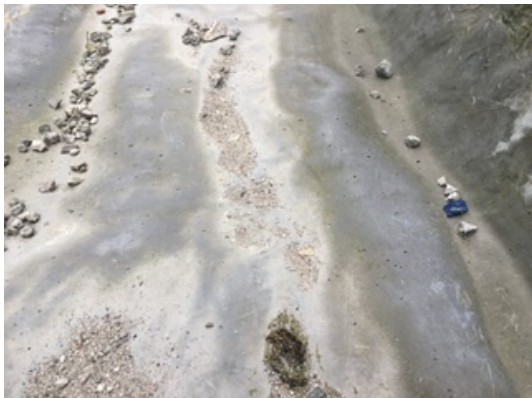
**Photo 3**

You can clearly see large blisters appearing in this area which is evidence of moisture trapped below

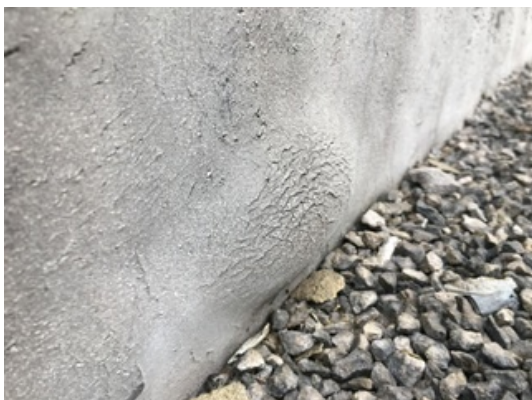
**Photo 4**

Another example of blisters around the perimeter of the roof

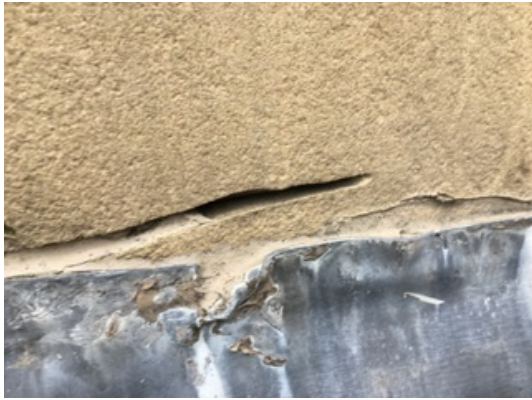
**Photo 5**

Cracking around the perimeter of the building

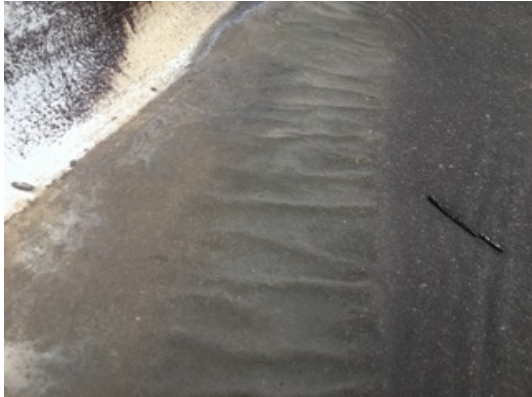
**Photo 6**

Evidence of ponding water which has subsequently lead to UV damage

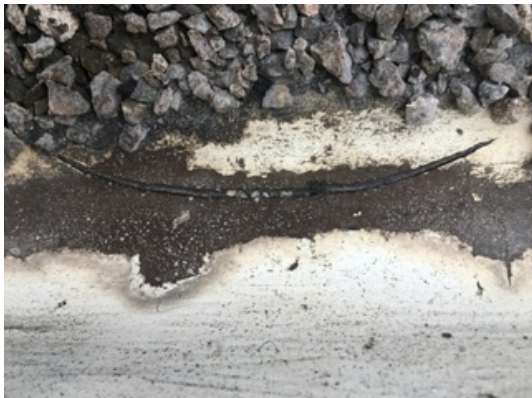
**Photo 7**

More evidence of cracking in the asphalt

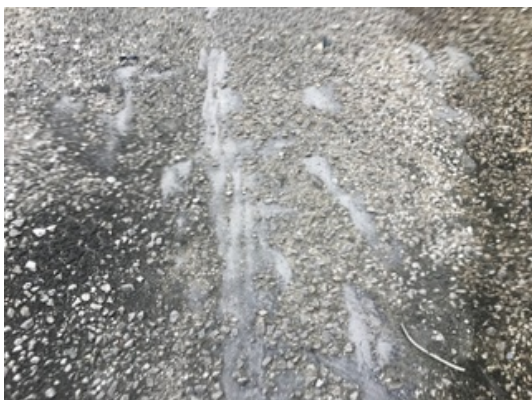
**Photo 8**

As discussed in the summary the main field has a loose laid aggregate which made it difficult to find defects, this is one area where blisters are present

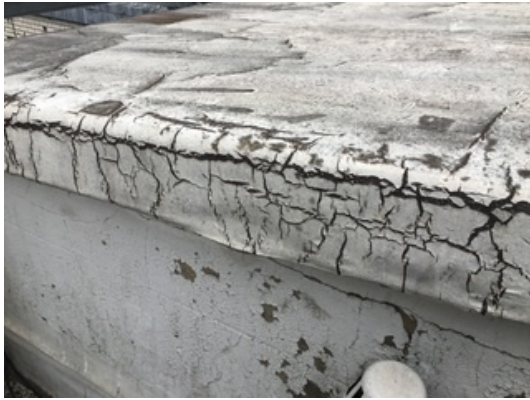
**Photo 9**

Severe cracking of the asphalt on this section which will need to be addressed

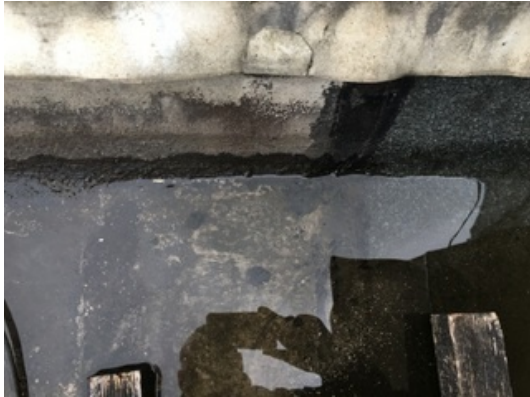
**Photo 10**

There has also been liquid coatings used on a number of the upstands which haven't been reinforced these are only a short terms fix and should be reapplied every six months. As a result of ponding water around the water pump, the felt has started to lose its mineral content, bare felts are common in these sort of circumstances due to UV damage, I would suggest keeping an eye on this area and replace the felts when they start to display blisters none was present at the time of my visit.

As discussed in the summary the ponding water in this area is leading to bare felts of the torch applied membrane this will lead to failure over time and will need to be monitored closely

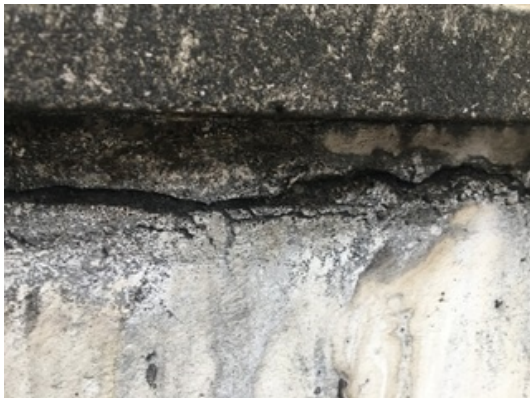
**Photo 11**

There is an internal parapet wall between roof section B and D where the coping stones have completely failed in places, I have provided images of the failed mortar and some severe cracking below the coping stones, as part of ongoing remedial works I would suggest that these are repaired as soon as possible to prevent water getting permeating the system in this area.

Cracks are present under the coping stones between roof section B and D

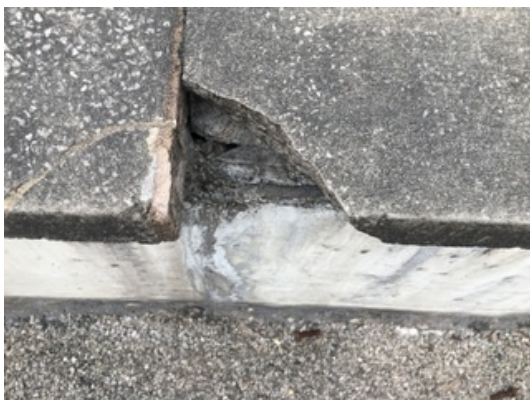
**Photo 12**

Coping stone failures

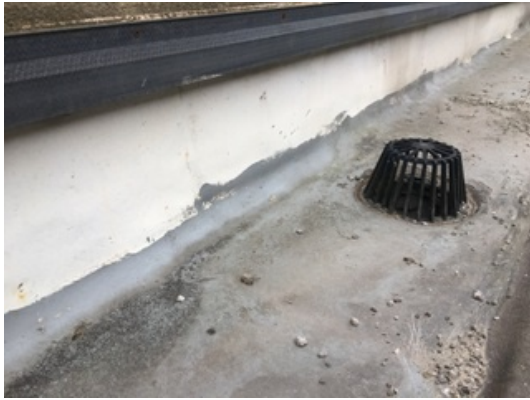
**Photo 13**

Example of the unreinforced liquid coating being used, this will need to be reapplied regularly

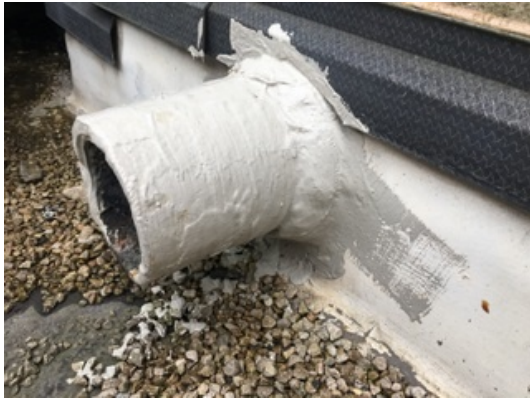
**Photo 17**

Example of temporary repairs made in this section

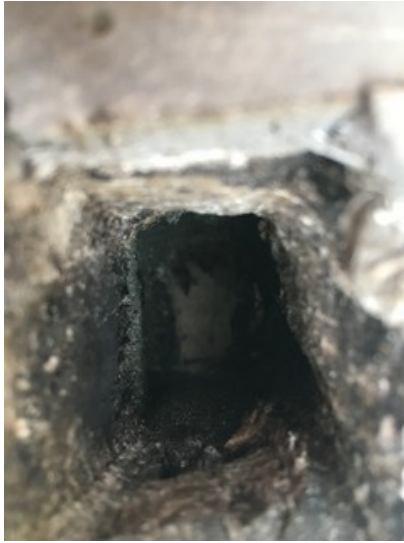
**Photo 18**

A core cut was performed on this section, I have provided full details of the build-up on this report

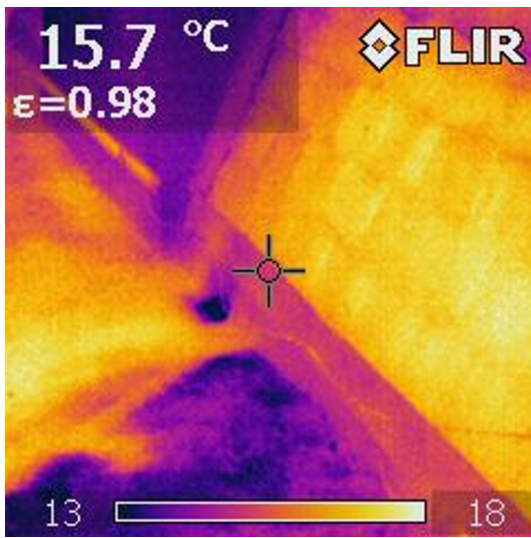
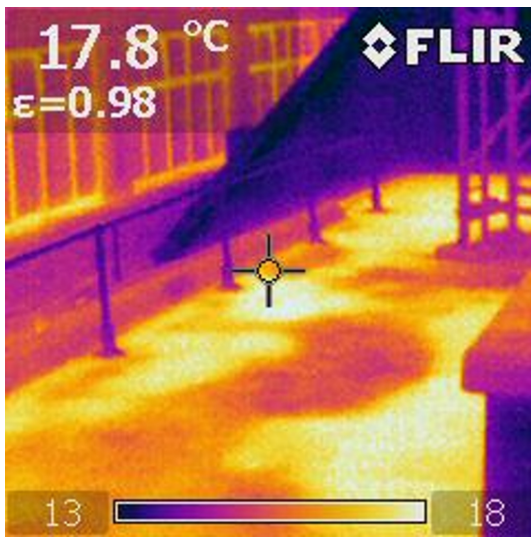
In order to fully understand the extent of water ingress across the site, thermal imaging photos were taken on the roof section. As is very clear to see, the yellow areas are where the roof is emitting a large amount of heat from the facility due to poor thermal capabilities and the purple and black areas are water ingress issues.

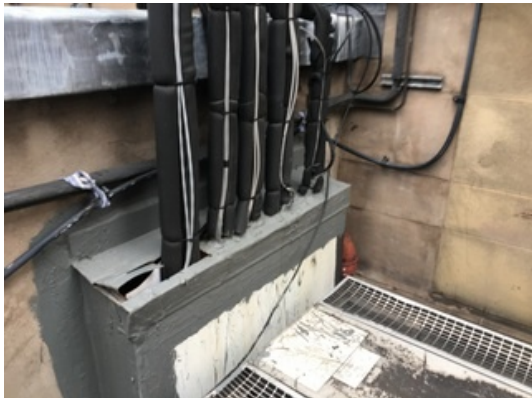
**Photo 1**

Example of poor detailing you can see that liquids have been used but ultimately the cables haven't been made water tight.

- Clearing the drains of any debris
- Waterproofing a minimum of 1 meter inwards from the edge of the cage
- Correctly detailing all the upstands on the metal frame
- We would need to dress the waterproofing under the lead flashings
- Creating new housing for the cable boxes
- Correctly terminate all repairs
- Waterproof all the plinths

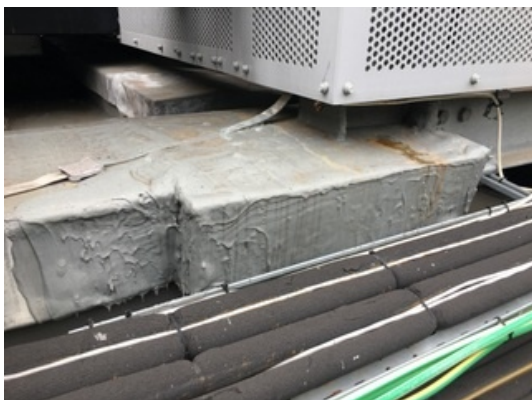
**Photo 4**

This liquid coating looks uneven the lightning conductor has also been coated over this will fail due to thermal movement

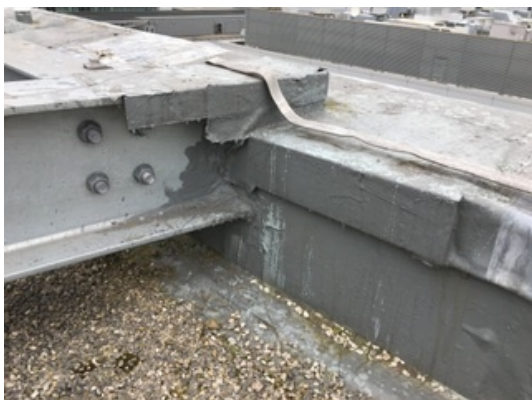
**Photo 8**

Poorly detailed repair

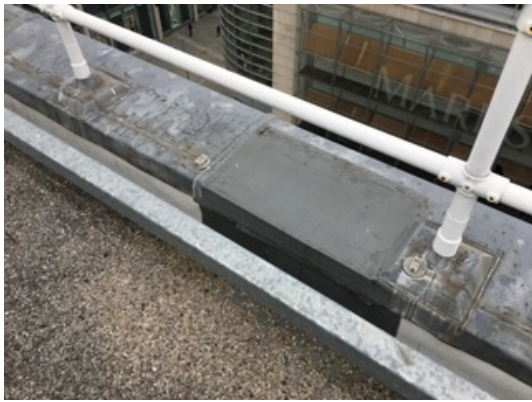
**Photo 9**

Liquid Repair

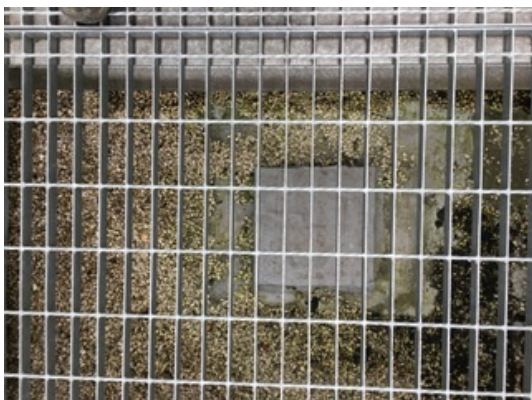
**Photo 12**

These plinths will need to redone I saw a number of failings on these sections

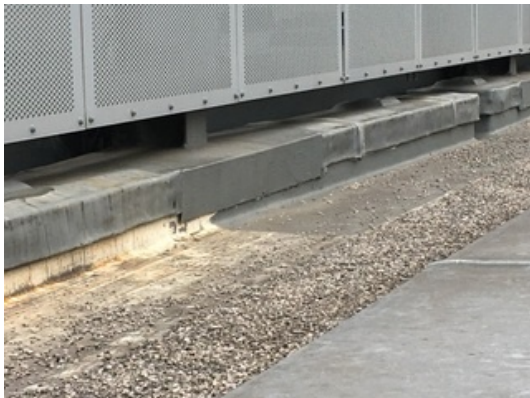
**Photo 15**

Unterminated liquid repair

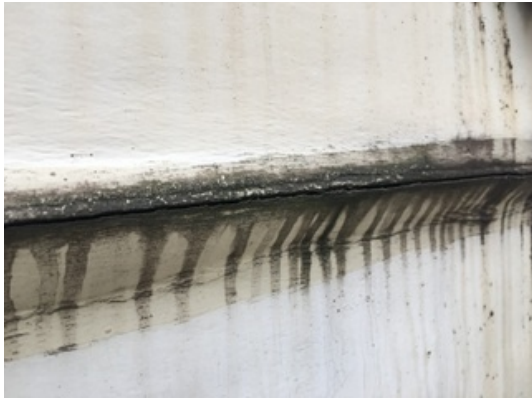
**Photo 1**

Example of failed abutment

| Minimal requirements for this roof are needed just the repair of the abutment which can be factored into the programme whilst works are being completed in other areas | | | |

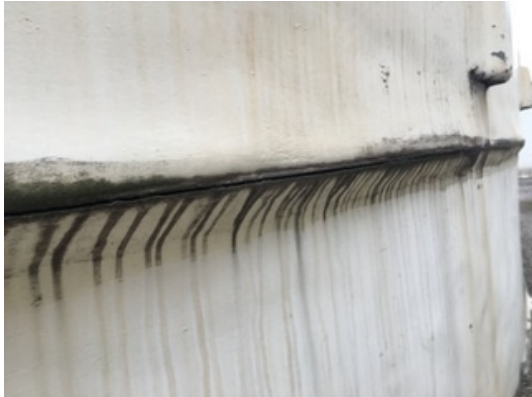
**Photo 2**

Example of failed abutment

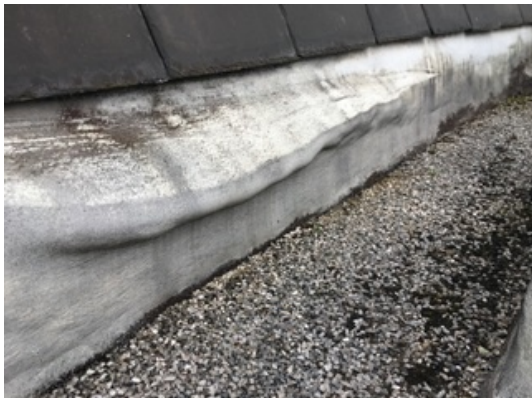
**Photo 3**

An isolated area of slumping

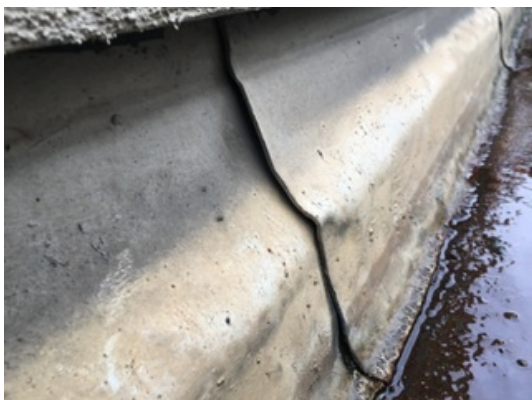
**Photo 4**

All flashings are in good condition

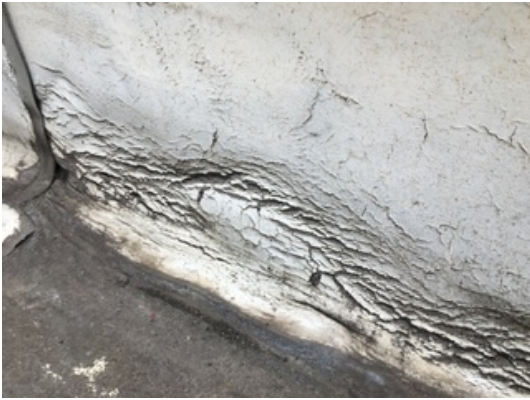
**Photo 2**

As discussed in the summary a found areas of slumping/blistering around the perimeters

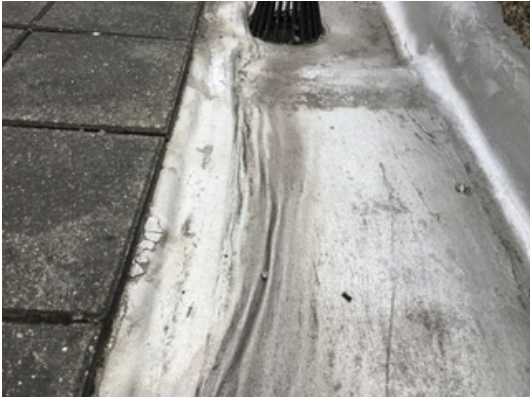
**Photo 3**

Evidence of folds and blisters in the asphalt

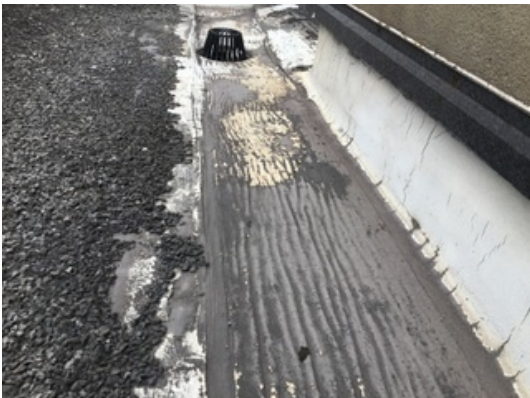
**Photo 4**

Evidence of UV damage and blistering in this area

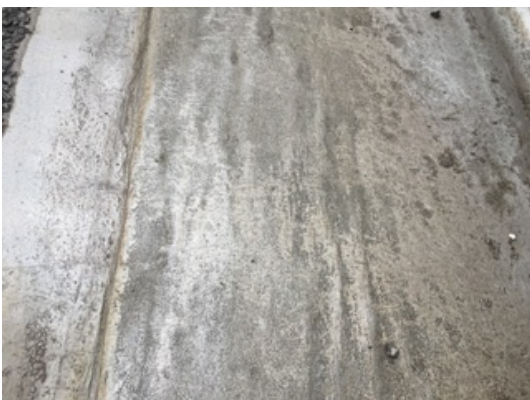
**Photo 5**

More evidence of UV damage in this area which has also caused some cracking

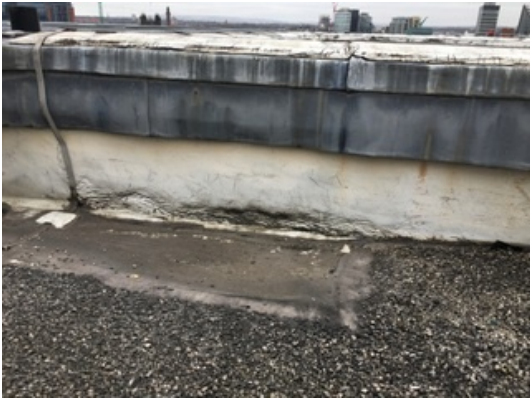
**Photo 6**

Slumping and blisters were found around the perimeter

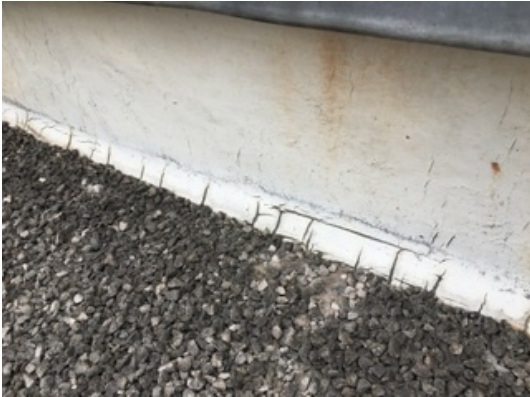
**Photo 7**

Cracks in the asphalt as discussed in the summary

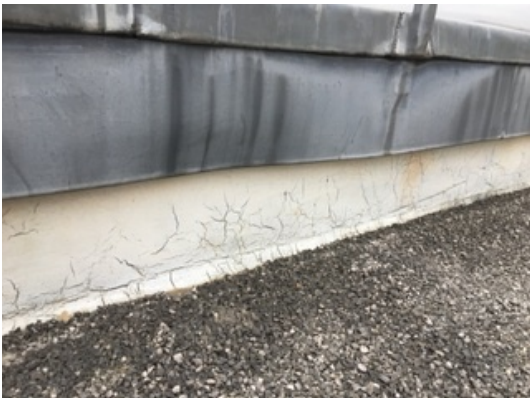
**Photo 8**

Failures around the perimeter

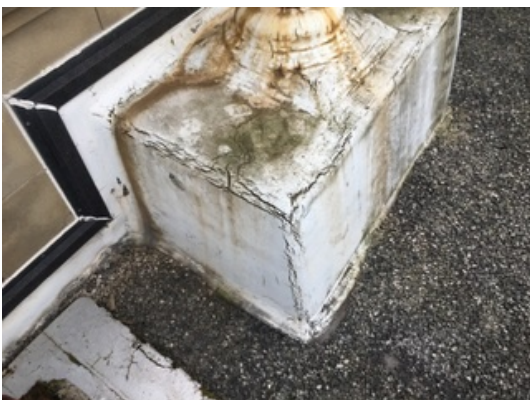
**Photo 9**

Deterioration in the asphalt on this upstand

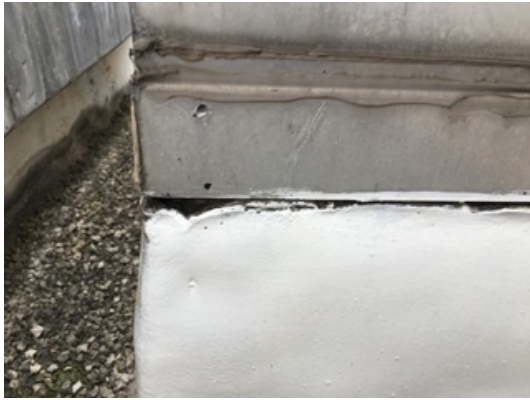
**Photo 10**

I also found a couple of failures around the flashings on the plant towards the back end of the roof, these aren't urgent but will need to be addressed if remedial works are carried out.

Failed flashing as discussed in the summary

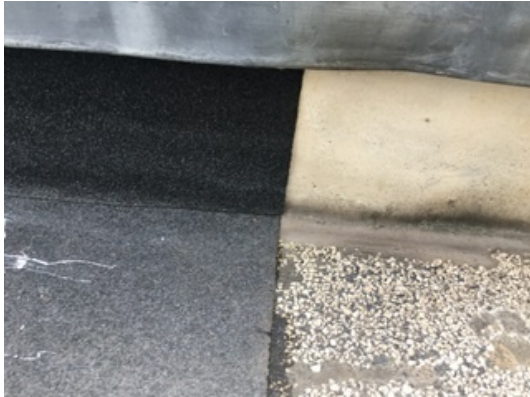
**Photo 11**

One area has been repaired using a modified bitumen membrane, I found some areas of the laps have started to debond from the substrate, this is due to the lack of bleed out created when installing, under a Garland specification we always require a minimum of 3mm of bitumen bleed out at the laps for this reason.

No bleed out created

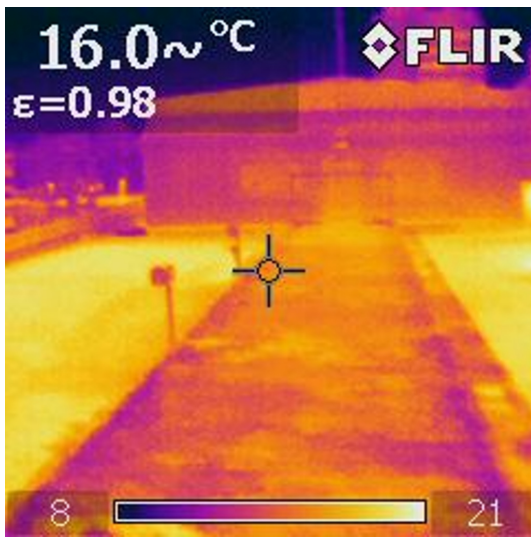
**Photo 14**

In order to fully understand the extent of water ingress across the site, thermal imaging photos were taken on the roof section. As is very clear to see, the yellow areas are where the roof is emitting a large amount of heat from the facility due to poor thermal capabilities and the purple and black areas are water ingress issues.

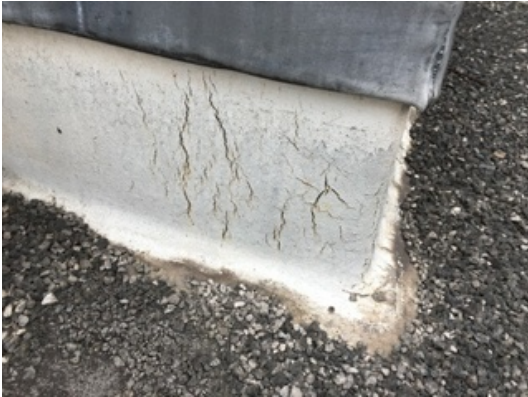
**Photo 2**

Cracking in the asphalt around the perimeter of the building

| No urgent action needed the current repair will need to be monitored as well as the cracking around the perimeter | | | |

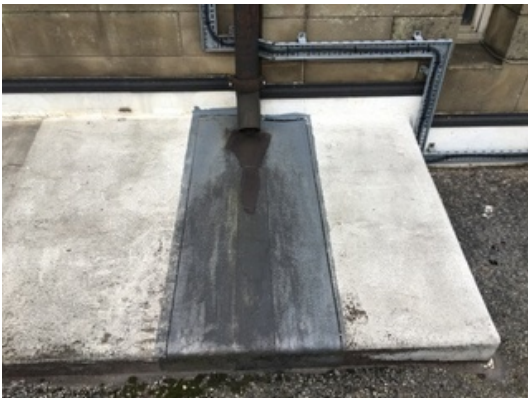
**Photo 3**

Liquid repairs made in this area

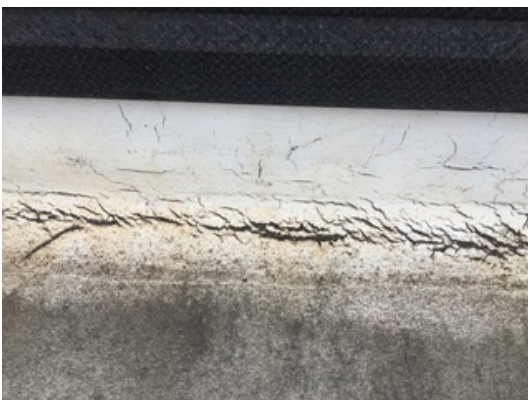
**Photo 4**

Cracking of the asphalt around the perimeter

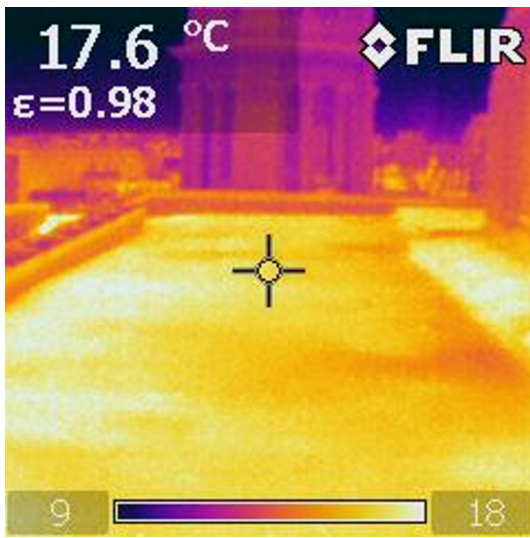
**Photo 5**

In order to fully understand the extent of water ingress across the site, thermal imaging photos were taken on the roof section. As is very clear to see, the yellow areas are where the roof is emitting a large amount of heat from the facility due to poor thermal capabilities and the purple and black areas are water ingress issues.

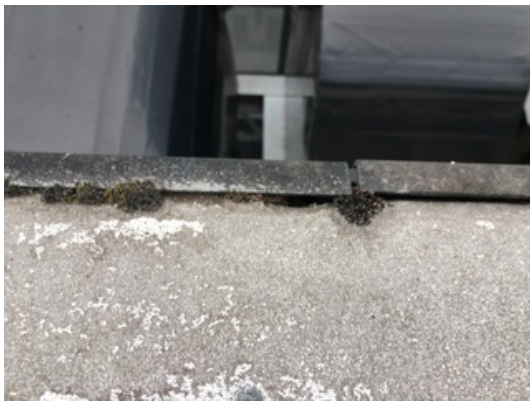
**Photo 2**

Missing sealant around the trim

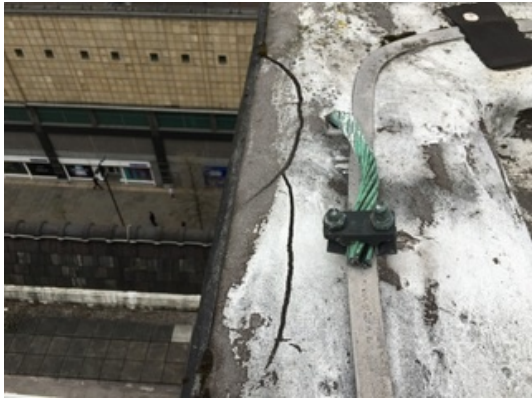
**Photo 3**

Cracks found around the perimeter of roof section G

No urgent action needed but a repair should take place on the cracks found in the asphalt again this can be added onto a work programme once work starts on the other sections.

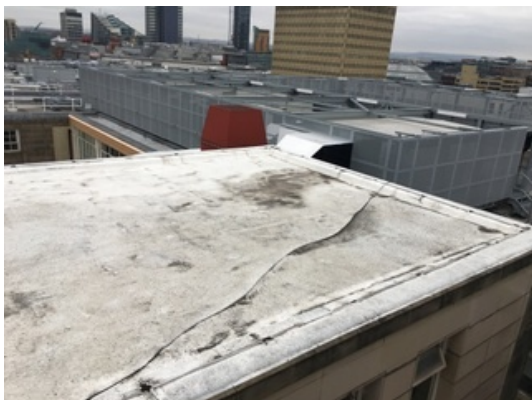
**Photo 5**

Roof section I cracking is present
