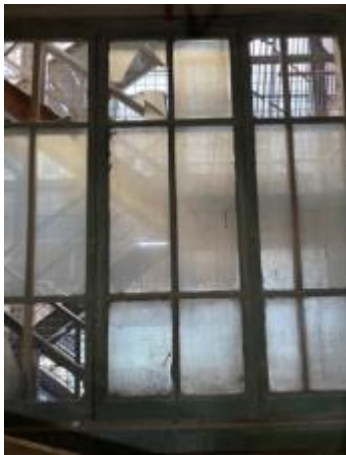
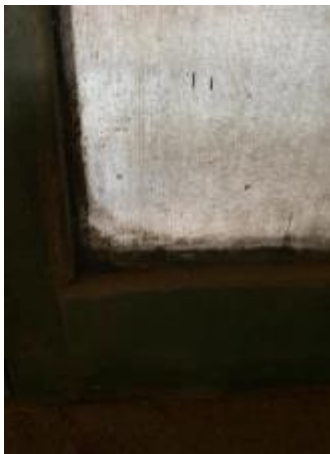
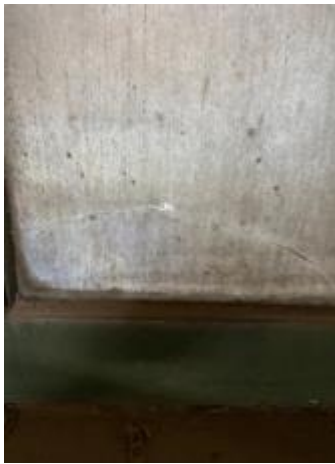
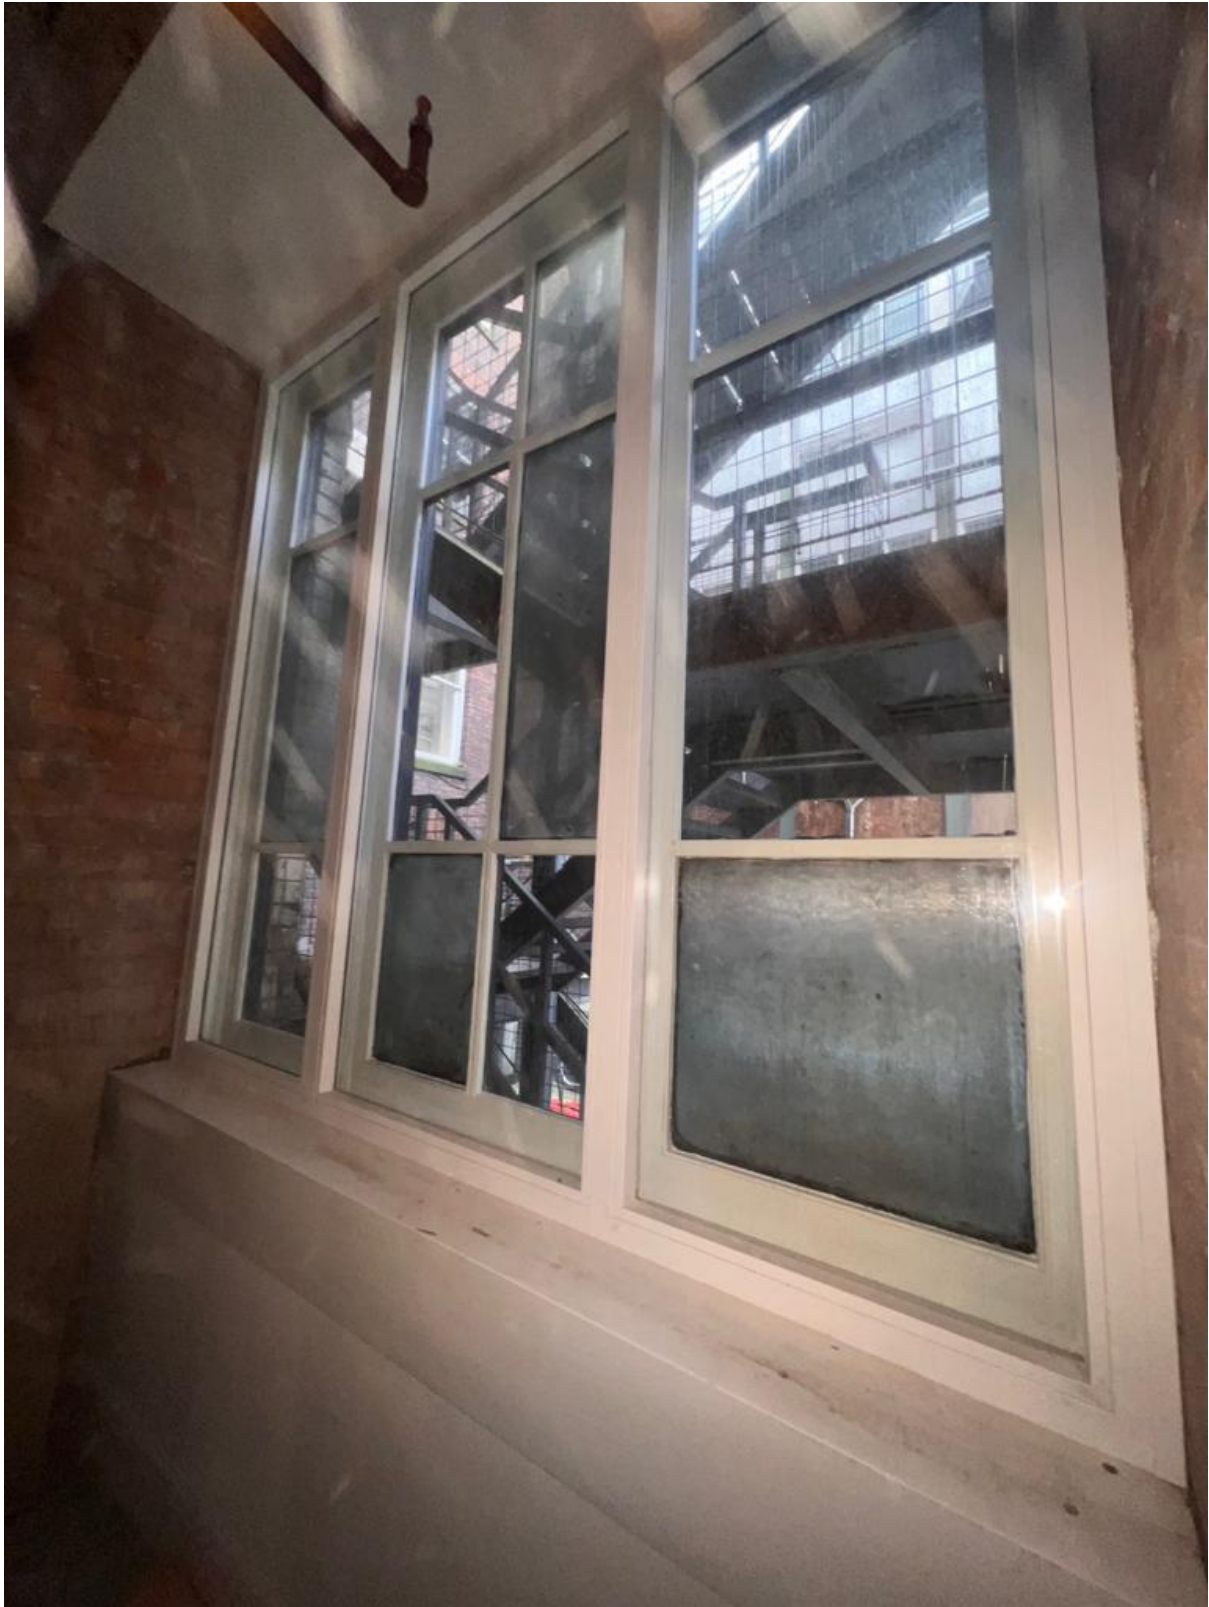
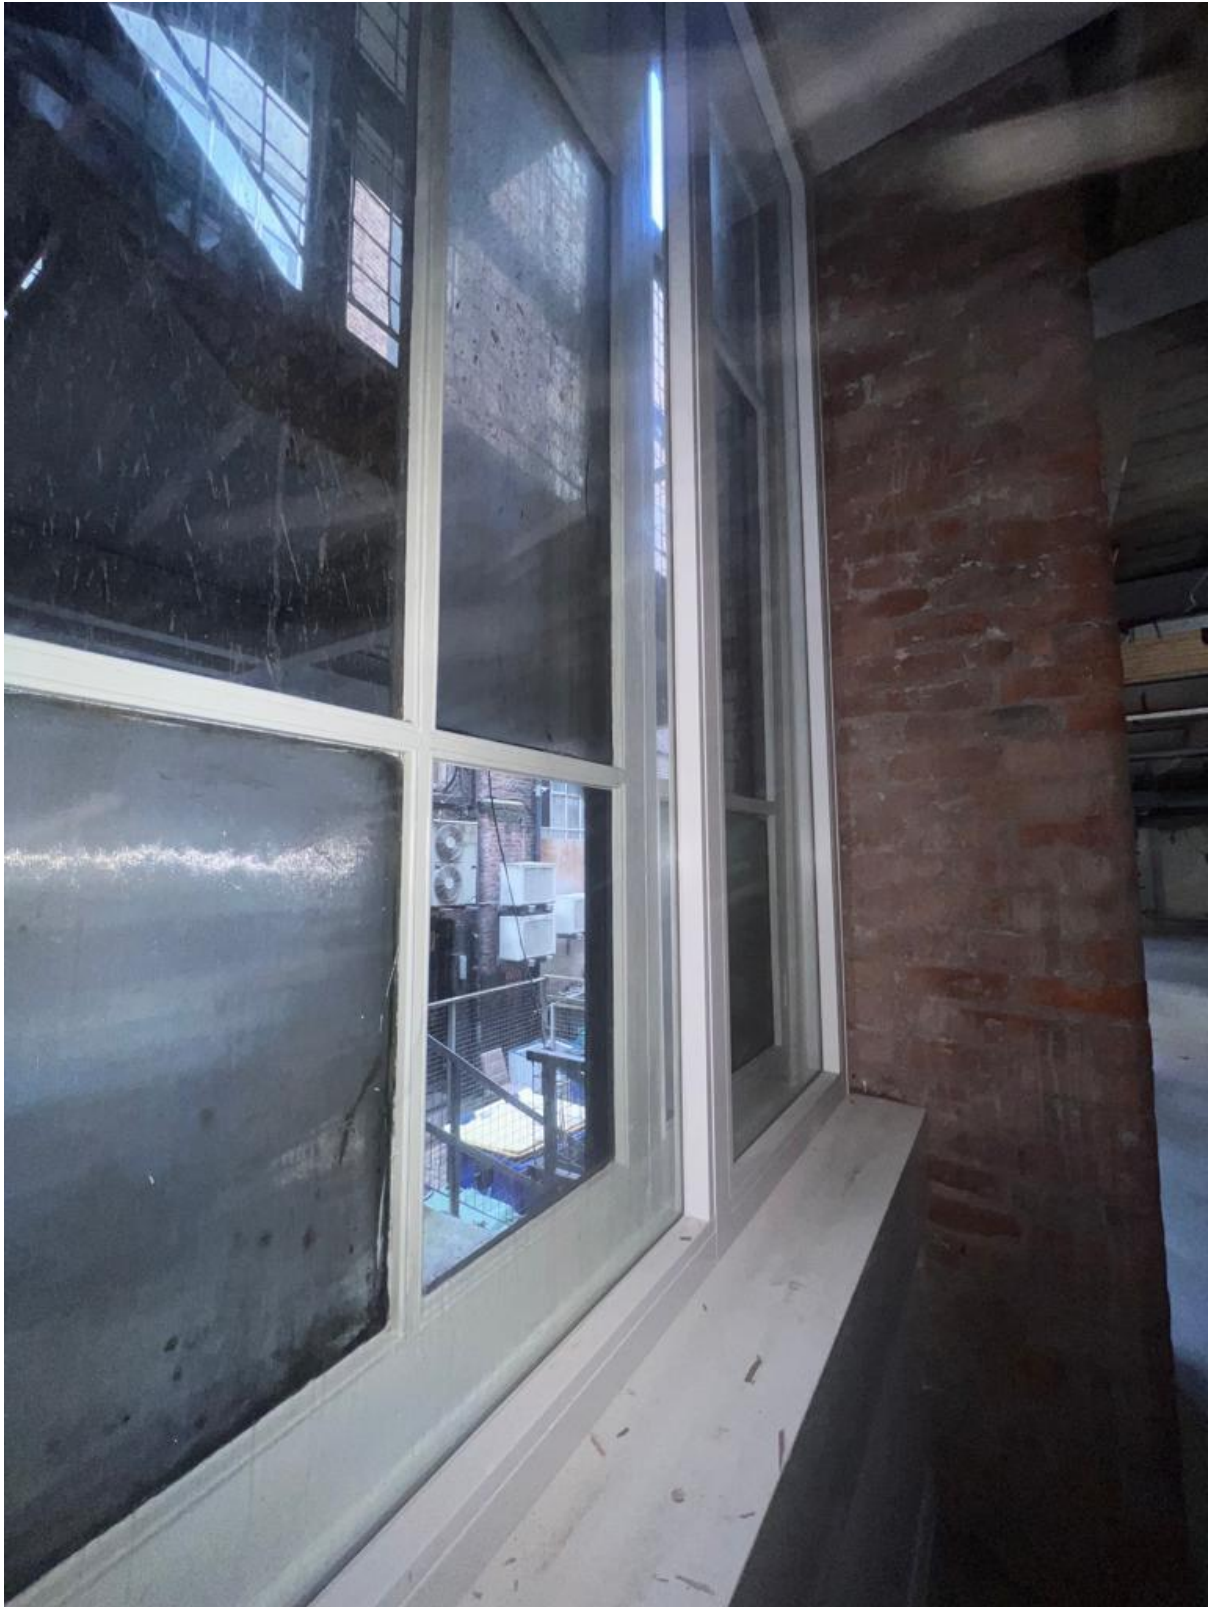
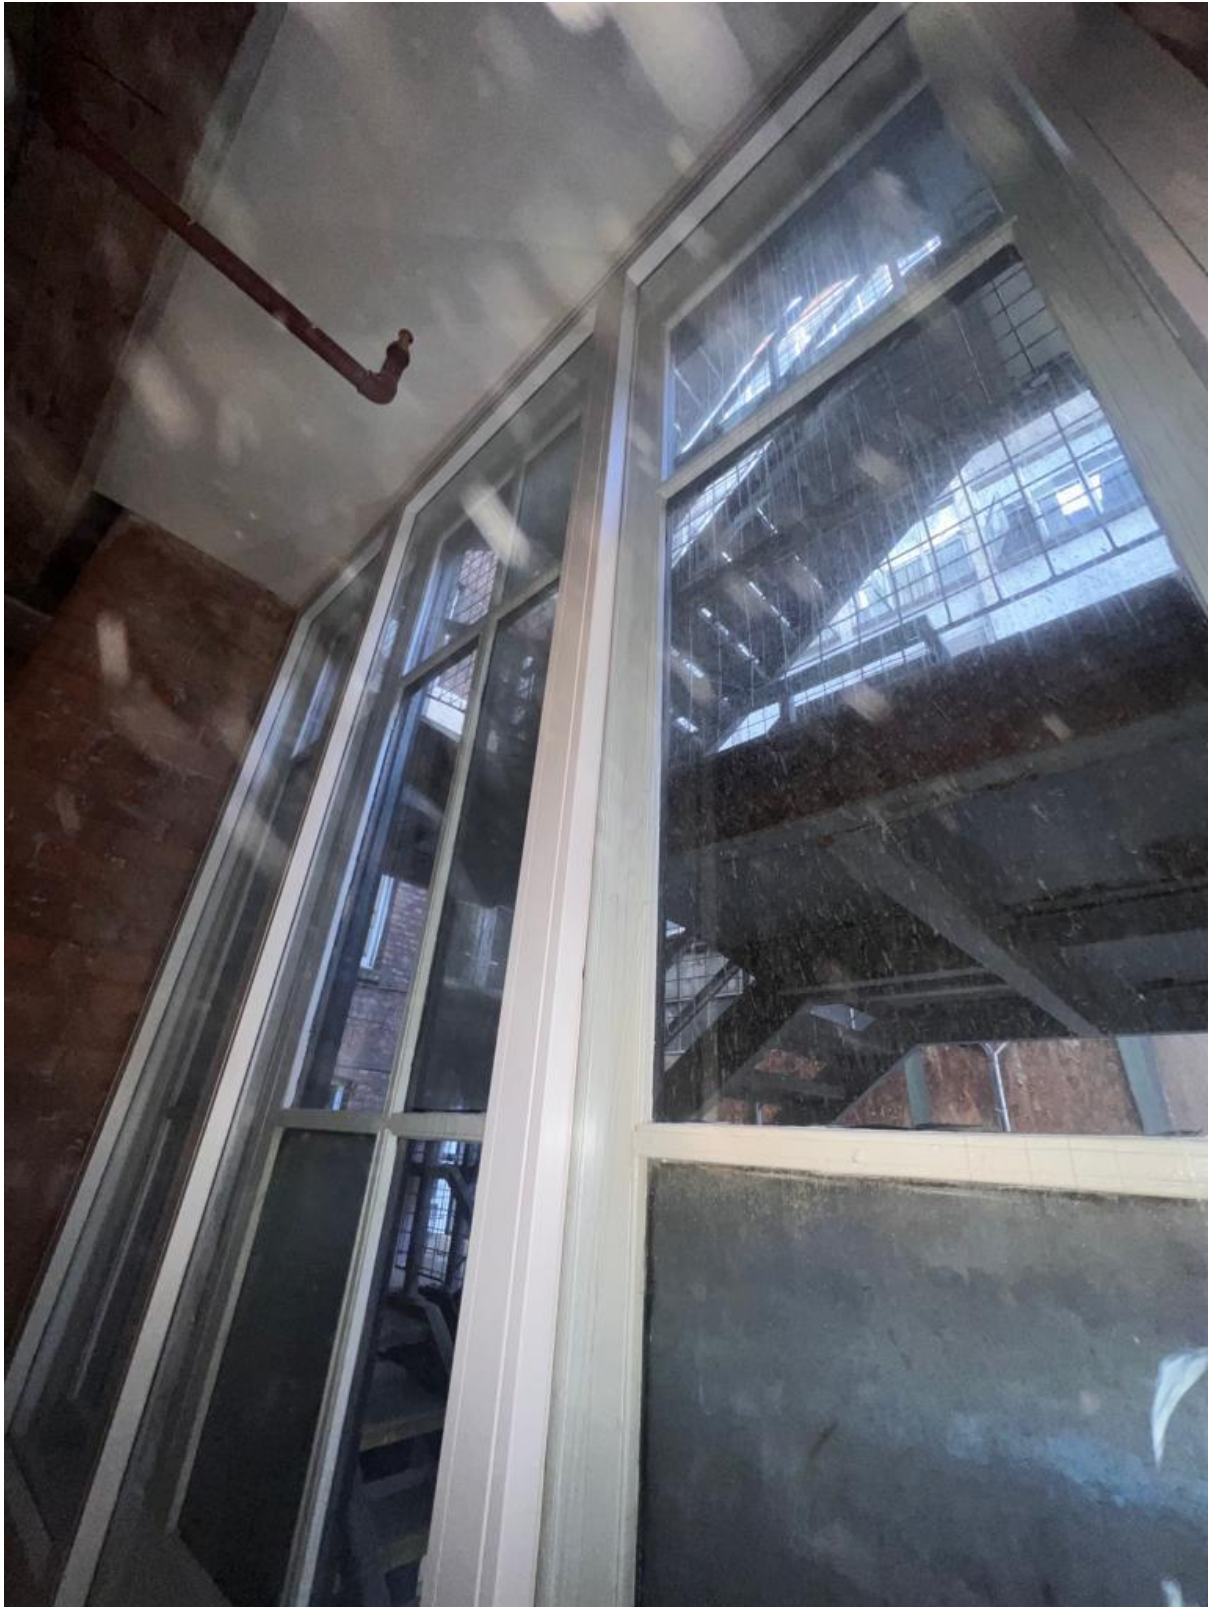
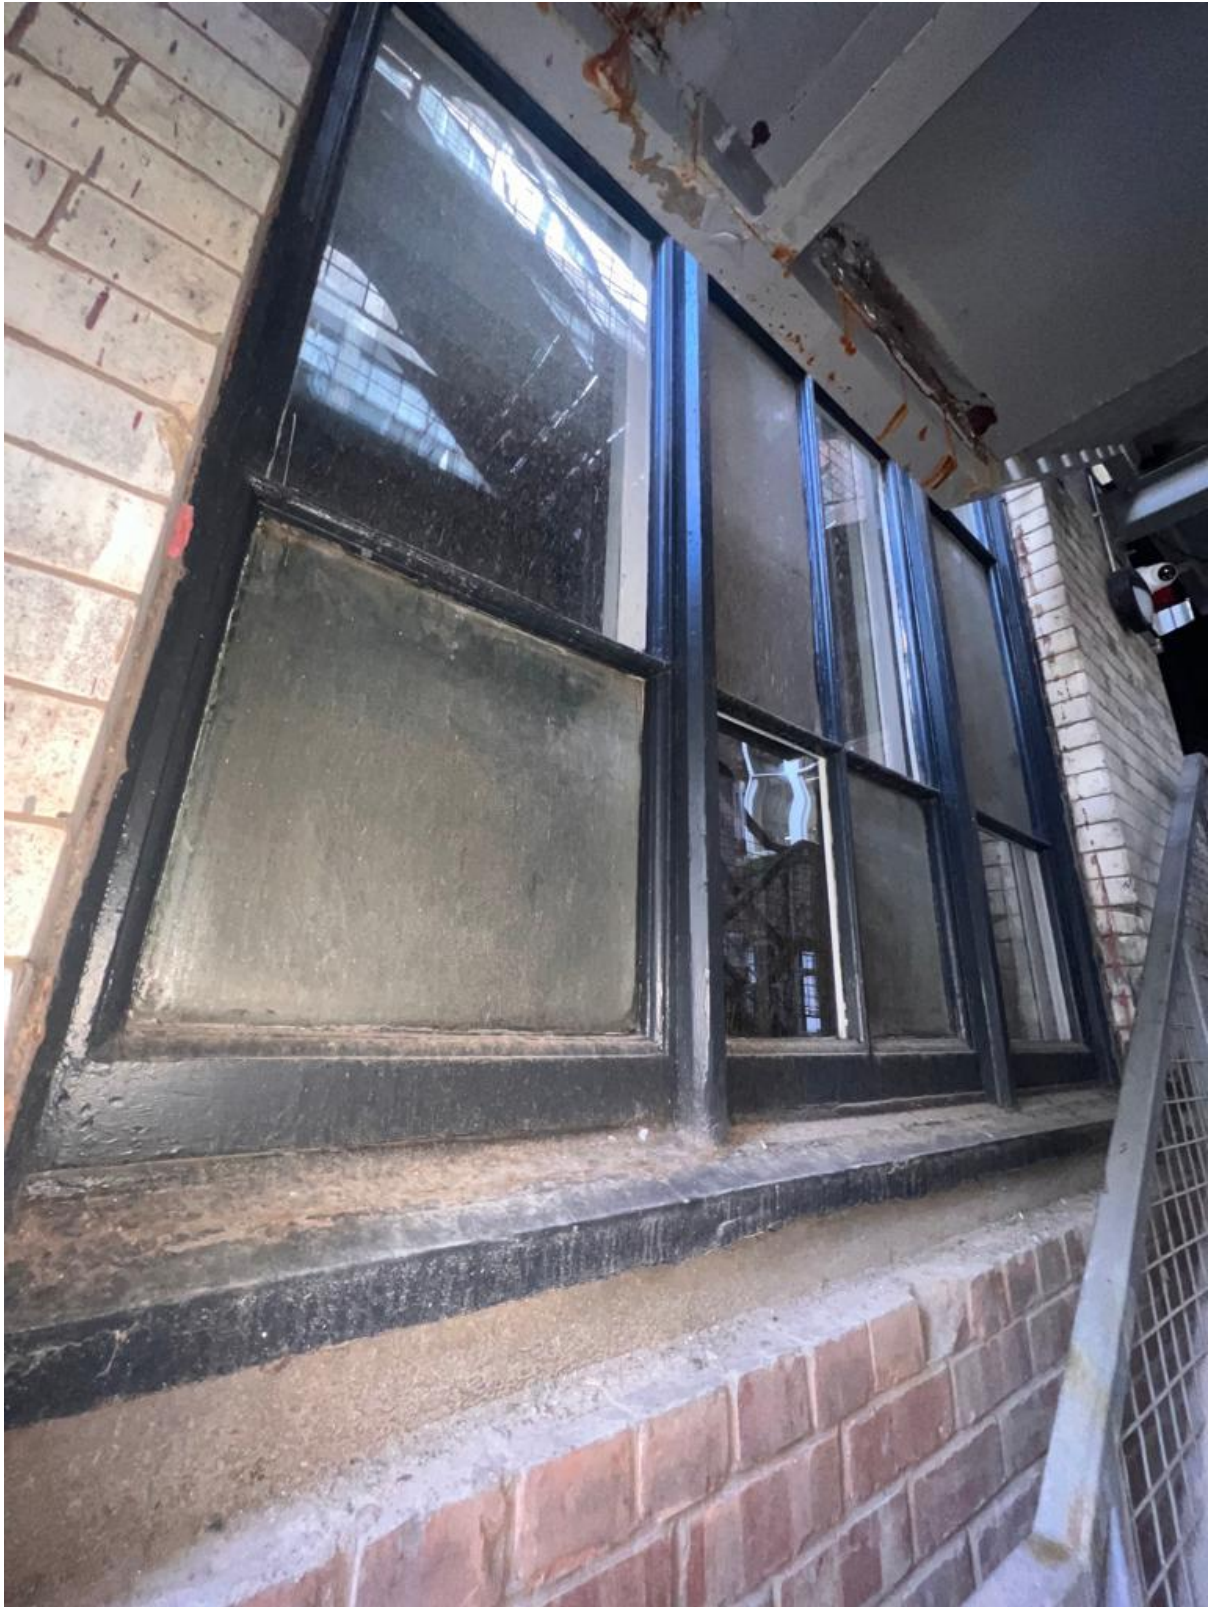
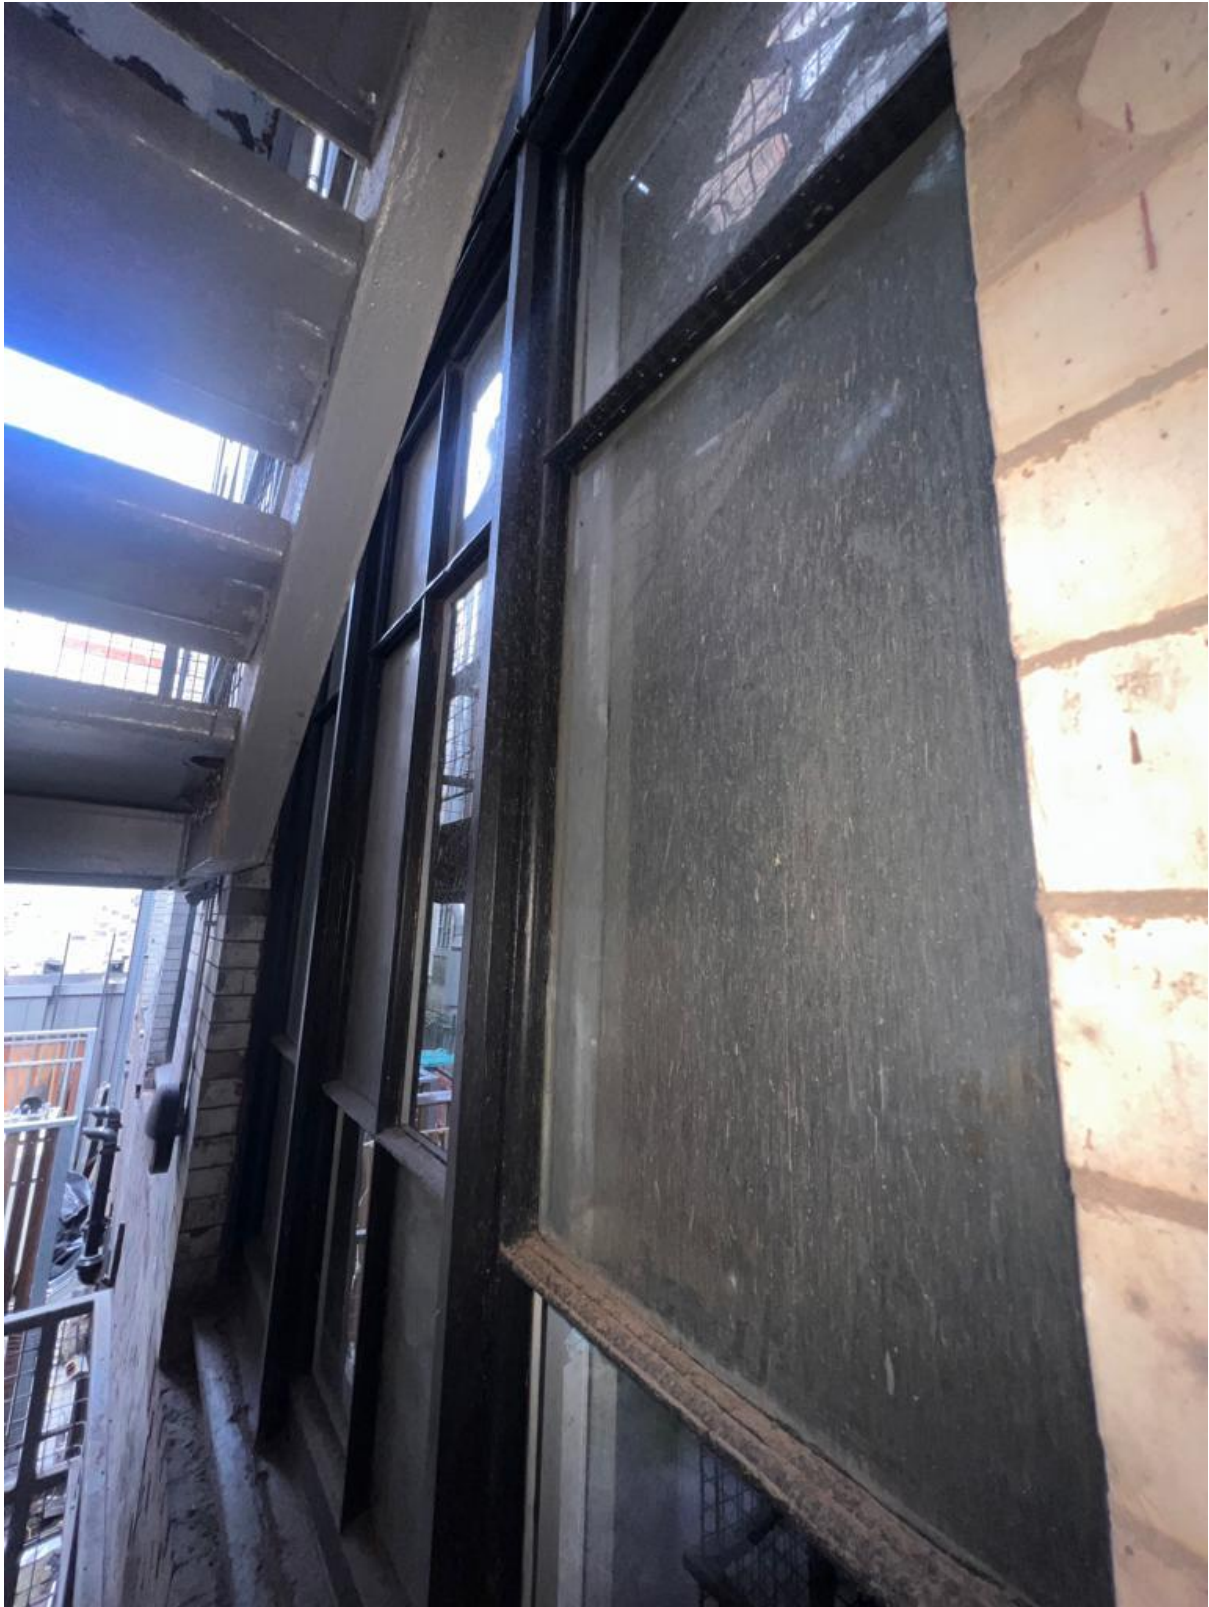
- 2no cracked panes of glass
- 4 no panes of glass missing
- 5m badly damaged glazing beads
- 2no sash stays missing
- External cill 1m rotten
- External window full of screws and nails

| WP.0.17 | <p>2no cracked panes of glass</p> <p>4 no panes of glass missing</p> <p>5m badly damaged glazing beads</p> <p>2no sash stays missing</p> <p>External cill 1m rotten</p> <p>External window full of screws and nails</p> | Black and Grey | TH | No Original comment no access at the time of original report – Revised report September 2022 this window is in a condition that can be repaired. | Repair |

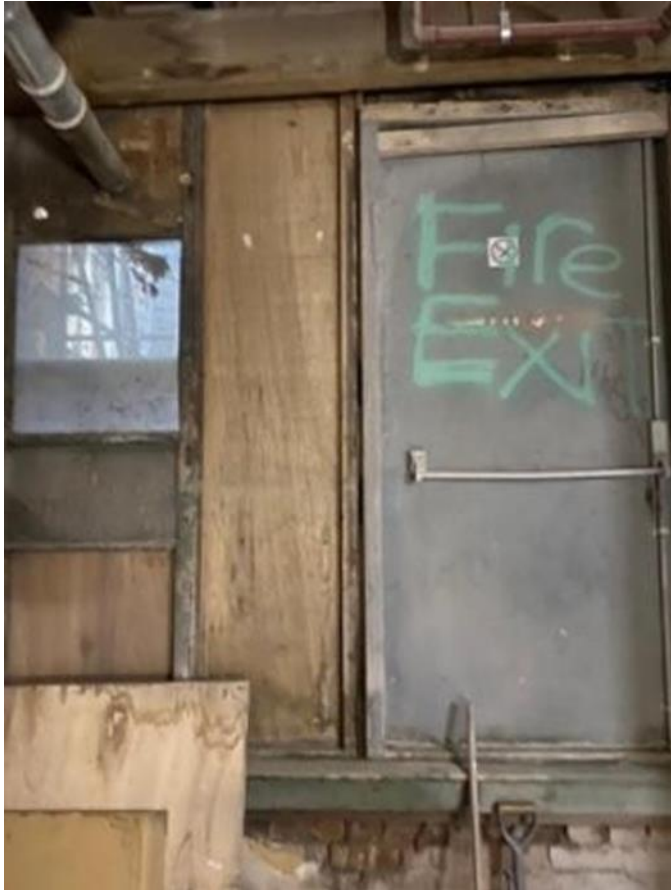
Figure 55:WP.0.18 (Credit Fairhurst 2022)

- Opening to receive new aluminum Door and Window

| WP.0.18 | Opening to receive new aluminum Door and Window | Black and Grey | TH | The Heritage Contractor has proposed a Solid metal door set and an Aluminium framed, fixed light, double glazed for the window opening. | Replace |

CubicWorks have replaced WP.0.18 With an Aluminum slate grey 2300x2250mm manual swing door and four fixed field two of which are glazed.

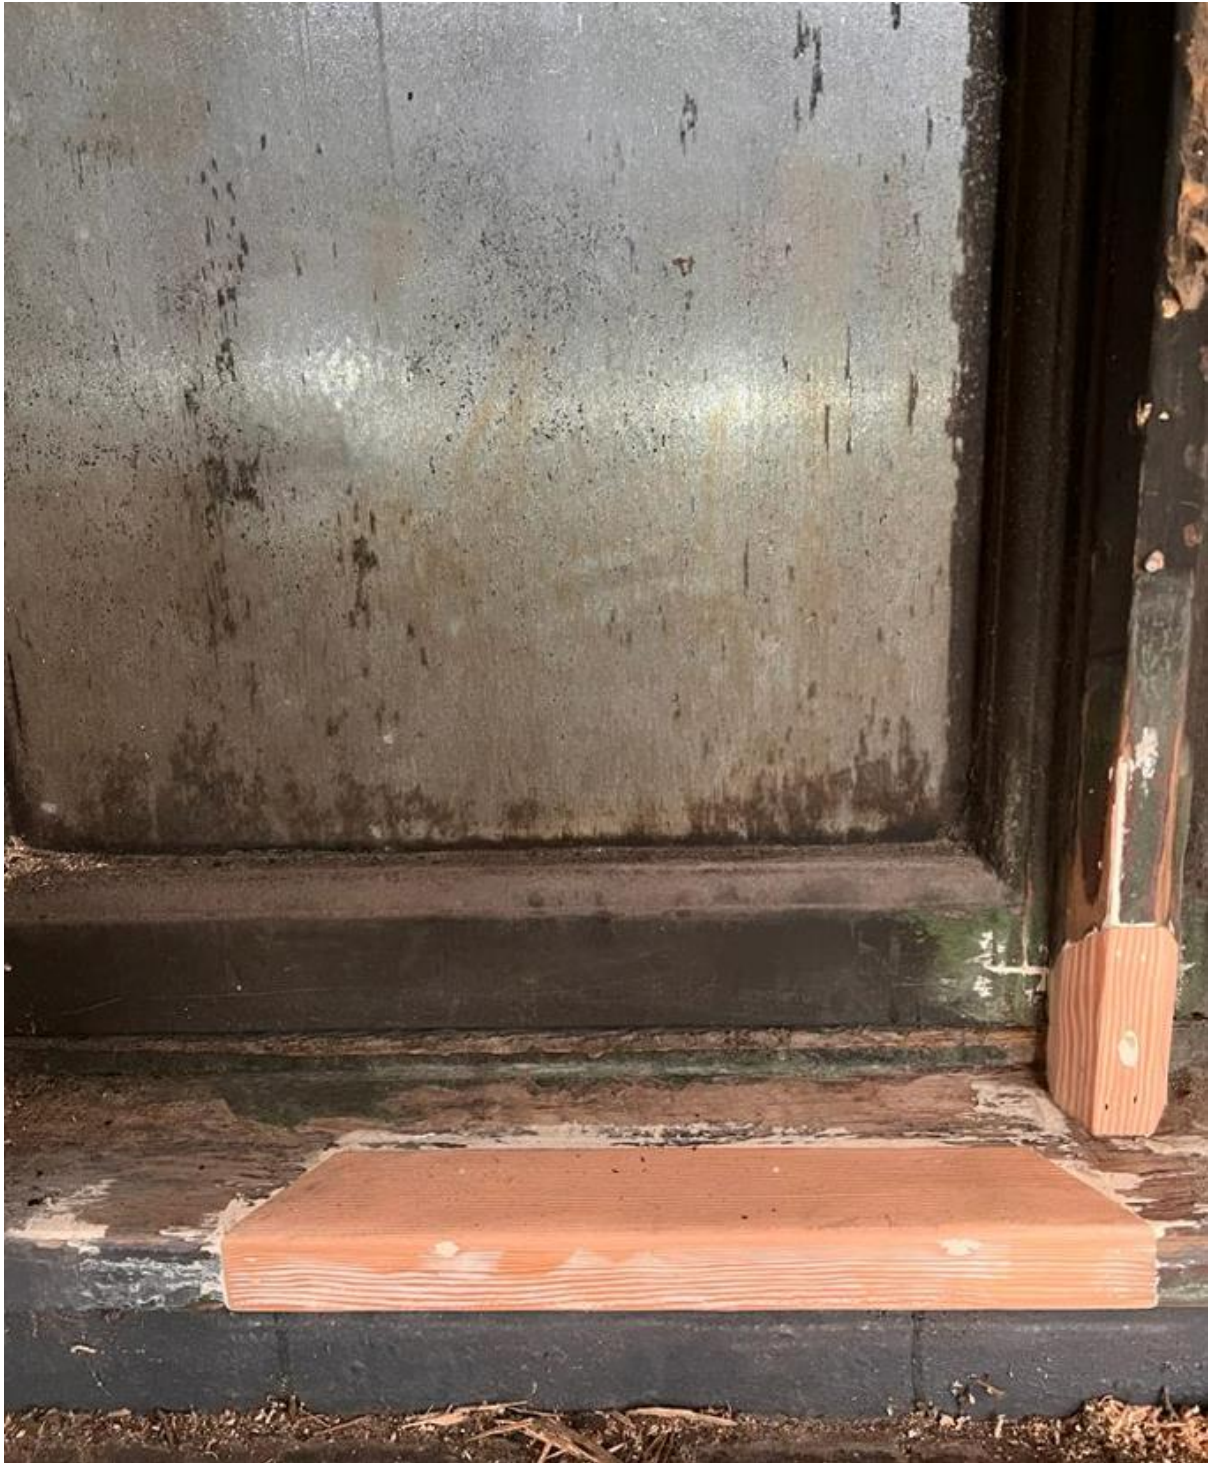
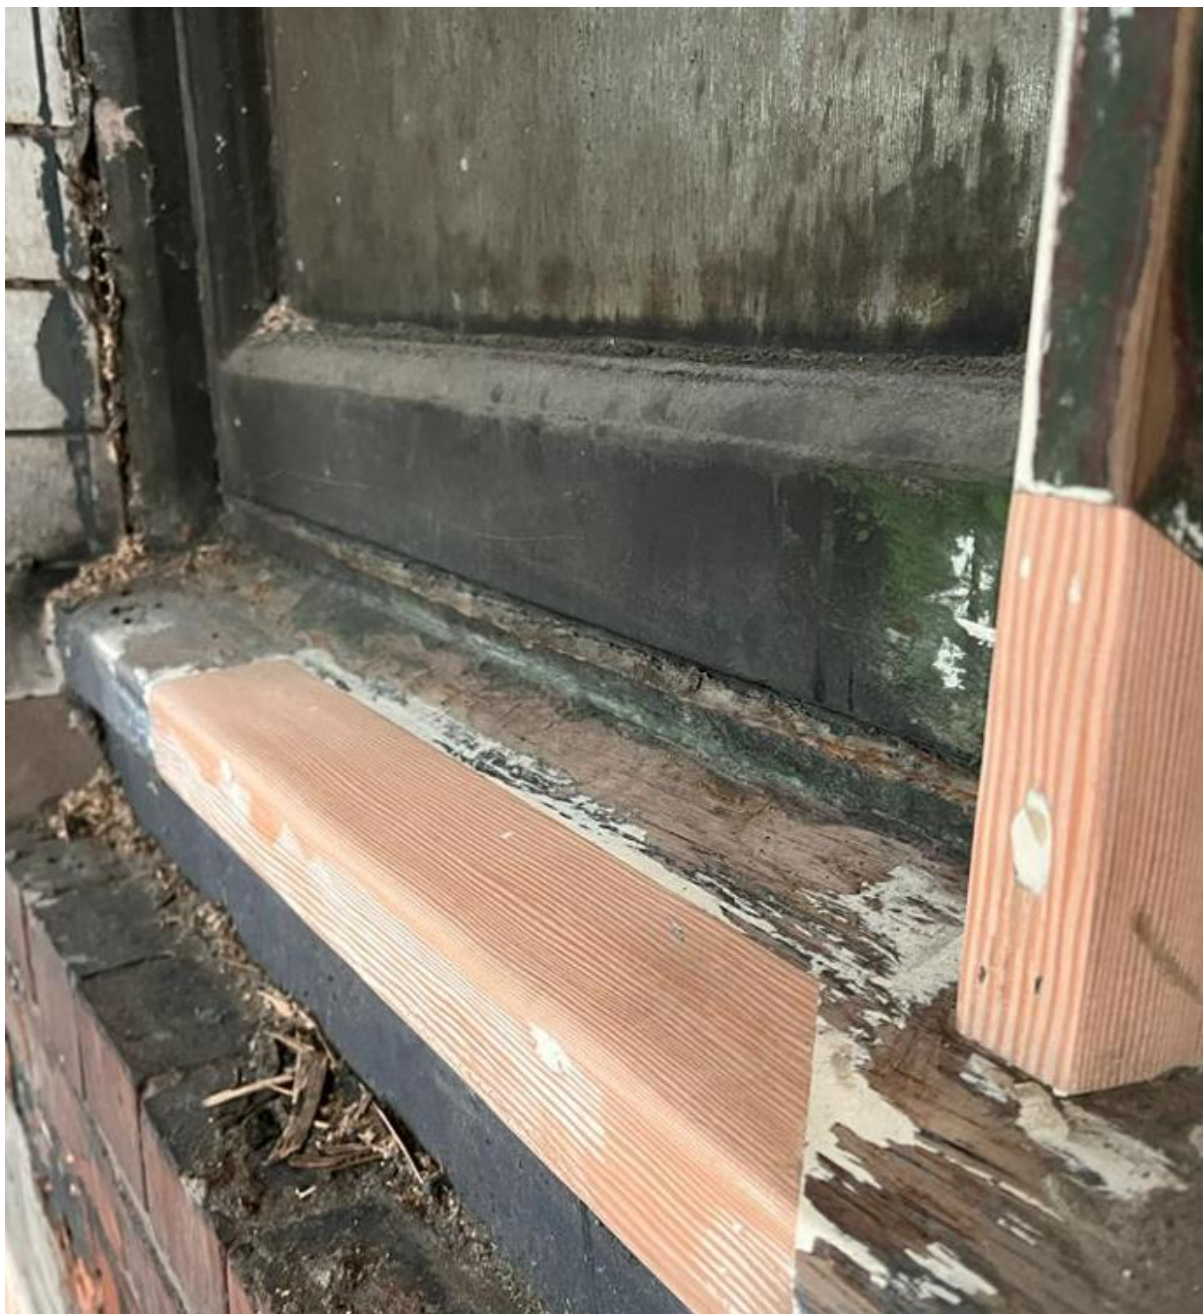
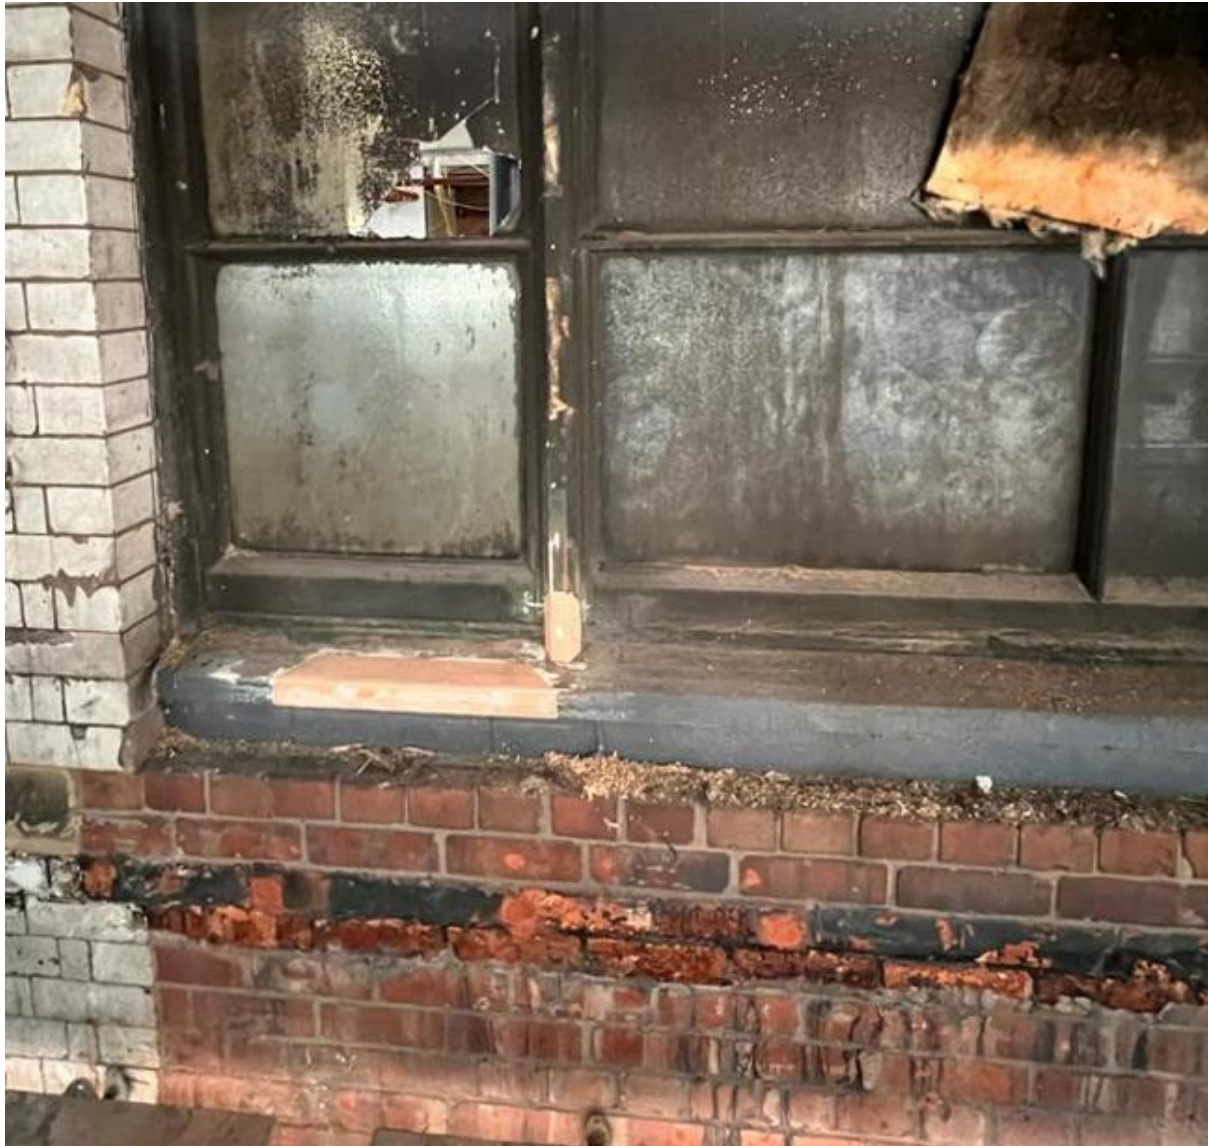
| WP.0.08 | <p>12 Nr Pane casement.</p> <p>1m Glazing bar.</p> <p>Window board down stand badly damaged.</p> <p>External Cill rotten in areas.</p> <p>Window full of redundant screws and nails.</p> | Black and Grey | TH | <p>8 Nr pane glass to be replaced.</p> <p>10 Meter Glazing bead damaged, to be replaced.</p> <p>Damaged Window board needs splicing.</p> <p>Window full of redundant screws and nails, to be removed.</p> | Repair |

WP.0.08 has been first cut in the rotten areas and the old timber around has been shaped so the space is left as regular as possible. A regular shape is created to allow the new timber to fit the hole as close to the original frame.

The new pieces are drilled, with screws to hold the pieces in place as the glue sets. It is important to note the screws are below the finished surface for aesthetics, with the excess glue carefully removed too.
