**Project Name:** 2023\_07\_17 Echo Street Murrywood

**Project Date:** 17/07/2023

**Inspection Standard:** MSCC5 Sewers & Drainage GB (SRM5 Scoring)

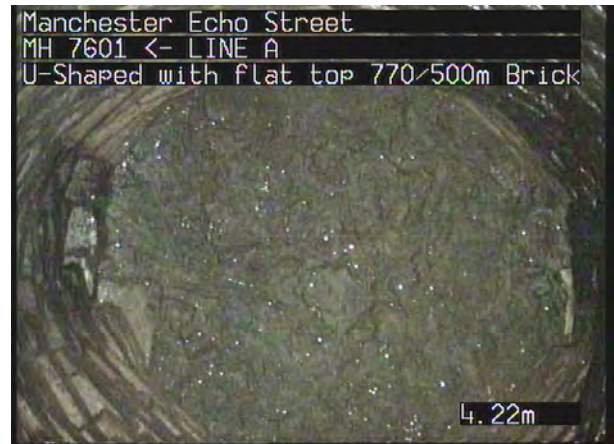
LINE A  
 X\_c8a0c224-e695-4ad6-b4af-debe01c157fc\_20230717\_1048  
 15\_819.jpg, 00:00:43, 4.22 m  
 General remark, BURIED MANHOLE NO LID

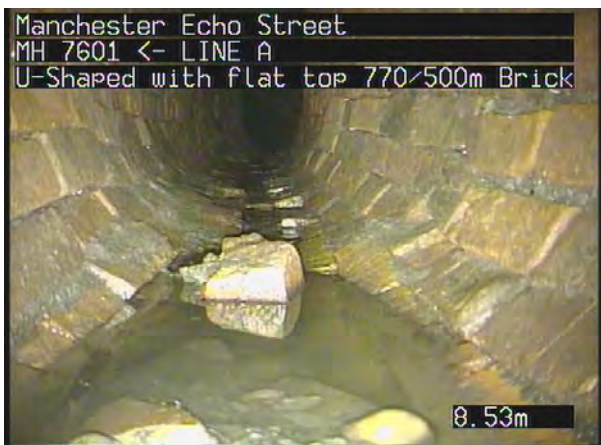
LINE A  
 X\_5350beea-e6e5-429d-901b-f2beae4cb2f4\_20230717\_1049  
 14\_399.jpg, 00:01:23, 8.53 m  
 Settled deposits, fine, 10% cross-sectional area loss, BRICK N  
 STONE

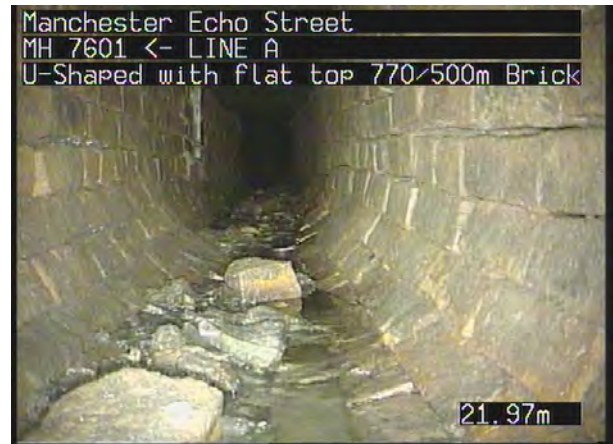
LINE A  
 X\_270a0a84-9673-494f-8284-e51a4adb76ea\_20230717\_105  
 214\_410.jpg, 00:03:28, 21.97 m  
 Settled deposits, fine, 20% cross-sectional area loss, STONE  
 N BRICK

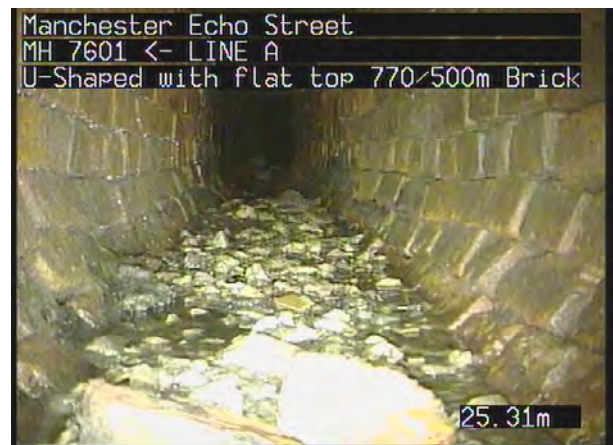
LINE A  
 X\_1350f6e7-f18e-4c30-83de-8ed6a1d86ebb\_20230717\_1054  
 47\_510.jpg, 00:05:46, 25.31 m  
 Settled deposits, fine, 25% cross-sectional area loss

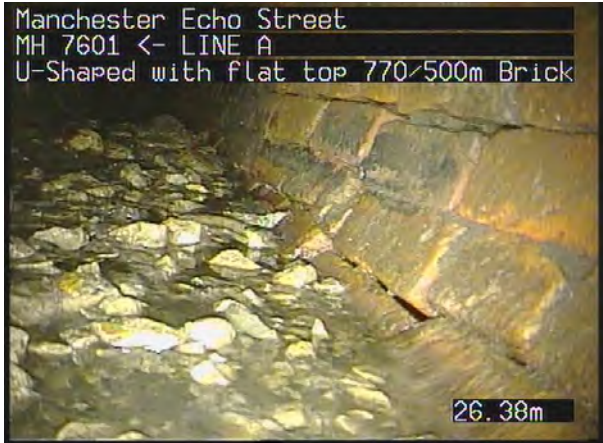
LINE A  
 X\_f58353ce-032a-4184-9e14-bdf1e89e6531\_20230717\_1058  
 02\_683.jpg, 00:08:47, 26.38 m  
 Survey abandoned, ON SILT N STONE

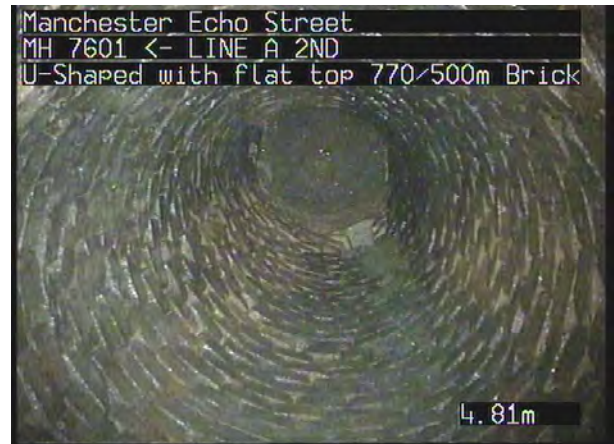
LINE A  
 2NDX\_72aad229-d09f-4c65-9193-c3c745308ee3\_20230717\_  
 124216\_688.jpg, 00:00:42, 4.81 m  
 General remark, BURIED MANHOLE NO LID

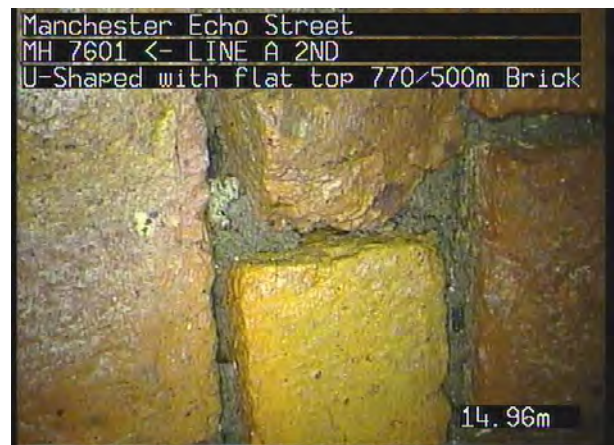
| Scale: 1:429 | Position [m] | Code | Observation | MPEG | Photo | Grade |
|---|---|---|---|---|---|---|
| | 14.96 | MM | Missing mortar, between 5mm and 15mm at 09 o'clock | 00:02:08 | LINE A<br>2NDX_97f47725-803 | 2 |

LINE A  
 2NDX\_97f47725-8038-4c76-8201-865f9627aaa3\_20230717\_  
 124417\_010.jpg, 00:02:08, 14.96 m  
 Missing mortar, between 5mm and 15mm at 09 o'clock

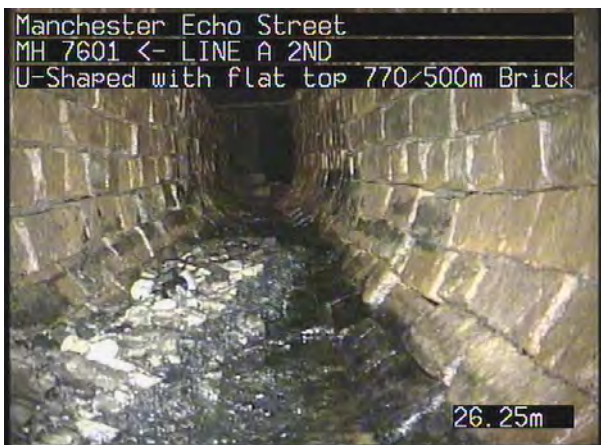
LINE A  
 2NDX\_048f4e84-3533-4ece-b2e2-b7602a37bc85\_20230717\_  
 124706\_211.jpg, 00:03:54, 26.25 m  
 Settled deposits, fine, 15% cross-sectional area loss, STONE  
 NSILT

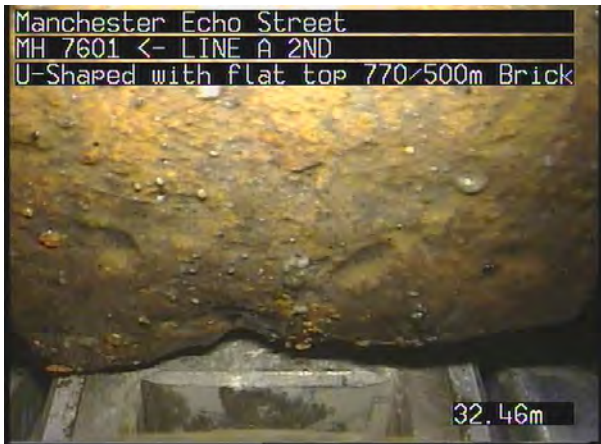
| Section | PLR | Grade | Description |
|---|---|---|---|
| 2 | LINE A 2NDX | 5 | Other obstacles, brick or masonry in invert from 04 o'clock to 07 o'clock, 35% cross-sectional area loss |

LINE A  
 2NDX\_14d2c551-5794-427a-b58b-3bd3f292be7a\_20230717\_125116\_965.jpg, 00:07:32, 32.46 m  
 Other obstacles, brick or masonry in invert from 04 o'clock to 07 o'clock, 35% cross-sectional area loss

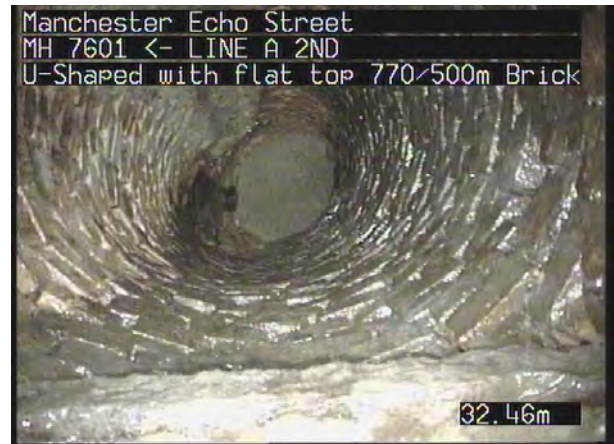
LINE A  
 2NDX\_0f67b30e-fd9b-496a-92bf-a2917fef1d4c\_20230717\_125301\_977.jpg, 00:09:01, 32.46 m  
 General remark, BURIED MANHOLE NO LID

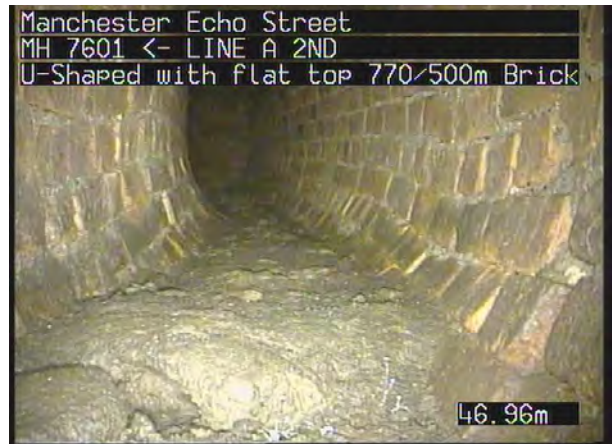
LINE A  
 2NDX\_33b50735-a69f-4a53-95bc-5c75659f7b33\_20230717\_1  
 25635\_921.jpg, 00:12:07, 46.96 m  
 Settled deposits, fine, 25% cross-sectional area loss

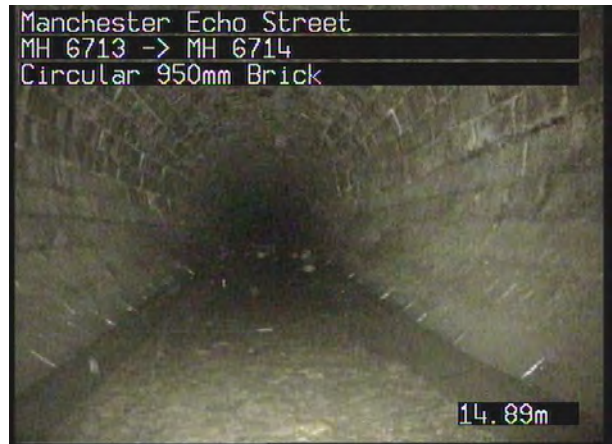
MH  
 6713X\_613f8e99-0517-4a19-a1ff-ee0e771b08de\_20230717\_141011\_224.jpg, 00:01:12, 14.90 m  
 Settled deposits, fine, 15% cross-sectional area loss

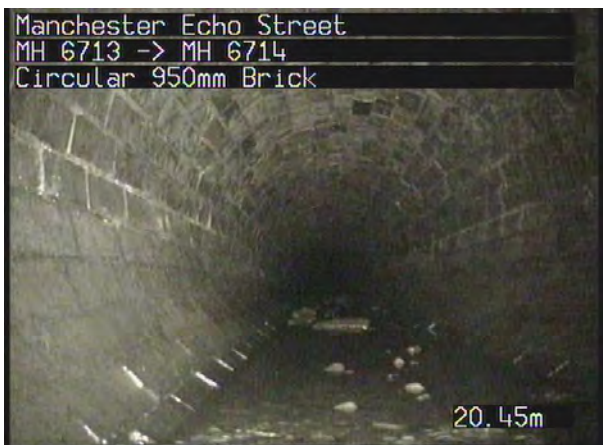
MH  
 6713X\_8906f02f-ce2e-4482-b2a9-311778d20603\_20230717\_141045\_442.jpg, 00:01:41, 21.27 m  
 Settled deposits, fine, 20% cross-sectional area loss

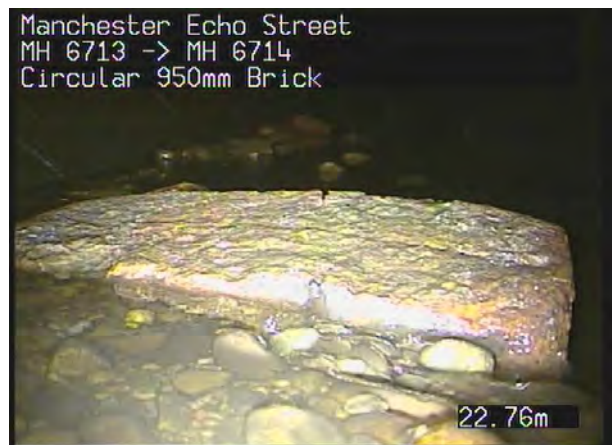
MH  
 6713X\_788a78cf-8aa5-4dda-99ae-20ba25fd7099\_20230717\_141233\_612.jpg, 00:03:08, 22.76 m  
 Other obstacles, brick or masonry in invert at 06 o'clock, 20% cross-sectional area loss

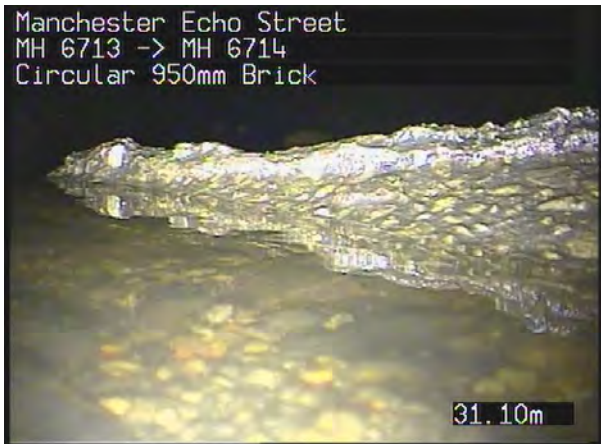
MH  
 6713X\_a1e33c7e-6ee3-4ae8-9263-8819fb3a78da\_20230717\_141424\_346.jpg, 00:04:19, 31.10 m  
 Other obstacles from 05 o'clock to 06 o'clock, 10% cross-sectional area loss, PIECE OF TARMAC

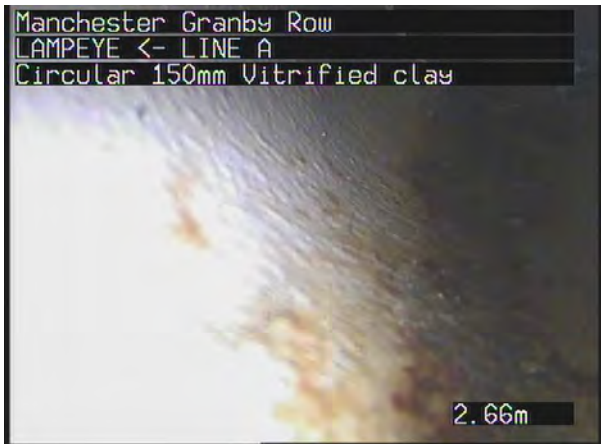
LINE A  
 X\_e83d5d0e-b85d-4e82-85ed-4c2053a91ff6\_20230718\_1027  
 14\_115.jpg, 00:00:30, 2.66 m  
 Joint displaced, medium

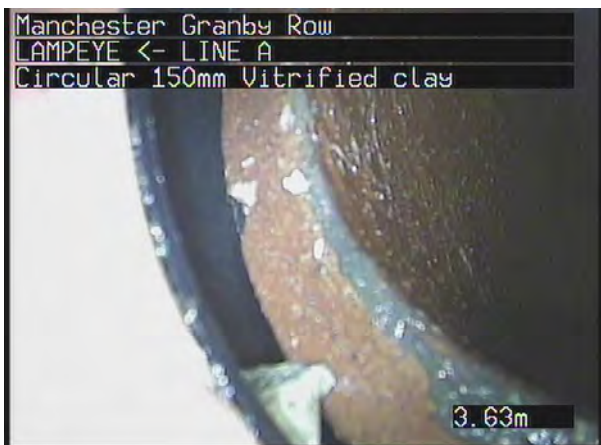
| Section | PLR | Grade | Description |
|---|---|---|---|
| 6 | LINE A X | 4 | Joint displaced, large |

LINE A  
 X\_e7d89ef1-3036-4fef-a44e-82615515e760\_20230718\_1027  
 36\_562.jpg, 00:00:48, 3.63 m  
 Joint displaced, large

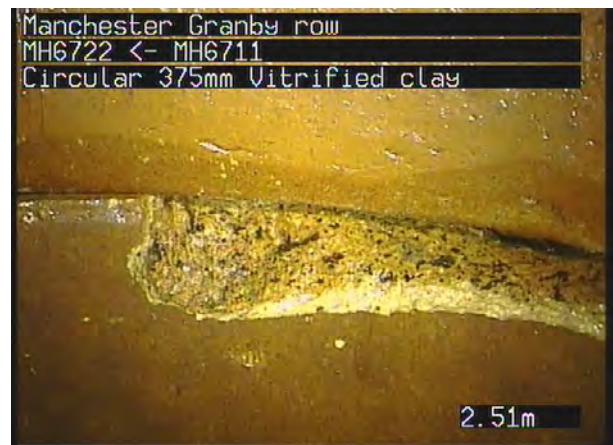
| No. | m+ | Code | Observation |
|---|---|---|---|
| 5 | 2.51 | BJ | Broken pipe at joint from 02 o'clock to 04 o'clock |

| Scale: | 1:100 | Position [m] | Code | Observation | MPEG | Photo | Grade |
|---|---|---|---|---|---|---|---|
| | | 2.51 | BJ | Broken pipe at joint from 02 o'clock to 04 o'clock | 00:00:47 | MH6711X_c14feb4c-a9ec-450 | 4 |

MH6711X\_c14feb4c-a9ec-450a-93ac-521bec3bd889\_202307  
 18\_115111\_329.jpg, 00:00:47, 2.51 m  
 Broken pipe at joint from 02 o'clock to 04 o'clock

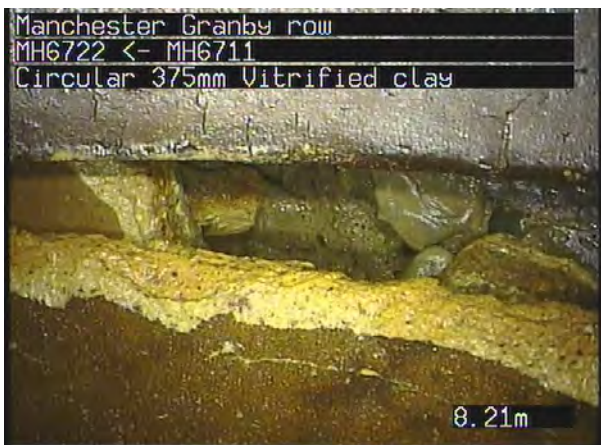
| No. | m+ | Code | Observation |
|---|---|---|---|
| 8 | 8.21 | BJ | Broken pipe at joint from 12 o'clock to 12 o'clock |

| Scale: | 1:100 | Position [m] | Code | Observation | MPEG | Photo | Grade |
|---|---|---|---|---|---|---|---|
| | | 8.21 | BJ | Broken pipe at joint from 12 o'clock to 12 o'clock | 00:01:45 | MH6711X_4194830b-2646-4c | 4 |

MH6711X\_4194830b-2646-4cd5-b88a-7ae2284d648e\_20230718\_115225\_973.jpg, 00:01:45, 8.21 m  
 Broken pipe at joint from 12 o'clock to 12 o'clock

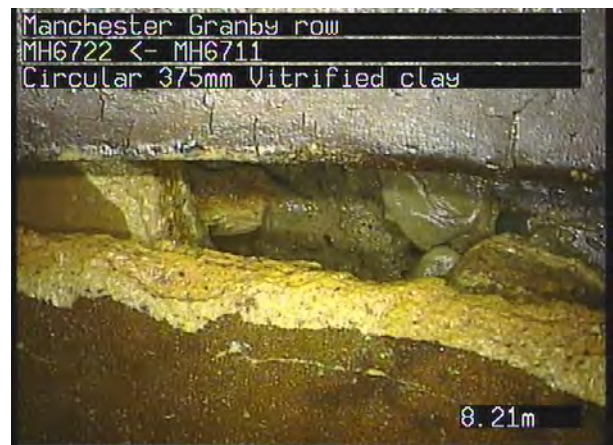
| No. | m+ | Code | Observation |
|---|---|---|---|
| 9 | 8.21 | VV | Void visible beyond defect |

| Scale: | 1:100 | Position [m] | Code | Observation | MPEG | Photo | Grade |
|---|---|---|---|---|---|---|---|
| | | 8.21 | VV | Void visible beyond defect | 00:01:49 | MH6711X_dec4dd89-6f8b-49a | |

MH6711X\_dec4dd89-6f8b-49ac-afbc-482d24593ba9\_20230718\_115230\_455.jpg, 00:01:49, 8.21 m  
 Void visible beyond defect

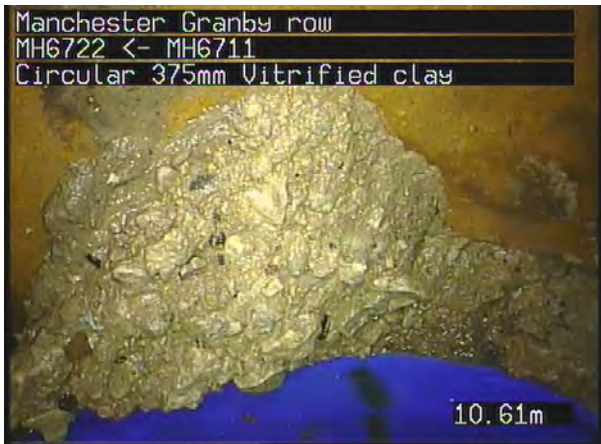
MH6711X\_18627ed7-fa88-4966-898e-cf427f35350c\_20230718\_115342\_972.jpg, 00:02:33, 10.61 m  
 Other obstacles from 06 o'clock to 07 o'clock, 20% cross-sectional area loss, CONCRETE

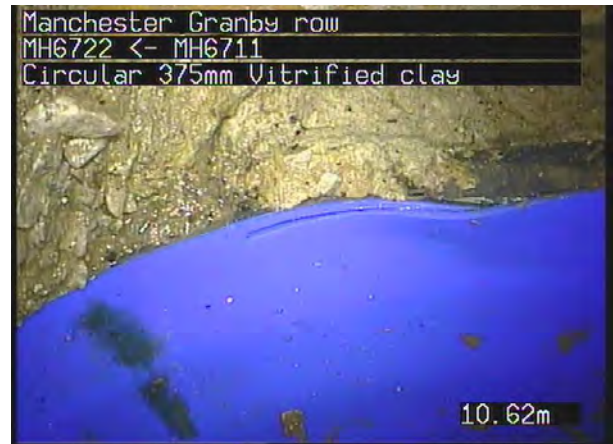
MH6711X\_ed51d130-f2d9-42cf-a06b-123c7563c678\_20230718\_115355\_765.jpg, 00:02:41, 10.62 m  
 Open joint, large

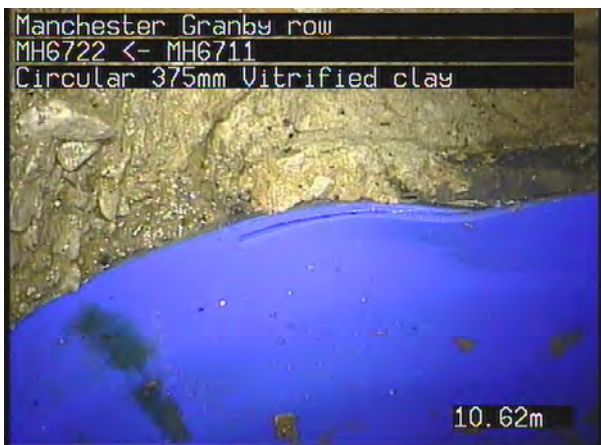
| No. | m+ | Code | Observation |
|---|---|---|---|
| 12 | 10.62 | VV | Void visible beyond defect |

| Scale: | 1:100 | Position [m] | Code | Observation | MPEG | Photo | Grade |
|---|---|---|---|---|---|---|---|
| | | 10.62 | VV | Void visible beyond defect | 00:02:45 | MH6711X_7c12078a-cc50-4b | |

MH6711X\_7c12078a-cc50-4b70-8bd7-e067bc56a60d\_20230718\_115400\_760.jpg, 00:02:45, 10.62 m  
 Void visible beyond defect

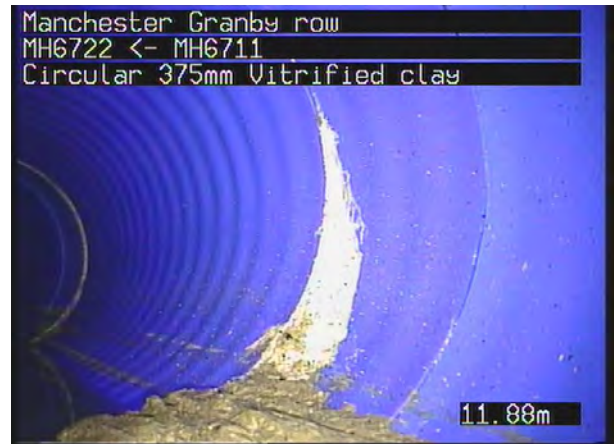
MH6711X\_85357160-4bc6-40ca-a651-38927401ca5d\_20230718\_115545\_525.jpg, 00:03:12, 11.88 m  
 Other obstacles from 05 o'clock to 07 o'clock, 15% cross-sectional area loss, CONCRETE

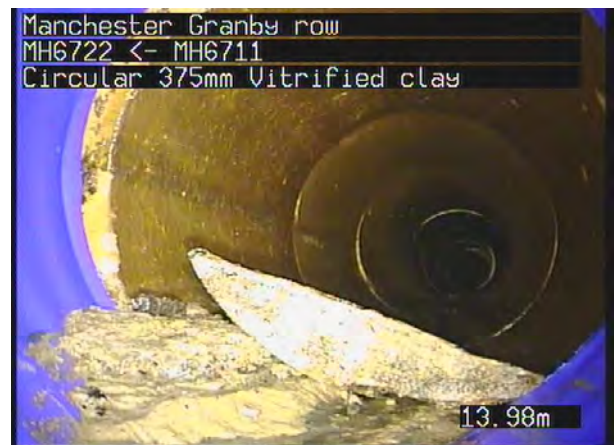
MH6711X\_ccf1d9c3-8408-459e-ade5-588497a06963\_20230718\_115637\_060.jpg, 00:03:34, 13.98 m  
 Other obstacles from 04 o'clock to 08 o'clock, 30% cross-sectional area loss, CONCRETE

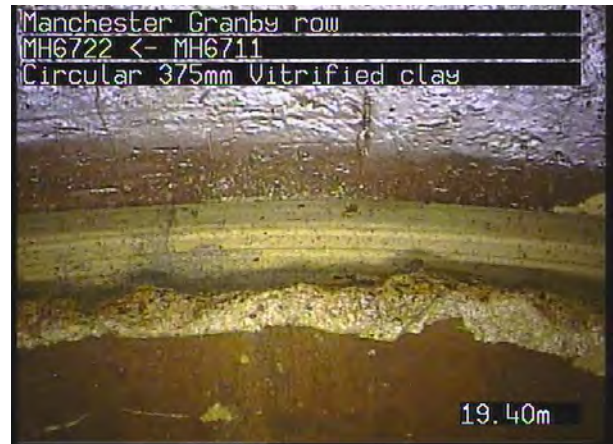
| No. | m+ | Code | Observation |
|---|---|---|---|
| 19 | 19.40 | BJ | Broken pipe at joint from 12 o'clock to 12 o'clock |

MH6711X\_933ac639-f2e9-428c-bb4d-c3b1e01c25b2\_20230718\_115951\_427.jpg, 00:06:15, 19.40 m  
 Broken pipe at joint from 12 o'clock to 12 o'clock

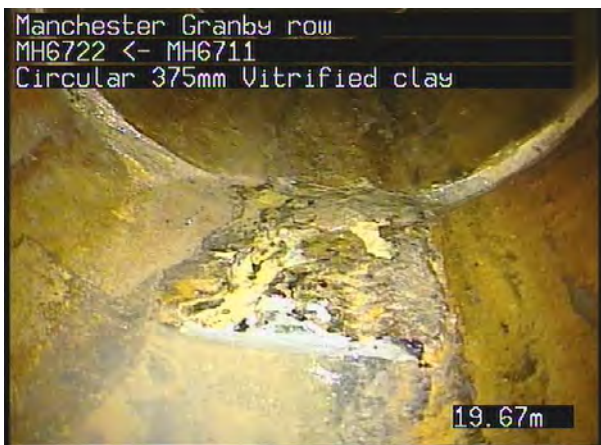
MH6711X\_55bc5f45-bd57-4dbc-92d4-6759f58b6a2f\_20230718\_120059\_276.jpg, 00:06:30, 19.67 m  
 Attached deposits, other at 09 o'clock, 5% cross-sectional area loss, CONCRETE

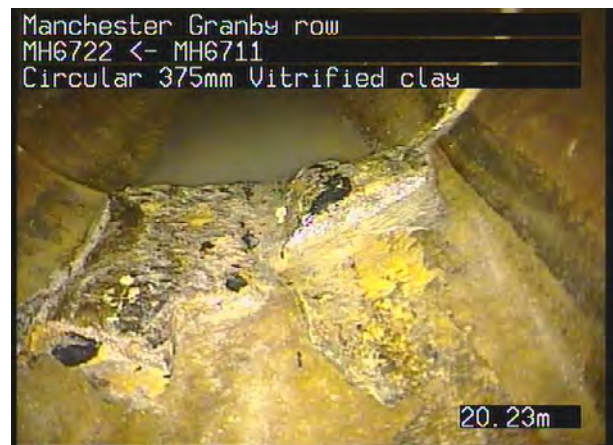
MH6711X\_d5c9e128-2e23-44c6-8aa5-0bb95df380d9\_20230718\_120130\_540.jpg, 00:06:41, 20.23 m  
 Attached deposits, other from 04 o'clock to 07 o'clock, 10% cross-sectional area loss, CONCRETE

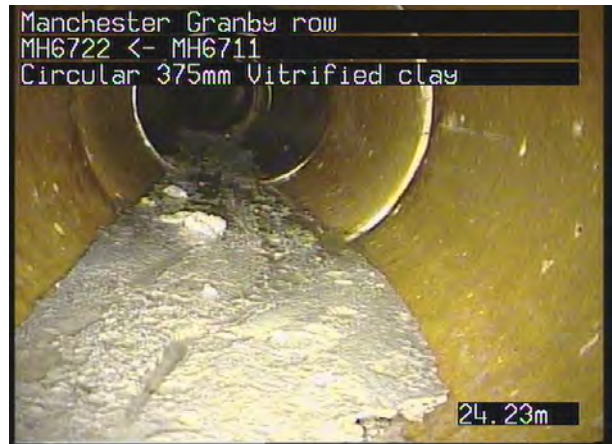
MH6711X\_59fe7c64-8d6d-46d2-bdf0-cf9b3594be25\_20230718\_120249\_679.jpg, 00:07:34, 24.23 m  
 Attached deposits, other from 04 o'clock to 07 o'clock, 20% cross-sectional area loss, CONCRETE

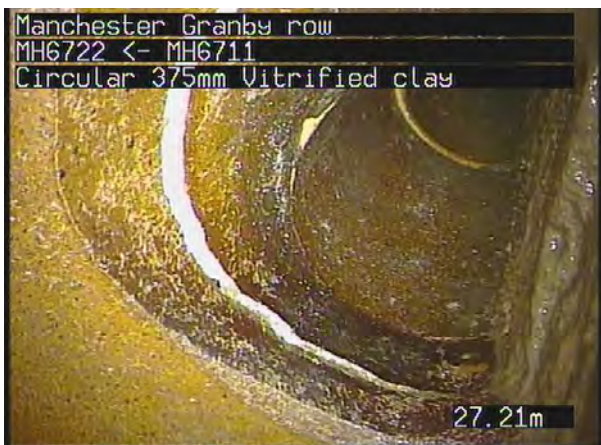
MH6711X\_19de32e6-c3e9-482d-8f31-9d2adaa55481\_20230718\_120350\_394.jpg, 00:07:56, 27.21 m  
 Junction, other at 02 o'clock, 150mm dia, CONCRETE COMING FROM JUNCTION
