# Design and Access Statement 86 Princess Street - Whole Facade Repairs Job 1944

Client: LWP Eastbrook Property Limited

Date: July 2023

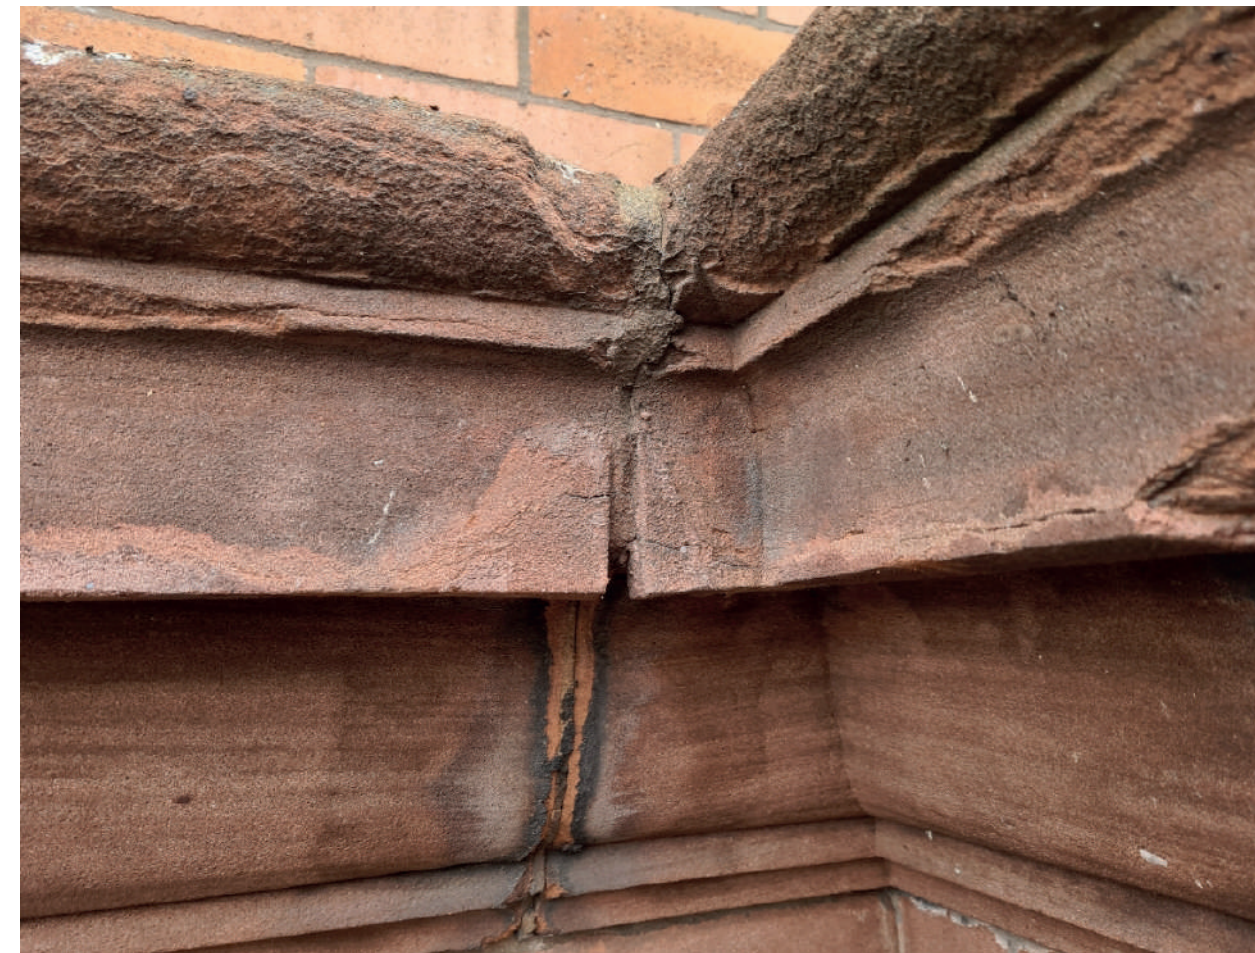
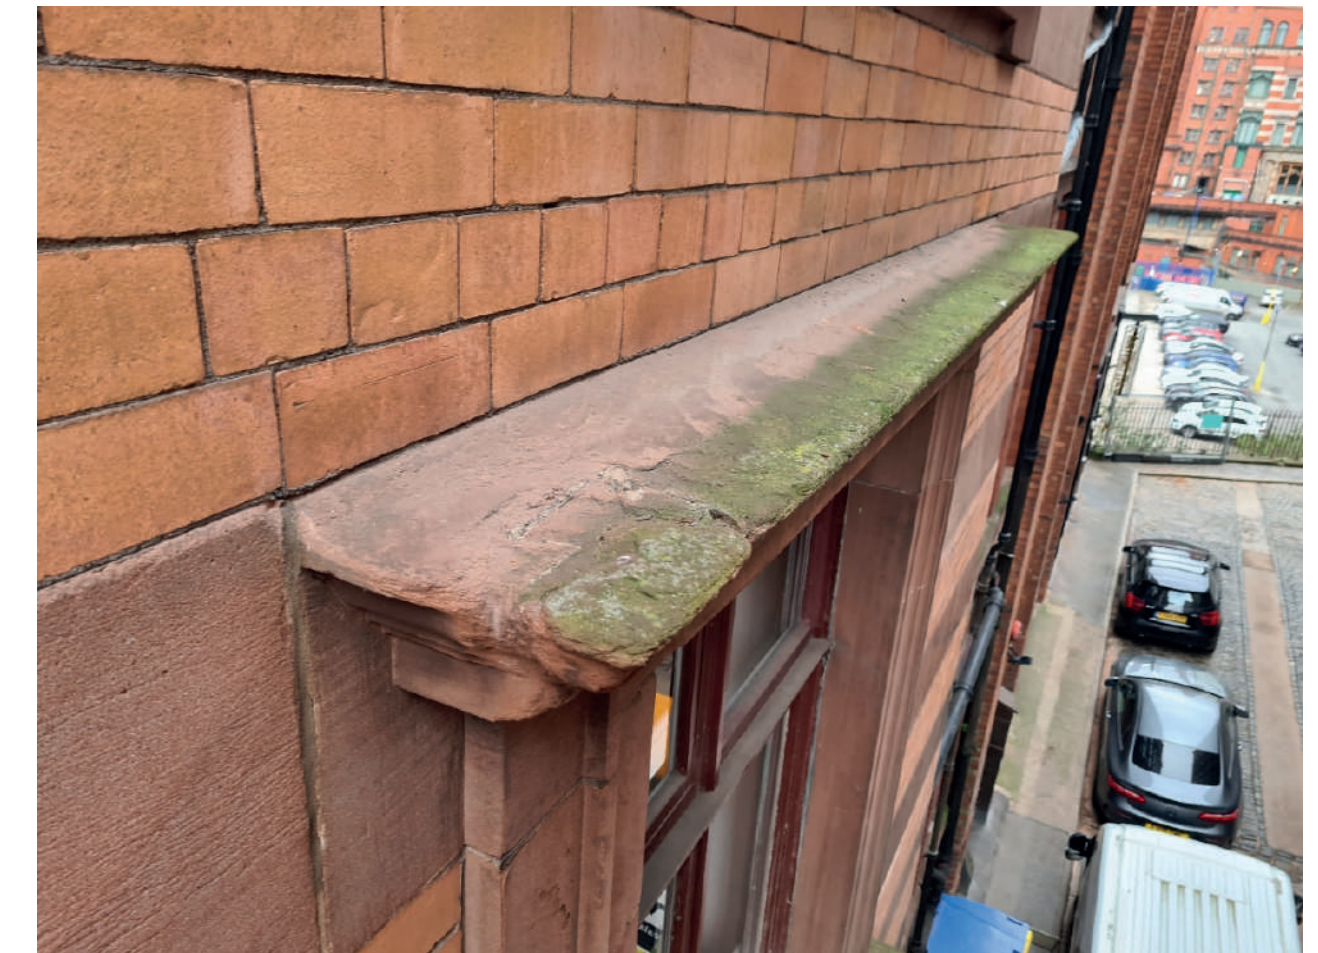
b) Incorrect bedding to cornices/sills. Due to the length of these elements, they have originally been horizontally/naturally bedded. Unfortunately, edge bedded matching stone cannot be obtained to this length.

Examples of exposed horizontally bedded stone delaminating.

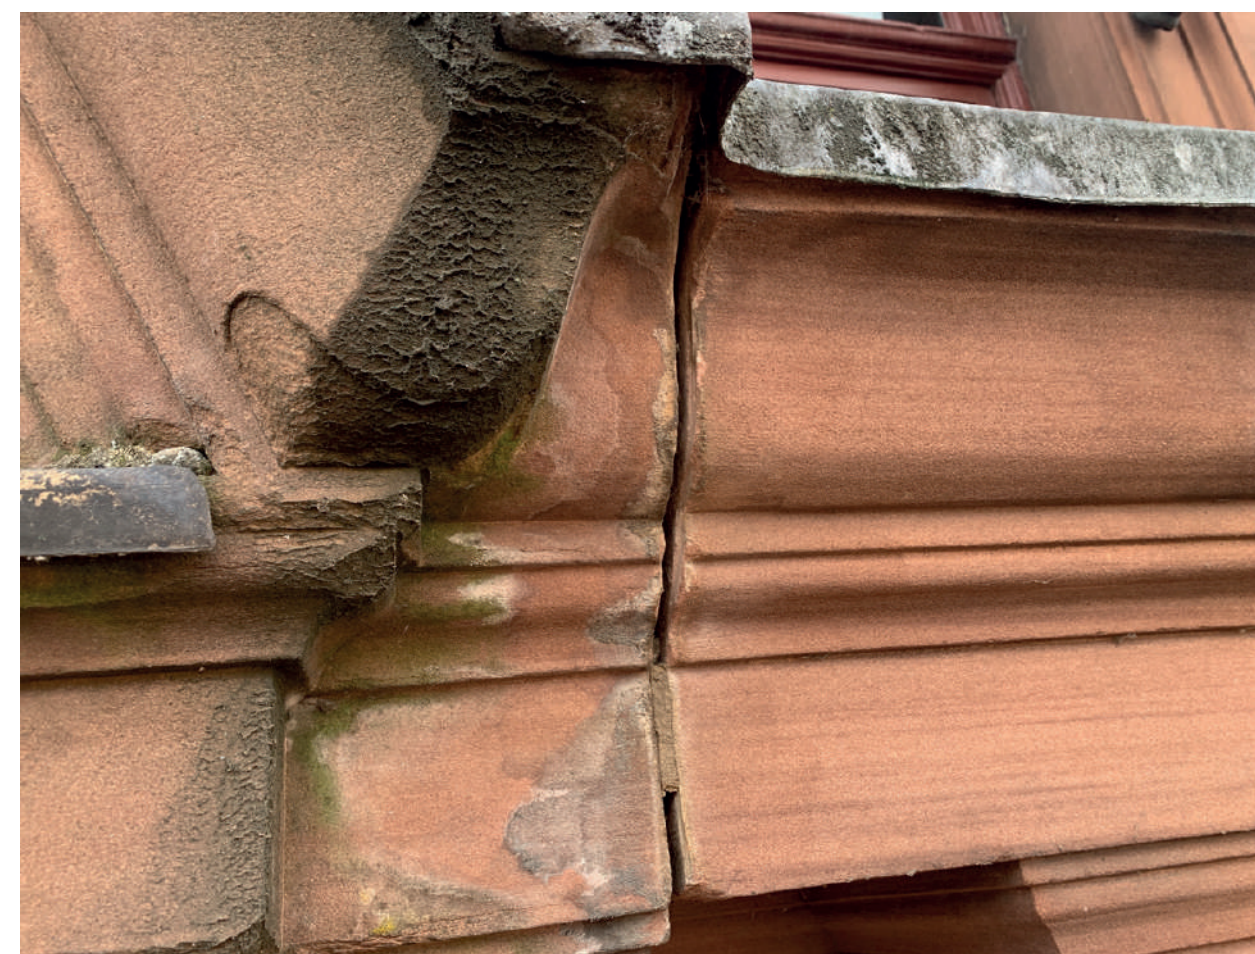
a) Missing/damaged pointing to cornices and copings. This has caused water to concentrate and locally discharge onto the surfaces below, accelerating erosion patterns

Examples of failing pointing.

Repointing to a mix matching the strength, texture and colour of the existing mix is proposed where erosion has occurred or pointing is missing entirely. Note that if none of the original pointing/mortar mix can be found for sampling - as was the case for the hood mould area, an NHL lime: sand mix will be proposed as used on the hood mould. Please refer to the NBS for details.

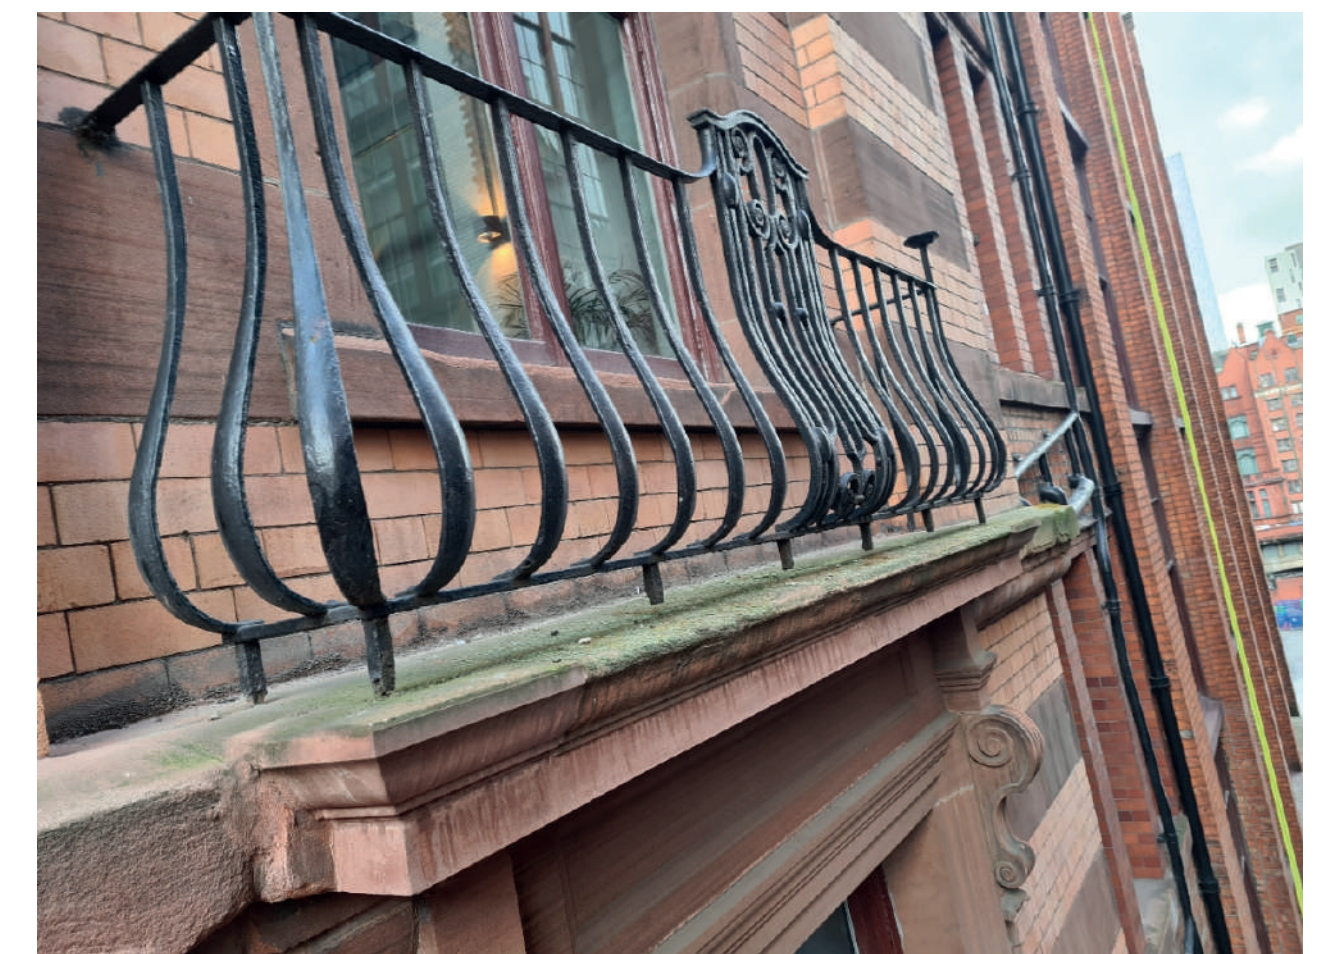
c) Insufficient falls to horizontal features such as sills - this is thought to contribute to water settling and subsequent freeze/thaw action delaminating the surface and encouraging biological growths to accumulate. Maintenance regimes also play a part in the accumulation of soiling.

Insufficient falls contributing to biological soiling.

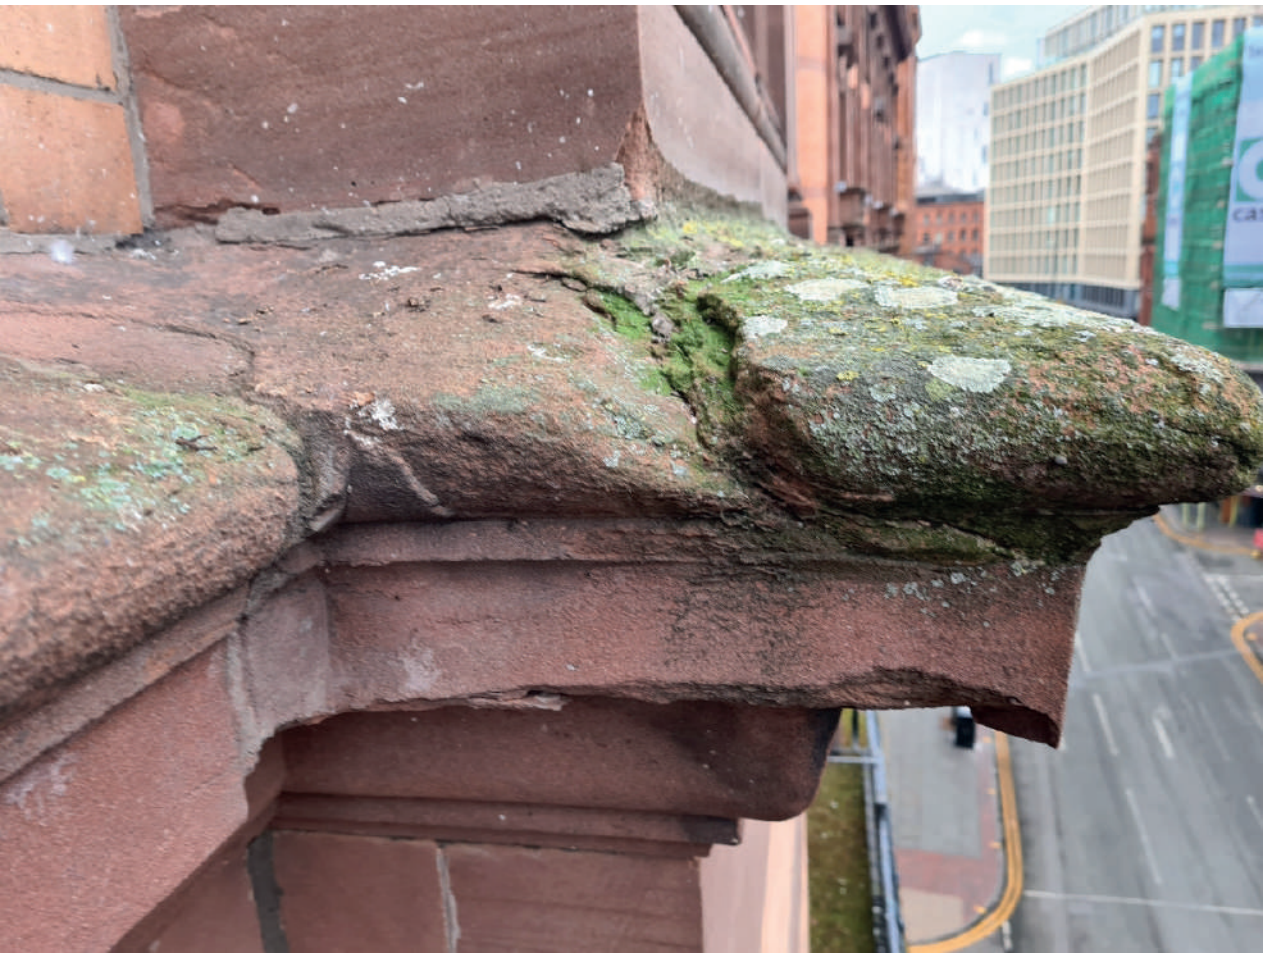
| Grid/Item Ref (from Vertical Access Survey Report) | Description of Condition | Image of Condition (if available) | Recommendation (from Vertical Access Survey Report) | Repair urgency (from Vertical Access Survey Report) | Methodology Type | Proposed Methodology |
|---|---|---|---|---|---|---|
| A02, 5 | Stone corner is degraded and has 2 valleys which water runs through. This over time will break away and possibly be a danger to the public. Cause most likely to be due to incorrect bedding of the original stone pieces. | | Resin dowel this decorative stone to prevent movement or remove | Red | 1 | Phase 1 Temporary structural repair (carried out urgently from high level ropes): Resin bound dowel/pin to prevent movement. Drill through the stone to form hole for resin bound stainless steel dowel. Dowels located to minimise diameter and pin fractured stone piece back into larger more secure stone. End of dowel to be recessed min 10mm from face of stone and hole filled with matching stone plug. Contractor to submit proposals which minimise risk of future cracking of surrounding stones due to movement. Dress off any loose/friable stone faces. Phase 2 - Replacement Stone (from scaffolding). Carefully cut out damaged stone with hand tools such as sharp chisels and stone saws. Clean out cavity. Install newly prepared matching stone block - course or natural bedded - to be agreed. Secure with resin bound stainless steel dowels. Hand finished to match original (not artificially distressed). Include discrete mason's mark (location TBA). Perimeter joints to be minimal in width and pointed with lime mortar to match stone. NB Extent of stone replacement required to be reviewed upon close inspection once the scaffold is erected. |

Location A02,5 - stone at risk of detaching.

In July 2023 works commenced under approval ref. 131998/LO/2021 to carry out localised repairs to the main hood mould on princess st. Whilst these works are on site, the intention is to carry out localised temporary stabilisation works on this item, via high access ropes. Through correspondence with the Conservation Officer (Paul Mason) we are agreeing the detail of this temporary repair.

Once the approval for the wider facade repair works is received, our client intends to commission a full scaffolding of this facade so that a permanent repair can be carried out.

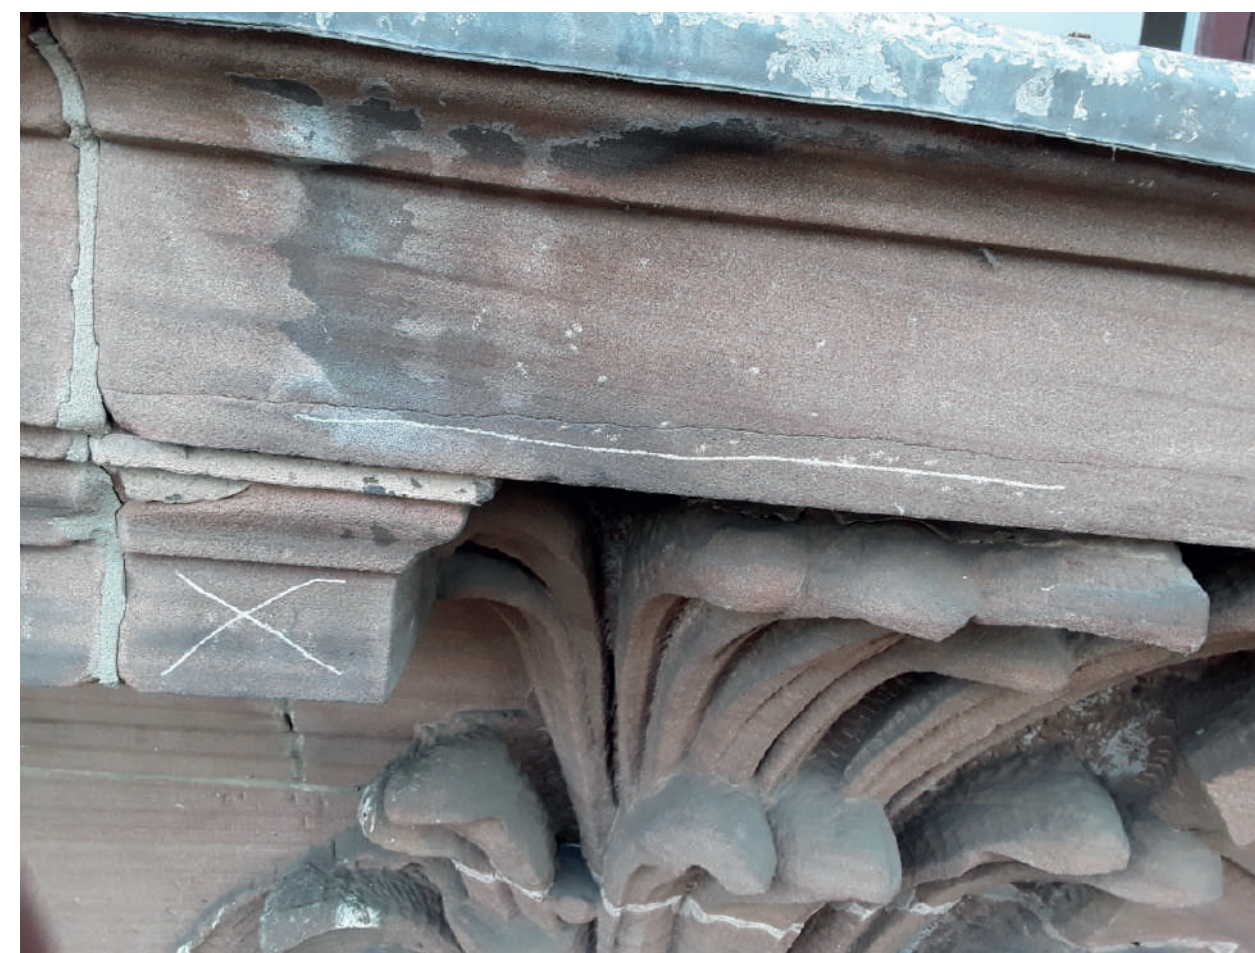
Location A04.7 - Loose stone marked with an 'x'.

In several locations - as identified on the proposed elevations, the stone is sufficiently damaged such that if left in this condition, the stone would be at risk of detaching from the building. In these circumstances we propose to pin the loose stone back to the main structure using resin bound stainless steel pins/dowels. This allows the retention of the historic fabric, and stone plugs will cover the dowel insertion points to minimise any visual alteration.

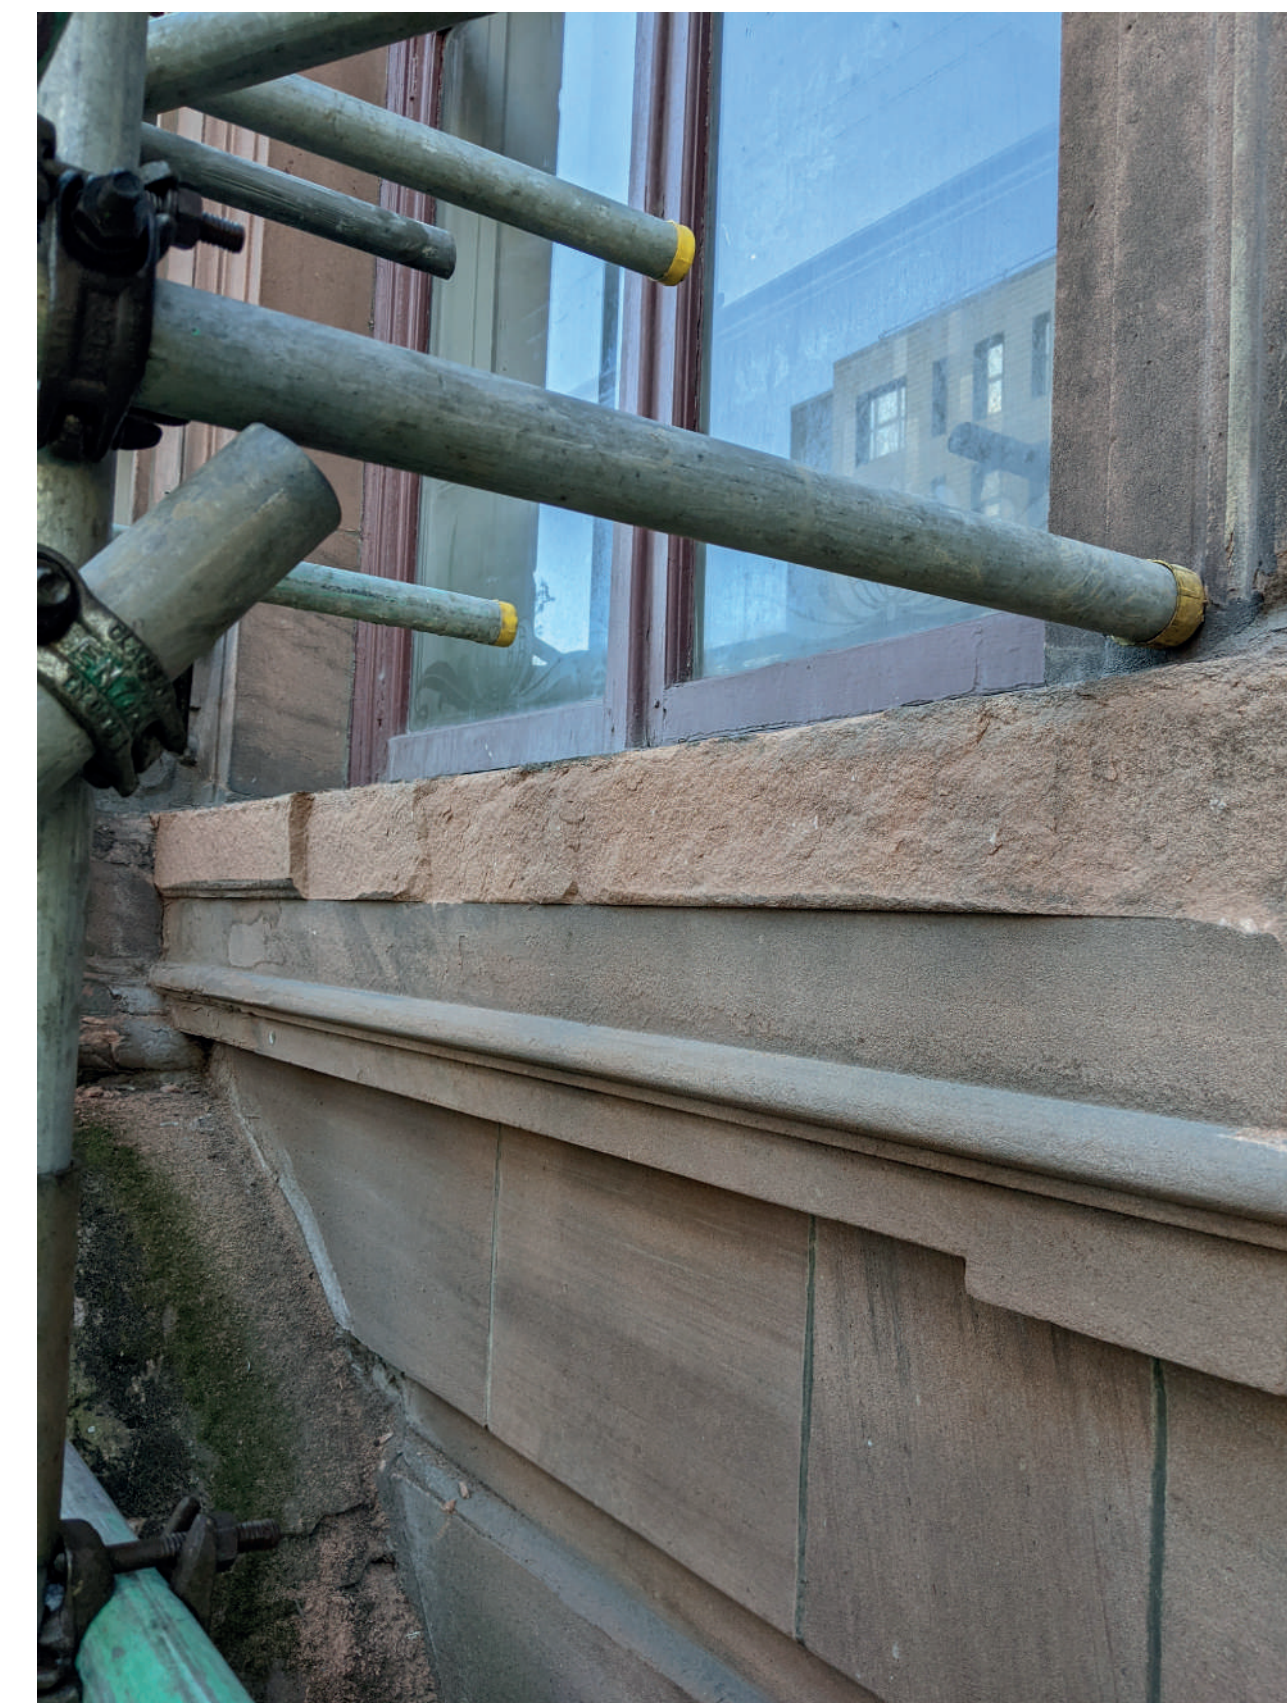
This survey and report was commissioned by the building owner following the sudden failure of one stone sill, which resulted in large pieces of sandstone falling to the ground.

Location A05.2 - Sill face sheared off the building. This is thought to be due to the original stone having been face bedded.

The sill at location A05,2 suddenly sheared off the face of the building thus triggering this survey. A replacement matching sill is now being installed as part of the works currently on site. The details of this have been agreed via a site visit and written correspondence with the Conservation Officer. The item is included in this application to formalise the consent.

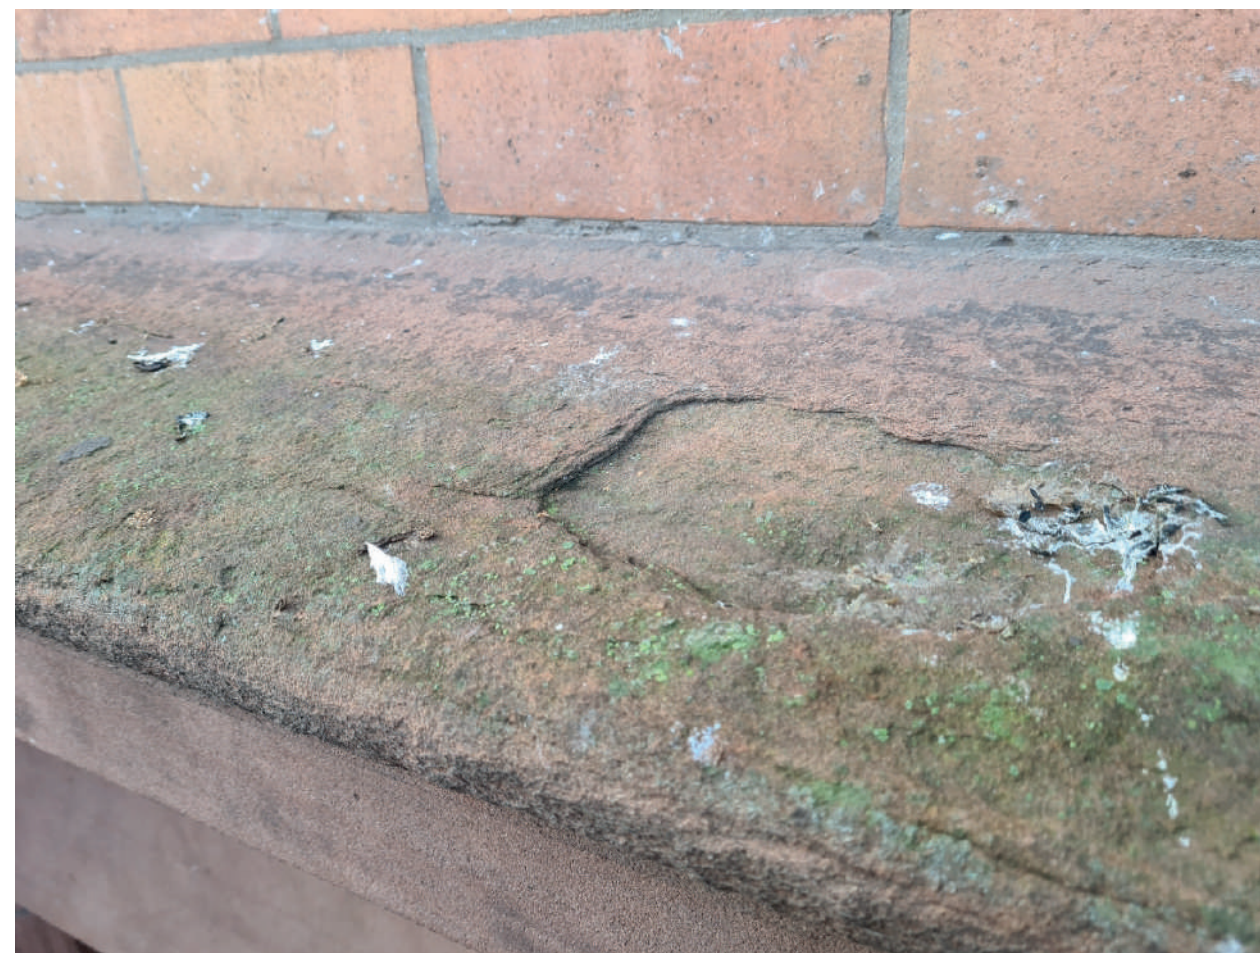
A07,5 - stone surface delaminating, risking accelerated freeze/thaw erosion. Stone indent proposed.

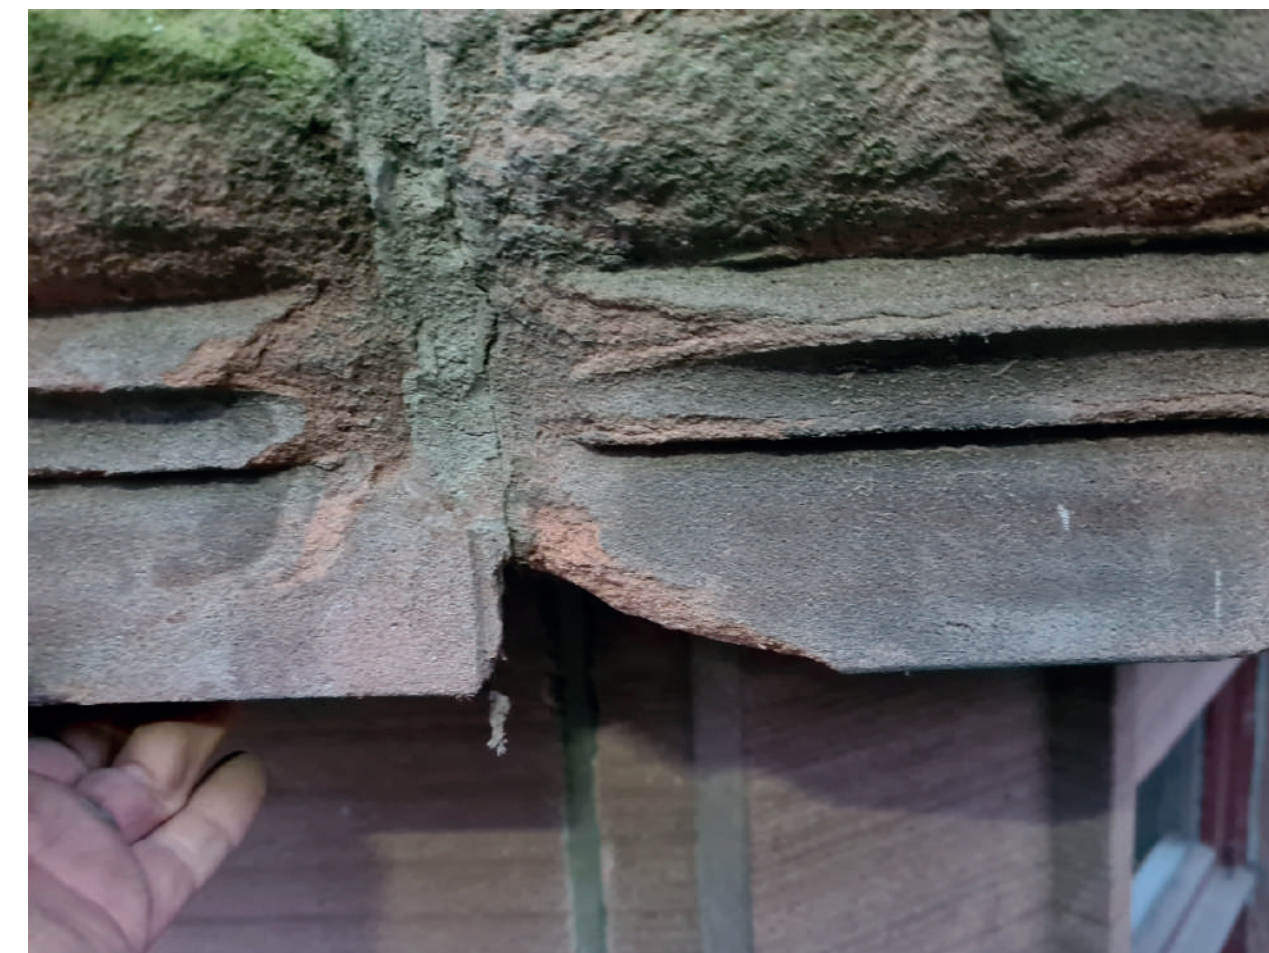
B01, 3 - Stone broken away. Stone indent proposed, followed by repointing.

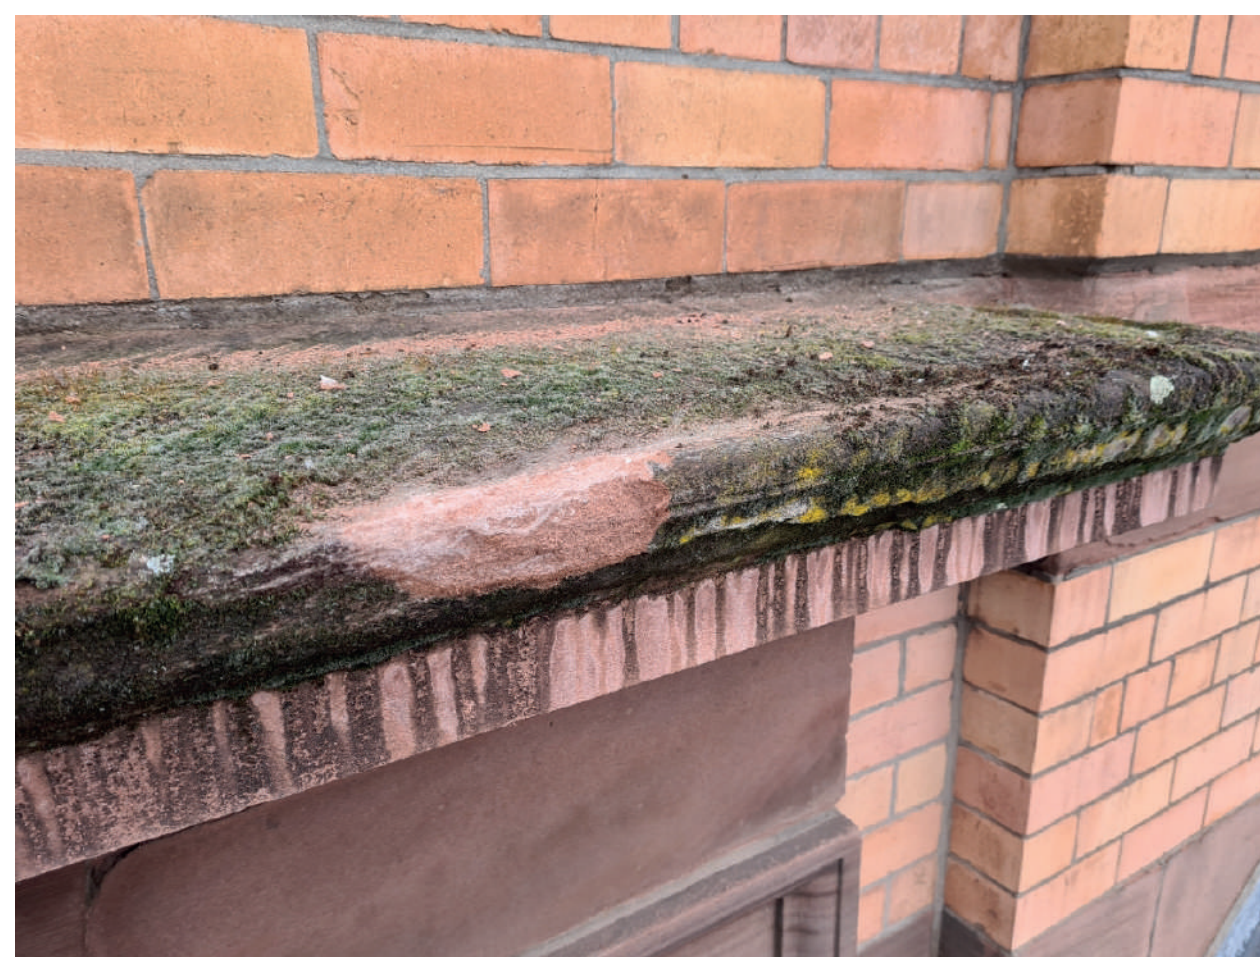
A02,8 - Significant areas of delaminated stone, and loss of original surface. Replacement proposed.

Where stone erosion is not localised, but affects a larger portion of a stone element, stone indents would require the loss of more stone than could be retained. Therefore, we are proposing these pieces to be fully replaced with matching Red Bee Sandstone. Note that the following alternatives were considered, but ruled out:

Once the scaffolding is erected, all areas of stone proposed for replacement will be inspected. Areas deemed to be repairable with indent or not sufficient to require action, will have their methodology updated accordingly.

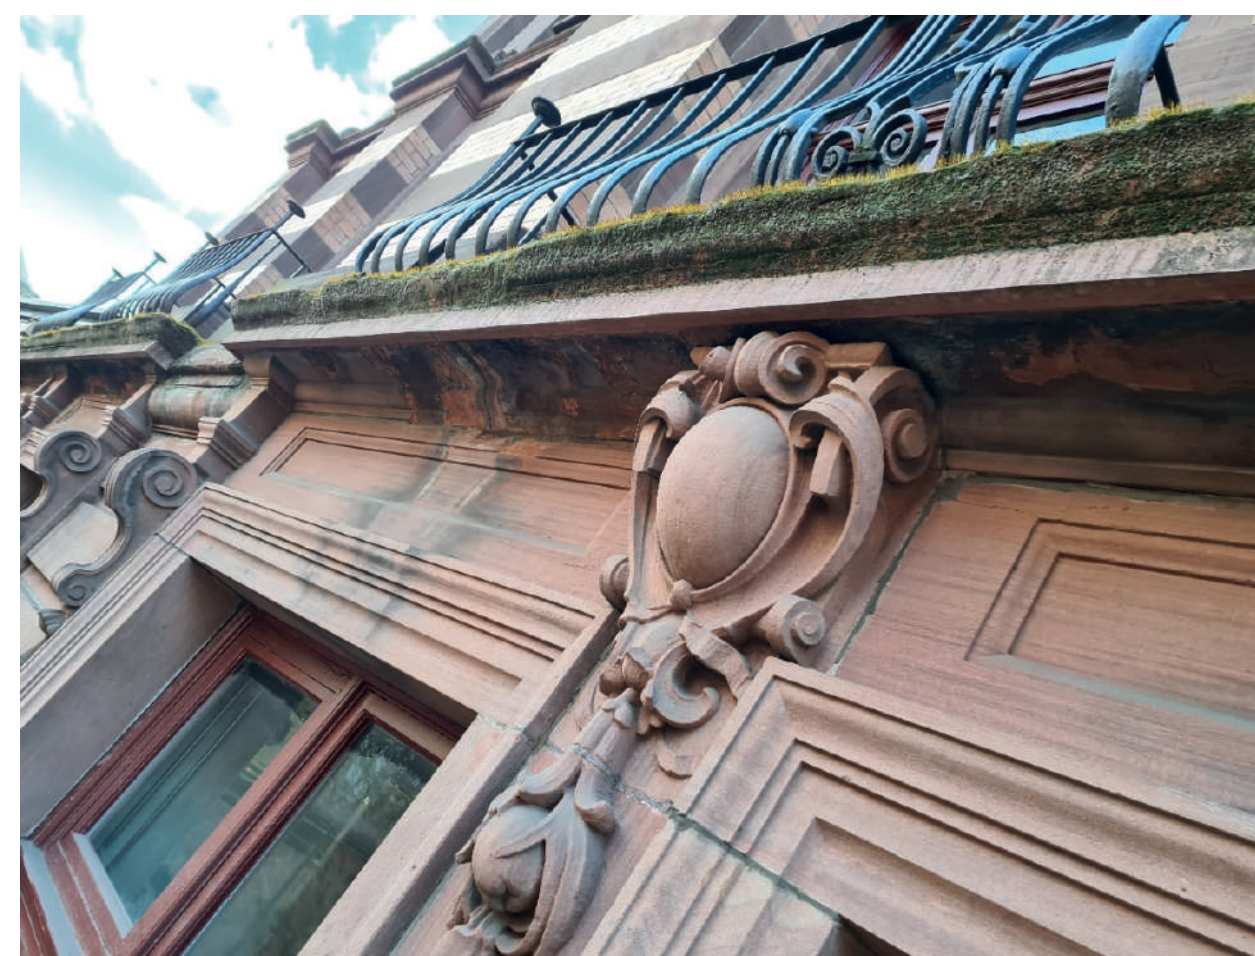
Example of biological deposits to be cleaned off.

Heated steam cleaning is proposed to remove accumulations of atmospheric dirt/crust, guano deposits, and biological growths.

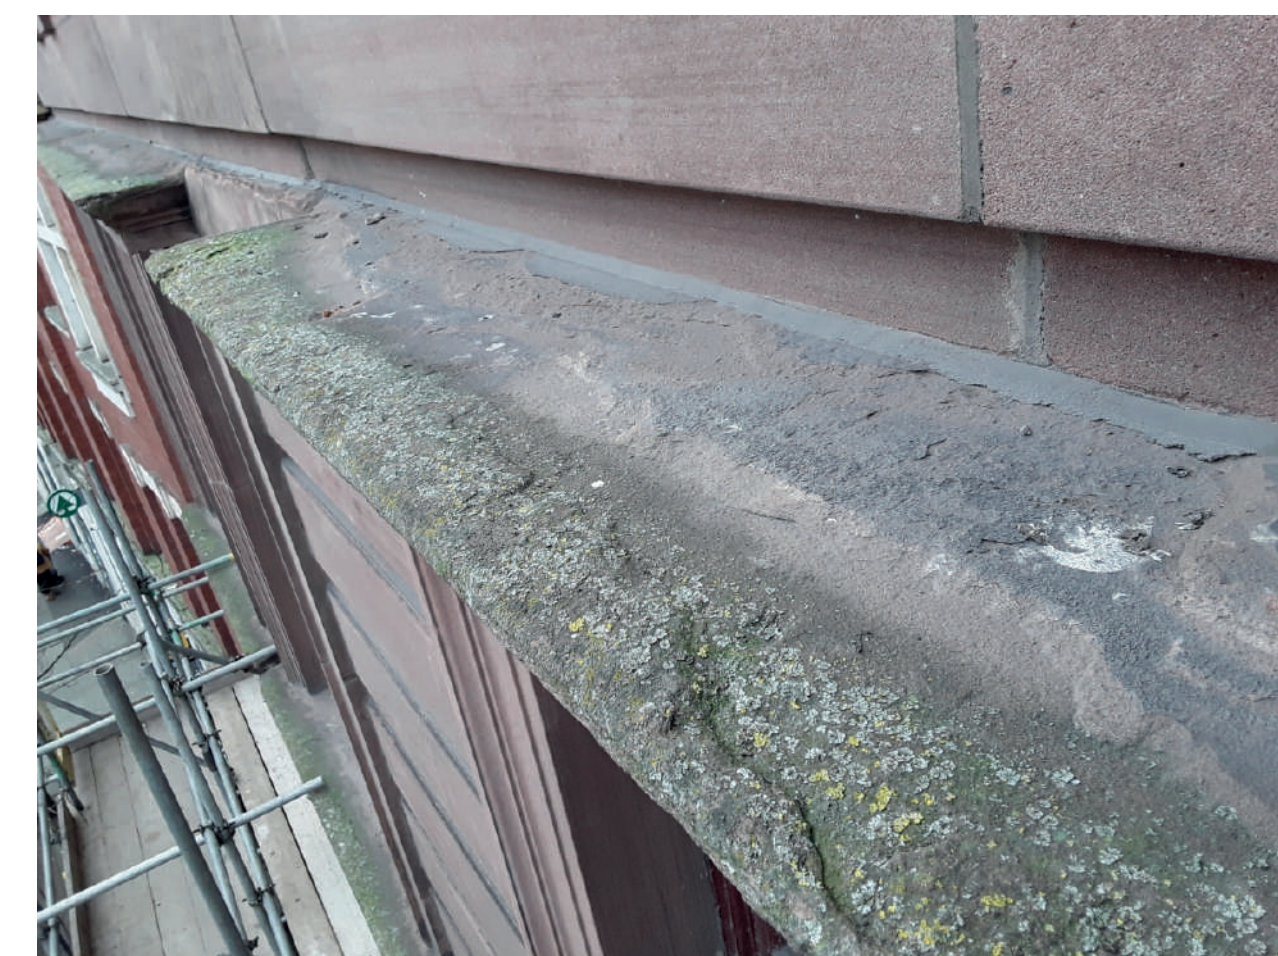
Example of potential atmospheric dirt crust to be cleaned off - pending close inspection.

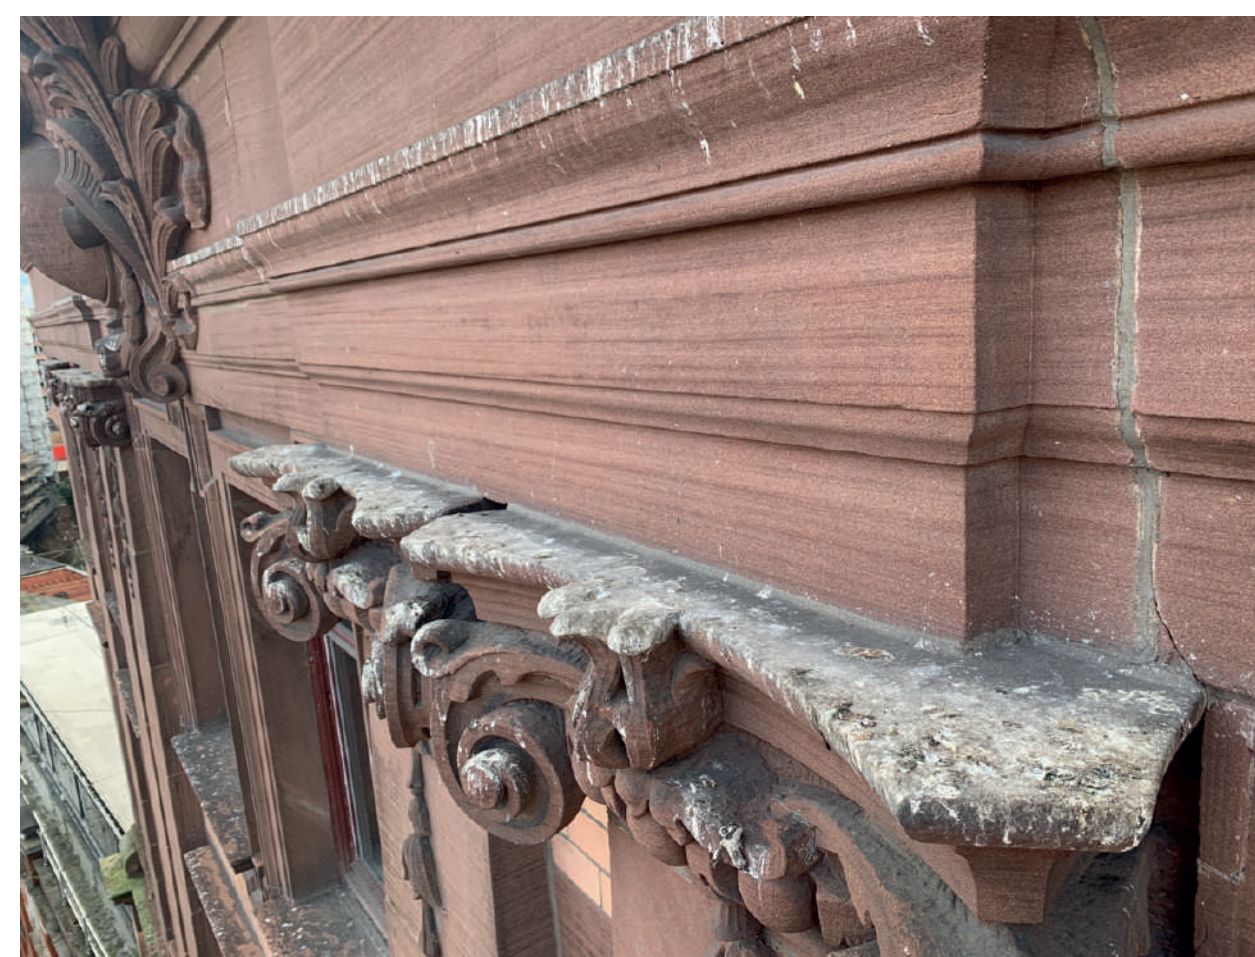
Example of guano deposits to be cleaned off.
