## **86 Princess Street External Stone Inspection**

28/02/2023 - 03/03/2023

Client: Mather and Ellis

Following a large piece of ornate sandstone falling from the front elevation of 86 Princess Street, Vertical Access have been instructed to carry out a safety inspection.

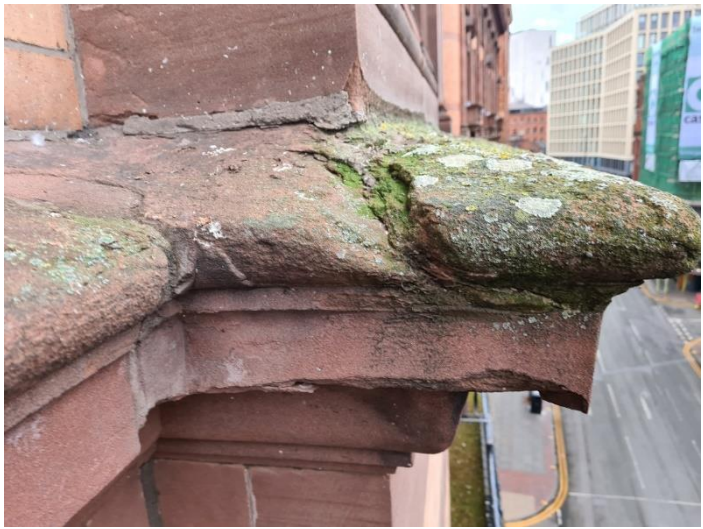
| Grid Ref.: | A02,5 | |

| Defect Descriptions: | Hollow, delamination. Stone corner is degraded and has 2 valleys which water runs through. This over time will break away and possibly be a danger to the public. | |
| Repair Urgency | Red | |

| Grid | Ref. | Description | H Size (mm) | V Size (mm) | Depth (mm) | Comments | Before Photos | After Photos | Repair Urgency | Recommendation |
|---|---|---|---|---|---|---|---|---|---|---|
| A02 , 5 | 1 | 7DL,HA | 500 | 100 | 250 | Stone corner is degraded and has 2 valleys which water runs through. This over time will break away and possibly be a danger to the public. | A02,5(1)--bef_1, A02,5(1)--bef_2, A02,5(1)--bef_3, A02,5(1)--bef_4 | | Red | Resin dowel this decorative stone to prevent movement or remove |

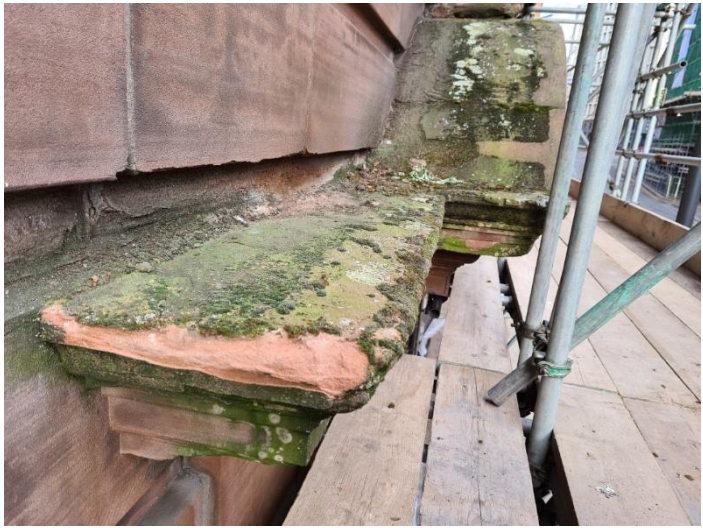
| Grid Ref.: | A03,2 | |

| Defect Descriptions: | Loose, removed | |
| Repair Urgency | Green | |

| Grid | Ref. | Description | H Size (mm) | V Size (mm) | Depth (mm) | Comments | Before Photos | After Photos | Repair Urgency | Recommendation |
|---|---|---|---|---|---|---|---|---|---|---|
| A03 , 2 | 1 | 7L,R | 300 | 50 | 50 | | A03,2(1)--bef_1, A03,2(1)--bef_2 | A03,2(1)--aft_1, A03,2(1)--aft_2 | Green | Monitor |

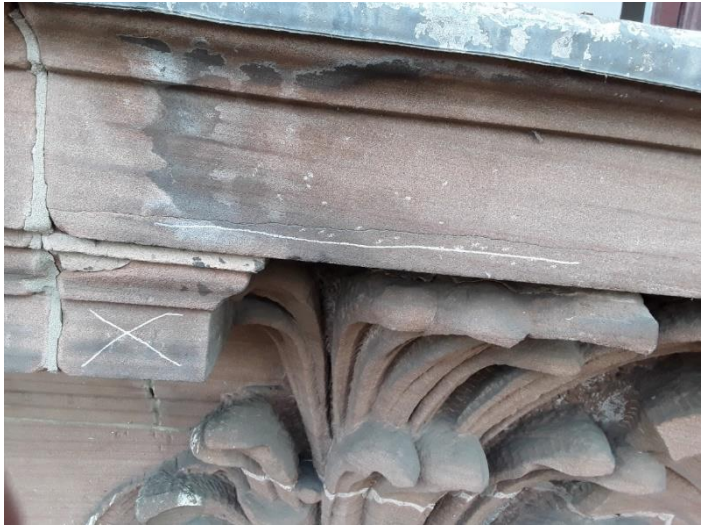
| Grid Ref.: | A04,7 | |

| Defect Descriptions: | Horizontal crack, hollow. X marked stonework sounds loose to the tap, mortar bed loose | |
| Repair Urgency | Red | |

| Grid | Ref. | Description | H Size (mm) | V Size (mm) | Depth (mm) | Comments | Before Photos | After Photos | Repair Urgency | Recommendation |
|---|---|---|---|---|---|---|---|---|---|---|
| A04 , 7 | 1 | 7HA,HC | 500 | 40 | 40 | X marked stonework sounds loose to the tap, mortar bed loose | A04,7(1)--bef_1, A04,7(1)--bef_2 | | Red | 2No. resin anchors |

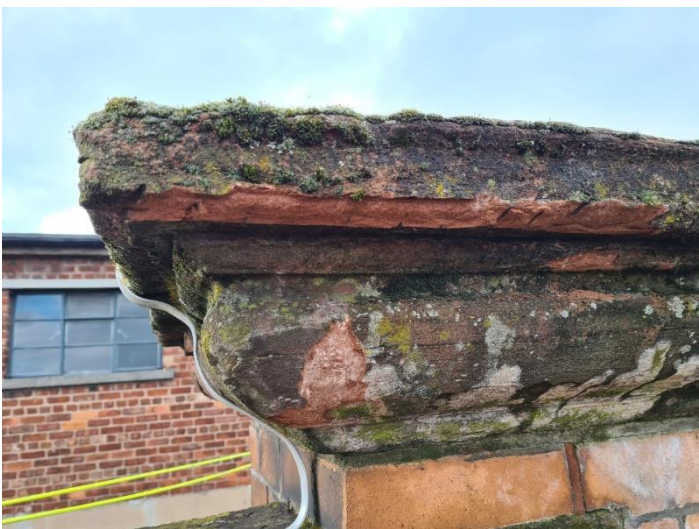
| Grid Ref.: | A05,9 | |

| Defect Descriptions: | Loose, removed, degraded, delamination. Old cuts made weakening stone | |
| Repair Urgency | Amber | |

| Grid | Ref. | Description | H Size (mm) | V Size (mm) | Depth (mm) | Comments | Before Photos | After Photos | Repair Urgency | Recommendation |
|---|---|---|---|---|---|---|---|---|---|---|
| A05 , 9 | 1 | 7D,DL,L,R | 350 | 25 | 30 | Old cuts made weakening stone | A05,9(1)--bef_1, A05,9(1)--bef_2 | A05,9(1)--aft_1 | Amber | Either removing the degraded chimney tops or Lead covering needed for whole of the chimney |

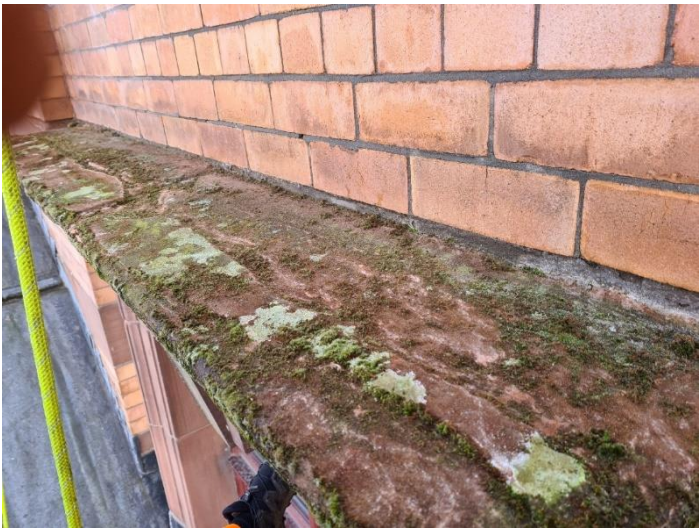
| Photos: | A07,8(1)--aft_1 | |

| Defect Descriptions: | Degraded, delamination. The coping ledge above has shed rain water on this lower ledge, eroding half the stone face away. Vegetation now removed. Through erosion present. | |
| Repair Urgency | Red | |

| Grid | Ref. | Description | H Size (mm) | V Size (mm) | Depth (mm) | Comments | Before Photos | After Photos | Repair Urgency | Recommendation |
|---|---|---|---|---|---|---|---|---|---|---|
| A07 , 8 | 1 | 7D,DL | 2600 | 150 | 350 | The coping ledge above has shed rain water on this lower ledge, eroding half the stone face away. Vegetation now removed. Through erosion present. | A07,8(1)--bef_1, A07,8(1)--bef_2, A07,8(1)--bef_3 | A07,8(1)--aft_1, A07,8(1)--aft_2, A07,8(1)--aft_3 | Red | Lead the ledge protecting from further erosion |

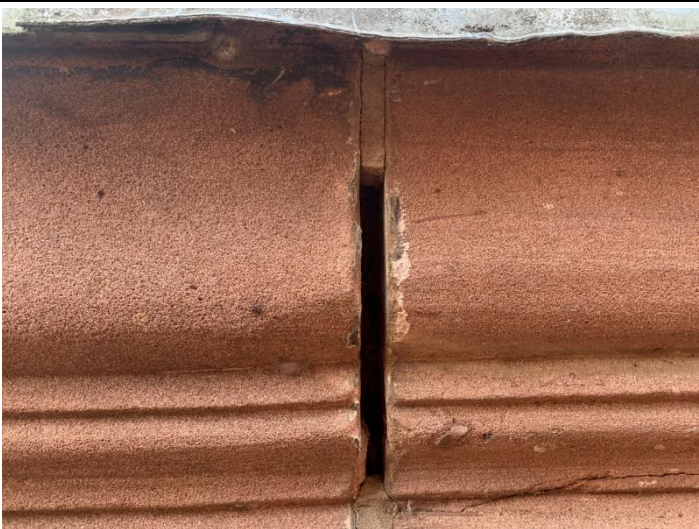
| Grid Ref.: | B03,7 | |

| Defect Descriptions: | Mortar removed | |
| Repair Urgency | Amber | |

| Grid | Ref. | Description | H Size (mm) | V Size (mm) | Depth (mm) | Comments | Before Photos | After Photos | Repair Urgency | Recommendation |
|---|---|---|---|---|---|---|---|---|---|---|
| B03 , 7 | 1 | 14R | 20 | 200 | 150 | | B03,7(1)--bef_1 | | Amber | Repoint |

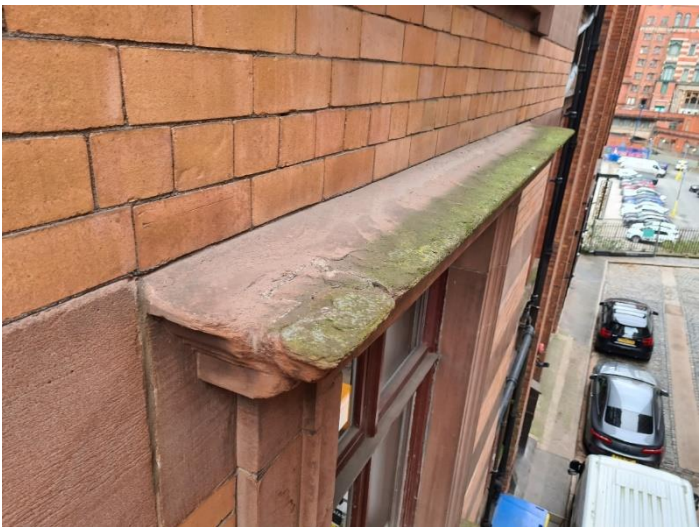
| Grid Ref.: | B05,2 | |

| Defect Descriptions: | Very loose - removed. Remainder of retro fit repair dovetailed and secure | |
| Repair Urgency | Amber | |

| Grid | Ref. | Description | H Size (mm) | V Size (mm) | Depth (mm) | Comments | Before Photos | After Photos | Repair Urgency | Recommendation |
|---|---|---|---|---|---|---|---|---|---|---|
| B05 , 2 | 1 | 7R | 230 | 160 | 100 | The rest of the retro fit repair dovetailed and secure | B05,2(1)--bef_1, B05,2(1)--bef_2, B05,2(1)--bef_3 | B05,2(1)--aft_1, B05,2(1)--aft_2 | Amber | Cover whole cill with lead to prevent more ingress to retro fit repair |

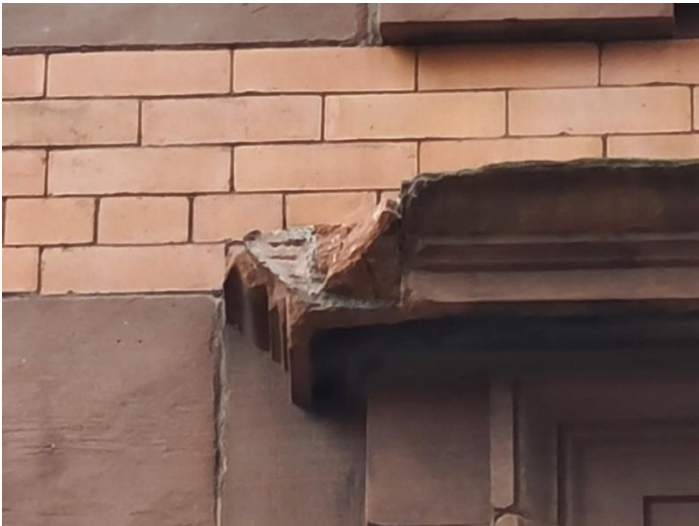
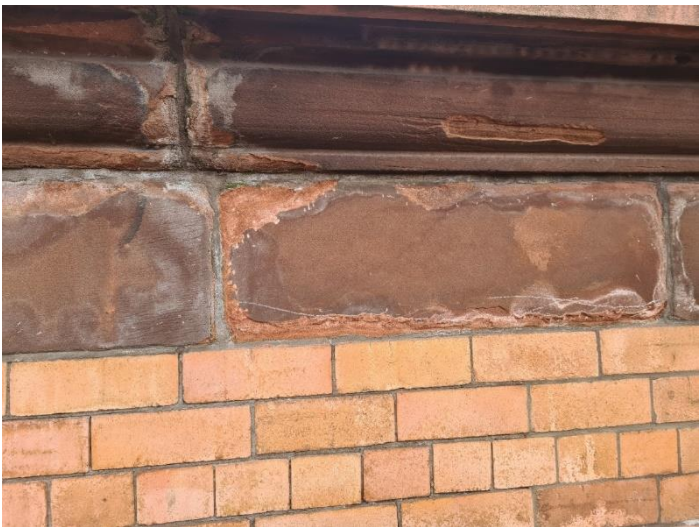
| Grid Ref.: | B05,8 | |

| Defect Descriptions: | Spalling | |
| Size: | Spalling stone face removed along coping string course. Water ingress and effervescence present. | |
| Repair Urgency | Green | |

| Grid | Ref. | Description | H Size (mm) | V Size (mm) | Depth (mm) | Comments | Before Photos | After Photos | Repair Urgency | Recommendation |
|---|---|---|---|---|---|---|---|---|---|---|
| B05 , 8 | 2 | 7S | 700 | 220 | 10 | Spalling stone face removed along coping string course. Water ingress and effervescence present. | B05,8(2)--bef_1 | B05,8(2)--aft_1 | Green | Monitor |

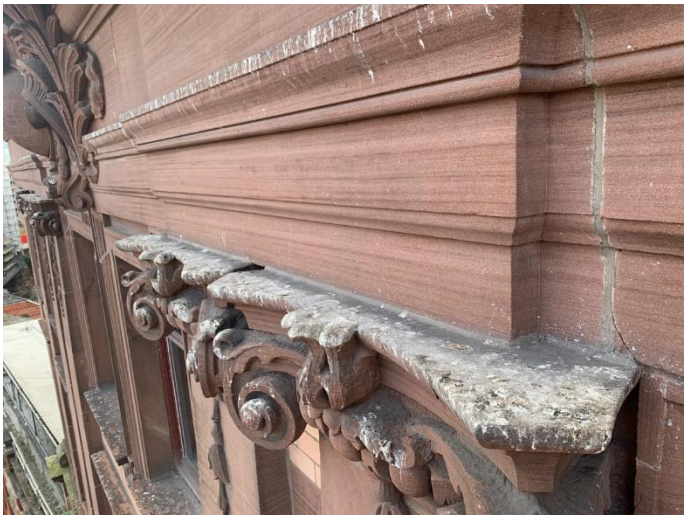
| <b>Gen. Com. No.</b> | GC1 | |

| <b>Description</b> | Heavy build-up of guano on ledges and down the building | |

| General Com. No. | Location | Description | Photos | Repair Urgency | Recommendation |
|---|---|---|---|---|---|
| GC1 | A & B elevations | Heavy build-up of guano on ledges and down the building | GC1_1, GC1_2, GC1_3, GC1_4, GC1_5, GC1_6, GC1_7 | Amber | Bird spikes |

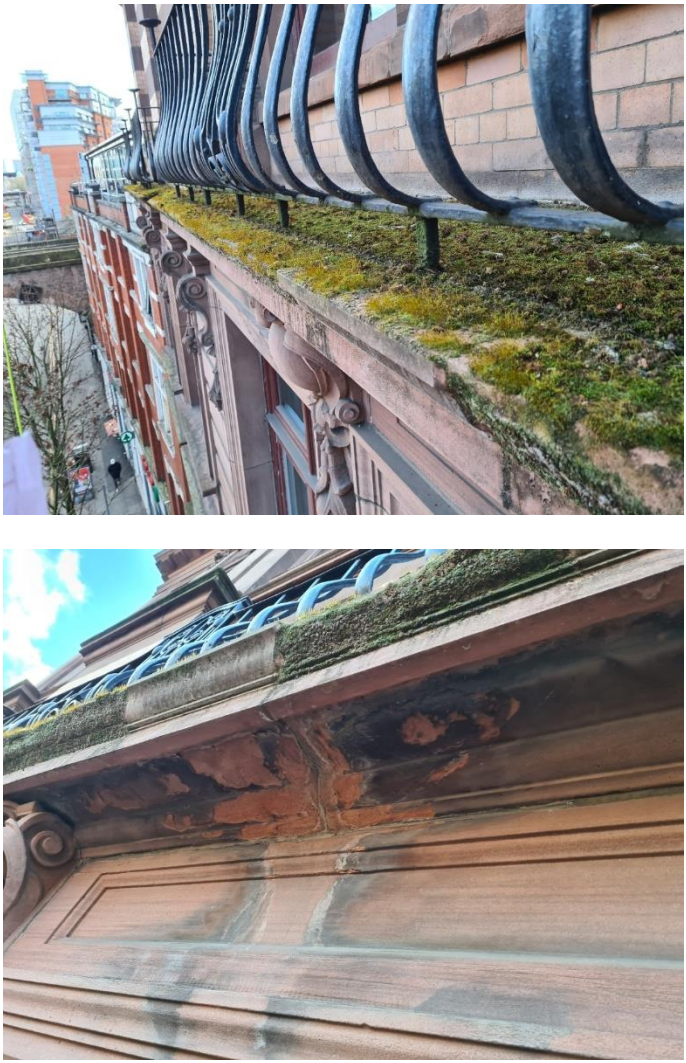
| <b>Gen. Com. No.</b> | GC2 | |

| <b>Description</b> | All railing balconies on floor 4 have a retrofit diminishing screed for rainwater. This has degraded, debonded and has thick moss growth. Although this isn't a potential falling object it's holding water and eroding. This is evident on the soffits. | |

| General Com. No. | Location | Description | Photos | Repair Urgency | Recommendation |
|---|---|---|---|---|---|
| GC2 | A & B elevations | All railing balconies on floor 4 have a retrofit diminishing screed for rainwater. This has degraded, debonded and has thick moss growth. Although this isn't a potential falling object it's holding water and eroding. This is evident on the soffits. | GC2_1, GC2_2, GC2_3, GC2_4, GC2_5, GC2_6 | Amber | Create a fall with tilt fillets and marine ply then cover with lead |

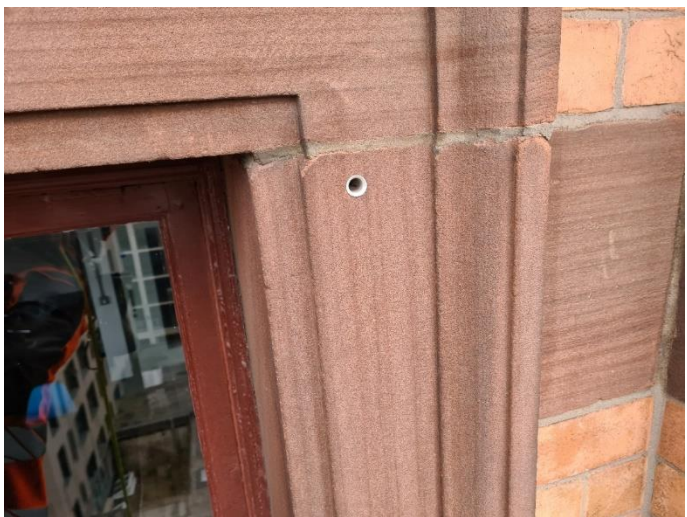
| <b>Gen. Com. No.</b> | GC3 | |

| <b>Description</b> | Scaffold fixed to stone work. Plugs left in. | |

| General Com. No. | Location | Description | Photos | Repair Urgency | Recommendation |
|---|---|---|---|---|---|
| GC3 | A & B elevations | Scaffold fixed to stone work. Plugs left in. | GC3_1, GC3_2, GC3_3, GC3_4 | Amber | Remove plugs and point holes |

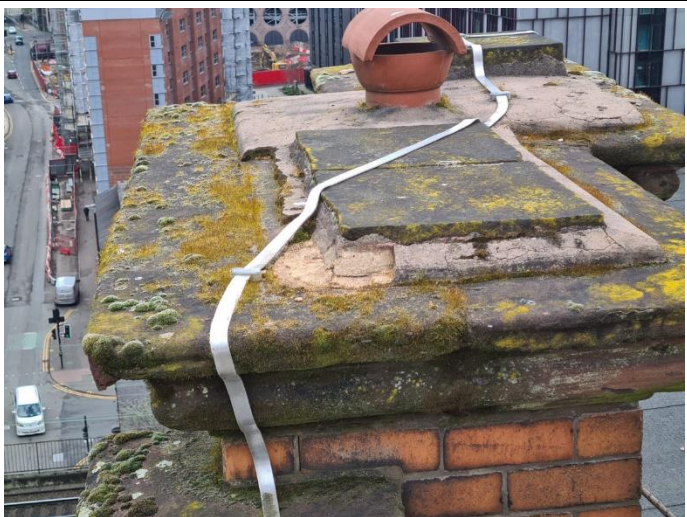
| <b>Gen. Com. No.</b> | GC4 | |

| <b>Description</b> | All chimney flaunches are degraded and in poor condition. | |

| General Com. No. | Location | Description | Photos | Repair Urgency | Recommendation |
|---|---|---|---|---|---|
| GC4 | All Chimneys | All chimney flaunches are degraded and in poor condition. | GC4_1, GC4_2, GC4_3, GC4_4, GC4_5, GC4_6 | Amber | Re-flaunch chimneys |
