**Project:** Abraham Moss Leisure Centre

# LAND QUALITY TECHNICAL NOTE 02: WATCHING BRIEF DURING EXCAVATION

| Job | <b>Abraham Moss Library and Leisure Centre, Manchester</b> |
| Report Ref: | <b>LP44107-RAM-ZZZ-XX-RP-Y-00009 P01 Technical Note 02</b> |

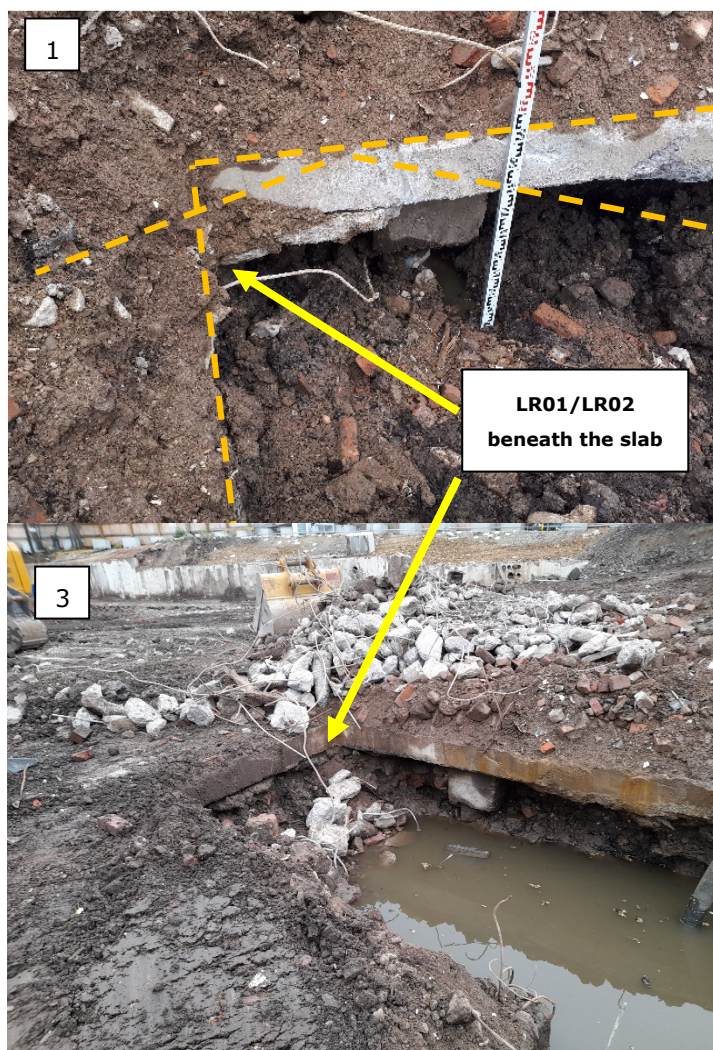
In brief, an area of soil with moderate hydrocarbon odours was encountered within the southern Basement Area directly below the former pool foundation slab (the slab was approximately 400mm in thickness). The impact was viewed from south-west only due to concrete slabs present to the immediate north; and north-east to the south-west of the area. Photographs 1 to 3 illustrate the position of the encountered contamination in relation to the foundation slabs in its immediate surroundings.

**Photograph 1** facing south-east, showing sample location LR01 and 02 beneath the foundation slab (dotted line illustrating the concrete slab present at time of excavation), August 2021;

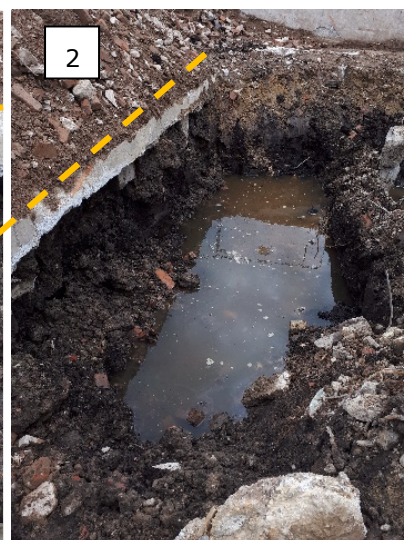
**Photograph 2** facing the south-west, showing excavation alongside impact (where no contamination was identified), August, 2021; and

**Photograph 3** facing the north and north-east during the October 2021 excavation.

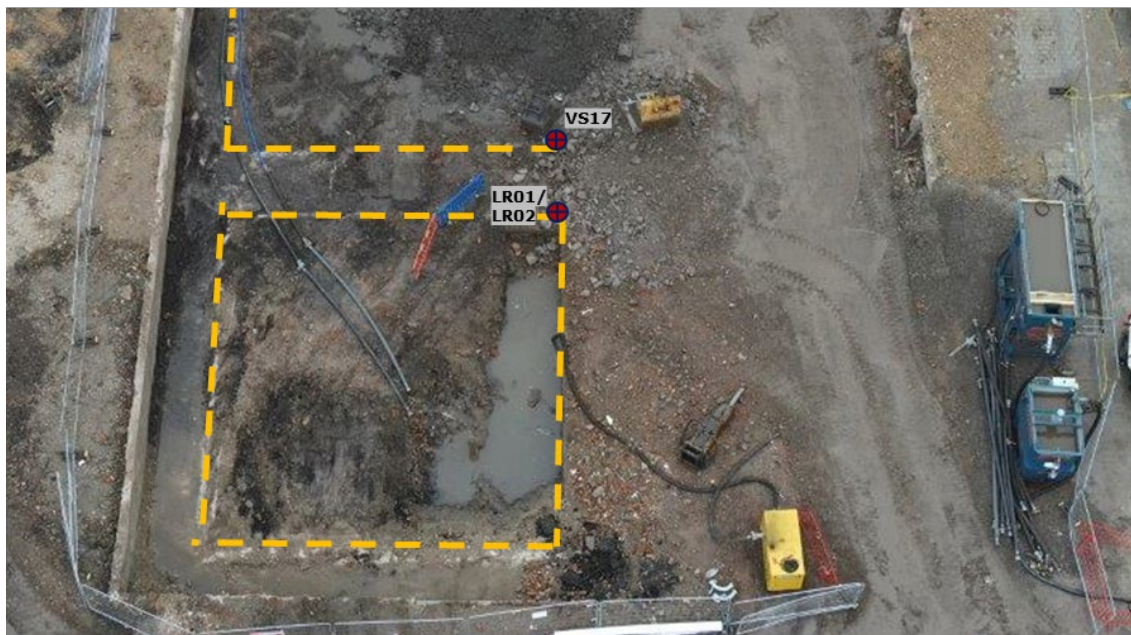
**Figure 2:** Approximate sampling locations in the Basement Area during the August sampling event. Aerial image taken facing the north-east. Dashed line depicts the concrete slab edges.

Soil samples of the suspected impacted soils were recovered as samples LR01 and LR02. Sample VS17 was also recovered approximately 2m north of LR01 / LR02 which was not covered by a foundation slab at the time of sampling. Figure 2 below illustrates the approximate sampling locations of these samples.

The strata around the encountered impact were field screened with a Photoionization Detector (PID), with a maximum reading of 373.7ppm recorded within the impacted area (around LR01 and LR02 sampling points). Other than the hydrocarbon odours from the soils in LR01, LR02 and VS17, no visual or olfactory evidence of contamination was identified during the August 2021 investigation works.

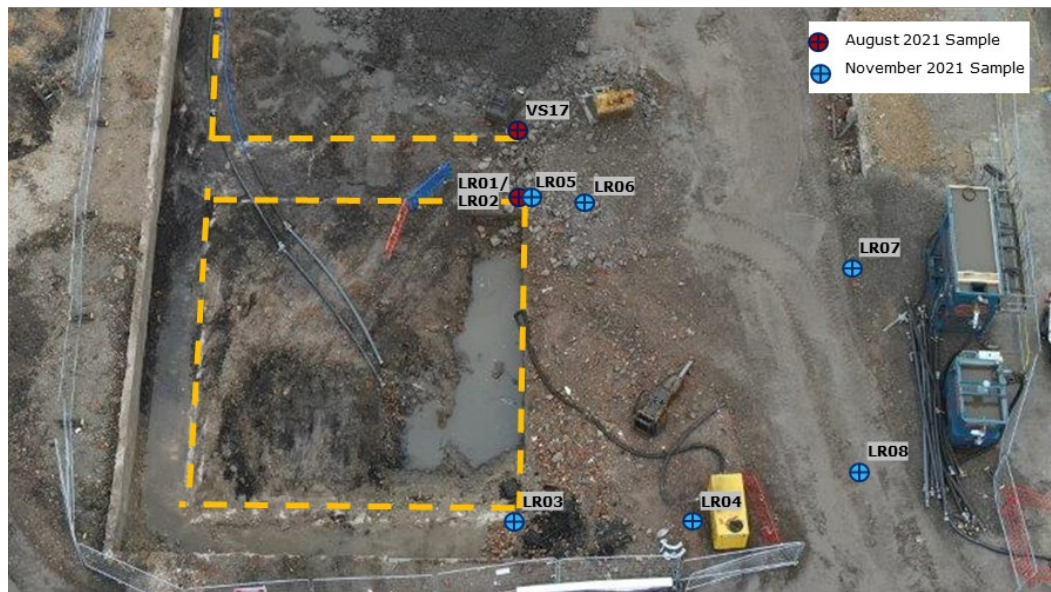
**Figure 3:** Approximate sampling locations in the Basement Area (LR03 to LR08) extending away from the unexpected contamination encountered in August 2021. Aerial image taken facing the north-east. Dashed line depicts the concrete slab edges.

Ramboll undertook verification sampling around the basement area excavation. Two soil samples were recovered from the base of the excavation (LR05 and LR06), and four samples were recovered from the excavation sides towards the east, south-east, south and south-west of the hydrocarbon contamination (sampling to the north was not required as discussed above). Figure 3 and Photographs 4 to 6 below illustrate the approximate sampling locations in proximity to the initial hydrocarbon contamination area (LR01/LR02).

All but one sample had TPH concentrations recorded to be below the limit of detection. Sample LR03 had very low concentrations (10 mg/kg to 52mg/kg) of heavy-end aromatic hydrocarbons (C16 to C35), which were well below the GAC for commercial end-use. The screening sheet of the analytical results relative to the GAC concentrations is included within Appendix F.

The results of the remaining soils indicate that the hydrocarbon contamination does not extend laterally or vertically within the basement area and the main source area *i.e.*, soils around LR01 and LR02 have removed from site. The TPH concentrations identified within the soils which remain within the basement area are not considered to pose a significant risk to the human health or the controlled water environment. It is therefore considered likely that the impact was a localised pocket which has now been full removed.

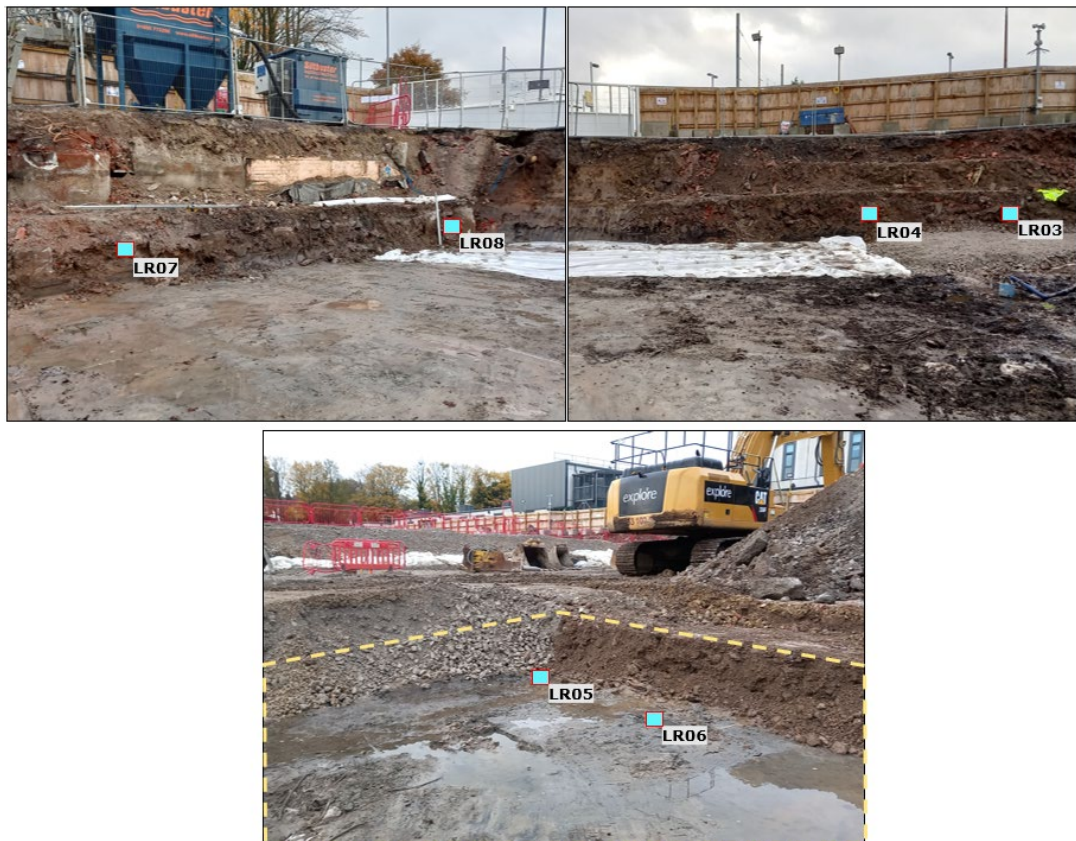
**Photographs 4 to 6:** **Photograph 4** facing south-eastern boundary, showing sample locations LR07 and LR08, downgradient of the impacted zone; and **Photograph 5** facing the southern boundary, showing sampling locations LR03 and LR04 downgradient to the impacted zone; and **Photograph 6** facing north, illustrating the sampling locations LR05 (base of the impact) and LR06 (downgradient of the impact). Yellow dashed line depicting the former concrete slab placement.

The sampled material (LR03 to LR08) consisted of both the Made Ground and the organic-rich sandy clay. The PID readings of the recovered samples ranged between 0.5ppm (LR07) and 22.0ppm (LR04). No visual or olfactory evidence of hydrocarbons were noted in the collected samples, at the base or around the excavation.

The excavation was then lined with a geotextile and backfilled with crushed demolition arisings to form the new foundation levels. Ramboll was not present on site at the time of the backfill in all areas.

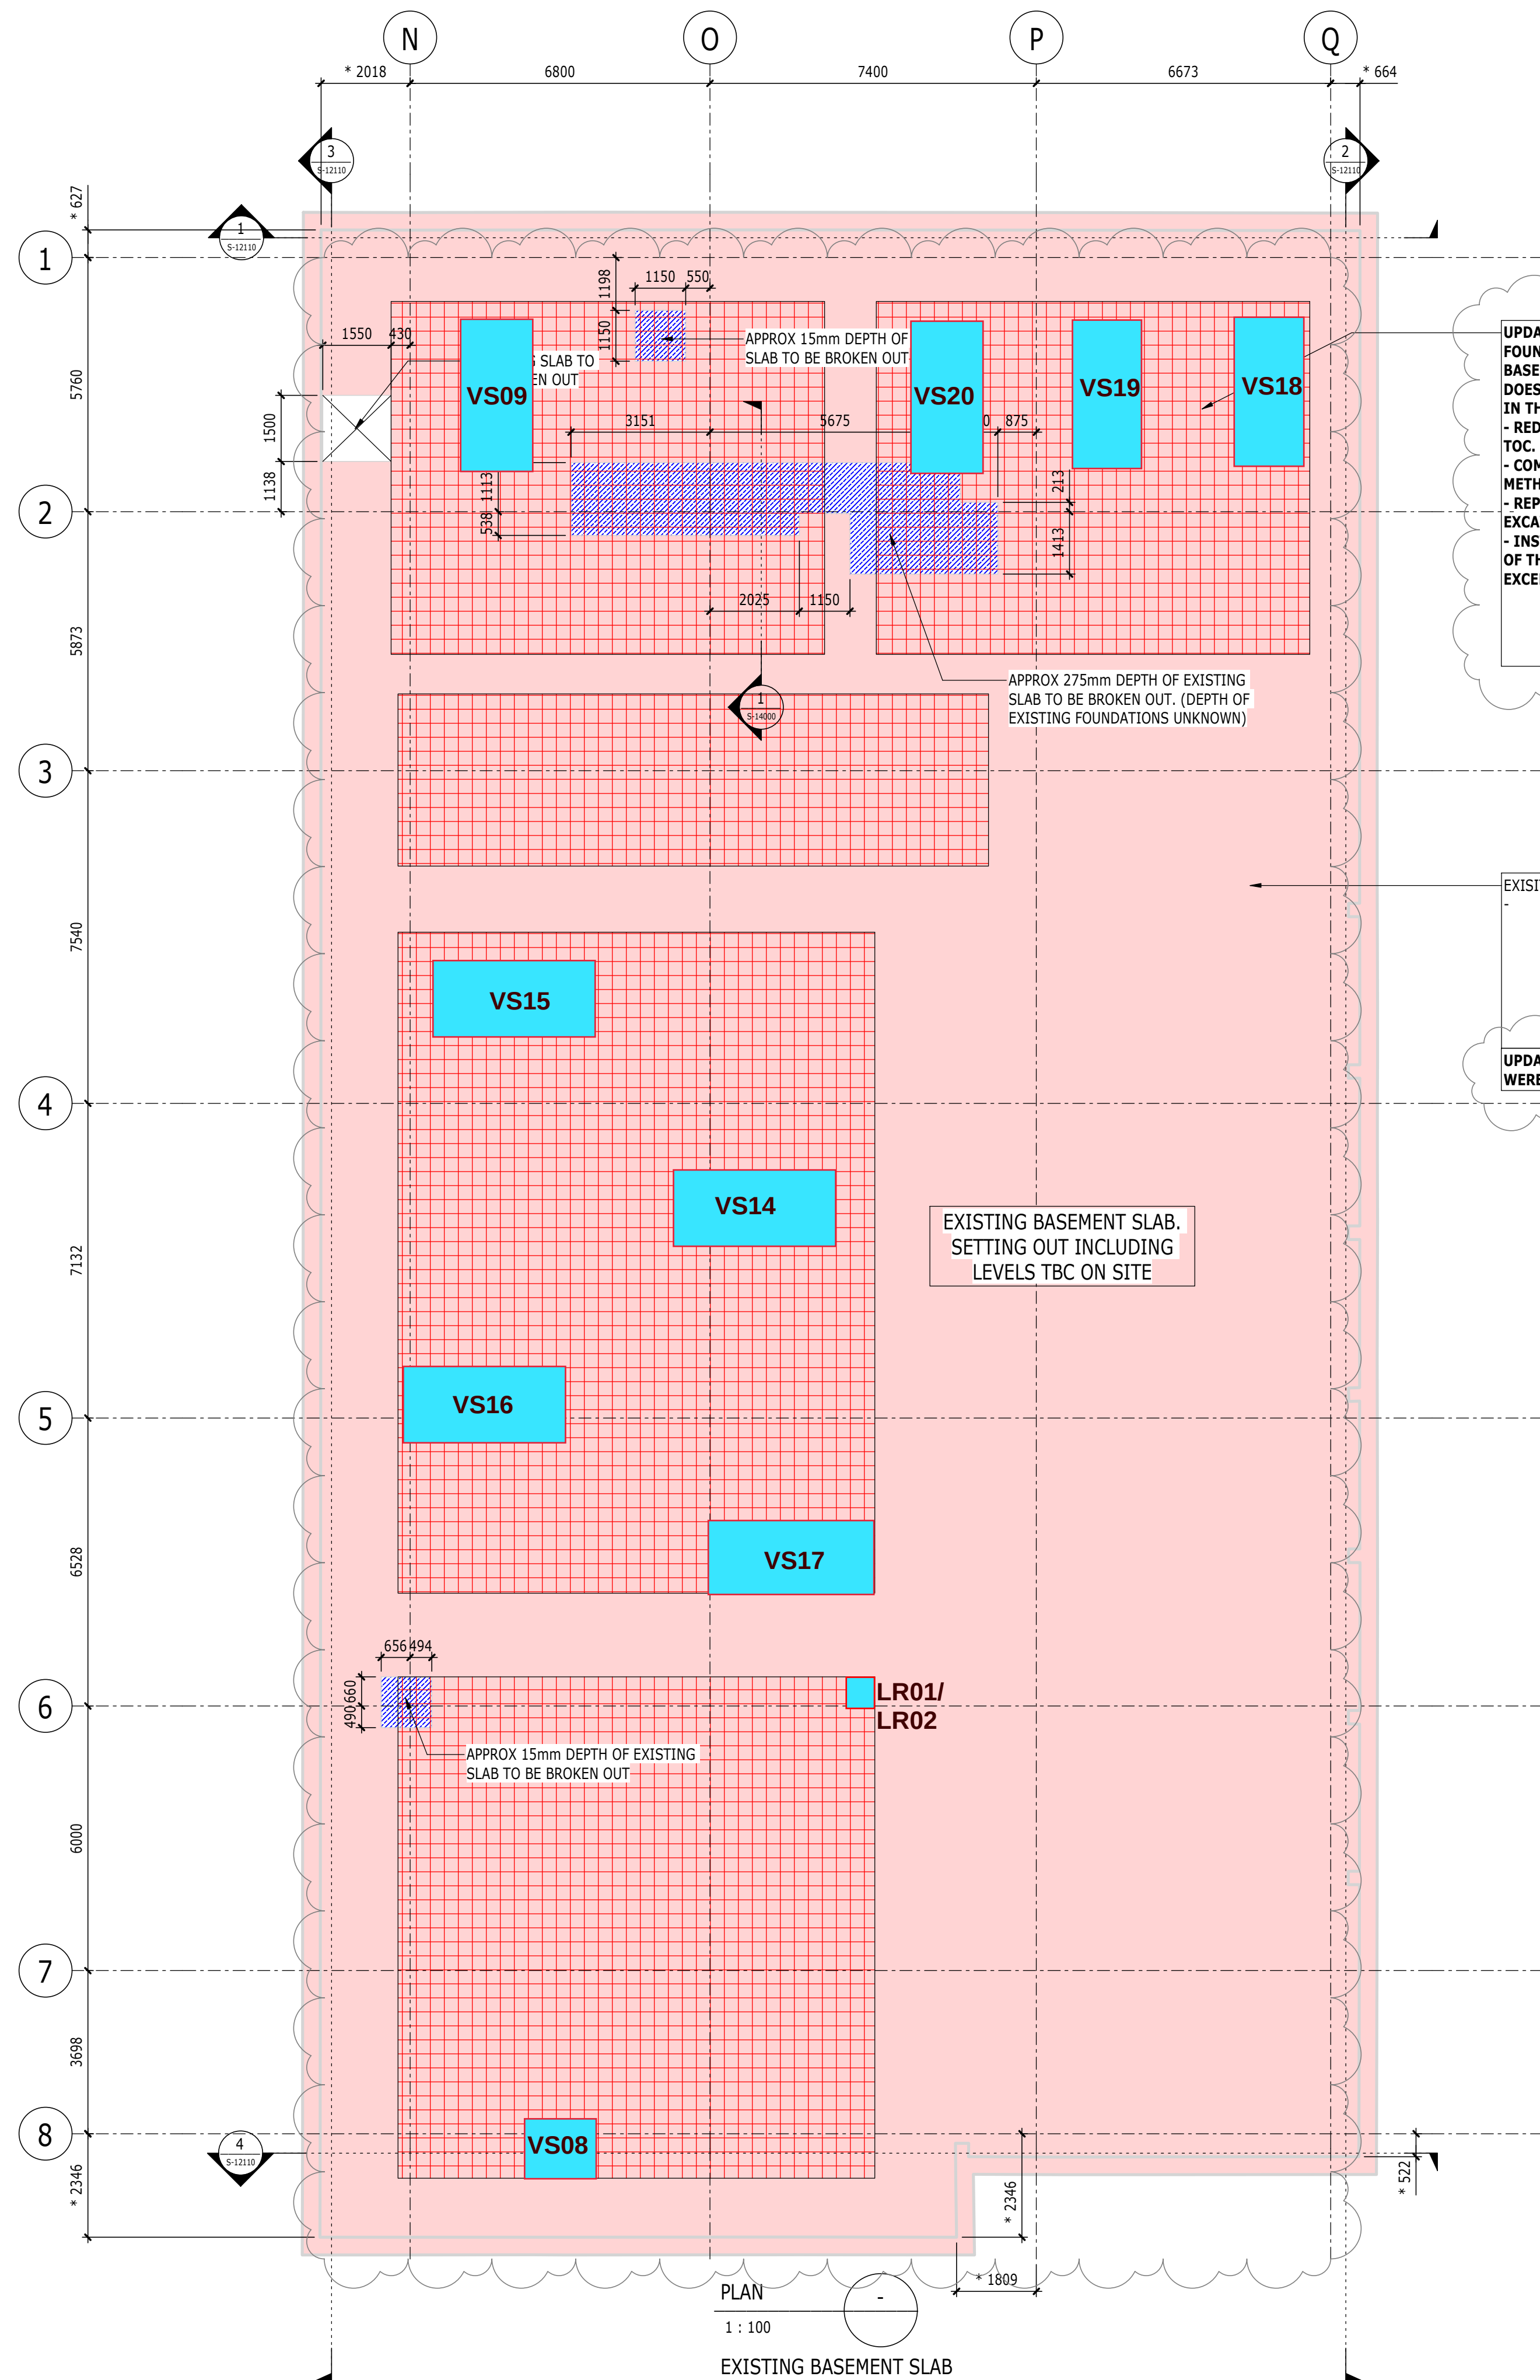
UPDATE - DURING DEMOLITION PHASE, THE OLD BASEMENT WAS FOUND TO BE A FOLDED SLAB CONSTRUCTION THAT FORMED THE BASE OF THE OLD SWIMMING POOLS. THERE BASEMENT SLAB DOES NOT EXIST IN THE HATCHED AREAS INDICATED. IN THESE AREAS THE GROUND IS TO BE PREPARED :  
- REDUCE LEVEL TO APPROX. 50mm BELOW EXISTING BASEMENT TOC.  
- COMPACT THE OLD FILL WITH A WACKER PLATE OR SIMILAR METHOD.  
- REPLACE ANY SOFT SPOTS IN LINE WITH THE RAMBOLL EXCAVATION & FILLING SPEC.  
- INSTALL A CONCRETE BLINDING LAYER TAKE THE LEVEL OF THESE PATCHES TO THE SAME AS THE MAIN BASEMENT TOC EXCEPT FOR THE AREAS MARKED IN BLUE

EXISTING BASEMENT - TEMPORARY CASE IN ORDER TO AVOID POTENTIAL BUOYANCY DUE TO HIGH GROUND WATER WHEN THE EXISTING BUILDING AND POOLS ARE REMOVED, CORE HOLES TO BE FORMED AND ANY INCOMING GROUND WATER TO BE MANAGED BY THE CONTRACTOR.  
150mm DIAMETER CORES TO BE CORED THROUGH EXISTING BASEMENT WALL, 225mm ABOVE BASEMENT (TO CENTRELINE) AROUND FULL PERIMETER AT 5m CENTRES  
UPDATE - DURING DEMOLITION PHASE, THESE PENETRATIONS WERE FOUND TO BE NO LONGER REQUIRED
