# **Phase 1 Land Contamination Risk Assessment**

## **Proposed Residential Development Comprising a Pair of Semi-Detached, Four- Bedroomed Dwellings with Associated Parking**

## **Land Adjacent to No 3, Slaithwaite Drive, Manchester M11 4BA**

3569D P1 Casey - Manchester

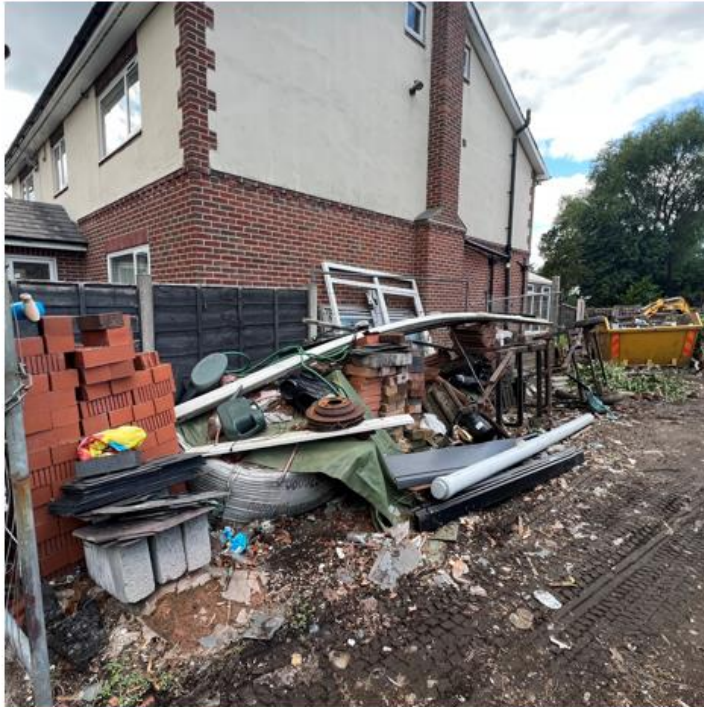
**Photo No.3: Facing SW from the site entrance showing heaped debris and offsite, adjacent and associated dwelling**

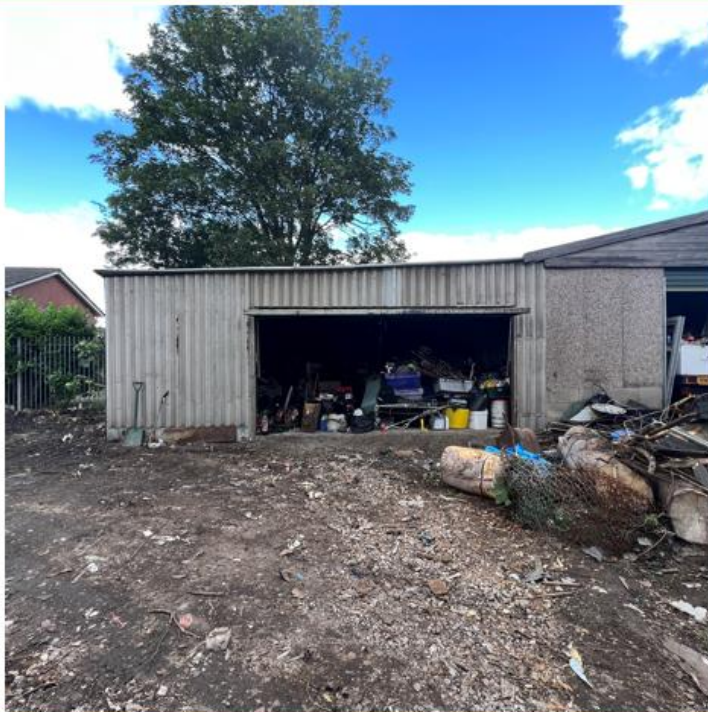
**Photo No.5: Facing north showing the southern face of the workshop, adjoined to the garage (right of photo)**

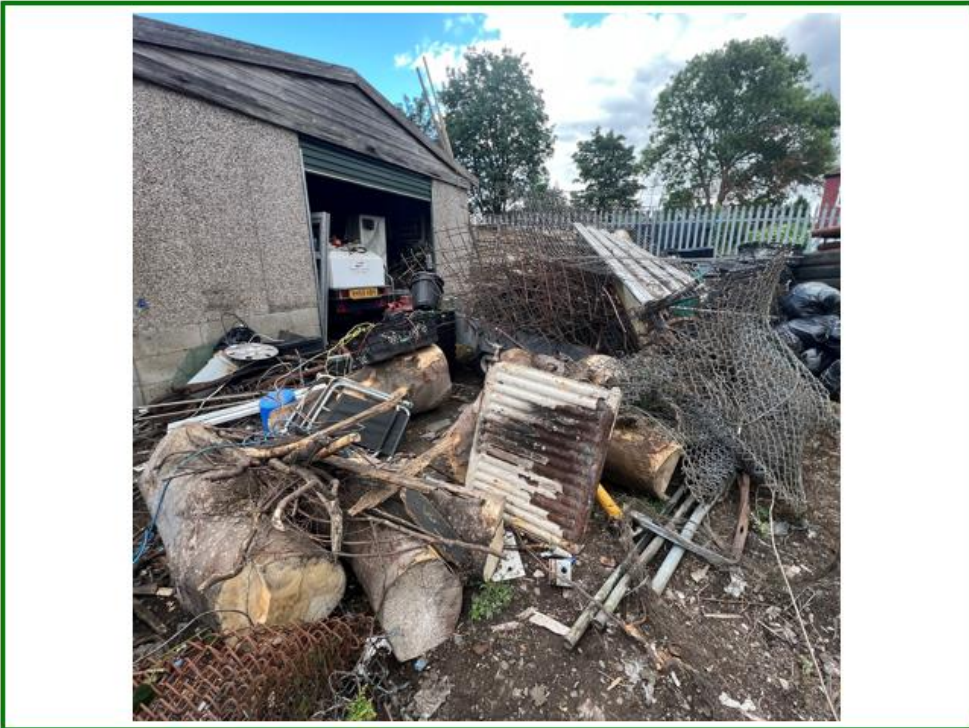
Potential sources of contamination noted on the site walkover include both the garage and workshop unit, the scattered debris noted both within and without the buildings, along with the scattered debris and refuse noted across the remainder of site. Topographically, the site is level as are surrounding areas.

**Photo No.7: Showing heaped debris outside garage and workshop**

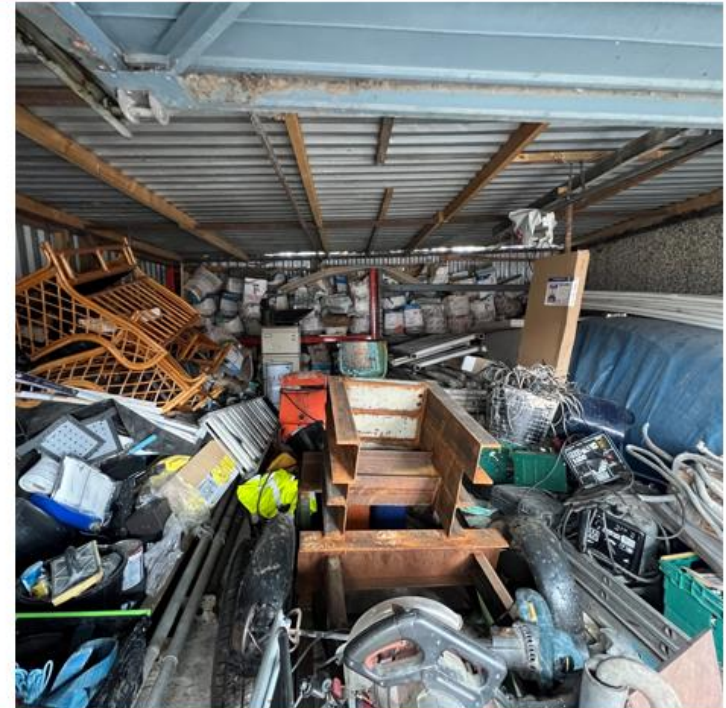
**Photo No.8: Showing heaped debris inside garage**

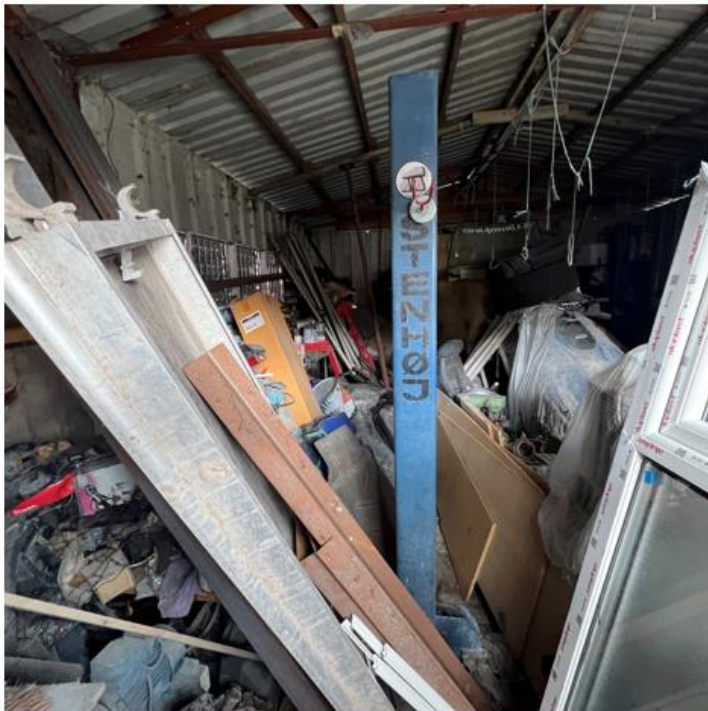
**Photo No.9: Showing heaped debris inside workshop**

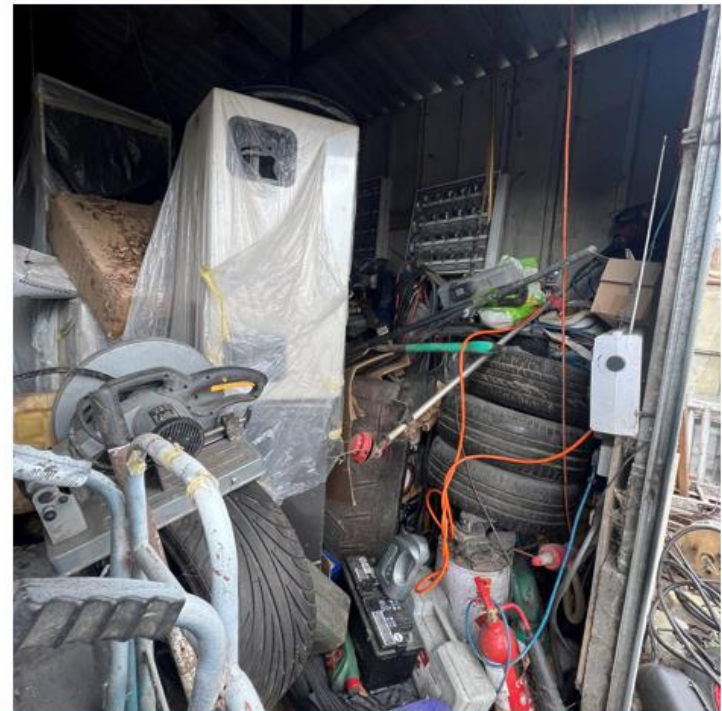
**Photo No.10: Showing heaped debris inside workshop**

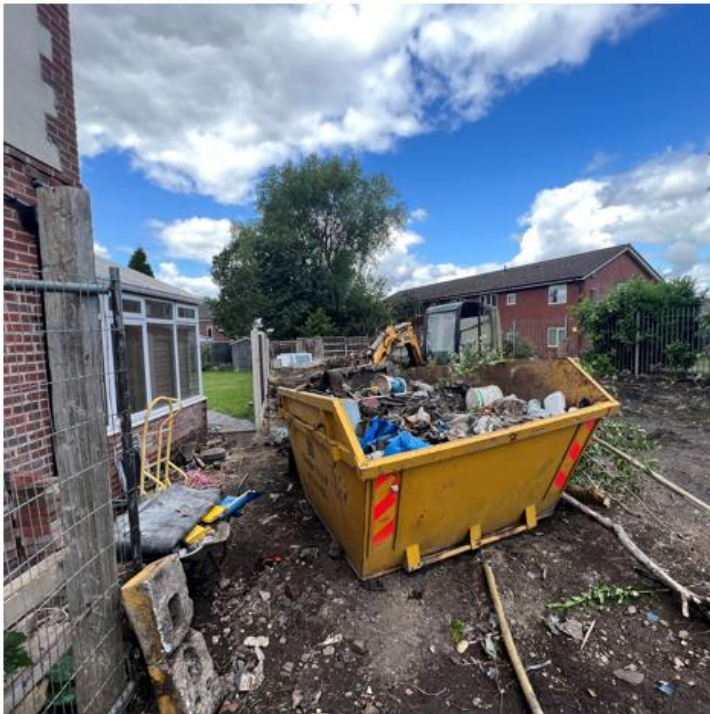
**Photo No.11: Facing slightly NW along the southern boundary of site towards the western extent and showing skip**

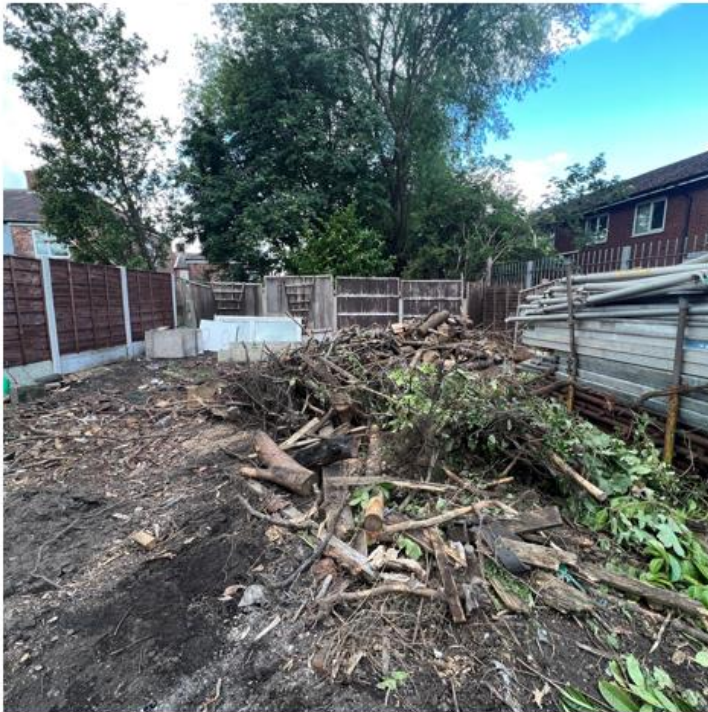
**Photo No.13: Facing west in the western extent of site showing heaped scaffolding items and vegetation cuttings**
