# Pre-Acquisition Survey Report

**Fretrade Exchange  
37 Peter Street,  
Manchester M2 5GB**

A REPORT PREPARED FOR AND ON BEHALF OF:  
Clearbell Capital  
2 Harewood Place, London W1S 1BX

Issue Date: 12 July 2021  
Revision No:  
Revision Date:

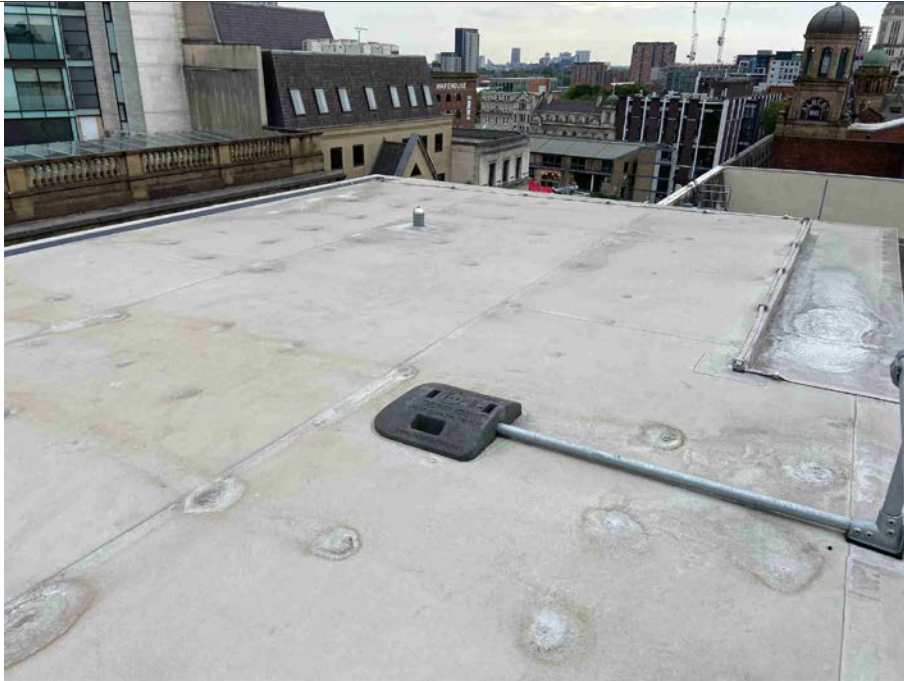
| 2.2.1 | There are no active roof leaks via the main flat above the fifth floor office space and subject to ongoing maintenance, this should remain weather tight for a further 5-7 years. However, on the assumption that the existing air-handling plant located at this level is replaced as part of your planned refurbishment, it would be prudent to replace the roof covering at the same time and we have therefore included a budget cost for this in our schedule of repairs. | M |

17: Main flat roof

| | Description | Tenant Responsibility Costs (£) | | Service Charge Recoverable (£) | | Landlord Non-Recoverable Costs (£) | |
|---|---|---|---|---|---|---|---|
| 1. | Renew main flat roof covering (potentially defer subject to leak detection) | | | | | 55,500 | |

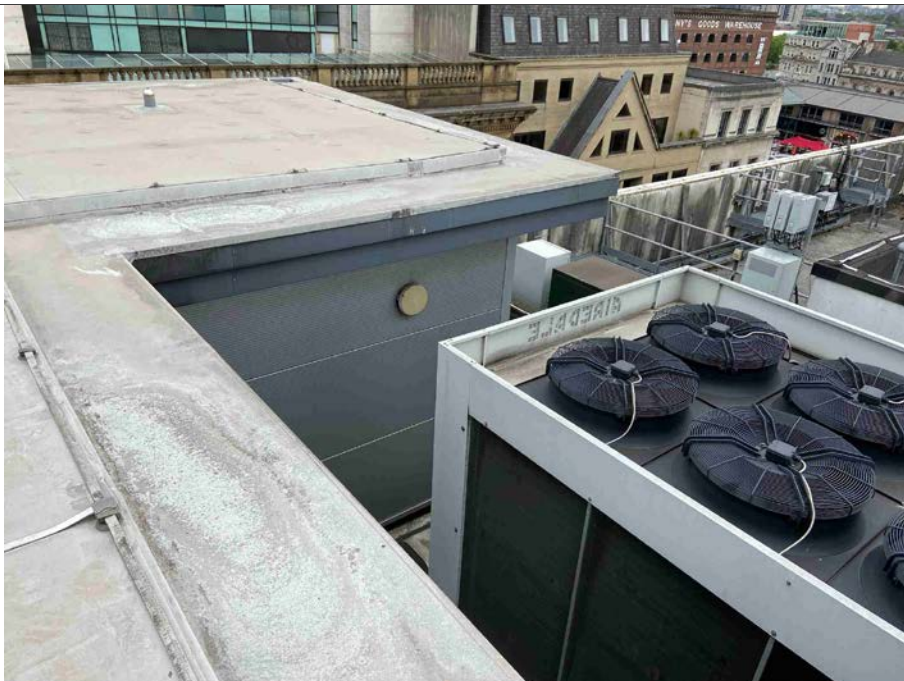
| 2.2.4 | Assuming the central chiller plant is replaced with a VRF system as part of your refurbishment, renewal of the secondary flat roof covering at fifth floor level where the current chiller plant is located will also be required. This secondary flat roof extends to a single ply covered gutter along the line of parapet which separates the adjoining building. Whilst we found no evidence of roof leaks internally via this gutter, we recommend the waterproof membrane is replaced at the same time. | M |

18: Main flat roof and central chiller plant (note composite panels)

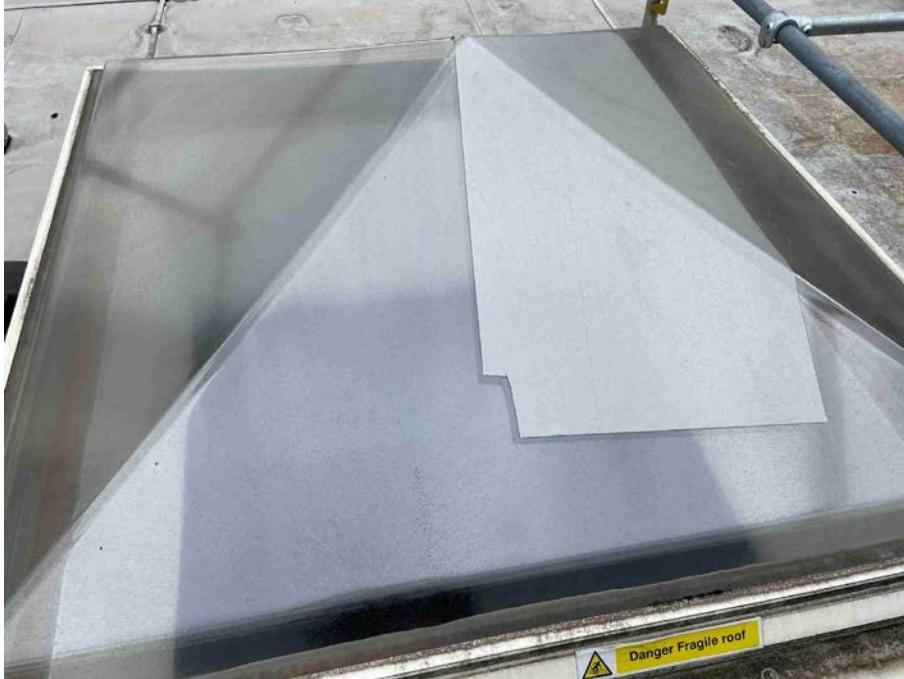
| 2.2.2 | One of the four polycarbonate covered pyramid rooflights has been repaired with an overlay film. We did not identify any internal roof leaks via these rooflights however they are now circa 15 years old and we recommend the polycarbonate covers are lifecycle replaced as part of the planned refurbishment. | M |

19: Repair to polycarbonate rooflight

| 2. | Renew polycarbonate roof lights (potentially defer subject to leak detection) | | | | | 4,850 | |

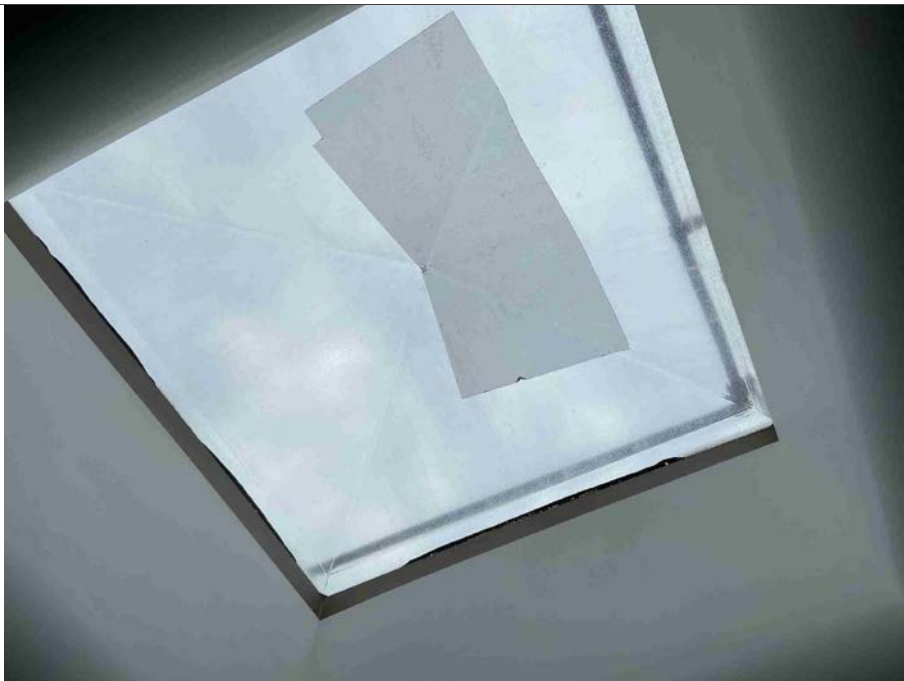
20: Repair to polycarbonate rooflight

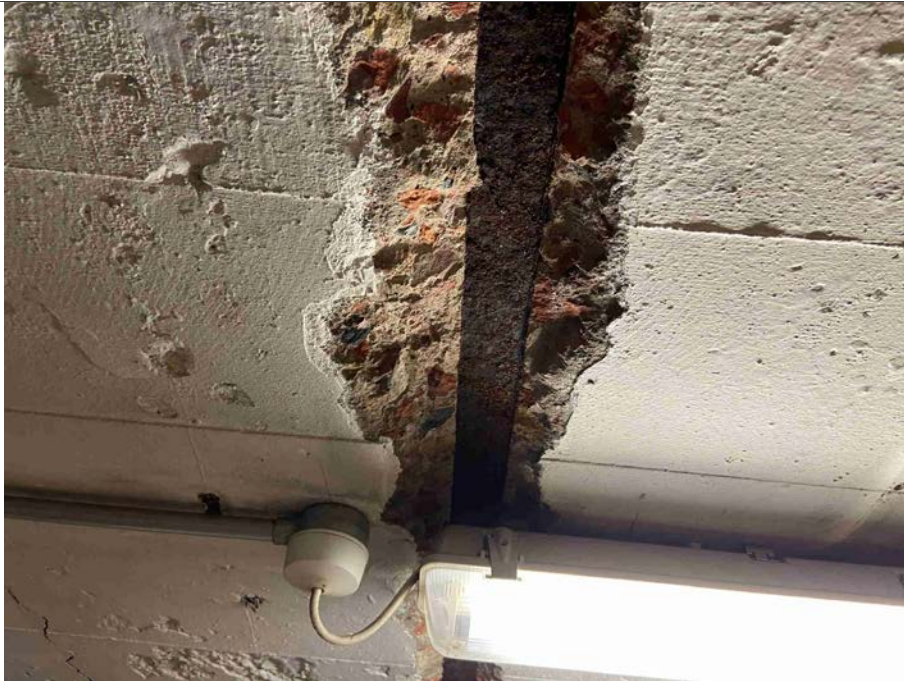
| 2.1.5 | We noted corrosion of embedded steelwork within a concrete roof deck over the front lift overrun plant room. The plant room is currently dry and this corrosion is clearly historic prior to the over-cladding and re-roofing of this plant room. As result, repairs are not considered necessary. | L |

21: Historic corrosion to embedded steelwork to roof plant room

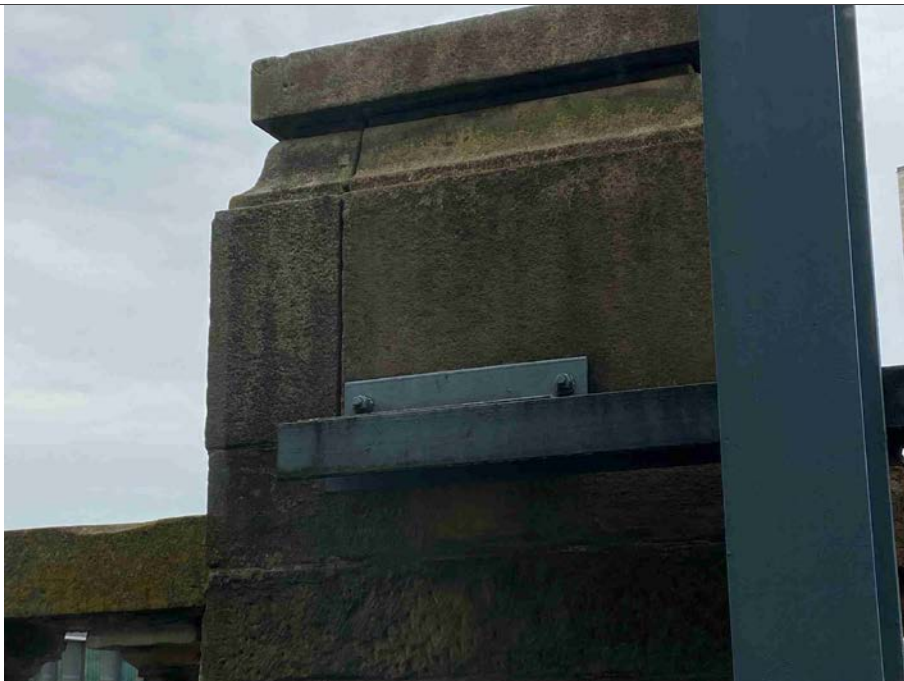
| 2.3.4 | The stone balustrade to the Peter Street and Southmill Street elevations was previously stabilised circa 2005-2007 as part of the roof extension at that time. The balustrade is tied back to an independent engineered steel frame. There is no evidence to suggest this has not been successful. Historic deflection/rotation of this balustrade can be seen, however mortar filleting to weather the junction of displaced units is of obvious age and remains intact indicating no further movement has occurred. Stonework repairs are however required to this balustrade as further described in the paragraph below. | M |

22: Example steel restraint tie to Peter Street and Southmill Street parapet stonework

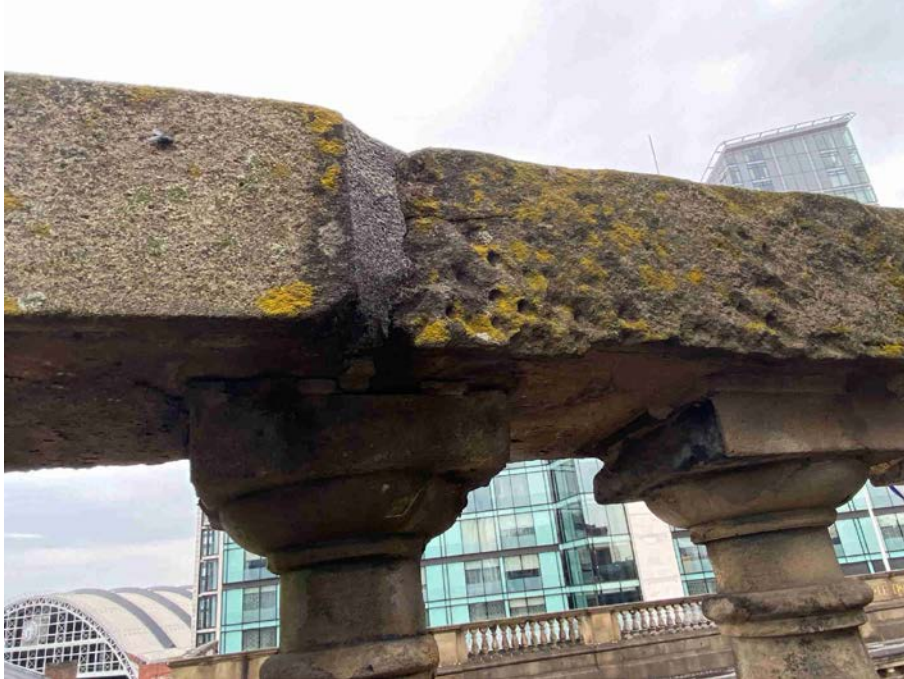
23: Example of historic displacement of stonework prior to restraint ties

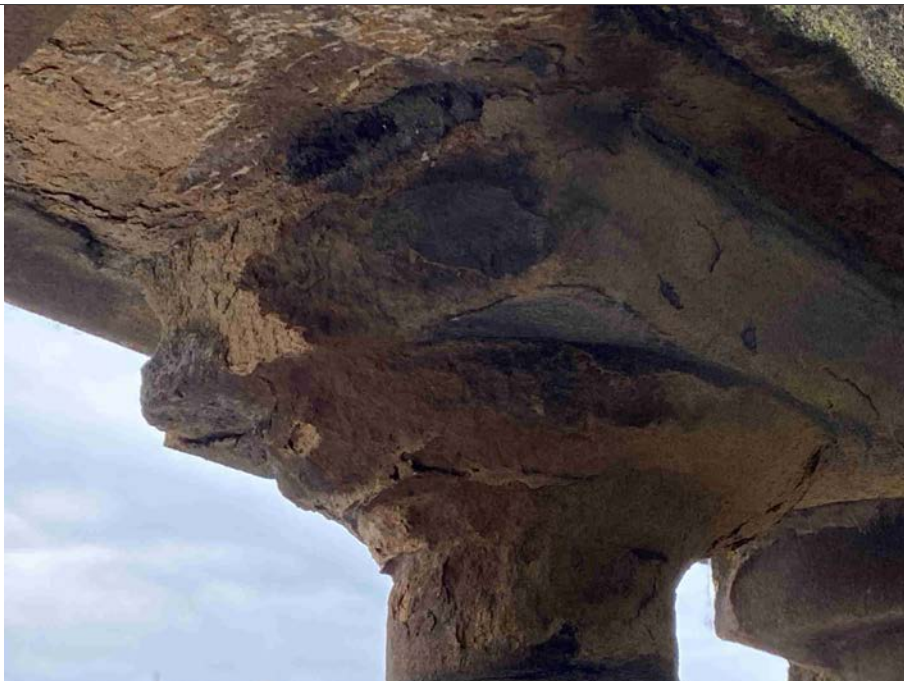
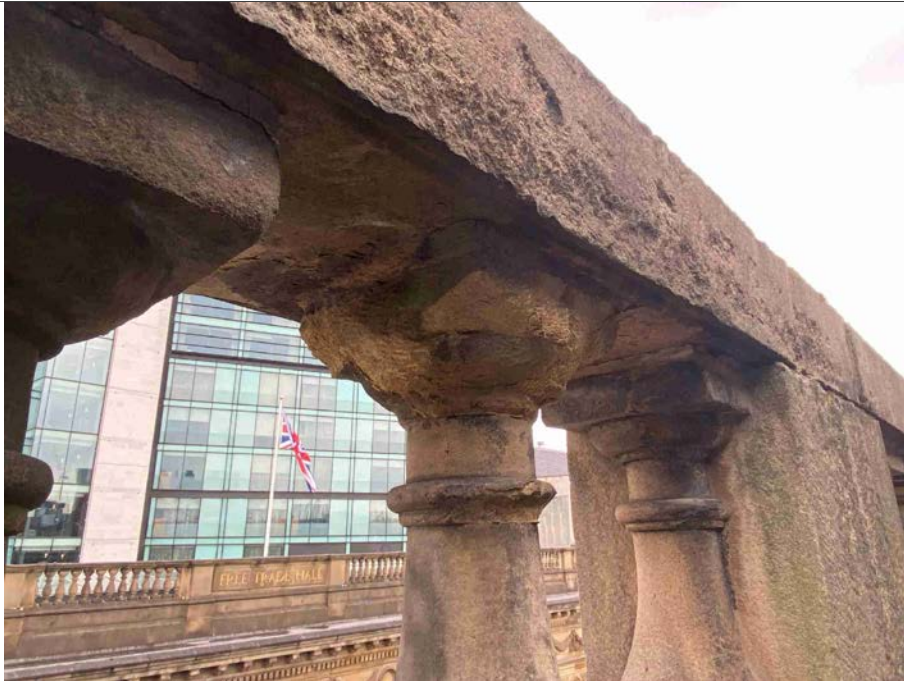
| 2.3.5 | Stone architraves, cornice and balustrading at eaves level has isolated areas of advanced erosion with friable stonework evident. Pointing is also friable or missing in places. These defects result from long-term weathering and saturation as evidenced by initial organic growth and "greening" of the stone. Utilising the scaffolding required for your planned refurbishment, a detailed survey of the high level stonework will be required to fully quantify and confirm the repairs required. We anticipate this will involve descaling, isolated repairs and repointing, together with the removal of organic material. | M |

24: Example condition of stonework to balustrade

25: Example condition of stonework to balustrade

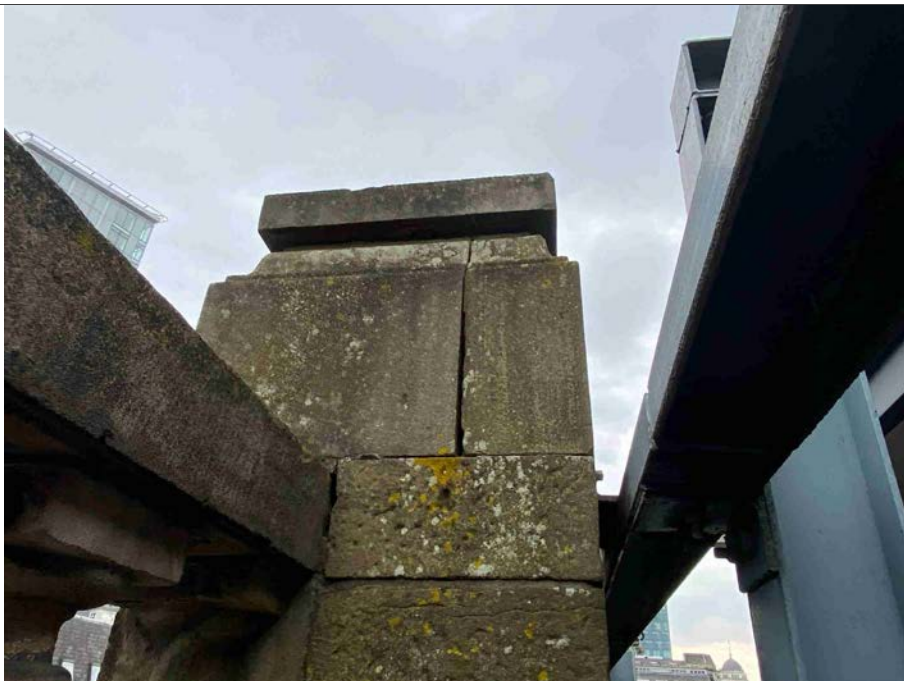
26: Example open joints to parapet level stonework (note steel restraint ties)

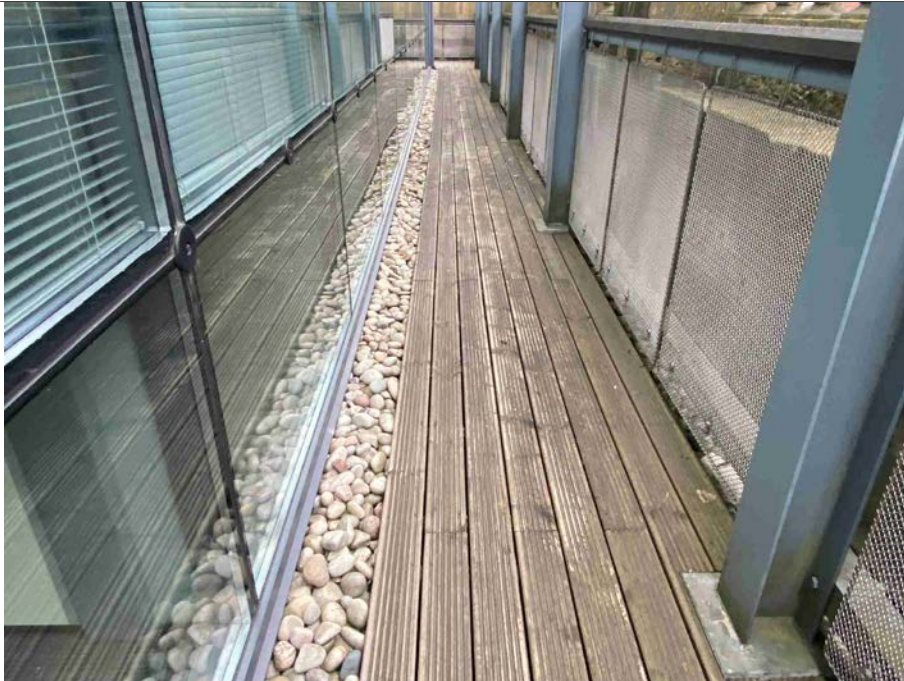
| 2.2.5 | Steelwork at fifth floor balcony level is in good condition however cyclical redecoration is now required. The timber handrails to the walkway suffer advanced wet rot and misalignment due to long-term saturation and require replacement. | L |

27: Fifth floor balcony walkway

| 7. | Level 5 balcony decking replacement | | | | | 6,250 | |
| 8. | Level 5 balcony timber handrail replacement | | | | | 2,550 | |

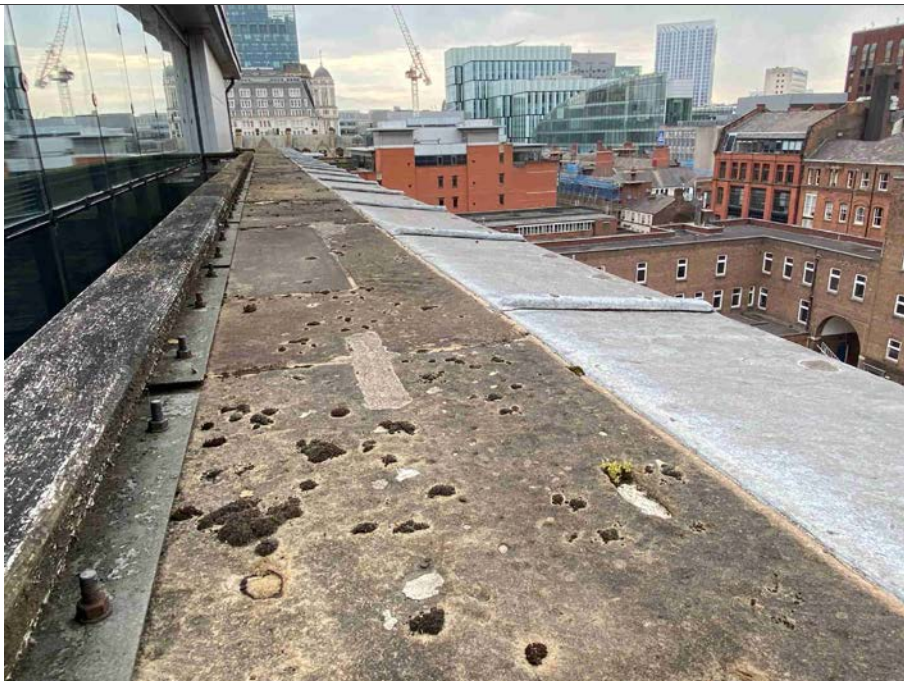
28: Stone coping to Bootle Street parapet (note partial lead capping)

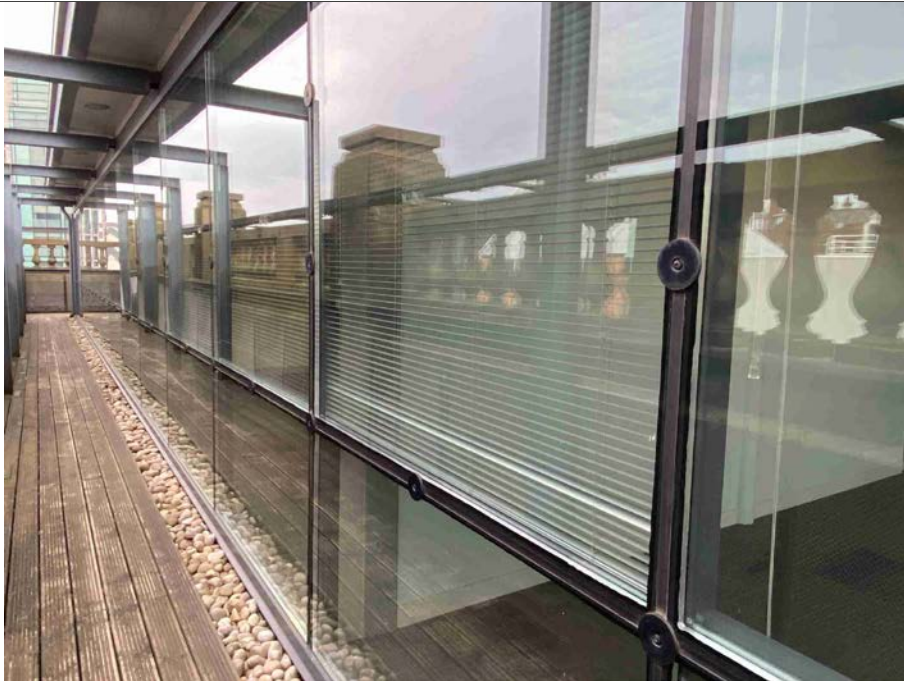
| 2.3.10 | <p>The front-sealed curtain glazing to the fifth floor extension is in good condition with no evidence of water ingress or weathering to seals. The PPC aluminium frames together with the associated doors suffer initial solar fading and minor impact damage and would benefit from insitu spray recoating.</p> | L |

29: Face sealed curtain glazing to fifth floor office

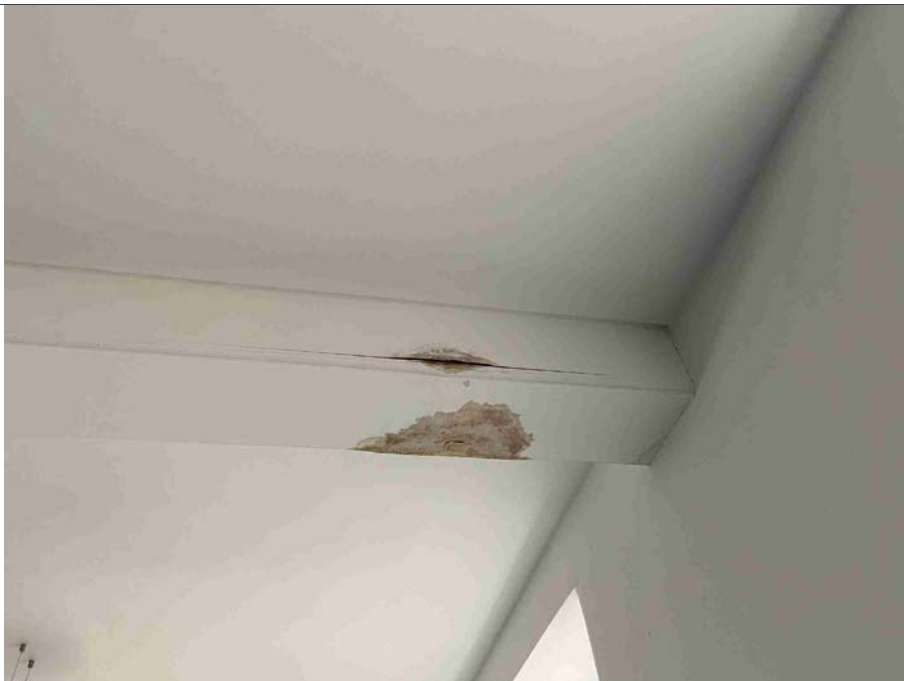
| 2.2.3 | There is evidence of minor roof leaks at fourth floor office level corresponding with the position of the fifth floor level balcony walkway above. The timber decking will require removal (it requires renewal in any event due to wet rot decay) and a remedial waterproof coating applied to this deck. The condition of this waterproofing and associated rainwater outlets is also a potential contributing cause of the masonry saturation discussed further below. | M |

30: Internal water ingress to fourth floor office via fifth floor balcony walkway

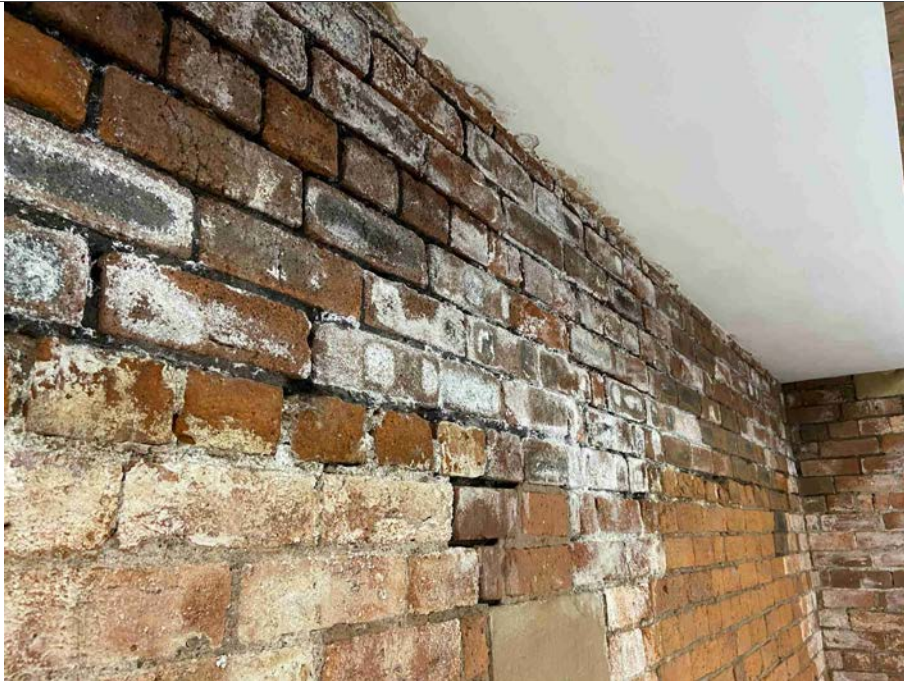
31: Salt staining and efflorescence to eaves level brickwork rear staircase

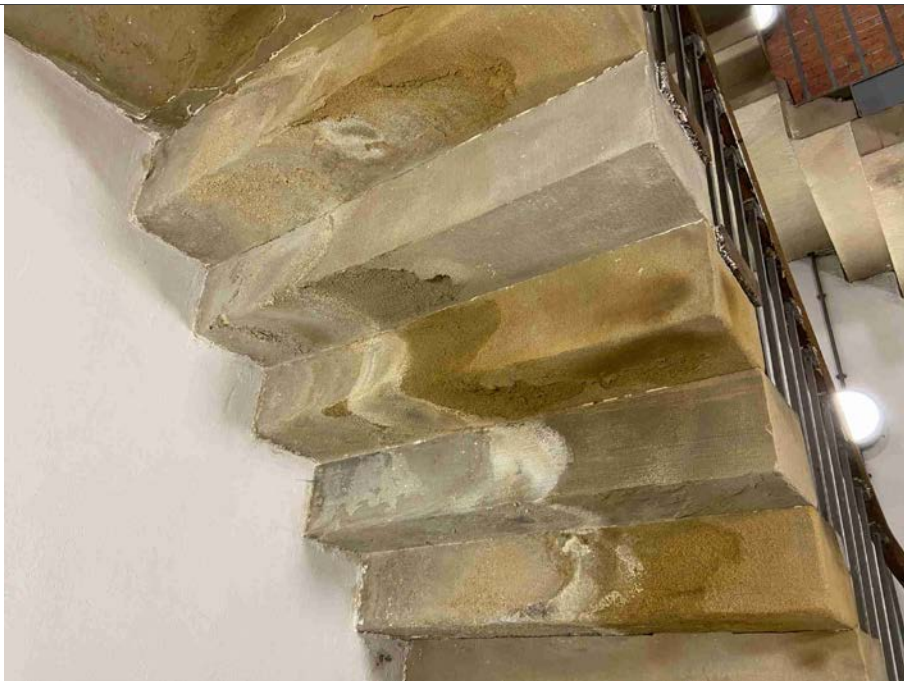
32: Salt staining and efflorescence to rear stairs between ground and lower ground floor

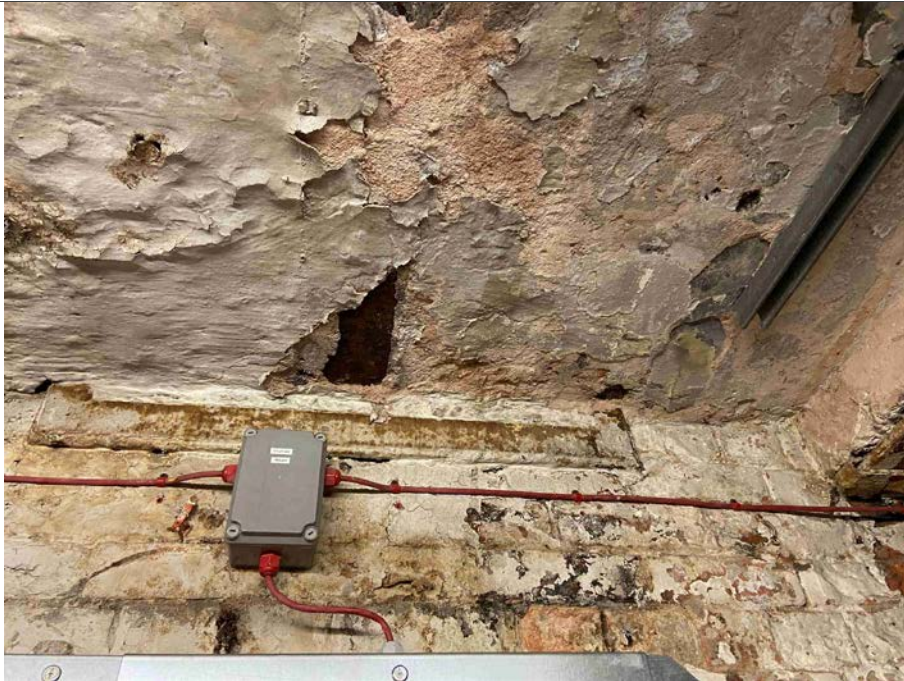
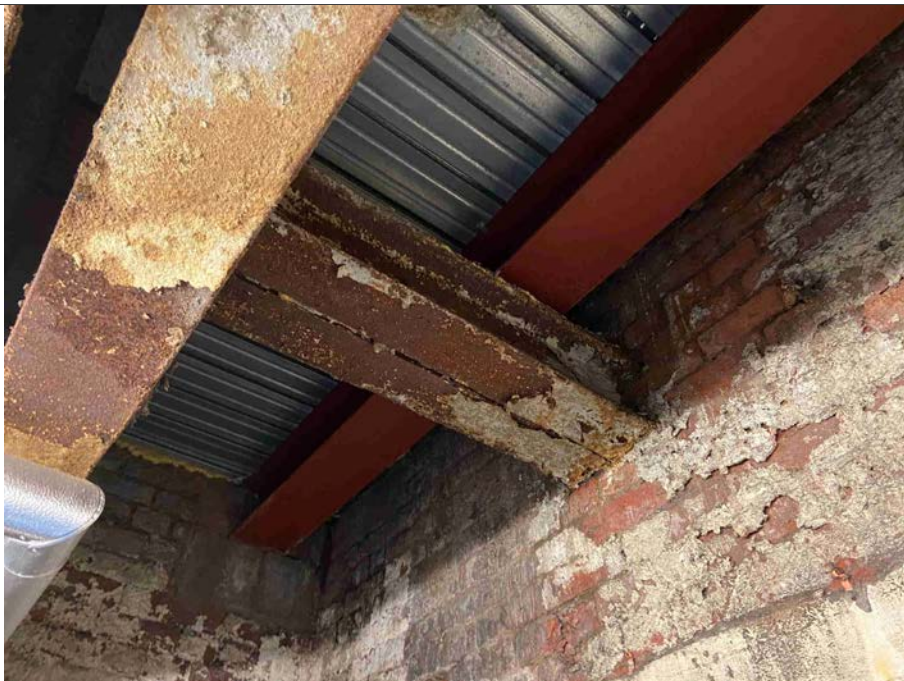
| 2.1.4 | We identified advanced corrosion to exposed steel floor beams and embedded steelwork in a concrete slab above the boiler room directly beneath the car lift. This is a result of long-standing water ingress, prior to the car lift and further deterioration in recent years directly via the car lift, caused by inadequate and defective drainage at the street level threshold to the car lift opening. The car lift itself is supported by a circa 2007 suspended concrete floor structure above this slab. The issue is localised and assuming the car lift is removed in your planned refurbishment, the cause of the ingress can be permanently resolved with a new suspended structural floor and waterproofing above this location. The lower slab above the boiler room will require insitu repairs including removal of loose concrete and corrosion treatment to steelwork. | M |

33: Basement boiler room soffit

34: Basement boiler room soffit – note new steelwork and metal deck supporting car lift with original steelwork below

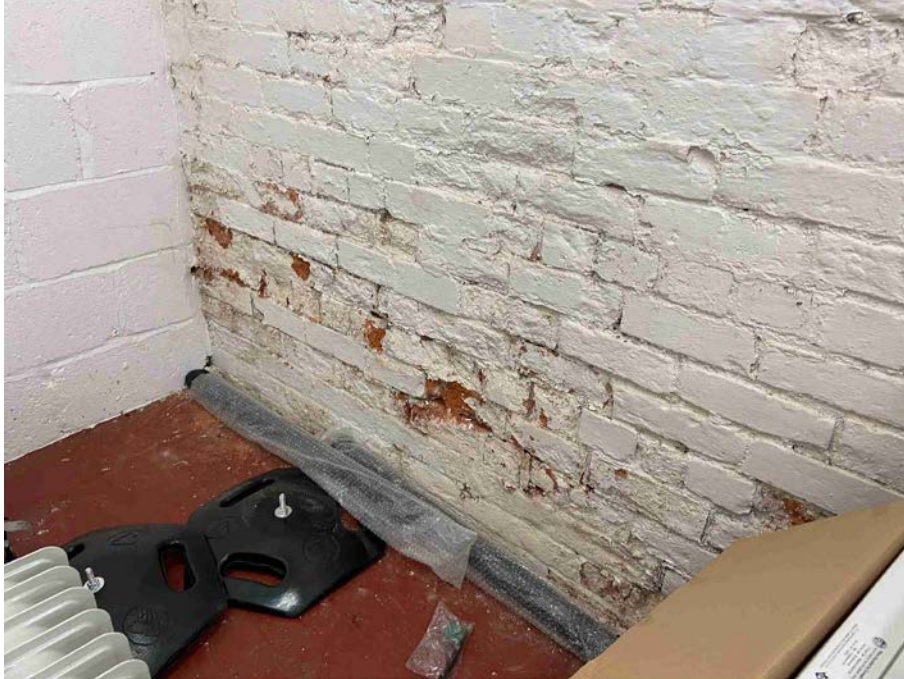
| 2.5.1 | <p>There are varying levels of water ingress at basement level. The majority of the space is dry and there is no evidence of active water ingress/flooding. There are however areas with high saturation/moisture levels as follows:</p> <ul style="list-style-type: none"> <li>The rooms below the front elevation on Peter Street suffer high levels of saturation at soffit and upper wall level with salt crystals and efflorescence prevalent. The Peter Street internal elevation at basement level requires vertical tanking if to be used for ancillary accommodation as opposed to general storage at present.</li> <li>Archive room 6 has a section of raised slab with a cementitious screed topping. The cement screed has delaminated through the full depth of screed as a result of long-term slab moisture levels. The screed requires removal, the concrete slab waterproofed, and the screed replacing in this area.</li> <li>Internal brickwork walls sub-dividing the basement space have typical high moisture levels up to approx. 500mm. A concrete screed laid over the original stone floor has minor spalling in areas due to moisture content. Remedial works will be dependent upon the use of these areas however tanking of the floor and at low level to walls is likely to be required.</li> <li>Between ground and basement level, the rear stone staircase has surface delamination to the exposed underside of the steps and risers. The staircase is built-in to the rear elevation brickwork and the saturation is consistent with moisture tracking via the external wall. Localised repointing wall tanking will be required in this area in order to manage this going forwards.</li> </ul> | M |

35: Typical water ingress to internal basement walls

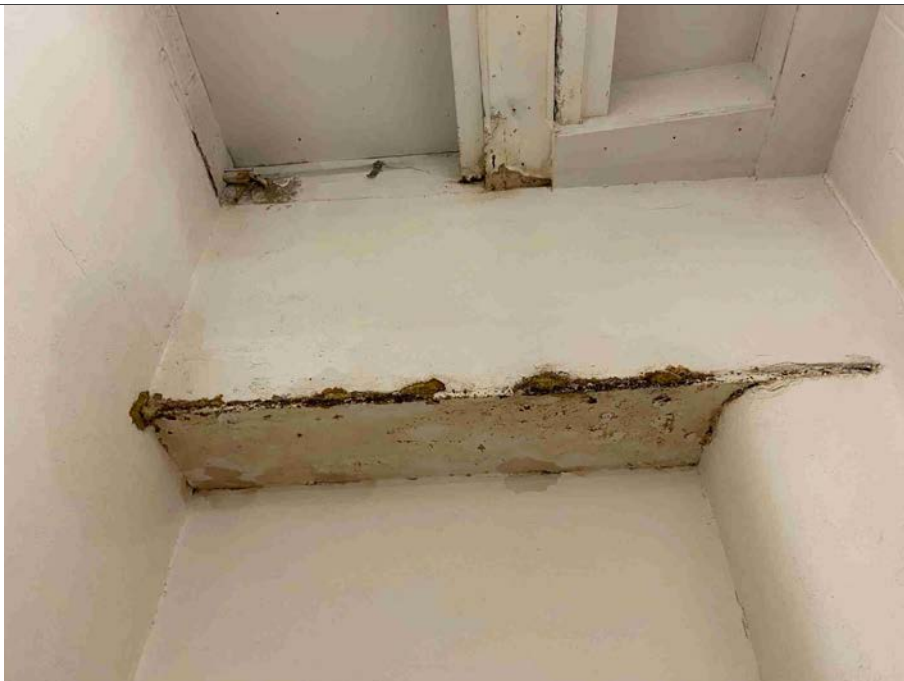
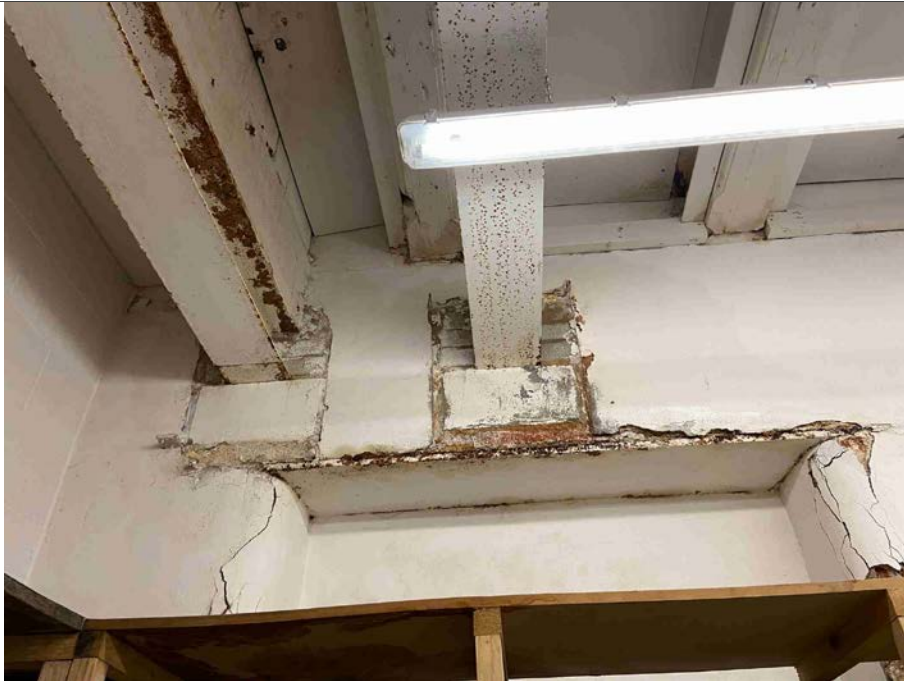
36: Typical water ingress at basement at high level Peter Street elevation

37: Typical water ingress at basement at high level Peter Street elevation

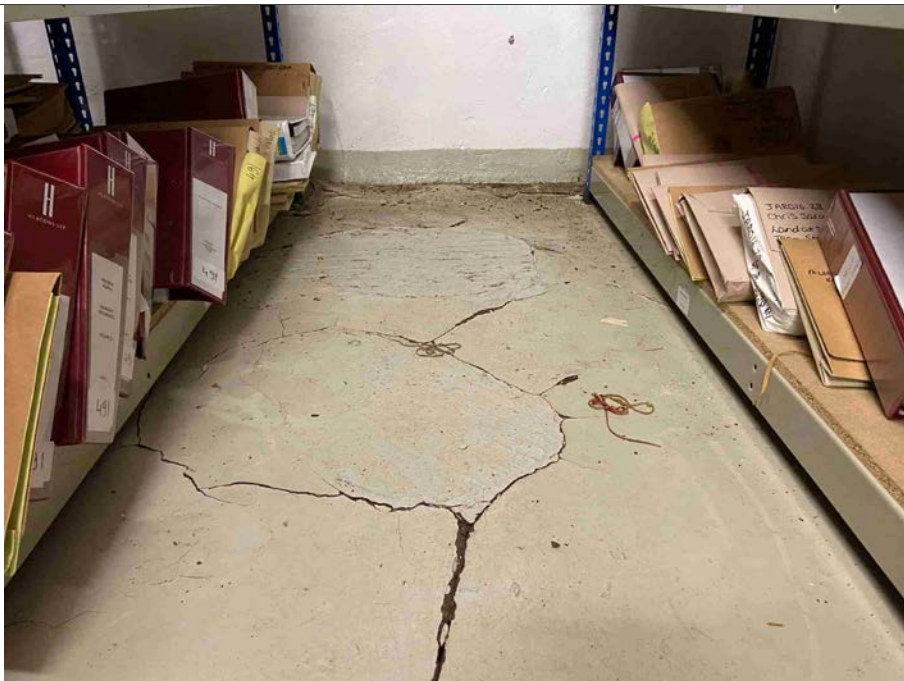
38: Saturated and delaminated floor screed to basement store room 6

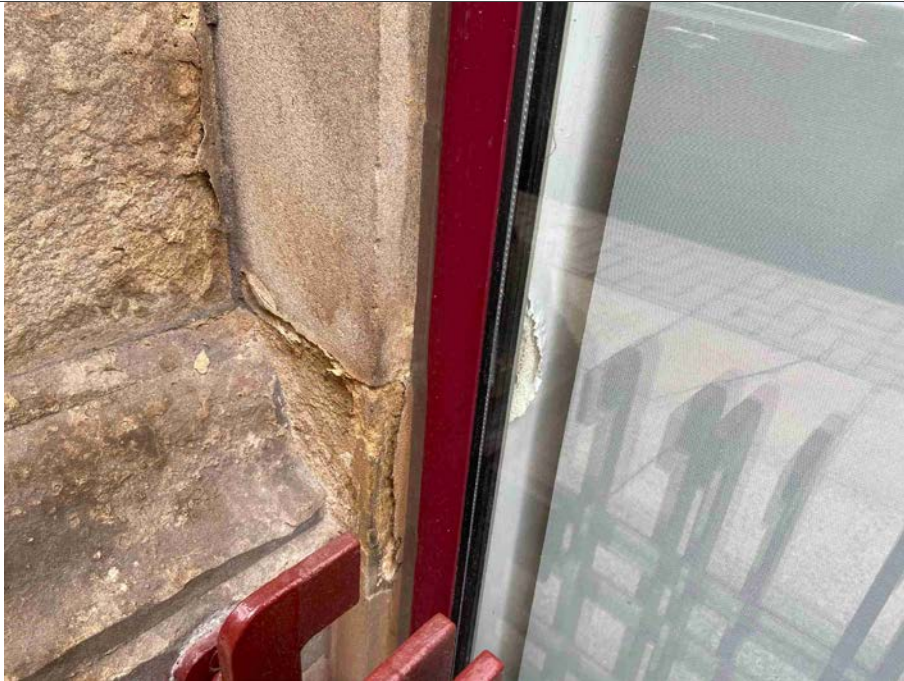
| 2.5.2 | There is no evidence of any water or damp ingress at lower ground floor with the exception of minor staining and efflorescence to five of the window reveals consistent with patches of friable stonework at the junction with the window frame. Minor staining and efflorescence is also evident to the internal wall between the rear staircase consistent with the defects described above. Minor external repairs are required as described in section 2.3 above. | L |

39: Example friable stonework resulting in water ingress to internal window reveals at lower ground floor

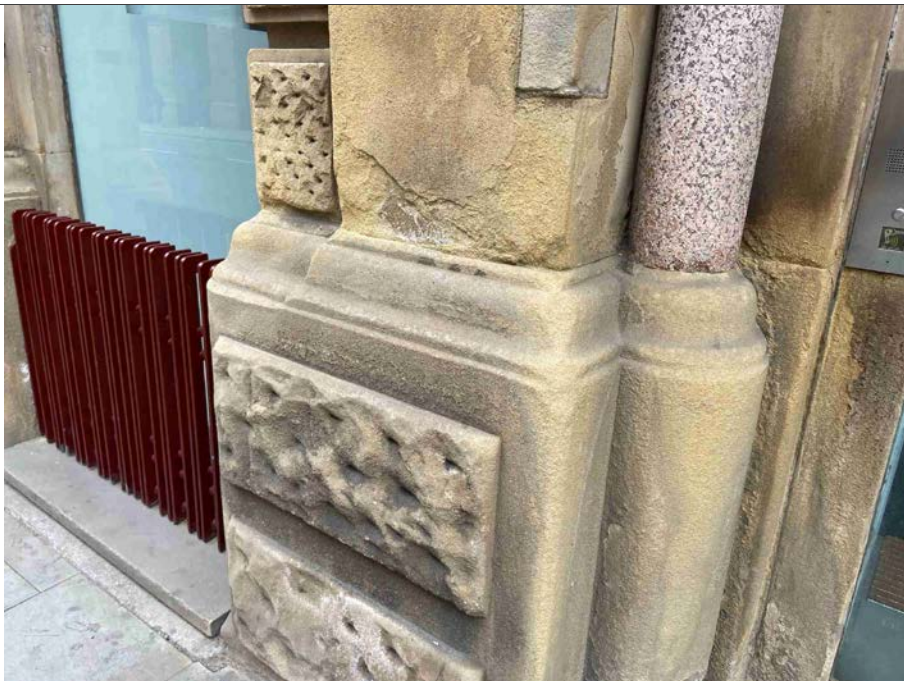
| 2.3.3 | Stone facings at street level suffer typical erosion from historic weathering and damage from highway de-icing salts. This is to be expected given the building age and wholesale replacement of stone units and mouldings is not necessary. There are however isolated areas where advanced weathering is resulting in friable material and minor damp ingress internally. This is specific to minor and isolated damp ingress around 5 windows at LG level and at ground level skirting level to the rear corner junction with Bootle Street and Southmill Street. Repairs will involve descaling (the sensitive removal of friable material) and if permitted by the conservation officer, the application of a proprietary sandstone stabilising sealant. | M |

40: Example historic erosion to stonework at street level.
