LYCH GATE & BOUNDARY WALLS, CHORLTON GREEN

Design & Access Statement & Heritage Impact Assessment

April 2023

KEPCZYK PEARCE SANDERSON  
ARCHITECTS, SURVEYORS & HISTORIC BUILDING CONSULTANTS

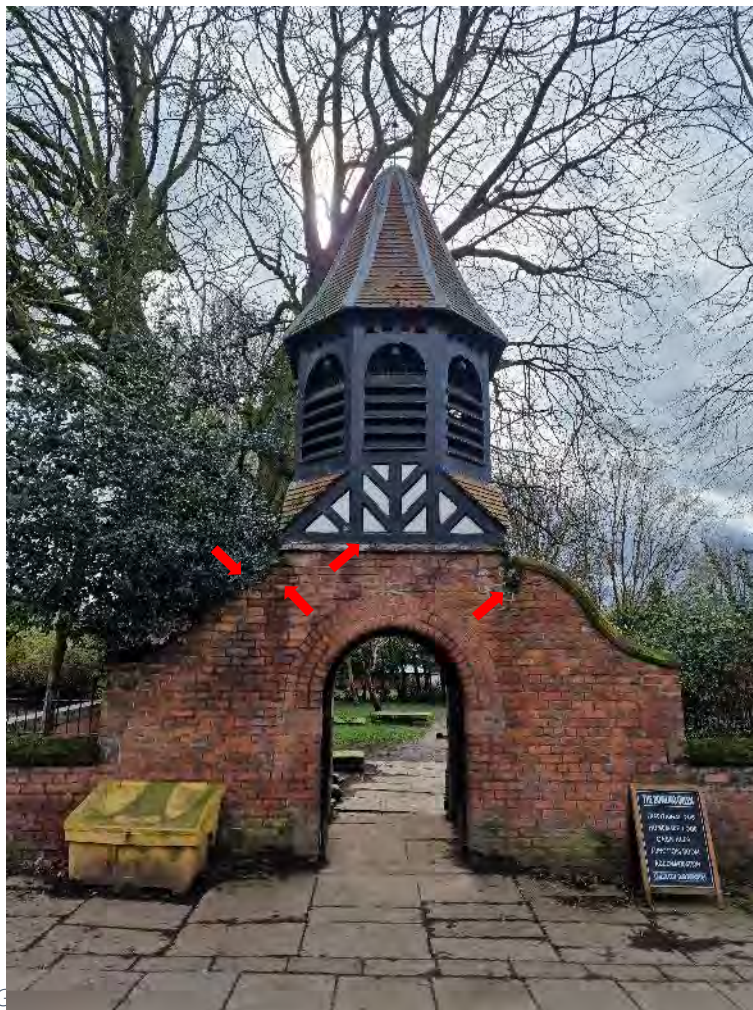
Figure 4: Lych Gate. Water stain is visible on the masonry wall surface due lack of water disposal system from the small triangular shape rooves. Pointing to the masonry in poor condition due to water run off on the wall surface. Significant timber decays (dry/wet rot) identified.

- Introducing new secret gutters and chutes to all triangular shape tile roof which would collect the water and drain it away from the building.
- Installing black netting to the outside and stainless-steel mesh to the inside of the bell tower to stop birds intruding inside the space.

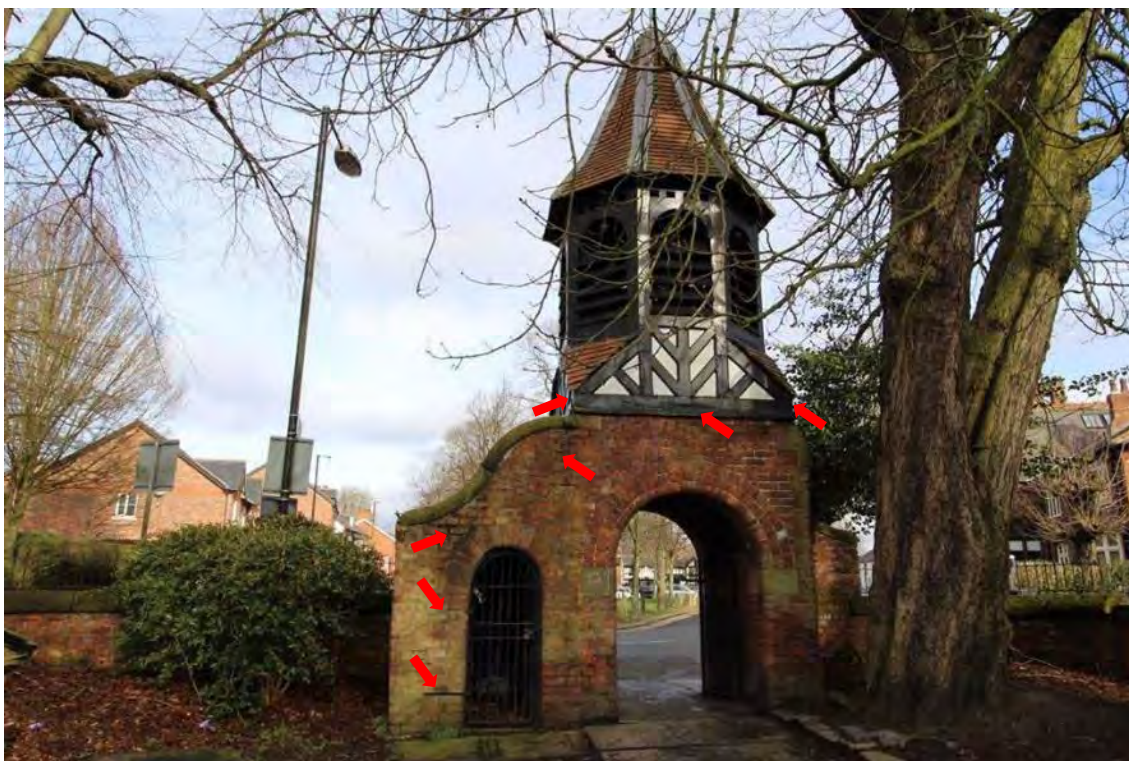
Figure 5: Lych Gate, South elevation. Water stain is visible on the masonry wall surface due lack of water disposal system from the small triangular shape roof. Pointing to the masonry in poor condition due to water run off on the wall surface. Significant timber decays (dry/wet rot) identified. Diagonal cracks were identified which caused by the corroded metal anchors.

- Raking out all existing pointing and repoint using NHL 3.5 mortar.
- Cleaning the masonry (bricks and stones) with biocide.
- Redecorating all existing cast-iron rails and gates using appropriate paint (see specification document)

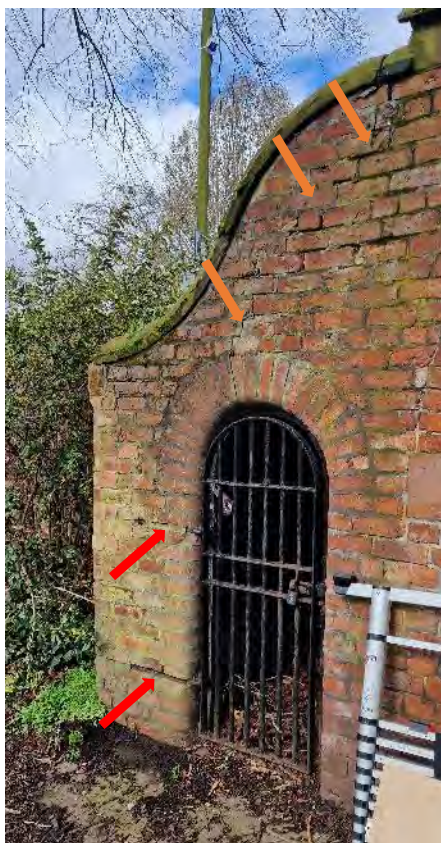
Figure 6: Orange colour arrows on top show the diagonal cracks on top of the door arch. Corrosion of metal wall anchors (red colour arrows) have caused the expansion of the joint and pushed the bricks up. The metal gate is not operational due to structural movement of the masonry wall. Internal timber barded door was left open and not operation, and it resulted in the chamber to be filled with debris, leaves and rubbish.

- Carrying out structural repair to the brickwork around the access door to Lych Gate.
- Replacing corroded door (gate to the chamber) anchors with stainless steel anchors and reinstate the cast-iron gate.

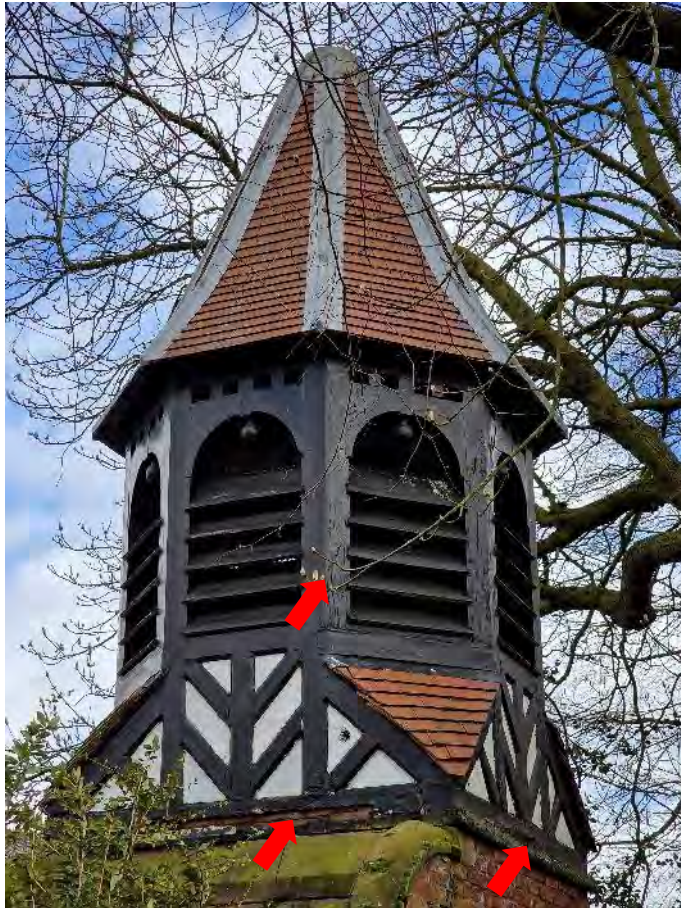
Figure 7: Bell Tower Turret, view from south -west. Extensive timber decay is present and visible on multiple places. The infill panels are built of plywood and painted in white which need to be removed and appropriate infill panels to be placed (Lath & Lime render)

- Installing new drip around the base timbe plate to push away the water from the surface building to reduce risks of damp and ingress.
- Remove all exiting plywood board infill panels and fill with Lath + Lime Render.

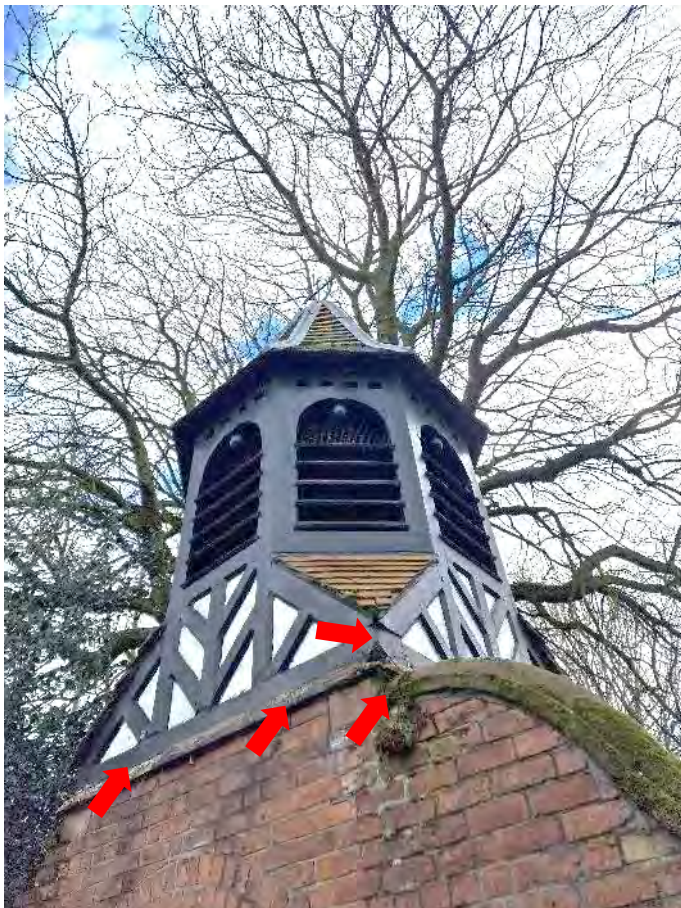
Figure 8: Bell Tower Turret, view from north-west. Extensive timber decay is present and visible (see red colour arrows). Absence of appropriate water collection/disposal from the small triangular shape tiled roof resulted in excessive water run-off and subsequently caused extensive decay and rot to the timber and building fabric.

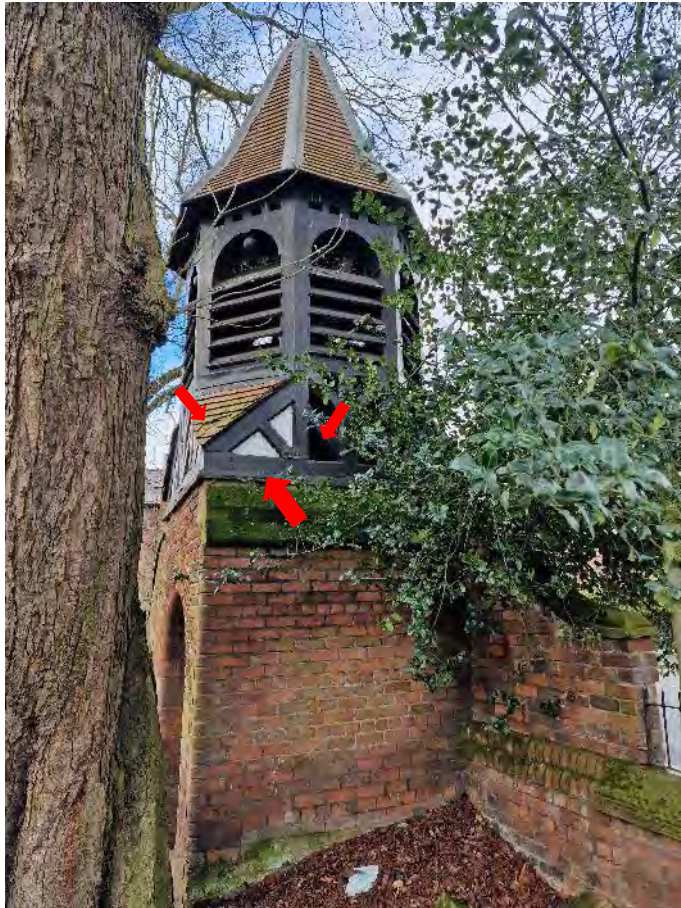
Figure 9: Bell Tower Turret, view from south-east. Extensive timber decay is present and visible. Roof tiles and infill panels are missing. The tree's branches caused damaged to the building fabric.

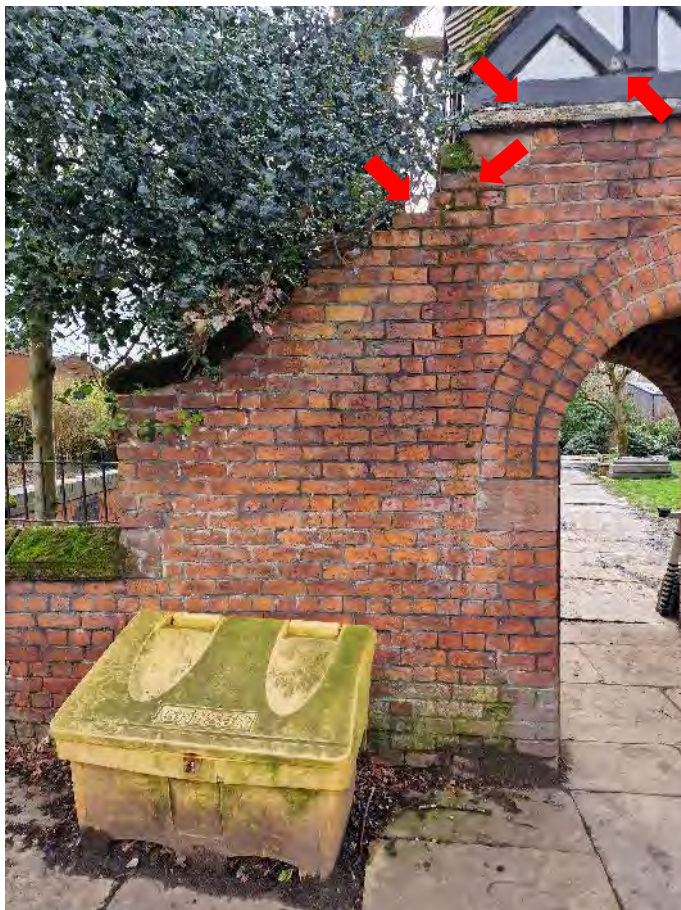
Figure 10: Bell Tower Turret, view from north-east. Extensive timber decay is present and visible. Existing coping stone is missing, and water ingress is visible on the masonry wall. Existing trees' branch has caused damaged to the building fabric.

- Missing coping stones to the Lych Gate to be reinstated and all exiting coping stone to be temporary removed and reinstated using NHL 3.5 lime mortar.

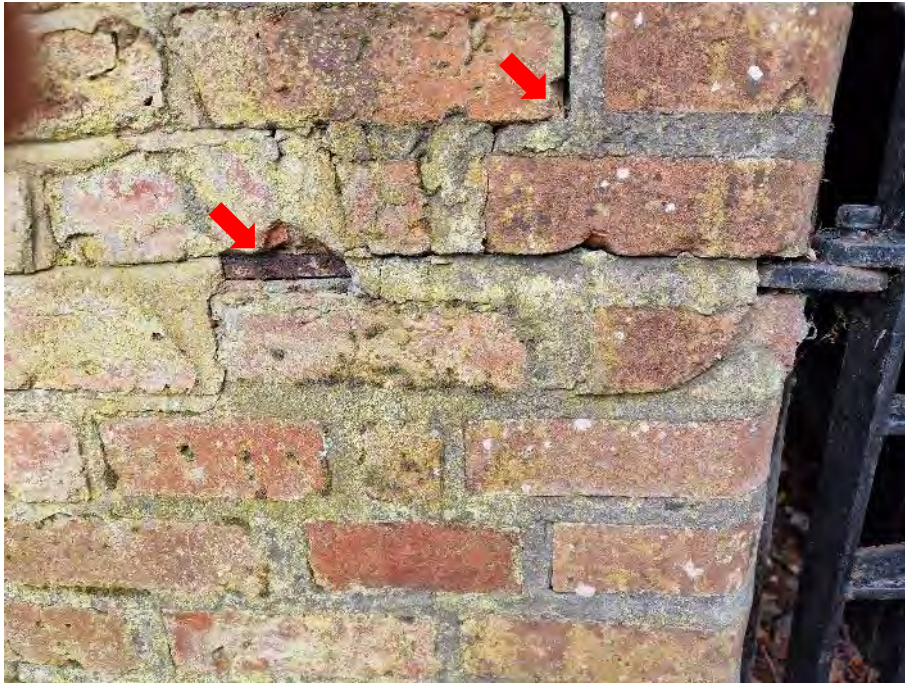
*Figure 11: Corroded gudgeon pins has caused expansions and caused damage and cracks to masonry brick wall.*

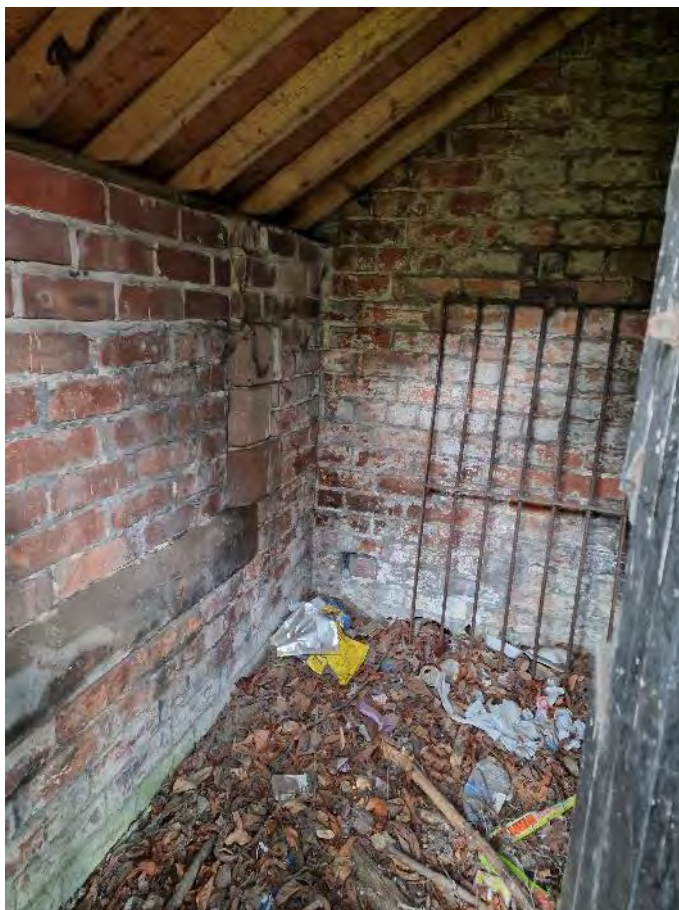
*Figure 12: View to the inside of the Lych Gate's access chamber. Leaves and debris accumulated inside the space as the internal timber-boarded door is not operational and left open.*

- Repair and make good to the existing timber boarded door to the chamber and redecorate. Ensure the door and gate are fully operational.
- Splice repair/replace all decayed timber to the bell tower turret and redecorate the timber using appropriate paint.
