# **Land at Victoria Avenue East, New Moston**

## **Proposed Retail Development**

### **Flood Risk Assessment & Outline Drainage Strategy**

For: Aldi Stores Ltd.

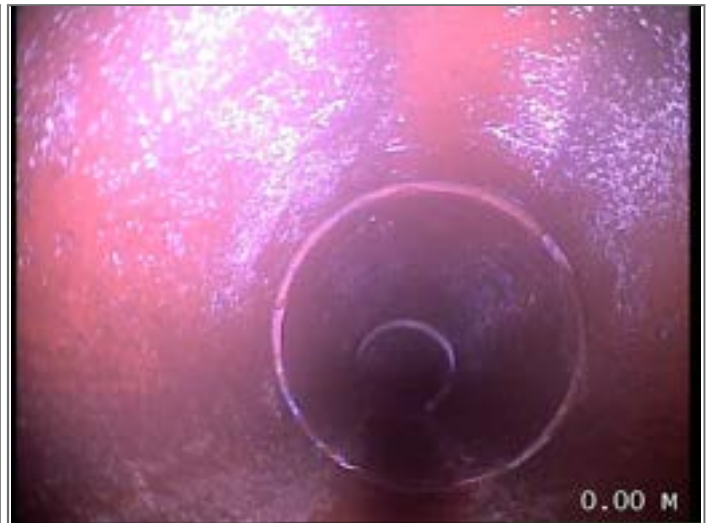
Joint displaced medium

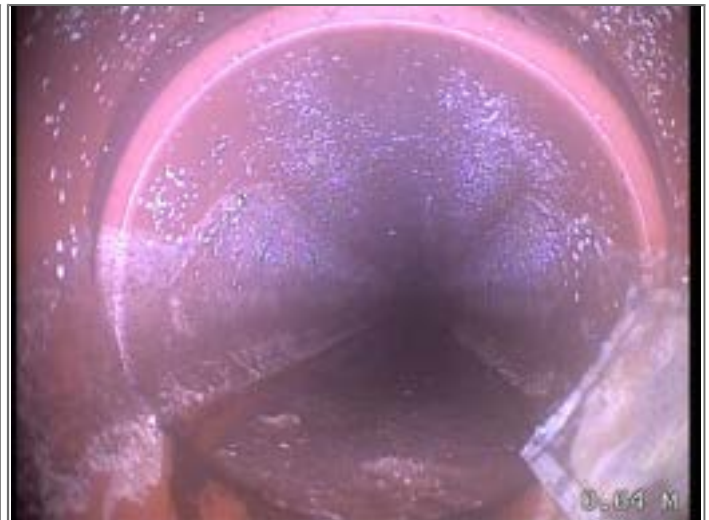
Joint displaced large

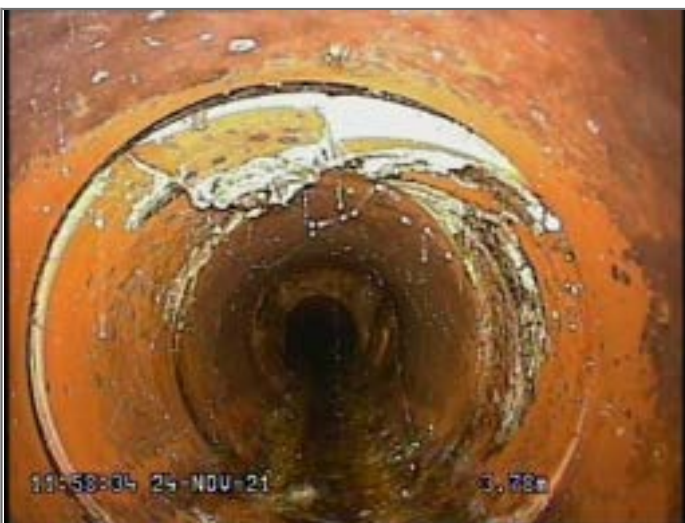
| Position | Code | Description | Photo | Type/Grade |
|---|---|---|---|---|
| 3.78 | FM | Fracture multiple from 10 to 2 o'clock | 5775654 | Structural / 4 |

Fracture multiple from 10 to 2 o'clock

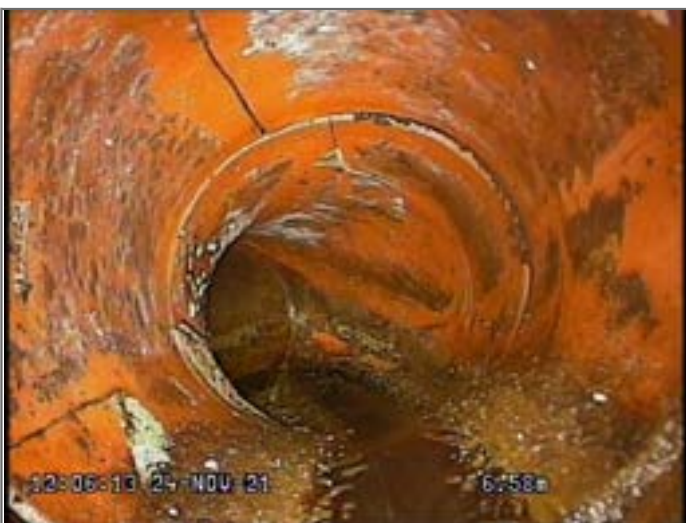
| Position | Code | Description | Photo | Type/Grade |
|---|---|---|---|---|
| 6.58 | FM | Fracture multiple from 12 to 12 o'clock | 5776994 | Structural / 4 |

Fracture multiple from 12 to 12 o'clock

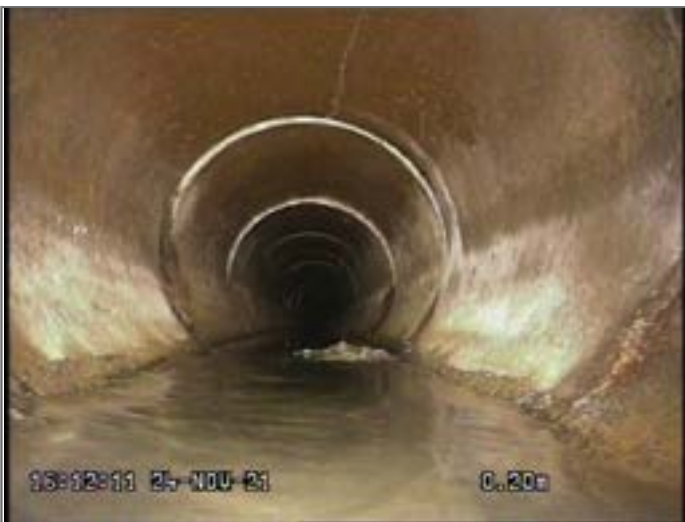
| Position | Code | Description | Photo | Type/Grade |
|---|---|---|---|---|
| 0.18 | CL | Crack longitudinal at 12 o'clock | 5779724 | Structural / 2 |

Crack longitudinal at 12 o'clock

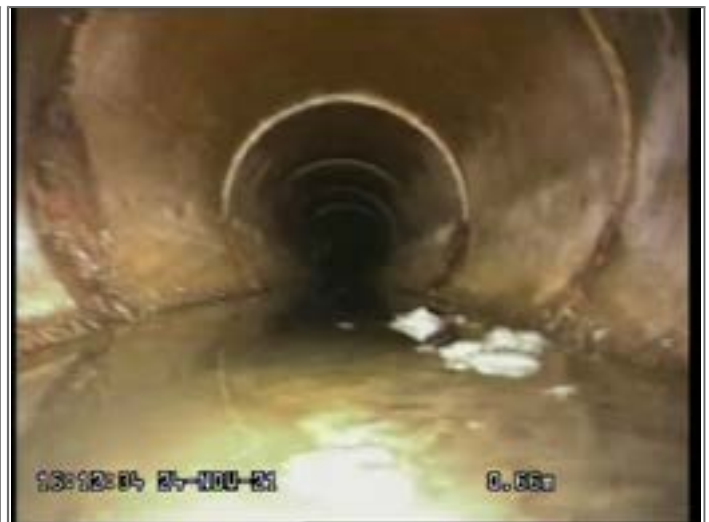
| Position | Code | Description | Photo | Type/Grade |
|---|---|---|---|---|
| 0.66 | DEE (S01) | Attached deposits, encrustation from 7 to 10 o'clock 5% cross-sectional area loss -<br>Remark: THIS IS A CONTINUOUS DEFECT UPSTREAM TO UU 1304 , Start | 5791839 | Service / 2 |

Attached deposits, encrustation from 7 to 10 o'clock 5% cross-sectional area loss - Remark: THIS IS A CONTINUOUS DEFECT UPSTREAM TO UU 1304 , Start

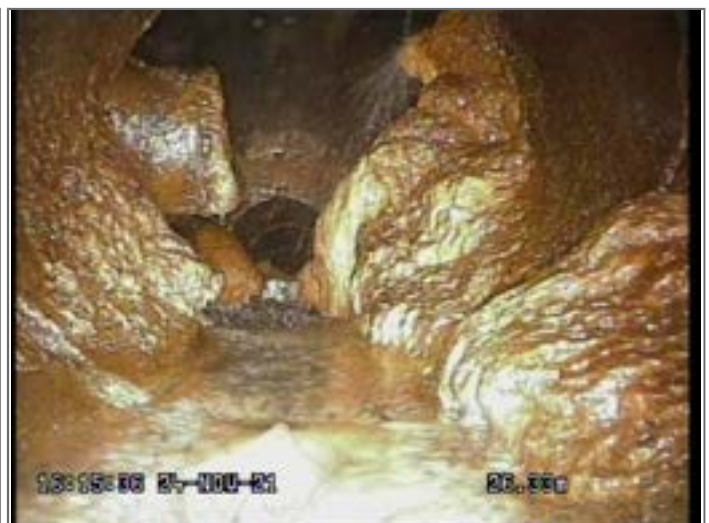
Attached deposits, encrustation from 1 to 6 o'clock 20% cross-sectional area loss

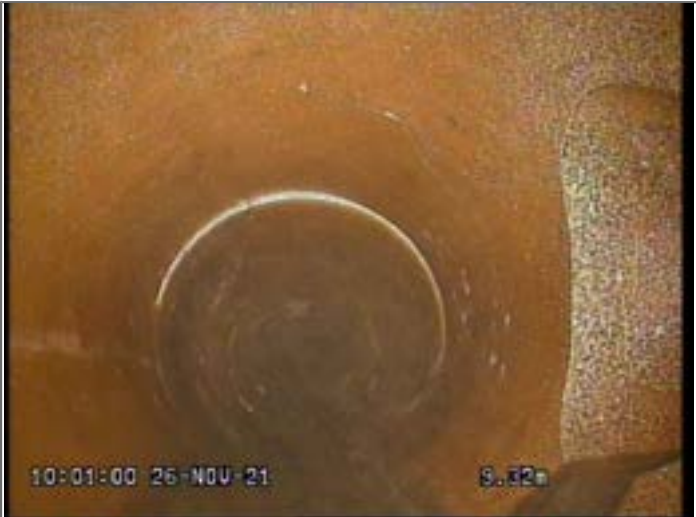
| Position | Code | Description | Photo | Type/Grade |
|---|---|---|---|---|
| 4.66 | DEE | Attached deposits, encrustation from 9 to 7 o'clock 5% cross-sectional area loss -<br>Remark: CONTINUOUS DEFECT DOWNSTREAM TO UU 1304 , Start | 5791831 | Service / 2 |

| Job Number<br>LAYERSERV0001064 | Surveyed by (Operator)<br>CHRIS LUCOCK | Base Unit<br>ELFEIYII63 | Date<br>26/11/2021 |
|---|---|---|---|
| Attached deposits, encrustation from 9 to 7 o'clock 5% cross-sectional area loss - Remark: CONTINUOUS DEFECT DOWNSTREAM TO UU 1304 , Start | | | |

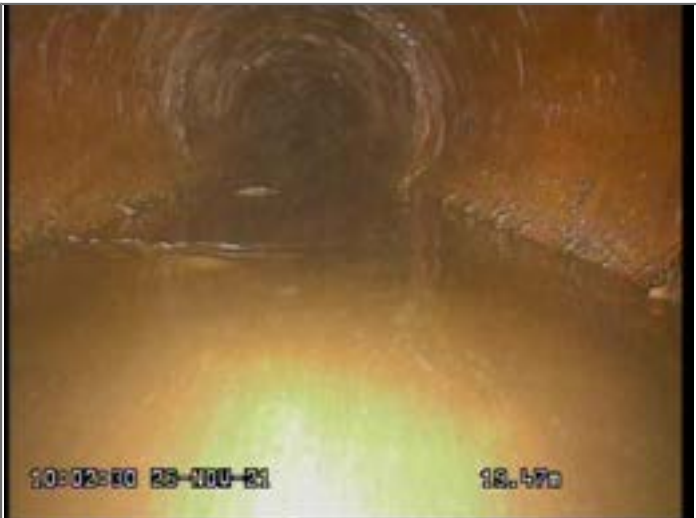
| Position | Code | Description | Photo | Type/Grade |
|---|---|---|---|---|
| 10.42 | CL | Crack longitudinal at 11 o'clock | 5791833 | Structural / 2 |

| Job Number<br>LAYERSERV0001064 | Surveyed by (Operator)<br>CHRIS LUCOCK | Base Unit<br>ELFEIYII63 | Date<br>26/11/2021 |
|---|---|---|---|
| Crack longitudinal at 11 o'clock | | | |

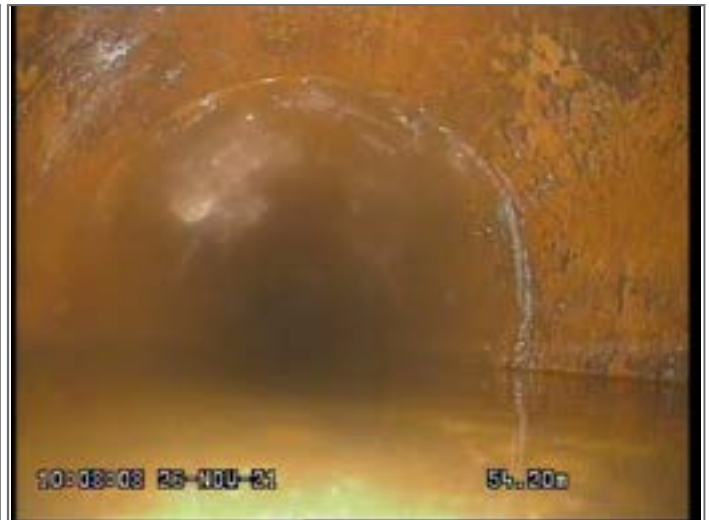
Attached deposits, fouling from 5 to 7 o'clock 20% cross-sectional area loss

Survey abandoned - Remark: OBSTRUCTION UNABLE TO PASS DUE TO ATTACHED DEPOSITS UNDER WATER

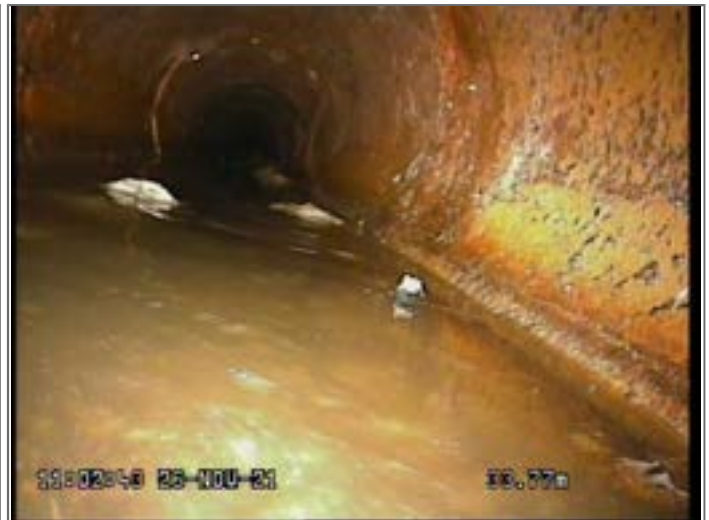
Survey abandoned - Remark: UNABLE TO PASS DUE TO FOUL AND SILT DEPOSITS

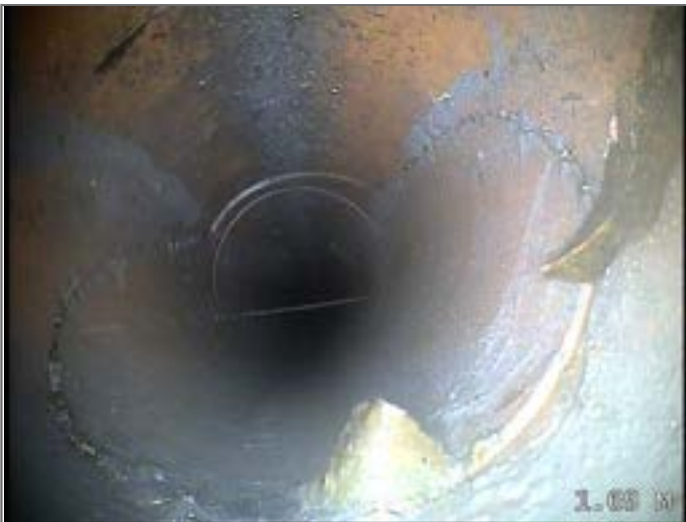
| Start Node Ref:MH S15 I/L :mm Depth: 0.78mm | | | | | |
|---|---|---|---|---|--|
| 1.69 | CS | Crack spiral from 1 to 9 o'clock | 5791924 | Structural / 3 | |

Crack spiral from 1 to 9 o'clock

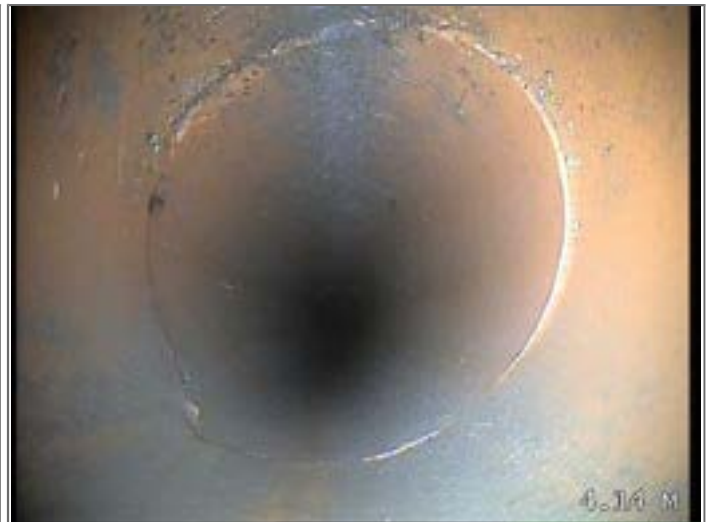
| Start Node Ref:MH S15 I/L :mm Depth: 0.78mm | | | | | |
|---|---|---|---|---|--|
| 4.14 | CC | Crack circumferential from 12 to 12 o'clock | 5791925 | Structural / 2 | |

Crack circumferential from 12 to 12 o'clock

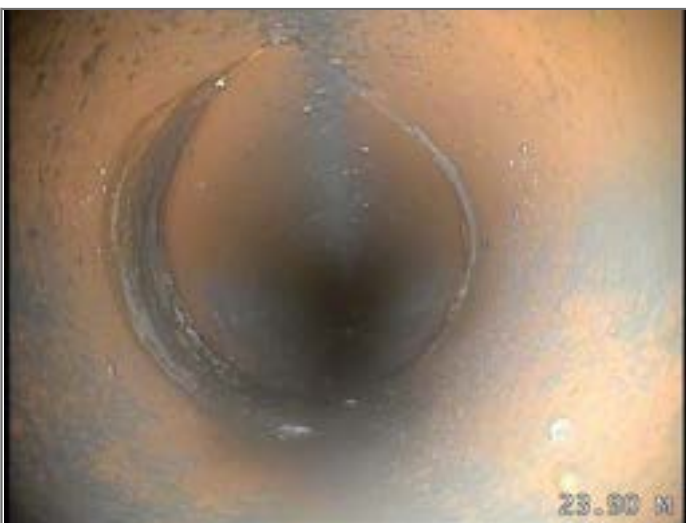
| Start Node Ref:MH S15 I/L :mm Depth: 0.78mm | | | | | |
|---|---|---|---|---|--|
| 23.90 | FC | Fracture circumferential from 12 to 12 o'clock | 5791926 | Structural / 3 | |

Fracture circumferential from 12 to 12 o'clock

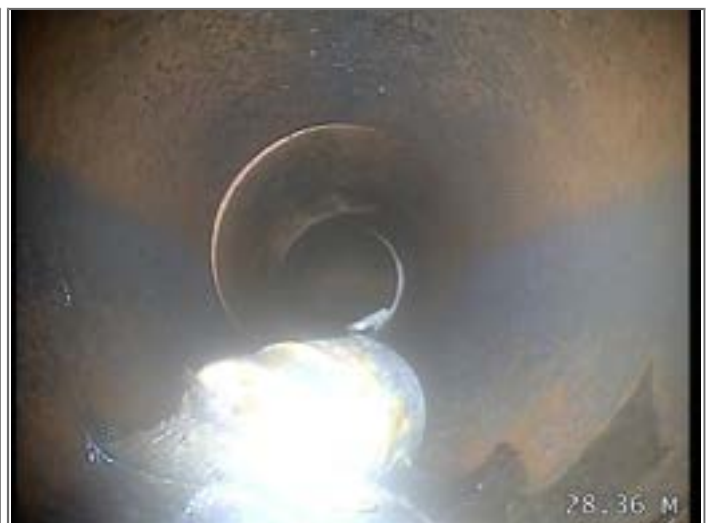
Other settled deposits 10% cross-sectional area loss - Remark: DEBRIS
