**RE: RENAISSANCE HOTEL, BLACKFRIARS STREET, MANCHESTER, M3 2EQ**

#### **CCTV SURVEY**

# Drainage Report

**RENAISSANCE HOTEL - CCTV Survey Report : 10/06/21**

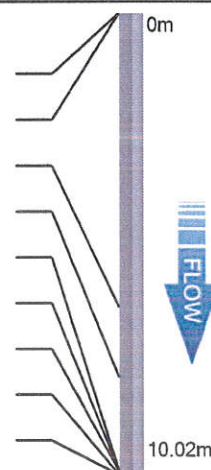
**Section 1**

This line is in poor condition & appears to have had a repair carried out at some time in the past, as there is evidence of shuttering supports & also plywood on the top of the drain, possibly to support a concrete repair.

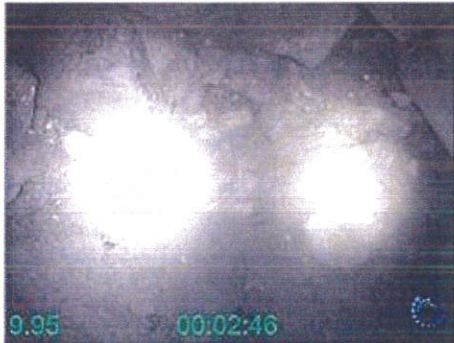
| Pos | Video Ref | Code | Description | Image |
|---|---|---|---|---|
| 09.95m | 0:01:56 | MCBR | Material of pipe changes to Brick | Image Provided - Ref: 0_4<br> |

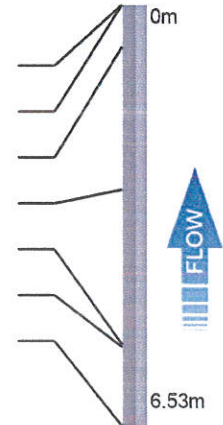
Section 2

Survey 2, overflow 1 to CSO 750mm pipe – we can only assume this drain is coming from the CSO in Deansgate, due to the foul smell & noise of rushing water. We would be unable to high pressure water jet this drain, due to an obstruction of concrete / heavy silt, & the downstream line leads directly into the River Irwell [this could result in major pollution]. We are uncertain where the upstream section of this drain comes from. We can only assume it is from the CSO in Deansgate.

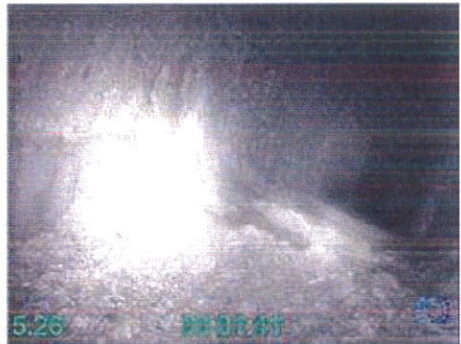
| Pos | Video Ref | Code | Description | Image |
|---|---|---|---|---|
| 05.26m | 0:01:24 | SC | Dimension of drain/sewer<br>changes: 0mm Diameter | Image Provided - Ref: 1_4<br> |
| 05.30m | 0:01:24 | OB | Other obstacles: 20% Cross<br>sectional area loss - Severity 3<br>POSSIBLE CONCRETE IN<br>THE INVERT 20% | |
