**St Margarets Chambers**  
For Charlotte Street Estates

Lightwell Elevations -  
Proposed Repairs and  
Conditions 1/2

scheme 1907  
drwg no. **P(236)**  
revision

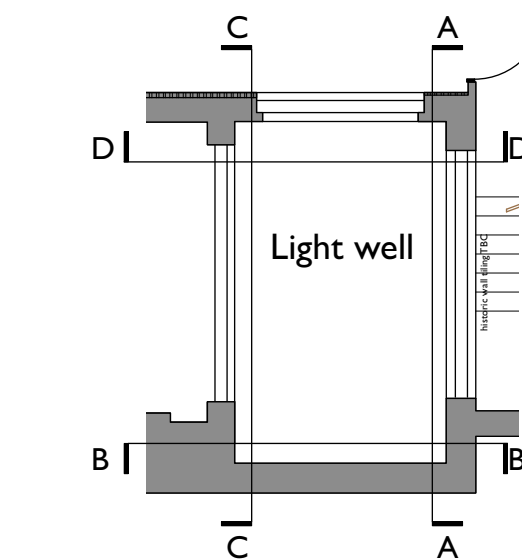
Lightwell Elevation AA  
Scale 1:100

- 1 Sandstone erosion - close inspection required.
- 2 Holes left by redundant fixings - mortar fill in accordance with specification.
- 3 Gaps in brickwork. Close inspection required to inform replacement with matching material.

- 4 Missing pointing between frieze panels. Reinststate in accordance with specification.
- 5 Redundant plant equipment carefully remove and make good fabric in accordance with specification.

- 6 Eroded sandstone coping. Close inspection required. Replacement matching stone inserts may be required to prevent further deterioration.
- 7 Rusting lintels Clean off and repaint in accordance with specification.

- 8 Biological growth to be removed from roof level.
- 9 Coping water staining. May require repointing. Close inspection required.
- 10 Previous repairs to sandstone. Poorly matched aesthetic and presumed composition, but no evidence repairs are causing damage to surrounding historic fabric. Add to building maintenance plan for regular monitoring.

- 11 Biological growth to stone to be cleaned in accordance with specification.
- 12 Water staining may be caused by missing pointing. Close inspection required to inform repair strategy.

- 13 Signs of cracking. Further inspection required on site.
- 14 Redundant cables/lights/alarm box. Carefully remove
- 15 Residue from former sign to be cleaned off sandstone. Method pending site trials.

- 16 Existing timber to be carefully removed from brickwork

- 17 Clean off atmospheric dirt from glazed tiles
- 18 Redecorate cill
- 19 Clean-out gutters
- 20 Missing slate to be investigated once high level access provided
- 21 Repair and redecorate timber window frame and rotten cill
- 22 Clean concrete cill
- 23 Reinststate missing pointing
- 24 Inspect felt roof
- 25 Loose board and flashing to be repaired
- 26 inspect stone cill. Possible damage causing biological growth and staining to wall
- 27 Paint flanking and signs of damp further inspection required

Allow for the renewal of gutters and rainwater outlet to roof

Lightwell Elevation BB  
Scale 1:100

COPYRIGHT OF ATELIER MB LTD  
DO NOT SCALE FROM THIS DRAWING  
DIMENSIONS TO BE CHECKED ON SITE

Note: These elevations are indicative and not based on a full measured survey

Existing  
Proposed

Note: Floor Levels are Approximate

Flashings to be renewed as required

Rev Note DRN CHK

scale 1:100 @ A3  
date first drawn February 2022  
drawn RG

SK sketch E existing P proposed T tender C construction FI final issue

[www.ateliermb.co.uk](http://www.ateliermb.co.uk)  
t 0161 236 0051  
e architect@ateliermb.co.uk
