**DEMOLITION SURVEY, ASSESSMENT AND REGISTER OF ASBESTOS  
CONTAINING MATERIALS**

**Islamic High School  
High Lane  
Chorlton  
Manchester  
M21 9FA**

**Cube Homes Limited**

| Project no: | A-20300 |

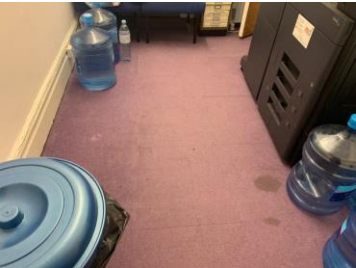
| | Inspection Date | Surveyor | Survey Type | Floor | Analysis | |
|---|---|---|---|---|---|---|
| | 27/10/2022 | Sam Hendry | Demolition | Ground Floor | Chrysotile | |

| | Inspection Date | Surveyor | Survey Type | Floor | Analysis | |
|---|---|---|---|---|---|---|
| Recommendations / Actions | | Non notifiable product - Remove under strict accordance with current and relevant legislation notes. | | | | |

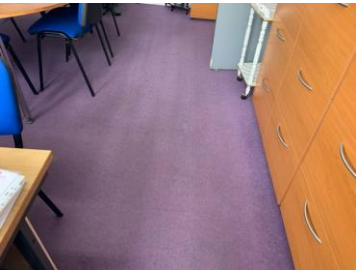
| | Inspection Date | Surveyor | Survey Type | Floor | Analysis | |
|---|---|---|---|---|---|---|
| | 27/10/2022 | Sam Hendry | Demolition | Ground Floor | NAD | |
| Surveyor Comments | Vinyl floor tiles beneath carpet flooring | | | | Review Date | Not required |

| | Inspection Date | Surveyor | Survey Type | Floor | Analysis | |
|---|---|---|---|---|---|---|
| Recommendations / Actions | No action required | | | | | |

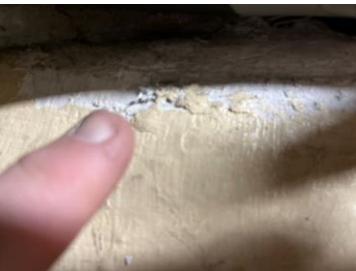
| | Inspection Date | Surveyor | Survey Type | Floor | Analysis | |
|---|---|---|---|---|---|---|
| | 27/10/2022 | Paul Walker | Demolition | Basement | Chrysotile/Amosite/Crocidolite | |
| Surveyor Comments | Thermal insulation residues to wall | | | | Review Date | 27/10/2023 |

| | Inspection Date | Surveyor | Survey Type | Floor | Analysis | |
|---|---|---|---|---|---|---|
| Recommendations / Actions | Notifiable product - to be removed by a licensed contractor under strict accordance with current and relevant legislation notes | | | | | |

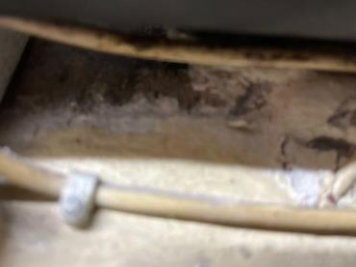
| | Inspection Date | Surveyor | Survey Type | Floor | Analysis | |
|---|---|---|---|---|---|---|
| | 27/10/2022 | Paul Walker | Demolition | Basement | Chrysotile/Amosite | |
| Surveyor Comments | | Thermal insulation residues to wall | | | Review Date | 27/10/2023 |

| | Inspection Date | Surveyor | Survey Type | Floor | Analysis | |
|---|---|---|---|---|---|---|
| Recommendations / Actions | | Notifiable product - to be removed by a licensed contractor under strict accordance with current and relevant legislation notes | | | | |

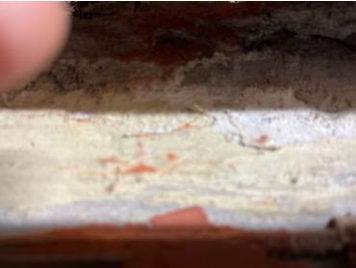
| | Inspection Date | Surveyor | Survey Type | Floor | Analysis | |
|---|---|---|---|---|---|---|
| | 27/10/2022 | Paul Walker | Demolition | Basement | Chrysotile/Amosite | |
| Surveyor Comments | | Thermal insulation residues to wall | | | Review Date | 27/10/2023 |

| | Inspection Date | Surveyor | Survey Type | Floor | Analysis | |
|---|---|---|---|---|---|---|
| Recommendations / Actions | | Notifiable product - to be removed by a licensed contractor under strict accordance with current and relevant legislation notes | | | | |

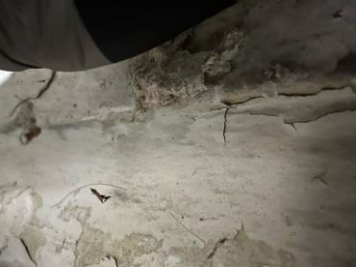
| | Inspection Date | Surveyor | Survey Type | Floor | Analysis | |
|---|---|---|---|---|---|---|
| | 27/10/2022 | Paul Walker | Demolition | Basement | Chrysotile/Amosite | |
| Surveyor Comments | | Thermal insulation residues to wall | | | Review Date | 27/10/2023 |

| | Inspection Date | Surveyor | Survey Type | Floor | Analysis | |
|---|---|---|---|---|---|---|
| Recommendations / Actions | | Notifiable product - to be removed by a licensed contractor under strict accordance with current and relevant legislation notes | | | | |

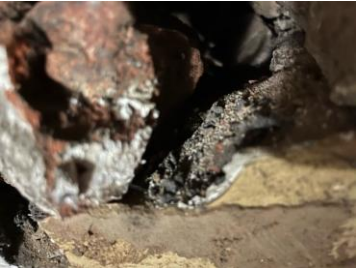
| | Inspection Date | Surveyor | Survey Type | Floor | Analysis | |
|---|---|---|---|---|---|---|
| | 27/10/2022 | Paul Walker | Demolition | Basement | Amosite | |
| Surveyor Comments | | Thermal insulation to brick work within former Furness. | | | Review Date | 27/10/2023 |

| | Inspection Date | Surveyor | Survey Type | Floor | Analysis | |
|---|---|---|---|---|---|---|
| Recommendations / Actions | | Restrict access and remove by a licensed contractor under strict accordance with current and relevant legislation notes | | | | |

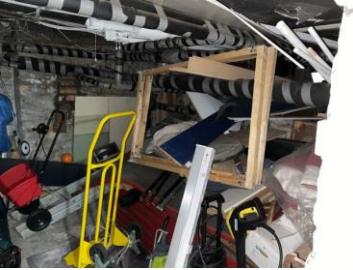
| | Inspection Date | Surveyor | Survey Type | Floor | Analysis | |
|---|---|---|---|---|---|---|
| | 27/10/2022 | Paul Walker | Demolition | Basement | Chrysotile/Amosite/Crocidolite | |
| Surveyor Comments | | Limited access due to stored items | | | Review Date | 27/10/2023 |

| | Inspection Date | Surveyor | Survey Type | Floor | Analysis | |
|---|---|---|---|---|---|---|
| Recommendations / Actions | | Sample to confirm the presence of Asbestos prior to any refurbishment works | | | | |

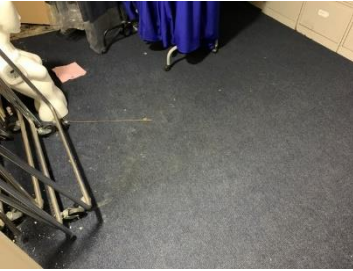
| | Inspection Date | Surveyor | Survey Type | Floor | Analysis | |
|---|---|---|---|---|---|---|
| | 27/10/2022 | Sam Hendry | Demolition | Basement | Chrysotile | |
| Surveyor Comments | | Vinyl floor tiles and adhesive | | | Review Date | 27/10/2023 |

| | Inspection Date | Surveyor | Survey Type | Floor | Analysis | |
|---|---|---|---|---|---|---|
| Recommendations / Actions | | Non notifiable product - Remove under strict accordance with current and relevant legislation notes. | | | | |

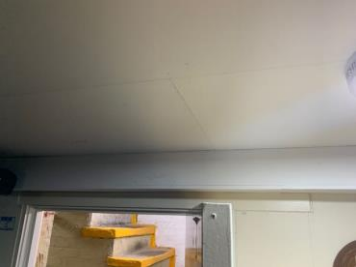
| | Inspection Date | Surveyor | Survey Type | Floor | Analysis | |
|---|---|---|---|---|---|---|
| | 27/10/2022 | Sam Hendry | Demolition | Basement | <b>Chrysotile/Amosite</b> | |
| Surveyor Comments | | Presumed thermal insulation to pipework within boxing due to no intrusive access | | | Review Date | 27/10/2023 |

| | Inspection Date | Surveyor | Survey Type | Floor | Analysis | |
|---|---|---|---|---|---|---|
| Recommendations / Actions | | Notifiable product - to be removed by a licensed contractor under strict accordance with current and relevant legislation notes | | | | |

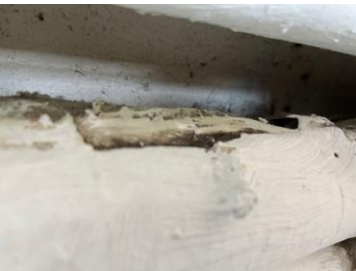
| | Inspection Date | Surveyor | Survey Type | Floor | Analysis | |
|---|---|---|---|---|---|---|
| | 27/10/2022 | Paul Walker | Demolition | Ground Floor | <b>Chrysotile</b> | |

| | Inspection Date | Surveyor | Survey Type | Floor | Analysis | |
|---|---|---|---|---|---|---|
| Recommendations / Actions | | Notifiable product - to be removed by a licensed contractor under strict accordance with current and relevant legislation notes | | | | |

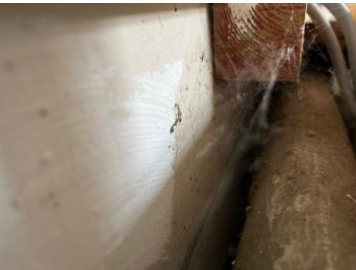
| | Inspection Date | Surveyor | Survey Type | Floor | Analysis | |
|---|---|---|---|---|---|---|
| | 27/10/2022 | Paul Walker | Demolition | Ground Floor | Chrysotile/Amosite/Crocidolite | |

| | Inspection Date | Surveyor | Survey Type | Floor | Analysis | |
|---|---|---|---|---|---|---|
| Recommendations / Actions | | Notifiable product - to be removed by a licensed contractor under strict accordance with current and relevant legislation notes | | | | |

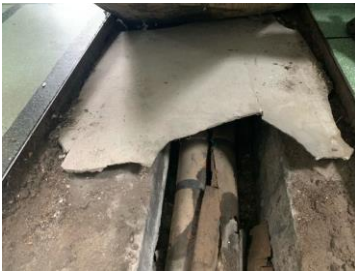
| | Inspection Date | Surveyor | Survey Type | Floor | Analysis | |
|---|---|---|---|---|---|---|
| | 27/10/2022 | Sam Hendry | Demolition | Ground Floor | Chrysotile | |

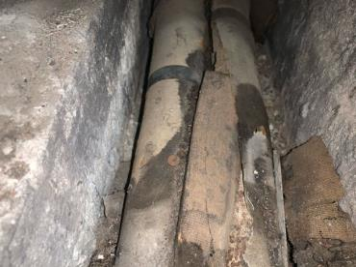
| | Inspection Date | Surveyor | Survey Type | Floor | Analysis | |
|---|---|---|---|---|---|---|
| | 27/10/2022 | Sam Hendry | Demolition | Ground Floor | <b>Chrysotile</b> | |

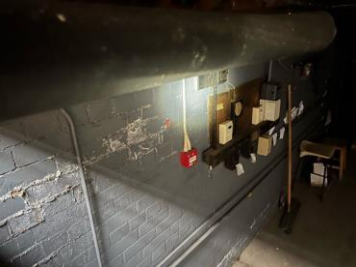
| | Inspection Date | Surveyor | Survey Type | Floor | Analysis | |
|---|---|---|---|---|---|---|
| | 27/10/2022 | Paul Walker | Demolition | Ground Floor | Chrysotile/Amosite/Crocidolite | |
| Surveyor Comments | Thermal insulation residue to wall | | | | Review Date | 27/10/2023 |

| | Inspection Date | Surveyor | Survey Type | Floor | Analysis | |
|---|---|---|---|---|---|---|
| Recommendations / Actions | Notifiable product - to be removed by a licensed contractor under strict accordance with current and relevant legislation notes | | | | | |

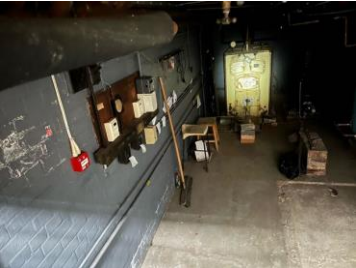
| | Inspection Date | Surveyor | Survey Type | Floor | Analysis | |
|---|---|---|---|---|---|---|
| | 27/10/2022 | Paul Walker | Demolition | Ground Floor | Chrysotile | |

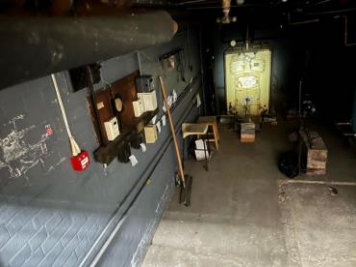
| | Inspection Date | Surveyor | Survey Type | Floor | Analysis | |
|---|---|---|---|---|---|---|
| | 27/10/2022 | Paul Walker | Demolition | Ground Floor | <b>Chrysotile</b> | |
| Surveyor Comments | Rope to boiler door | | | | Review Date | 27/10/2023 |

| | Inspection Date | Surveyor | Survey Type | Floor | Analysis | |
|---|---|---|---|---|---|---|
| Recommendations / Actions | Notifiable product - to be removed by a licensed contractor under strict accordance with current and relevant legislation notes | | | | | |

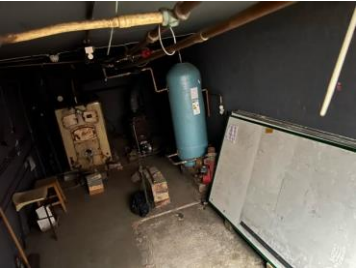
| | Inspection Date | Surveyor | Survey Type | Floor | Analysis | |
|---|---|---|---|---|---|---|
| | 27/10/2022 | Paul Walker | Demolition | Ground Floor | <b>Chrysotile</b> | |

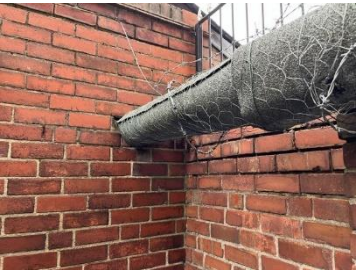
| | Inspection Date | Surveyor | Survey Type | Floor | Analysis | |
|---|---|---|---|---|---|---|
| | 27/10/2022 | Paul Walker | Demolition | Ground Floor | Amosite/Crocidolite | |
