**Project Name:** Premier House\_1

**Project Number:** GR/7771

**Project Date:** 08/09/2023

**Inspection Standard:** MSCC5 Sewers & Drainage GB (SRM5 Scoring)

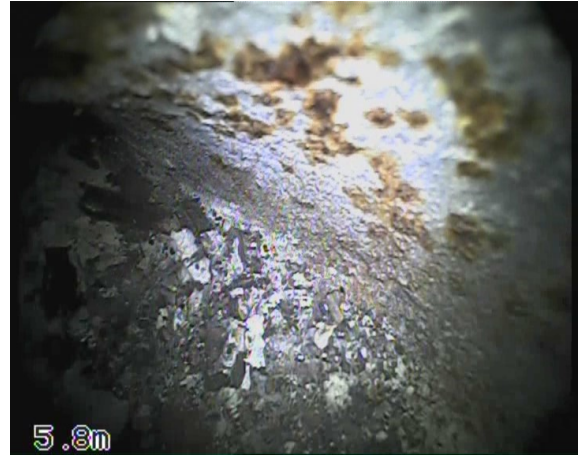
| Scale: | 1:52 | Position [m] | Code | Observation | MPEG | Photo | Grade |
|---|---|---|---|---|---|---|---|
| | | 5.90 | DES | Settled deposits, fine, 20% cross-sectional area loss: Debris/silt | 00:00:56 | RWDP3 (L1)X_55c78bcf-127 | 4 |

(L1)X\_55c78bcf-127c-4aaf-8c6a-21fc4b515138\_20230908\_095728\_466.jpg, 00:00:56, 5.90 m  
Settled deposits, fine, 20% cross-sectional area loss,  
Debris/silt

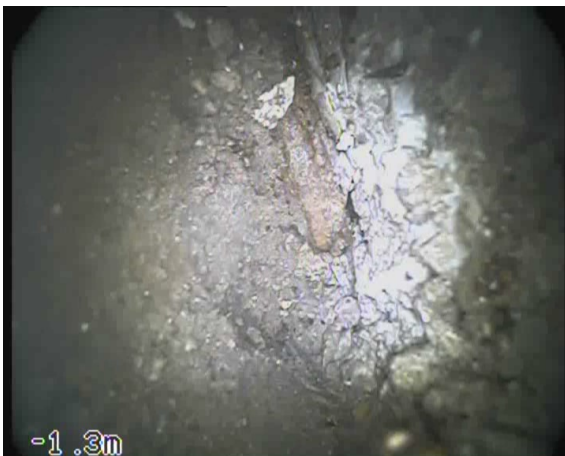
RWDP5  
(L1)X\_e966202c-af31-431e-998c-c26020799a07\_20230908\_101750\_530.jpg, 00:00:12, 0.00 m  
Settled deposits, fine, 100% cross-sectional area loss

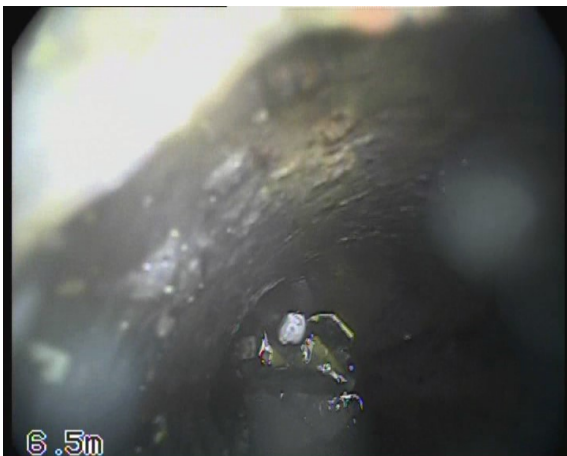
RWDP6  
(L1)X\_c24db34c-f1e1-4a54-bbe5-7b7f02461667\_20230908\_1  
02538\_566.jpg, 00:00:54, 6.50 m  
Other obstacles from 12 o'clock to 12 o'clock, 75%  
cross-sectional area loss, Obstruction

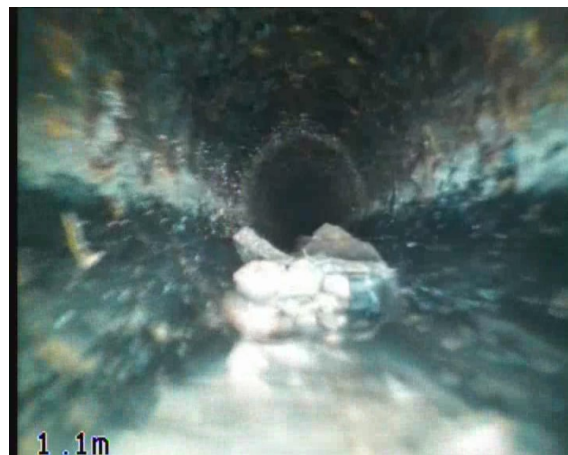
HOLX\_7026859b-40d0-4aca-84e8-937f54658df8\_20230908\_103745\_461.jpg, 00:00:13, 1.20 m  
Settled deposits, coarse, 20% cross-sectional area loss

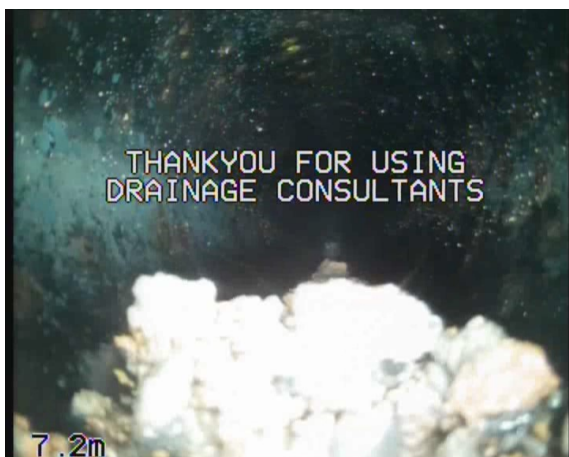
HOLX\_c1eb0fe9-052f-4f62-b33a-dcf2a21ca54e\_20230908\_104016\_325.jpg, 00:00:34, 7.20 m  
Survey abandoned, Unable to pass stones/rocks

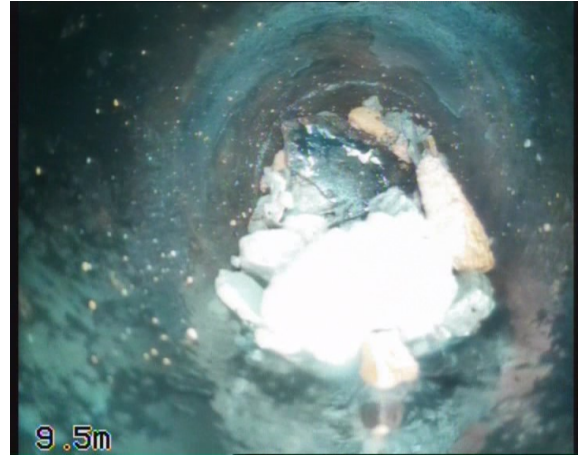
HOLX\_94bc95b6-bb27-4b87-95e1-b52527d7f798\_20230908\_105308\_299.jpg, 00:00:44, 9.60 m  
Settled deposits, coarse, 100% cross-sectional area loss, Stones/debris

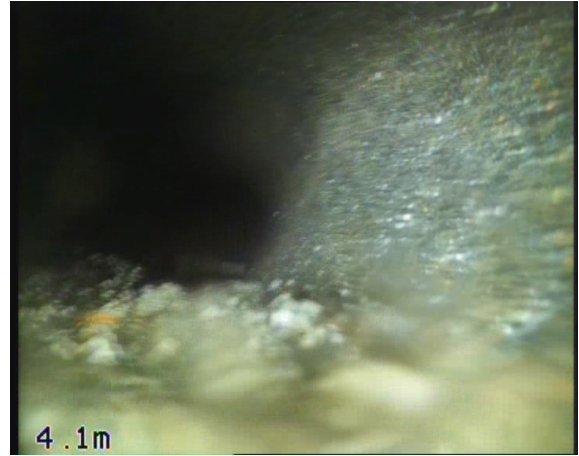
MH3X\_8168e281-fd89-4b71-970a-3cf638ef655e\_20230908\_11518\_521.jpg, 00:00:25, 4.10 m  
Settled deposits, fine, 20% cross-sectional area loss, Silt to 7.4m

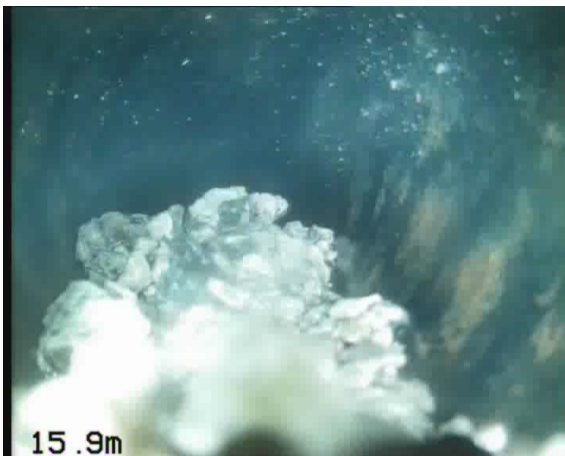
HOLX\_fd5669b4-efff-4b5d-9077-7f1b6216390f\_20230908\_113147\_577.jpg, 00:01:14, 15.90 m  
Settled deposits, coarse, 25% cross-sectional area loss, Stones

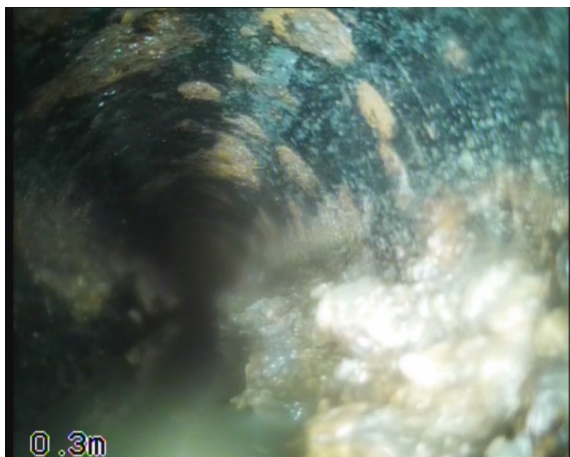
MH7X\_05b1cd5e-9e6c-4792-83ce-61d97ae24e37\_20230908\_122529\_746.jpg, 00:00:08, 0.30 m  
Attached deposits, encrustation from 3 o'clock to 6 o'clock,  
25% cross-sectional area loss

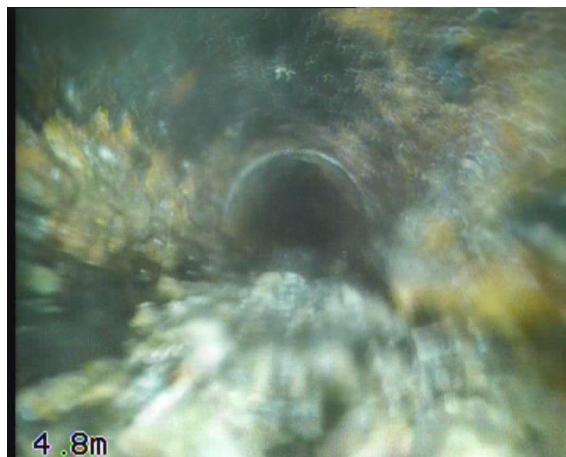
MH7X\_05f232a3-4170-4345-9aab-8eff82b04f2c\_20230908\_122613\_835.jpg, 00:00:41, 4.70 m  
Settled deposits, fine, 25% cross-sectional area loss,  
Silt/stones

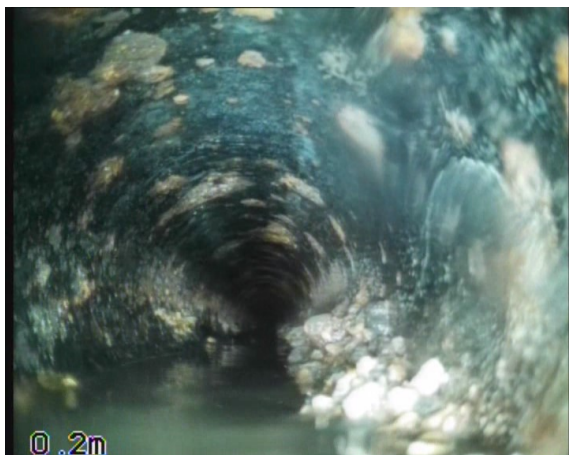
HOLX\_7c2a1aa2-165e-4995-beea-27b7d8be3c77\_20230911\_074626\_321.jpg, 00:00:09, 0.00 m  
Settled deposits, coarse, 20% cross-sectional area loss, Silt/stone

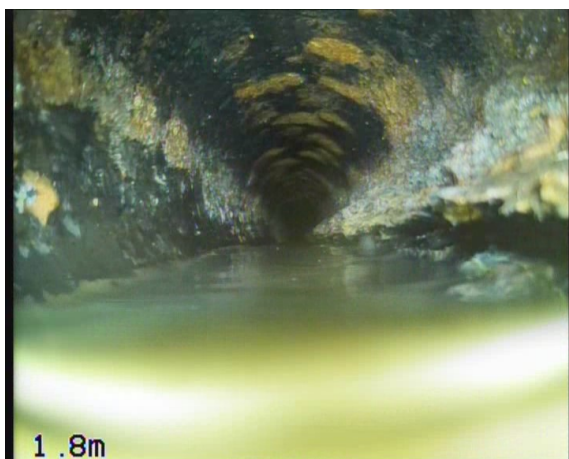
HOLX\_93e63aa0-d5b5-4514-985c-4dfadebf3cd7\_20230911\_074722\_536.jpg, 00:00:16, 1.80 m  
Attached deposits, encrustation from 3 o'clock to 9 o'clock, 20% cross-sectional area loss, throughout

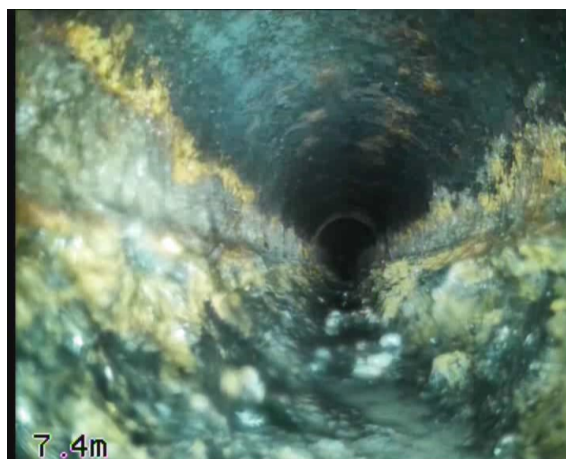
HOLX\_5dee4ea5-1ae1-40b2-a2f2-c8d17331fcfc\_20230911\_074926\_281.jpg, 00:00:16, 1.80 m  
Attached deposits, encrustation from 3 o'clock to 9 o'clock, 20% cross-sectional area loss, throughout

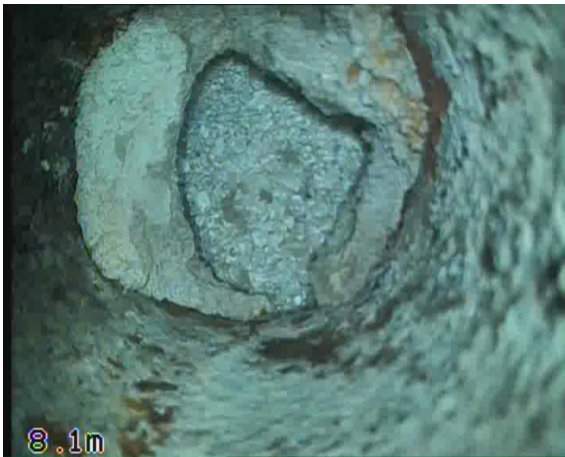
HOLX\_3025dfa4-df78-46f9-8c50-3b51d50e22d2\_20230911\_090250\_497.jpg, 00:00:54, 8.20 m  
Other obstacles from 12 o'clock to 12 o'clock, 100%  
cross-sectional area loss, Obstruction

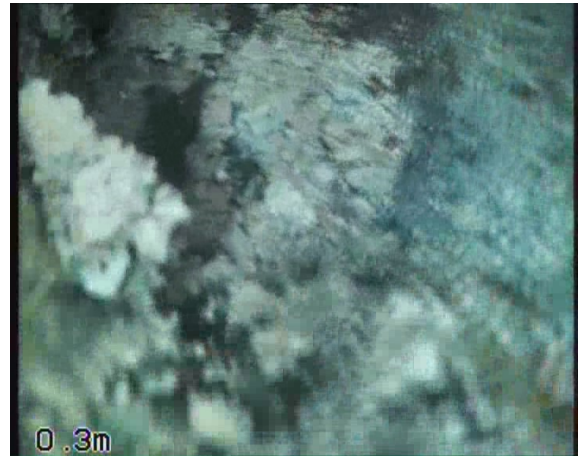
HOLX\_9557cb08-00c0-4933-8bbc-94e112317e59\_20230911\_092001\_064.jpg, 00:00:17, 0.40 m  
Attached deposits, encrustation from 12 o'clock to 12 o'clock, 75% cross-sectional area loss

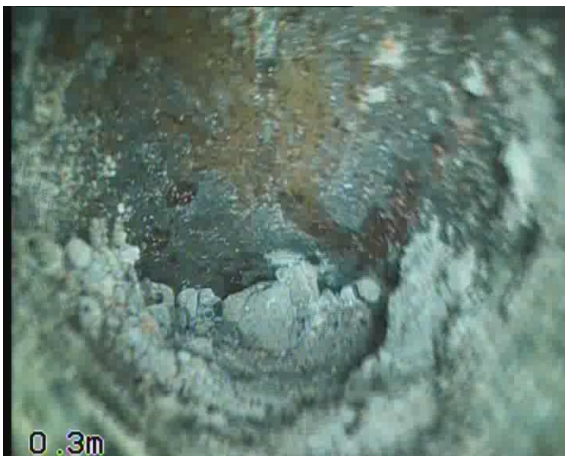
HOLX\_73bb7369-ef62-467b-b60c-dcb347e2b7a8\_20230911\_092255\_247.jpg, 00:00:22, 0.30 m  
Attached deposits, encrustation from 3 o'clock to 9 o'clock,  
50% cross-sectional area loss

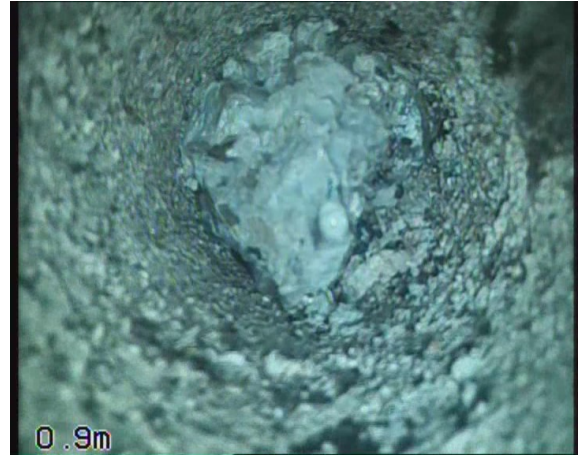
HOLX\_35e16080-5ab1-4555-b8e7-b6d411affb86\_20230911\_093055\_456.jpg, 00:00:22, 1.00 m  
Other obstacles from 12 o'clock to 12 o'clock, 100%  
cross-sectional area loss, Concrete / Obstruction

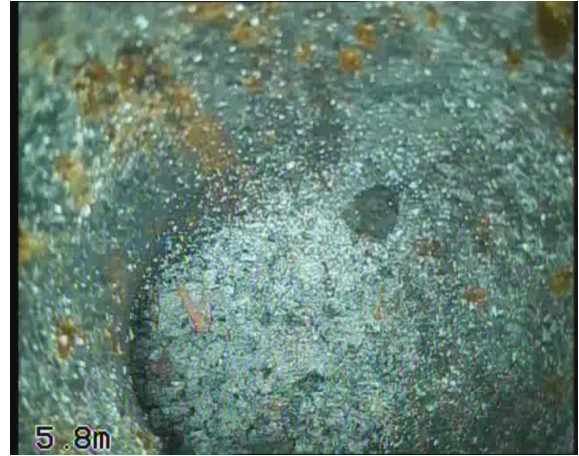
RWDP5  
(F1)X\_1adc471c-10ff-42fd-8b16-2dcc9c2a3c03\_20230911\_093520\_887.jpg, 00:00:32, 6.10 m  
Settled deposits, coarse, 25% cross-sectional area loss,  
Silt/stones

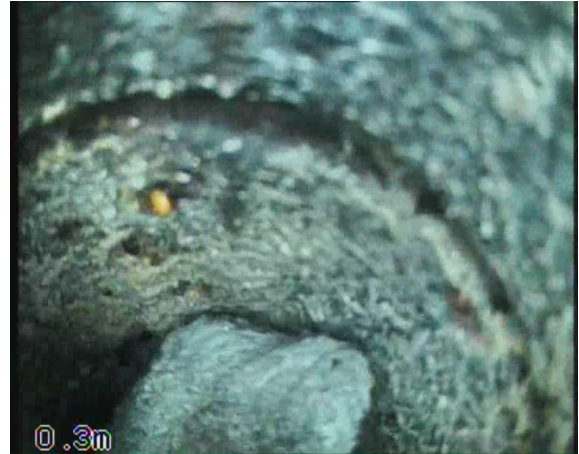
HOLX\_766d2511-d82f-4ba7-818f-dfc7d98f24ac\_20230911\_094402\_437.jpg, 00:00:21, 0.40 m  
Other obstacles from 12 o'clock to 12 o'clock, 90% cross-sectional area loss, Rock
