# Carriageway Condition Survey recorded on 28th July 2023

PICCADILLY GARDENS, MANCHESTER, M1 1AF

Friday, 28 July 2023

Prepared For L&G / Colliers

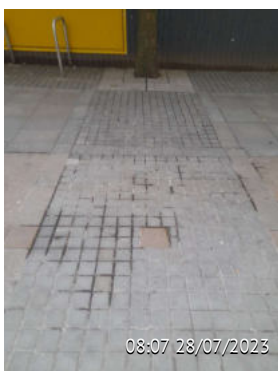
### Item 5

Assigned To Piccadilly pedestrian walkway

General condition: Feature block paving in a fair state of repair.

Grout loss to joints.

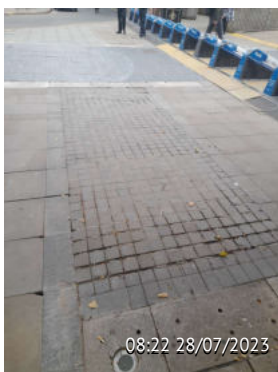
### Item 9

Assigned To Piccadilly pedestrian walkway

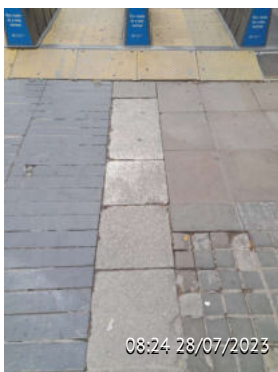
### Item 13

Assigned To Entrance to Main Walkway

Feature band flags cracked, chipped, spalled and grout missing from cobble sets.

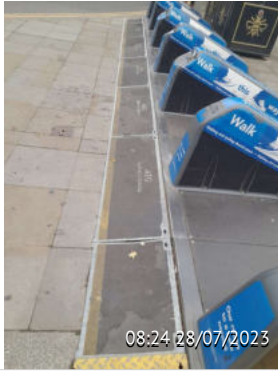
#### Item 14

Assigned To Entrance to Main Walkway  
Surface Guard ramps are buckled.

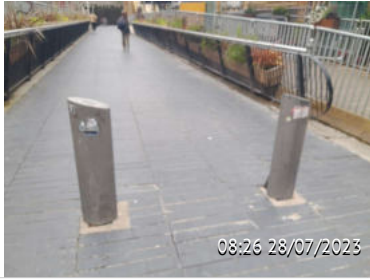
### Item 18

Assigned To Main Walkway bollards

General Condition: Fair

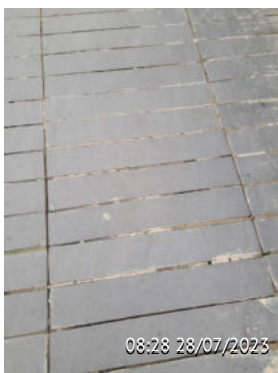
### Item 21

Assigned To Main Walkway through fountain

Grout failure to tiles resulting in movement and edge damage.

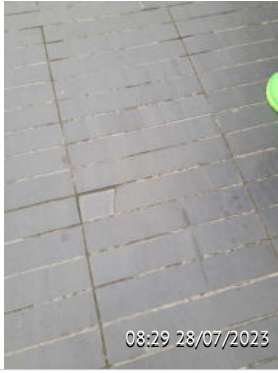
### Item 22

Assigned To Main Walkway through fountain

Bedding material ground failure causing movement resulting in cracking, spalling and edge damage.

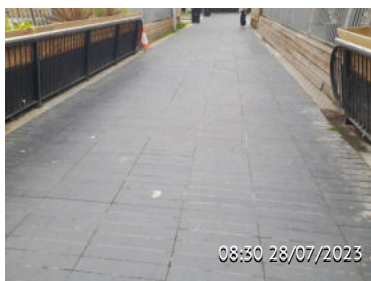
### Item 25

Assigned To Main Walkway exiting fountain area

Condition: Fair

Paving tile grout failure throughout.

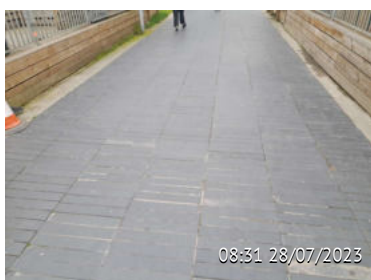
### Item 26

Assigned To Main Walkway exiting fountain area

General Condition: Fair

Paving tile grout failure throughout.

Several tile replacements have been carried out using a patch repair system.

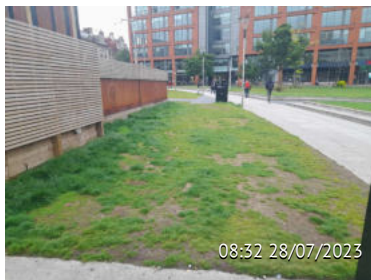
### Item 29

Assigned To Soft Landscaping zone to LHS rear of event space  
Grass is in poor condition with bare soil in multiple patches.

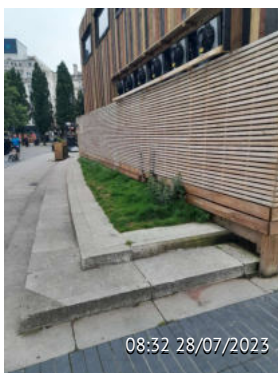
### Item 30

Assigned To Soft Landscaping zone to RHS rear of event space  
Soft landscape zone grass worn from foot traffic.

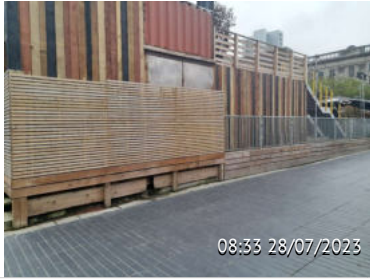
### Item 31

Assigned To Event space wall RHS of Main Walkway  
General condition: Good, no visible damage or disrepair.

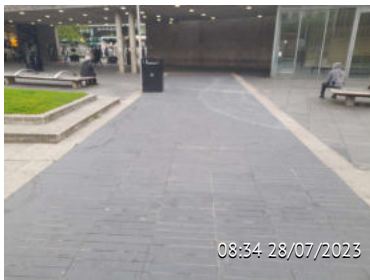
### Item 33

Assigned To Main Walkway leading up to Pavilion  
General Condition: Fair  
Bedding material and grout failure resulting in movement and edge damage.

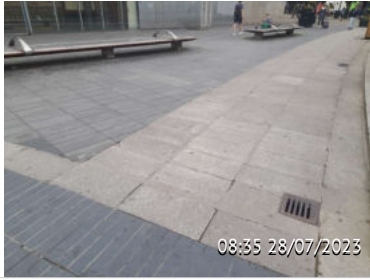
### Item 36

Assigned To Walkway leading to Mosley Street  
General Condition: Fair

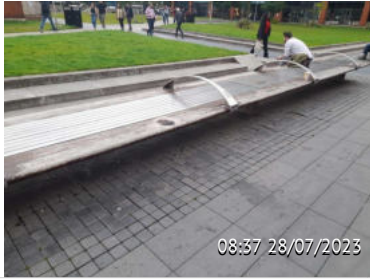
#### Item 40

Assigned To Pavilion Terrace

Bench seating condition: Poor, movement in bench seat components & protective coating failure.

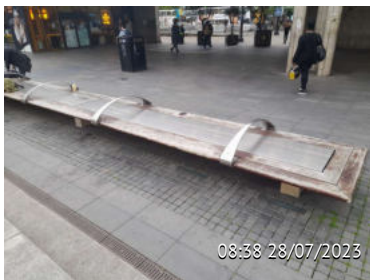
#### Item 42

Assigned To Pavilion Terrace

Bench Seating general condition: Poor

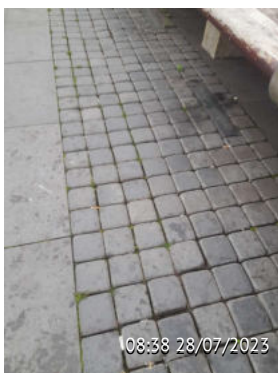
#### Item 43

Assigned To Pavilion Terrace LHS

Cobble sets to perimeter of bench seating moving / settling due to bedding & joint material failure.

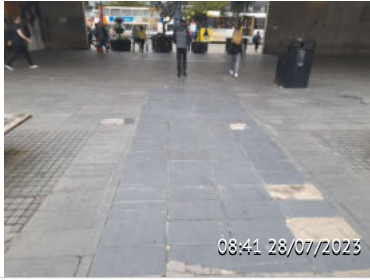
### Item 49

Assigned To Walkway to Tram Station

General Condition: Very Poor

Multiple missing tiles replaced with patch repair systems.

Paving Tile bedding / grout material failing causing movement and resulting in cracks, edge damage and spalls.

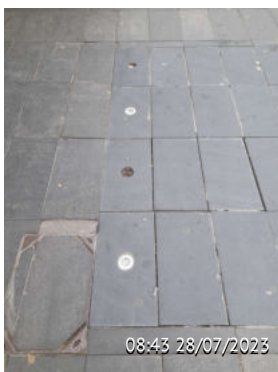
### Item 52

Assigned To Walkway to Tram Station

Missing feature lighting.

Movement has caused damage to tiles.

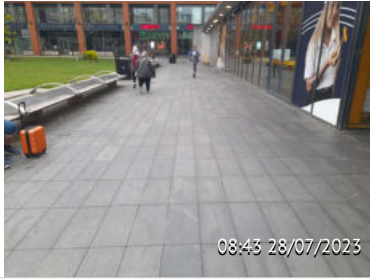
### Item 53

Assigned To Pavilion Terrace RHS

General Condition: Fair

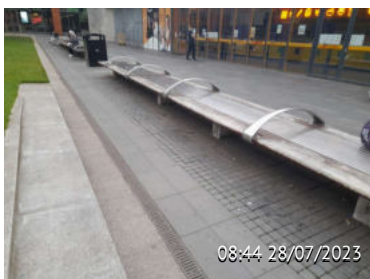
### Item 56

Assigned To Pavilion Terrace RHS

Bench Seating General Condition: Poor

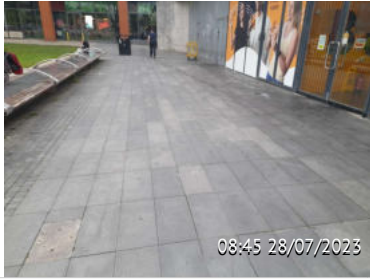
### Item 58

Assigned To Pavilion Terrace RHS  
General Condition: Fair

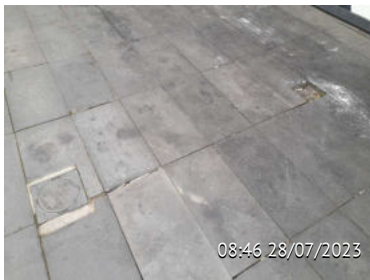
### Item 60

Assigned To Pavlion Terrace RHS  
Movement cuasing cracks and edge damage.  
Paving tile cut out leaving 20-25mm recessed trip hazard.

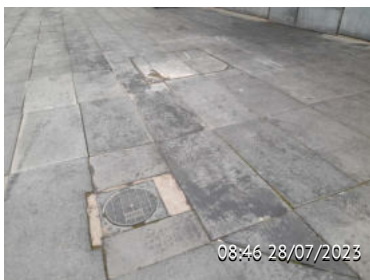
### Item 61

Assigned To Pavilion Terrace RHS  
Movement causing cracks and edge damage.  
Lipping to joints.

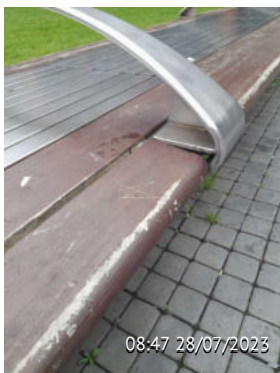
### Item 63

Assigned To Pavilion Terrace RHS  
Damaged seating

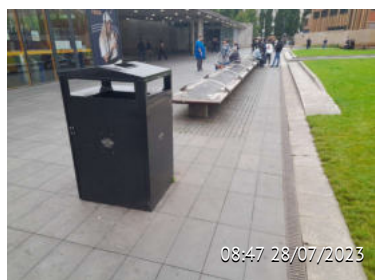
### Item 64

Assigned To Pavilion Terrace RHS  
General Condition: Fair

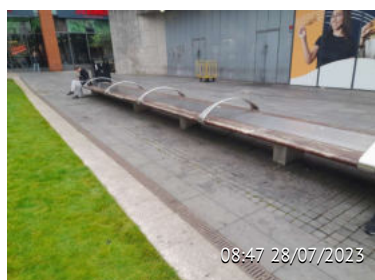
### Item 65

Assigned To Pavilion Terrace RHS  
Bench Seating General Condition: Poor

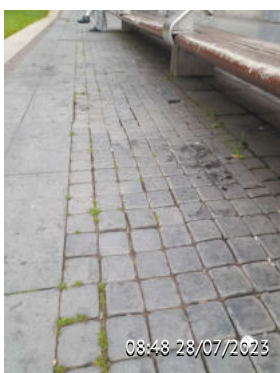
### Item 66

Assigned To Pavilion Terrace RHS  
Cobble sets to perimeter of bench seating moving / settling due to bedding & joint material failure.

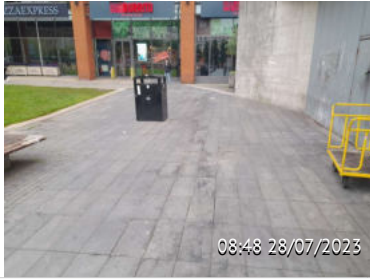
### Item 67

Assigned To Pavilion Terrace RHS

General Condition: Fair

Bedding / joint material failure causing movement resulting in cracking, spalls and edge damage.

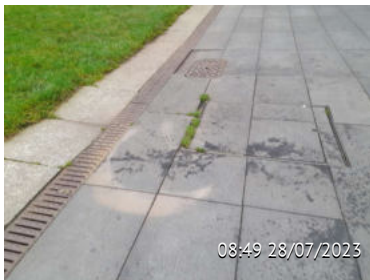
### Item 69

Assigned To Pavilion Terrace RHS

Drainage and paving showing signs of movement and settling around MH cover and water main Service Valve cover.

Excessive lipping present to multiple tiles, cracks, spalls and edge damage.

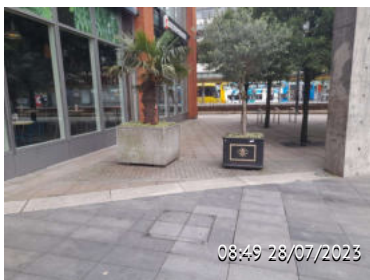
### Item 70

Assigned To Pavilion Terrace RHS through to Tramway on Parker St

General Condition: Fair

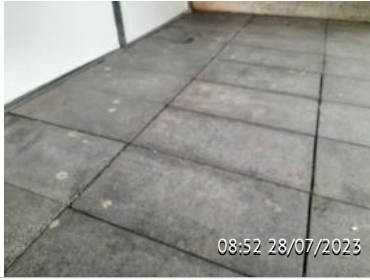
### Item 72

Assigned To Pavilion Terrace under roof area  
Bedding / joint material failure causing movement.

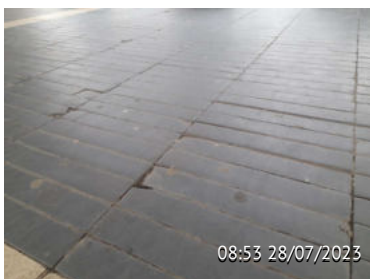
### Item 75

Assigned To Feature Walkway under Pavilion roof area  
Bedding / joint material failure causing movement resulting in cracks, spalls and edge damage.

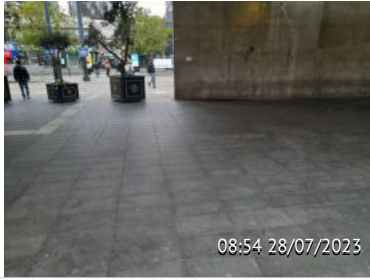
### Item 77

Assigned To Pavilion Terrace under roof area  
General Condition: Fair

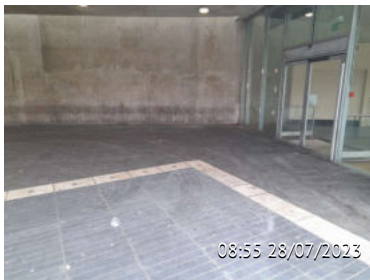
### Item 79

Assigned To Pavilion Terrace under roof area  
General Condition: Fair

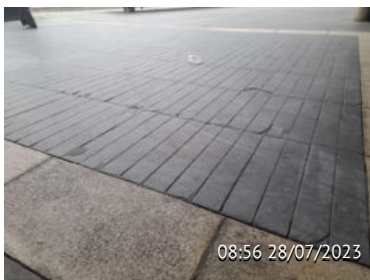
### Item 80

Assigned To Pavilion Terrace under roof area  
Paving tile bedding / joint material failure causing movement resulting in cracks, spalls and edge damage.

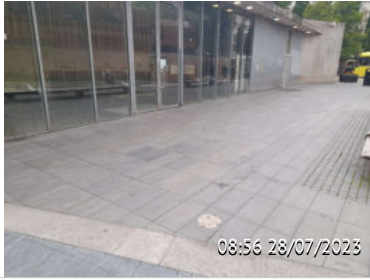
### Item 82

Assigned To Pavilion Terrace LHS  
General Condition: Fair

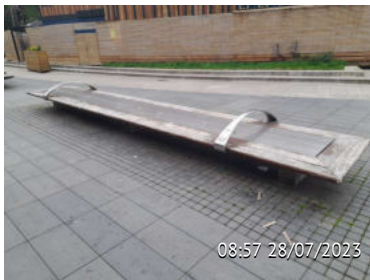
### Item 84

Assigned To Pavilion Terrace LHS  
Bench Seating Condition: Poor

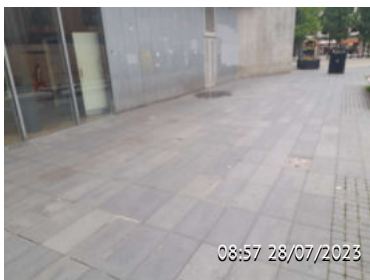
### Item 85

Assigned To Pavilion Terrace LHS  
General Condition: Fair.  
Historic street furniture removals and repairs.  
Movement causing cracking, spalling, and edge damage.

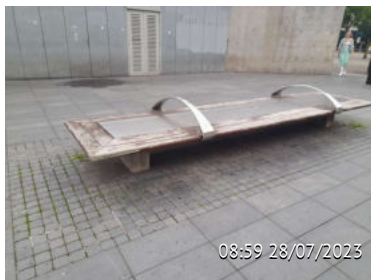
### Item 89

Assigned To Pavilion Terrace LHS  
Bench Seating General Condition: Poor

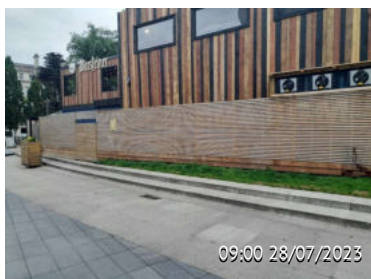
### Item 90

Assigned To Walkway towards Mosley St at rear of event space  
General condition of paving: Fair  
General condition of event space wall: Good

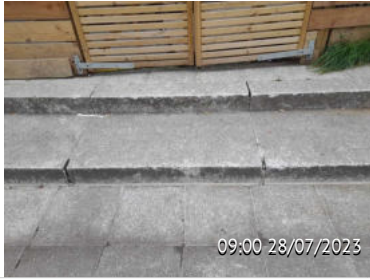
### Item 92

Assigned To Walkway to Mosley St

Damage to steps at access point into event space service area.

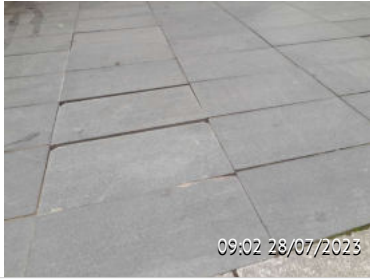
### Item 96

Assigned To Walkway to Mosley St

Bedding / joint material failure causing movement resulting in cracks, spalls, lipping and edge damage.

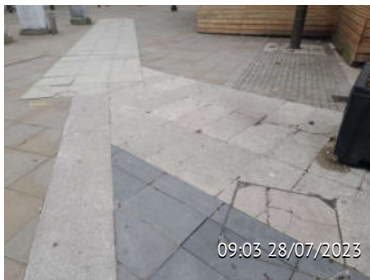
### Item 98

Assigned To Walkway to Mosley St

Paving flags / tiles to area behind planter in poor state of repair.

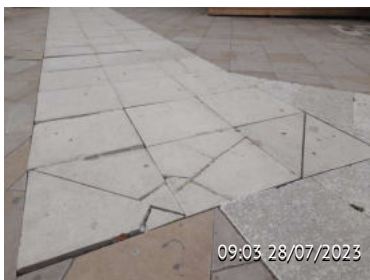
### Item 99

Assigned To Area of paving infill to feature wall removed.

General condition of PCC paving flags very poor with severe damage, cracks and excessive lipping.

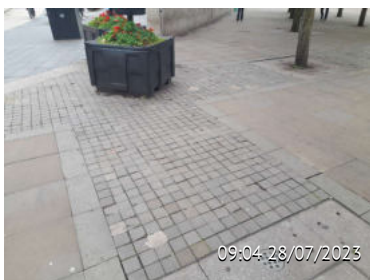
### Item 100

Assigned To Mosley St / Parker St tramway corner

Feature Cobble Set Paving: Poor condition.

Bedding / jointing material failure causing movement and settlement. Several missing cobble sets have been replaced using a patch repair system.

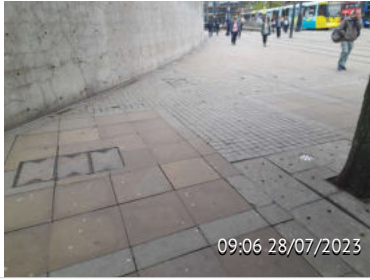
### Item 106

Assigned To Pedestrian Zone alongside Parker St tramway

General Condition: Poor

Feature Cobble Set areas are suffering from bedding / jointing material failure causing movement, edge damaged and missing cobble sets..

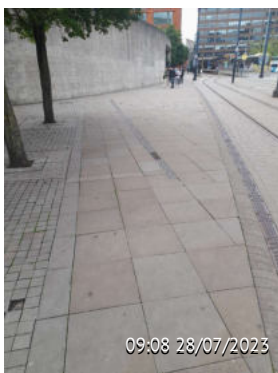
### Item 109

Assigned To Pedestrian Zone alongside Parker St tramway

Paving General Condition: Fair

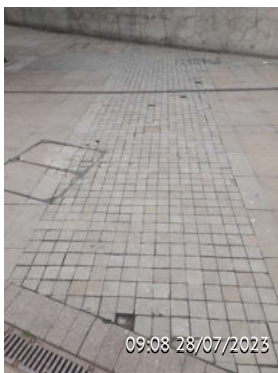
### Item 110

Assigned To Pedestrian Zone alongside Parker St tramway

Feature Cobble Set areas are suffering from bedding / jointing material failure causing movement, edge damaged and missing cobble sets.

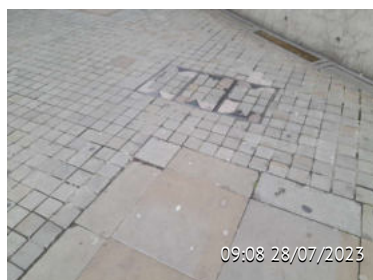
### Item 111

Assigned To Pedestrian Zone alongside Parker St tramway

Feature Cobble Set areas are suffering from bedding / jointing material failure causing movement, edge damaged and missing cobble sets.  
Settlement to feature band causing excessive lipping.

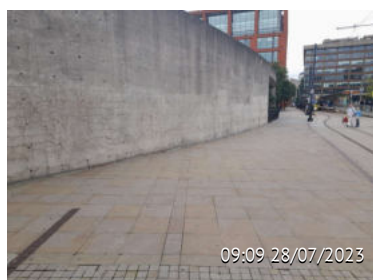
### Item 112

Assigned To Pedestrian Zone alongside Parker St tramway

Paving General Condition: Fair

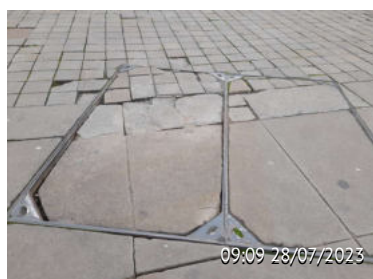
### Item 113

Assigned To Pedestrian Zone alongside Parker St tramway

Paving to Access Chamber lids and perimeter in a poor state of repair.

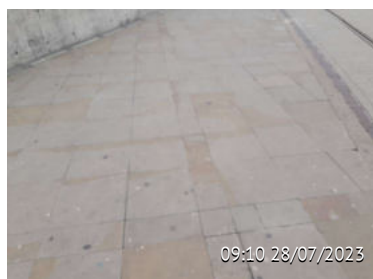
### Item 114

Assigned To Pedestrian Zone alongside Parker St tramway

Paving General Condition: Fair

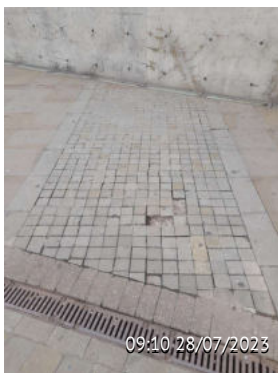
### Item 115

Assigned To Pedestrian Zone alongside Parker St tramway

Feature Cobble Set areas are suffering from bedding / jointing material failure causing movement, edge damaged and missing cobble sets.

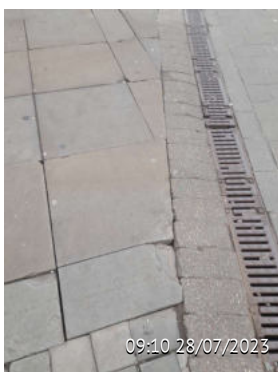
### Item 116

Assigned To Pedestrian Zone alongside Parker St tramway

Tramway kerb edge, paving spalled with severe edge damage.

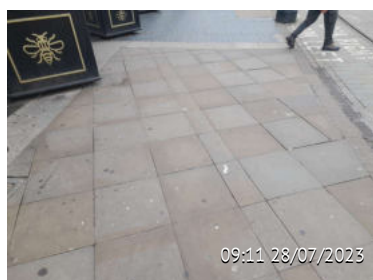
### Item 117

Assigned To Pavilion Access / Egress to Tram Station

Paving General Condition: Fair

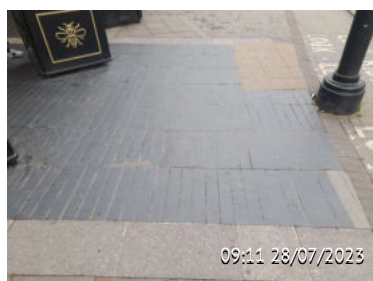
### Item 118

Assigned To Pavilion Access / Egress to Tram Station

Feature Paving Tile Condition: Poor

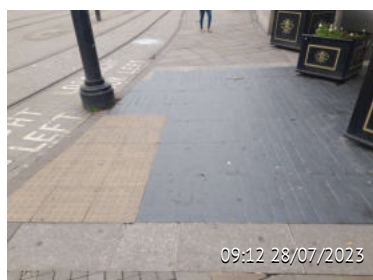
### Item 119

Assigned To Pavilion Access / Egress to Tram Station

Feature Paving Tile Condition: Poor

Tactile Paving Condition: Fair

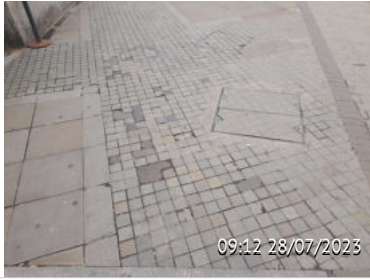
### Item 120

Assigned To Pavilion Access / Egress to Tram Station

Feature Cobble Set areas are suffering from bedding / jointing material failure causing movement, edge damaged and missing cobble sets.

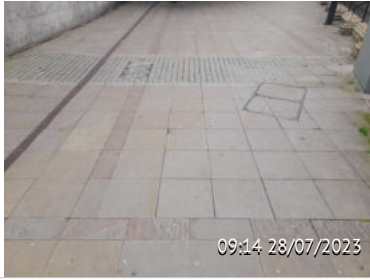
### Item 125

Assigned To Movement causing lipping, spalling and edge damage.

Paving General Condition: Fair

Feature band showing signs of heavy weathering.

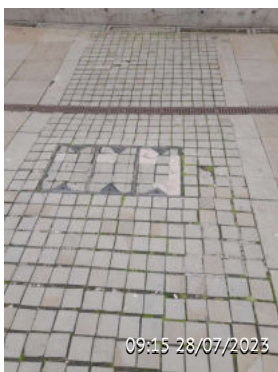
### Item 128

Assigned To Pedestrian Zone alongside Piccadilly Gdns tram station platform

Feature Cobble Set areas are suffering from bedding / jointing material failure causing movement, edge damaged and missing cobble sets.

Multiple missing cobble sets from Access Chamber covers have been replaced with patch repair system.

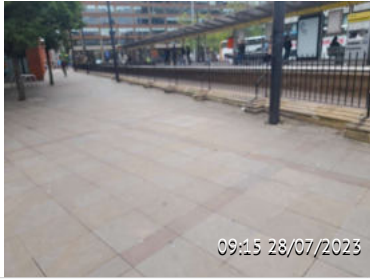
### Item 129

Assigned To Pedestrian Zone alongside Piccadilly Gdns tram station platform  
Paving General Condition: Fair

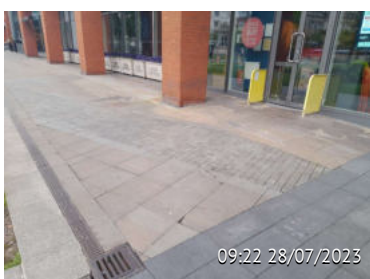
### Item 143

Assigned To Piccadilly Gardens restaurant terrace  
General Condition: Fair

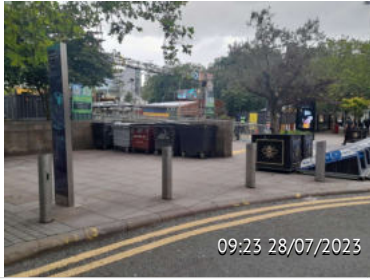
### Item 144

Assigned To Piccadilly

General Condition of paving, kerbs and street furniture: Fair

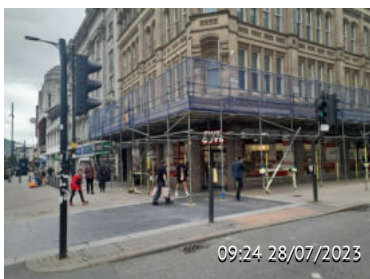
### Item 147

Assigned To Oldham St / Piccadilly junction

General Condition of paving, kerbs and street furniture: Fair

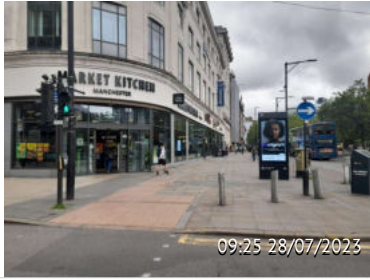
### Item 149

Assigned To Piccadilly

General Condition of paving, kerbs and street furniture: Fair

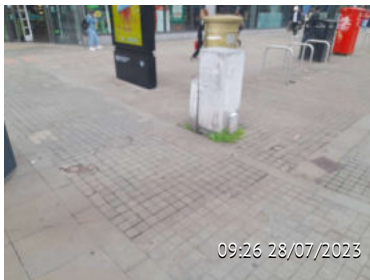
### Item 151

Assigned To Piccadilly

General condition of Cobble Sets: poor

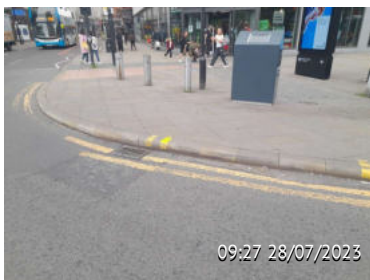
### Item 152

Assigned To Piccadilly

General Condition of paving, kerbs and street furniture: Fair

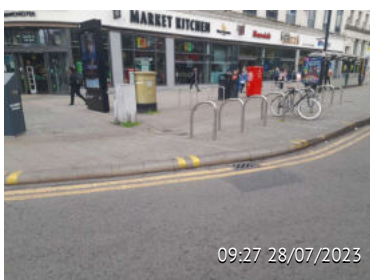
### Item 153

Assigned To Piccadilly

General Condition of paving, kerbs and street furniture: Fair

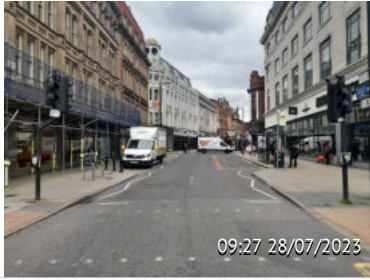
### Item 154

Assigned To Oldham St

General Condition of paving, kerbs and street furniture: Fair
