**St Margarets Chambers**  
For Charlotte Street Estates

Lightwell Elevations - Proposed Repairs and Conditions 2/2

scheme 1907  
drwg no. **P(237)**  
revision

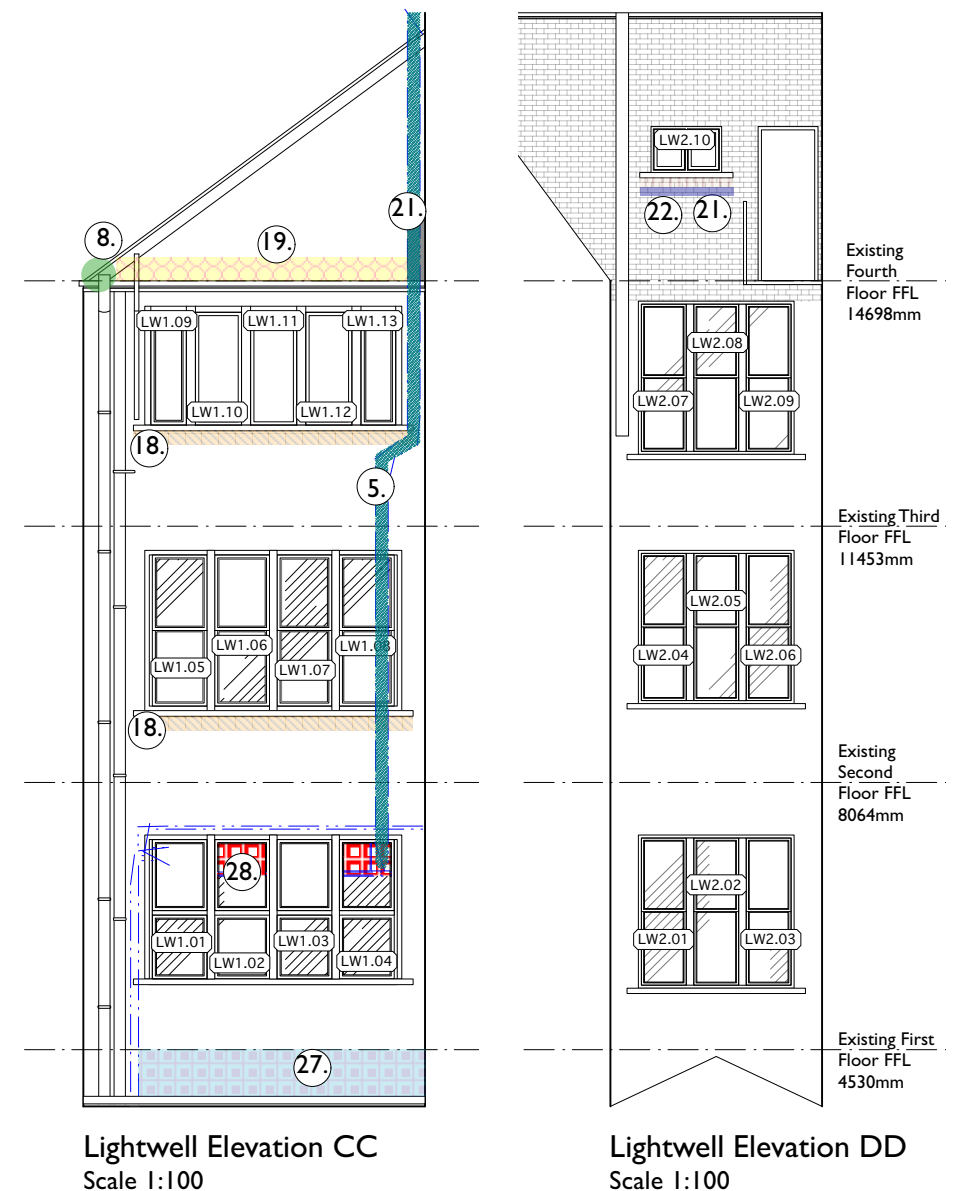
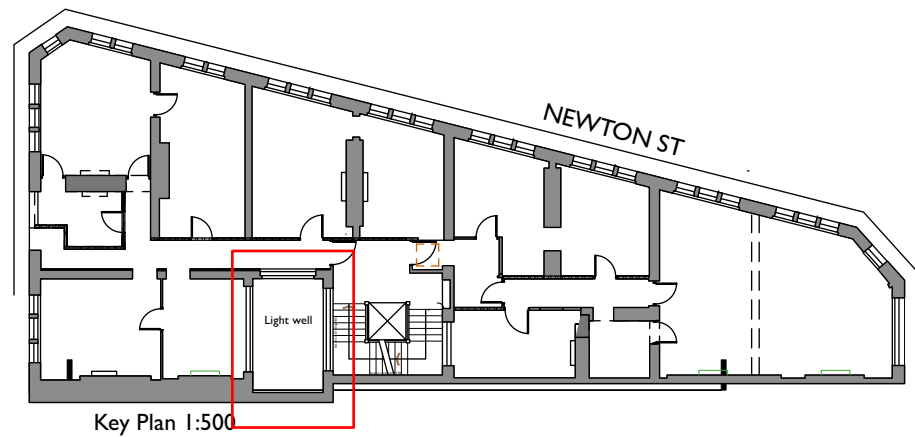
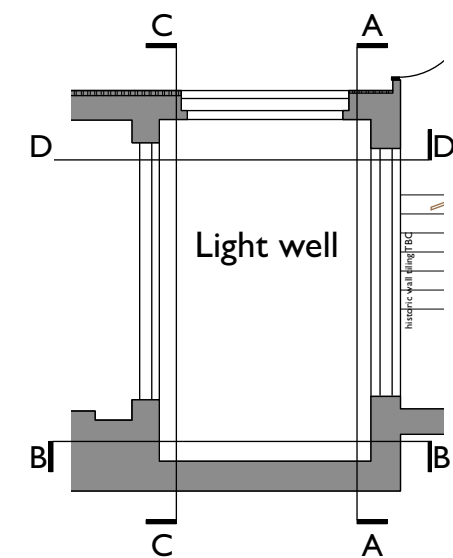
- 1 Sandstone erosion - close inspection required.
- 2 Holes left by redundant fixings - mortar fill in accordance with specification.
- 3 Gaps in brickwork. Close inspection required to inform replacement with matching material.

- 4 Missing pointing between frieze panels. Reinstall in accordance with specification.
- 5 Redundant plant equipment carefully remove and make good fabric in accordance with specification.

- 6 Eroded sandstone coping. Close inspection required. Replacement matching stone inserts may be required to prevent further deterioration.
- 7 Rusting lintels Clean off and repaint in accordance with specification.

- 8 Biological growth to be removed from roof level.
- 9 Coping water staining. May require repointing. Close inspection required.
- 10 Previous repairs to sandstone. Poorly matched aesthetic and presumed composition, but no evidence repairs are causing damage to surrounding historic fabric. Add to building maintenance plan for regular monitoring.

- 11 Biological growth to stone to be cleaned in accordance with specification.
- 12 Water staining may be caused by missing pointing. Close inspection required to inform repair strategy.

- 13 Signs of cracking. Further inspection required on site.
- 14 Redundant cables/lights/alarm box. Carefully remove
- 15 Residue from former sign to be cleaned off sandstone. Method pending site trials.

- 16 Existing timber to be carefully removed from brickwork

- 17 Clean off atmospheric dirt from glazed tiles
- 18 Redecorate cill
- 19 Clean-out gutters
- 20 Missing slate to be investigated once high level access provided
- 21 Repair and redecorate timber window frame and rotten cill
- 22 Clean concrete cill
- 23 Reinstall missing pointing
- 24 Inspect felt roof
- 25 Loose board and flashing to be repaired
- 26 inspect stone cill. Possible damage causing biological growth and staining to wall
- 27 Paint flanking and signs of damp further inspection required
- 28 Reinstall original sash configuration

Allow for the renewal of gutters and rainwater outlet to roof

Flashings to be renewed as required
