# Tree Health Report

**Client:** Robert Jackson, 9 Orchard Street, West Didsbury, Manchester, M20 2LP

**Date of visit:** 5/9/2023

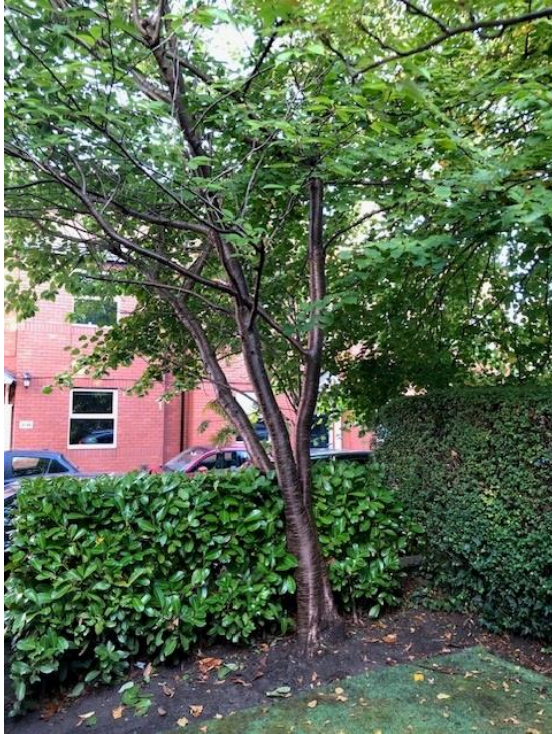
Figure 1: T1 Prunus Avium, view from front garden facing northeast.

| Tree ID | Tree Species | Height | Spread | Age Class | Observations | Condition | Work Priority | Inspection Frequency |
|---|---|---|---|---|---|---|---|---|
| T1 | Wild Cherry ( <i>Prunus Avium</i> ) | 6m | 9m | Young | The tree has been planted very close to the property's front boundary wall, it is leaning heavily towards the wall/adjacent pavement and is overshadowed by two large, mature lime trees. There is a moderate amount of deadwood in the crown but no signs of major ill health. | Overall tree condition: Fair.<br><br>Roots: Fair, some exposed roots. Artificial grass covering a large area of the root plate.<br><br>Stem: Good, Trifurcation at 1m from ground level.<br><br>Crown: Fair, Moderate amount of deadwood within crown. Rubbing branches at 2.5m from ground level on south side.<br>Stumps left from previous poor pruning. | Medium | 2 years |

- 6.3. The client's Cherry tree is situated on the northeastern boundary of the property adjacent to the perimeter wall and public pavement the other side, it is also leaning heavily in this direction due to overshadowing and phototropism.

- 7.1 Considering the unsuitable location of the tree and the damage it is causing to the client's property, it is recommended that the tree is removed and the stump ground out to prevent any regrowth and further damage to the wall.
- 7.2 It is also recommended that the artificial grass is removed and a small replacement (Japanese Maple) tree is replanted in a more suitable location where it will have the space needed to grow to maturity without impacting adjacent infrastructure i.e., in the centre of the lawn.
- 7.3 These recommendations should be carried out within the next 12 months by a suitably experience and qualified arboriculturalist.

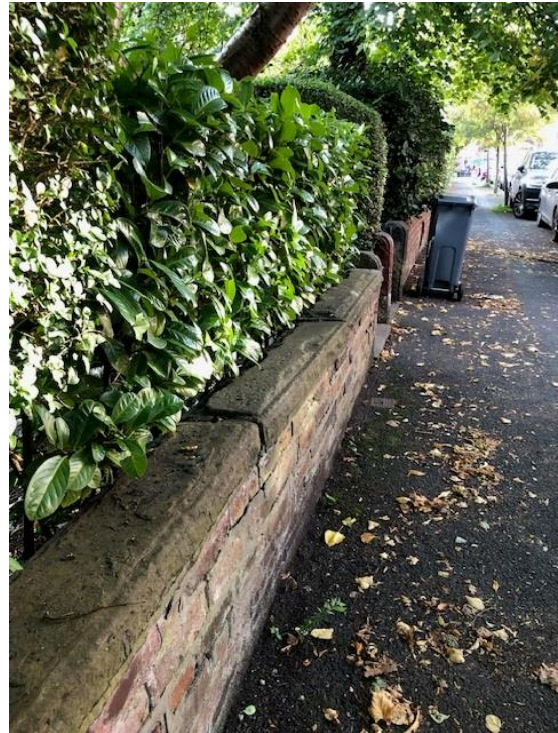
Figure 2: Damaged wall, view facing northwest.

- 6.4. The tree was planted in this location by a previous owner of the property probably unaware of the damage it could cause to the adjacent wall.
- 6.5. The overall condition of the tree is fair showing only minor defects from previous poor pruning. It has one rubbing branch at approximately 2.5m from ground level on the south side of the tree. It is heavily leaning in a northerly direction towards the wall/pavement and is obviously causing damage to the wall. Most of the root plate is covered by artificial grass and the tree is being overshadowed/suppressed by the two large lime trees either side.

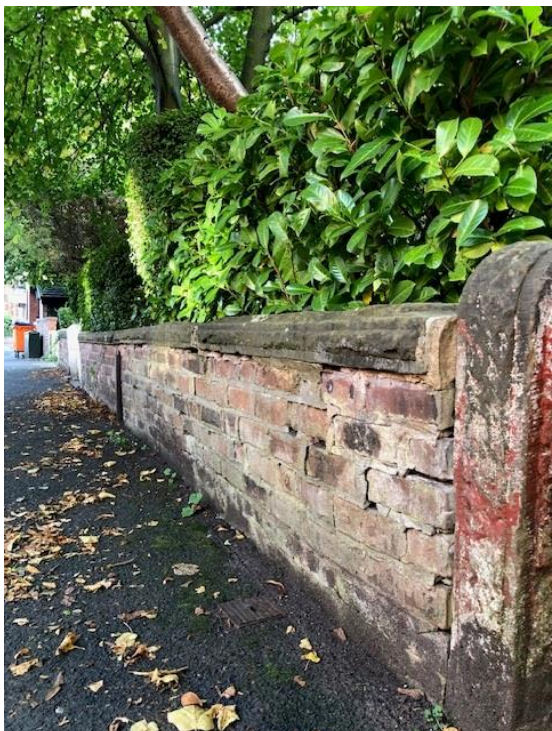
Figure 3: Damaged wall, view facing southeast.

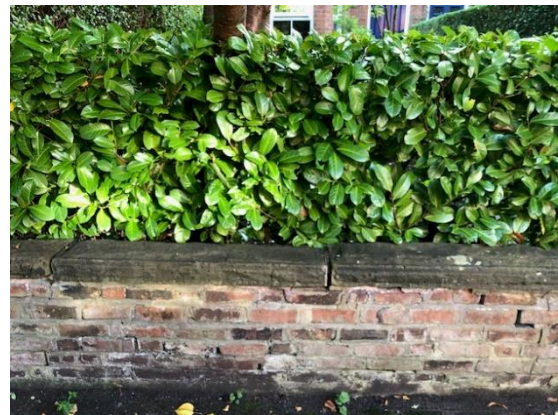
Figure 4: Damaged wall, view facing southwest towards T1 and property.
