**Project:** 23\_5837\_06\_45  
**Site:** 4 Middleton Road, Crumpsall, Manchester, M8 5DS  
**Client:** Shalshelles College

| Document Title: | Tree Survey & Tree Constraints Plan |
| Project Title: | 4 Middleton Road, Crumpsall, Manchester, M8 5DS |

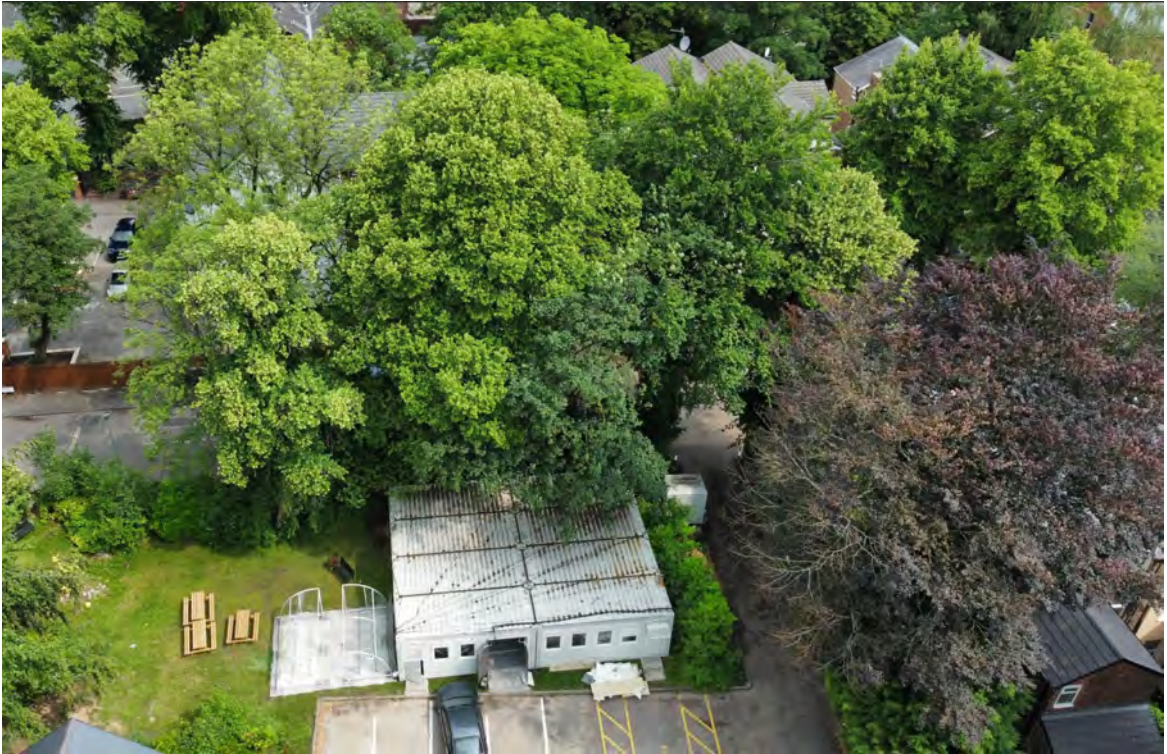
*Aerial image plate showing trees T7 to T19 located directly behind the recently implemented modular classrooms.*

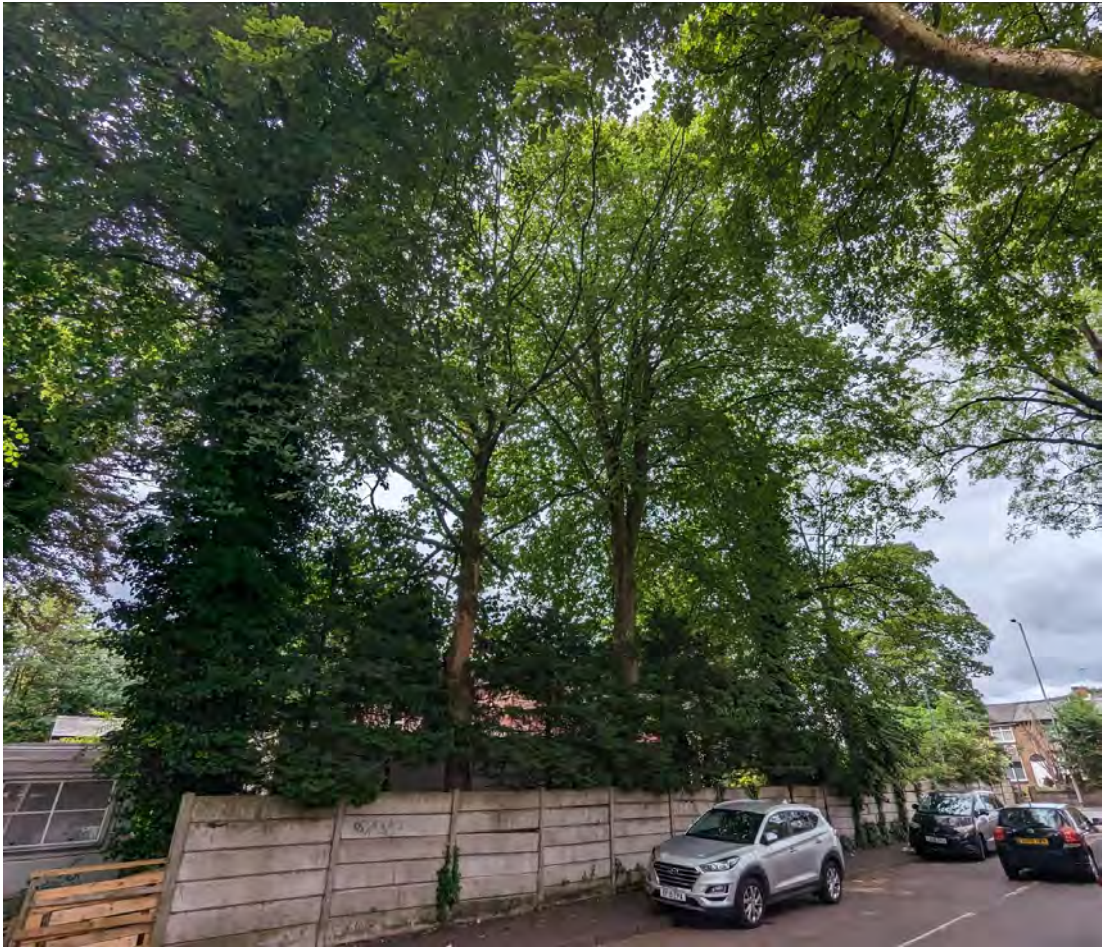
*Photographic plate showing T7 to T19 from outside the plot from the north.*

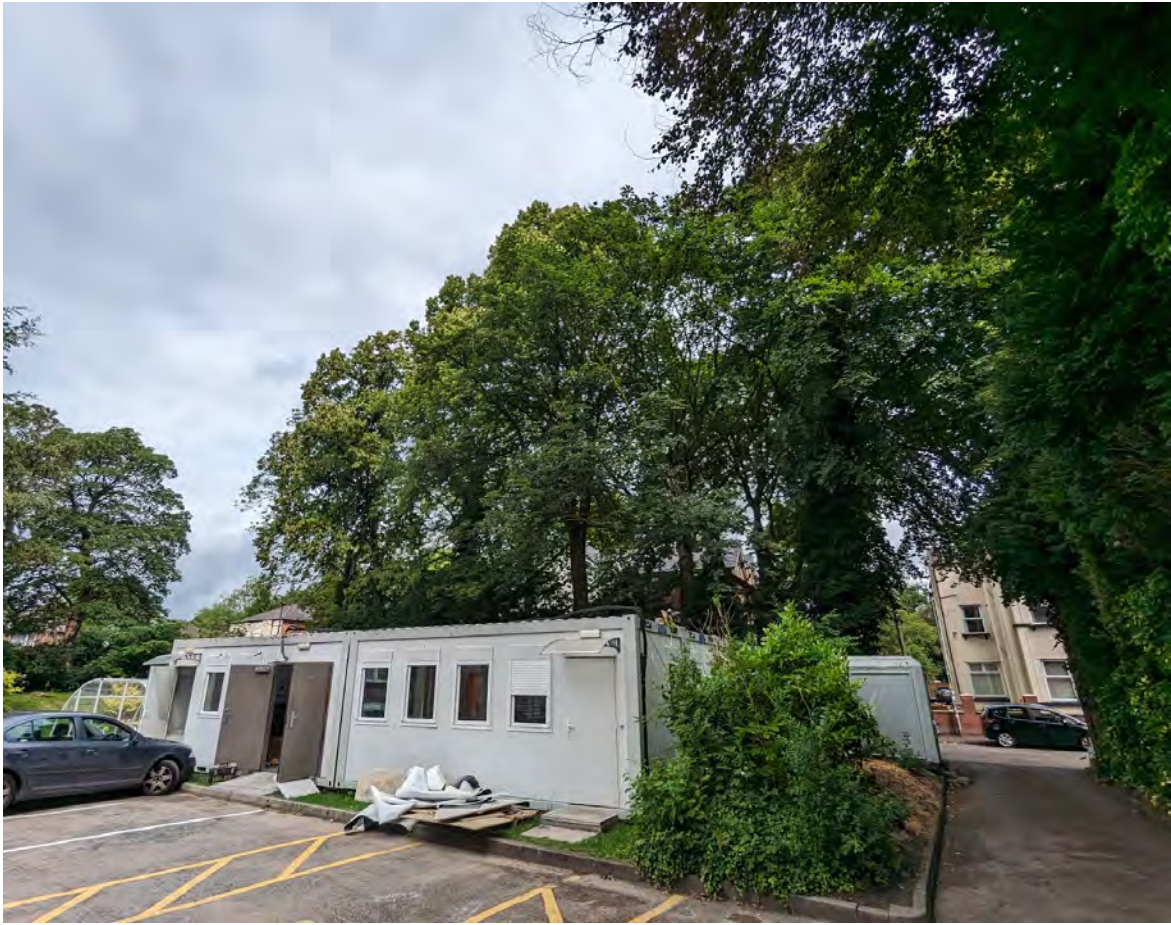
*Photographic plate showing T7 to T19 located directly behind the recently implemented modular classrooms.*

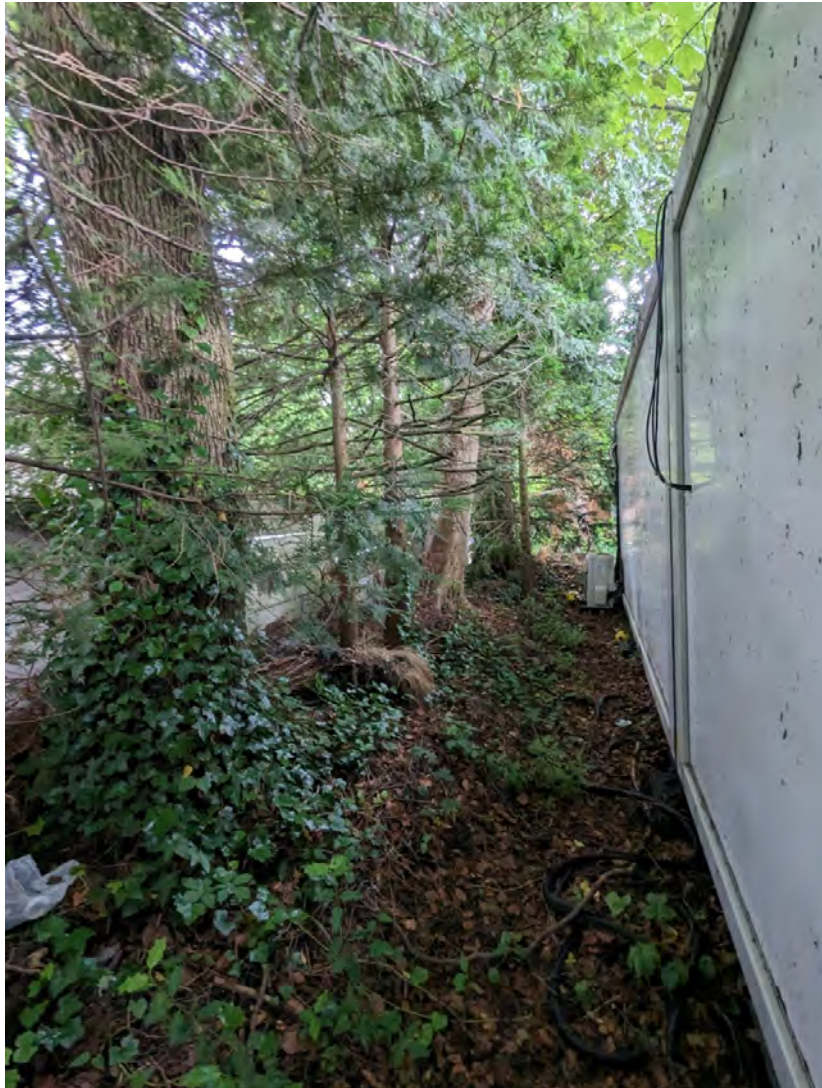
*Photographic plate showing the close proximity between the recently implemented modular classrooms and T7 to T19.*

- 3.3 Trees T8 to T27 have been subject to radial root protection area encroachment from the recently implemented modular classrooms. However, the modular classrooms have been implemented using a Jackpad system utilising Jackpad 400 support blocks. These blocks support the vertical load and disperse it through its base. Considering the modular classrooms have been implemented using a jackpad system, with no changes in ground level within any root protection areas. It is highly unlikely that the modular classrooms have caused any damage to the RPA's of T8 to T27. Furthermore, the jackpad system means that the modular classrooms sit above ground level which allows air and water to still flow through to the root systems of T8 to T27.

- 3.5 No damage or loss of vitality on T8 to T27 was observed during the survey however the trees should be monitored for a period of no less than three years.
- 3.6 Considering that the modular classrooms have been constructed using a jackpad system which has raised the modular classrooms above ground level the overall effect on T8 to T27 is considered to be low. Recommendations for the future management of T8 to T27 can be found in section 4 below.

- 4.2 It is recommended to mitigate the rain shadow effect caused by the modular classrooms by redirecting rainwater runoff underneath the modular classroom buildings so the areas of RPA located underneath are still receiving the correct levels of water.

- 4.3 Vertical mulching will create a higher quality rooting space for T8 to T27 whilst also alleviating some minor compaction that may have been caused by the implementation of the modular classrooms. Vertical mulching should be undertaken within the next 12 months in all the accessible areas around T8 to T27. If significant decline in T8 to T27 is observed before the end of the inspection period then vertical mulching in the area underneath the modular classrooms will be required.

- 4.4 It is recommended that T8 to T27 be monitored annually to ensure their safety in the urban environment and to ensure that no unseen damage has been caused by the implementation of the modular classrooms.

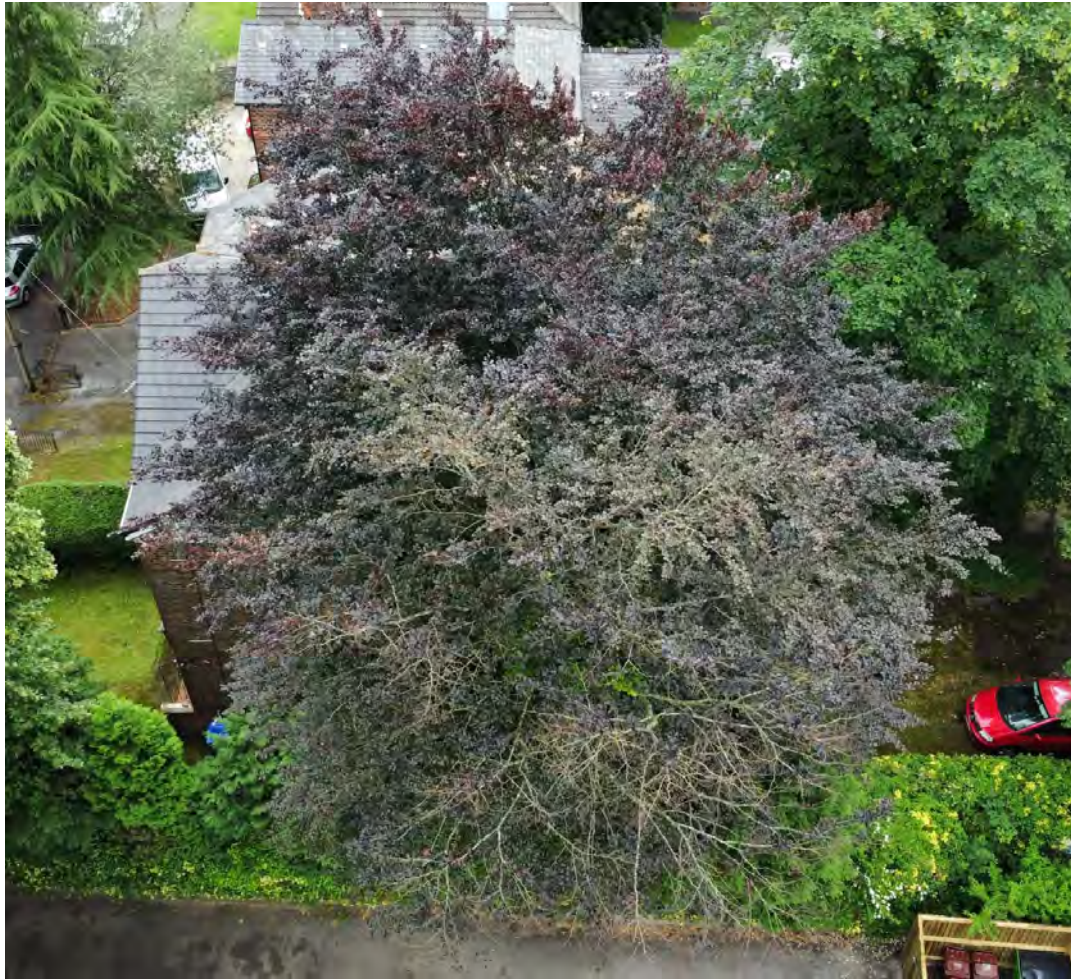
*Aerial image plate showing T25 with dieback present in the west side of the crown.*

| Tree Number | Species | Age Class | DBH | Height (crown height) | N | E | S | W | Condition | Life Expectancy | Physical Description | Comments | Managment Recommendations | RPA offset from stem. | Category Rating |
|---|---|---|---|---|---|---|---|---|---|---|---|---|---|---|---|
| T25 | <i>Fagus sylvatica</i> 'Purpurea' (Copper Beech) | M | 600 | 20(6) | 6 | 6 | 6 | 6 | Fair | 20+ | / | Ivy on tree. Unable to inspect stem due to Ivy. Boundary fence 0.5 metres to the north of basal area. Hardstanding access to site directly adjacent to the west of basal area. Dieback on the West side of the crown. | / | 7.2 | B1 |
