CLIENT:  
The Parish of Our Lady of Mount Carmel  
Blackley  
PROJECT:  
Our Lady of Mount Carmel, Blackley

DESCRIPTION:  
Repair Proposal - Lady Chapel Apsidal Roof

PURPOSE OF ISSUE:  
Planning  
DRAWN BY: CHECKED DATE: SCALE @ A1:  
JW AP 14.06.23 As indicated  
JOB NO: STATUS CODE: DRAWING NO: REV  
4200 S2 112  
FILE IDENTIFIER:  
MC-BTP-00-ZZ-DR-A-4200\_112

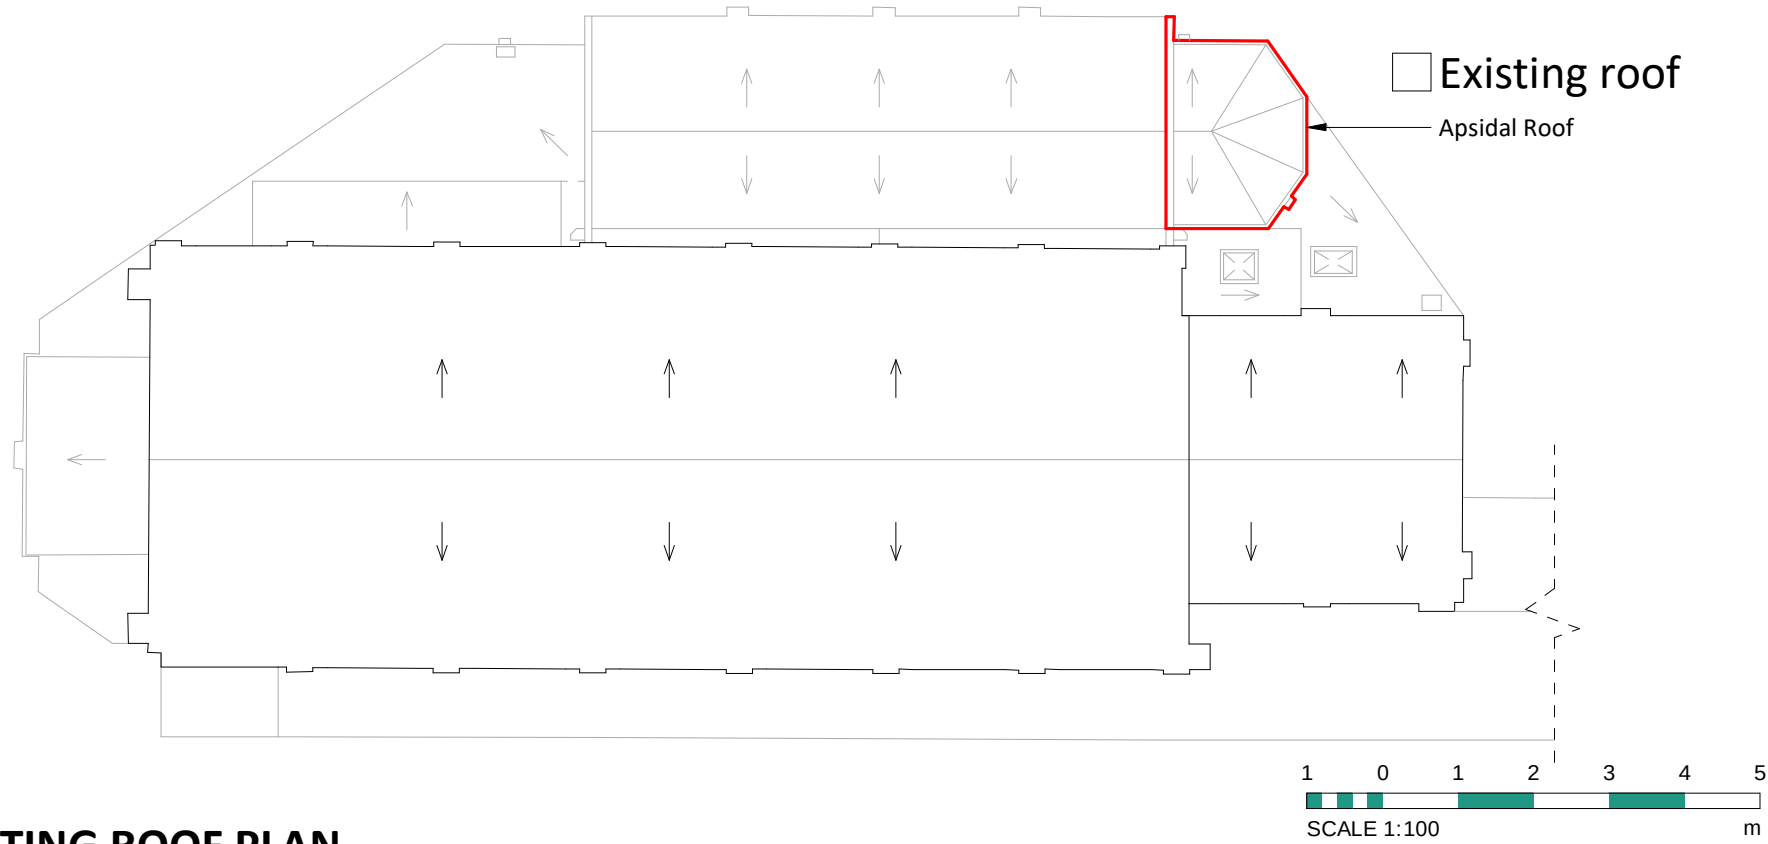
#### EXISTING ROOF PLAN

The existing copper sheet roof has been subject to lead theft which has resulted in the loss of one complete face of copper and damage to the two adjoining leaded facets. The 150mm copper box gutter detail on three of the five faces has been ripped off which has also caused consequential damage to the bottom edge drip detail. Of the five faces, it is likely that only two of the sheeted sections of roof could be retained and repaired and that the other three faces would need to be completely replaced with new copper sheet.

Given the long history of attack this section of the church has endured, and the relatively easy access available, it is highly likely that any new copper or high value roof sheeting will be subject to further attack/theft.

For the above reasons, the proposal is to renew the roof finish using Terne Coated Stainless Steel patinated to resemble lead sheet following completion.

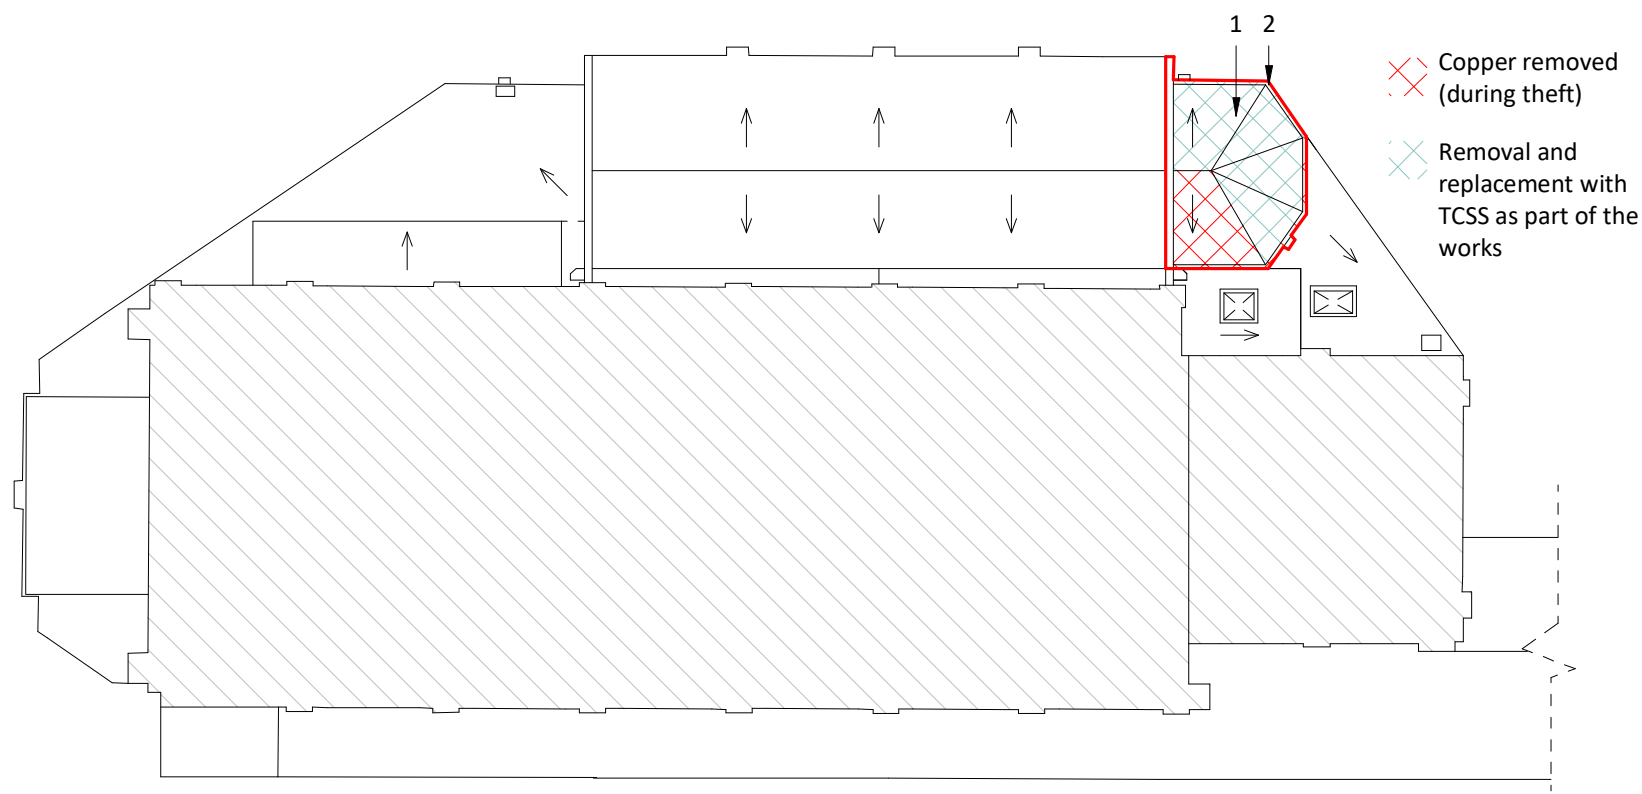
#### WORK AREAS (all compass references are based on liturgical directional notation i.e. Sanctuary at the east)

- 1. Copper Roof to Lady Chapel**  
Part of the copper roof covering was removed during a recent theft. Roof covering is to be replaced with TCSS (Terne coated stainless steel) roof coverings to minimise threat of future attack
- 2. Copper apaisal roof box gutter and spitter/outlet**  
Copper box gutter was partially removed during a recent theft. The box gutter is to be replaced with new TCSS box gutter to match original.

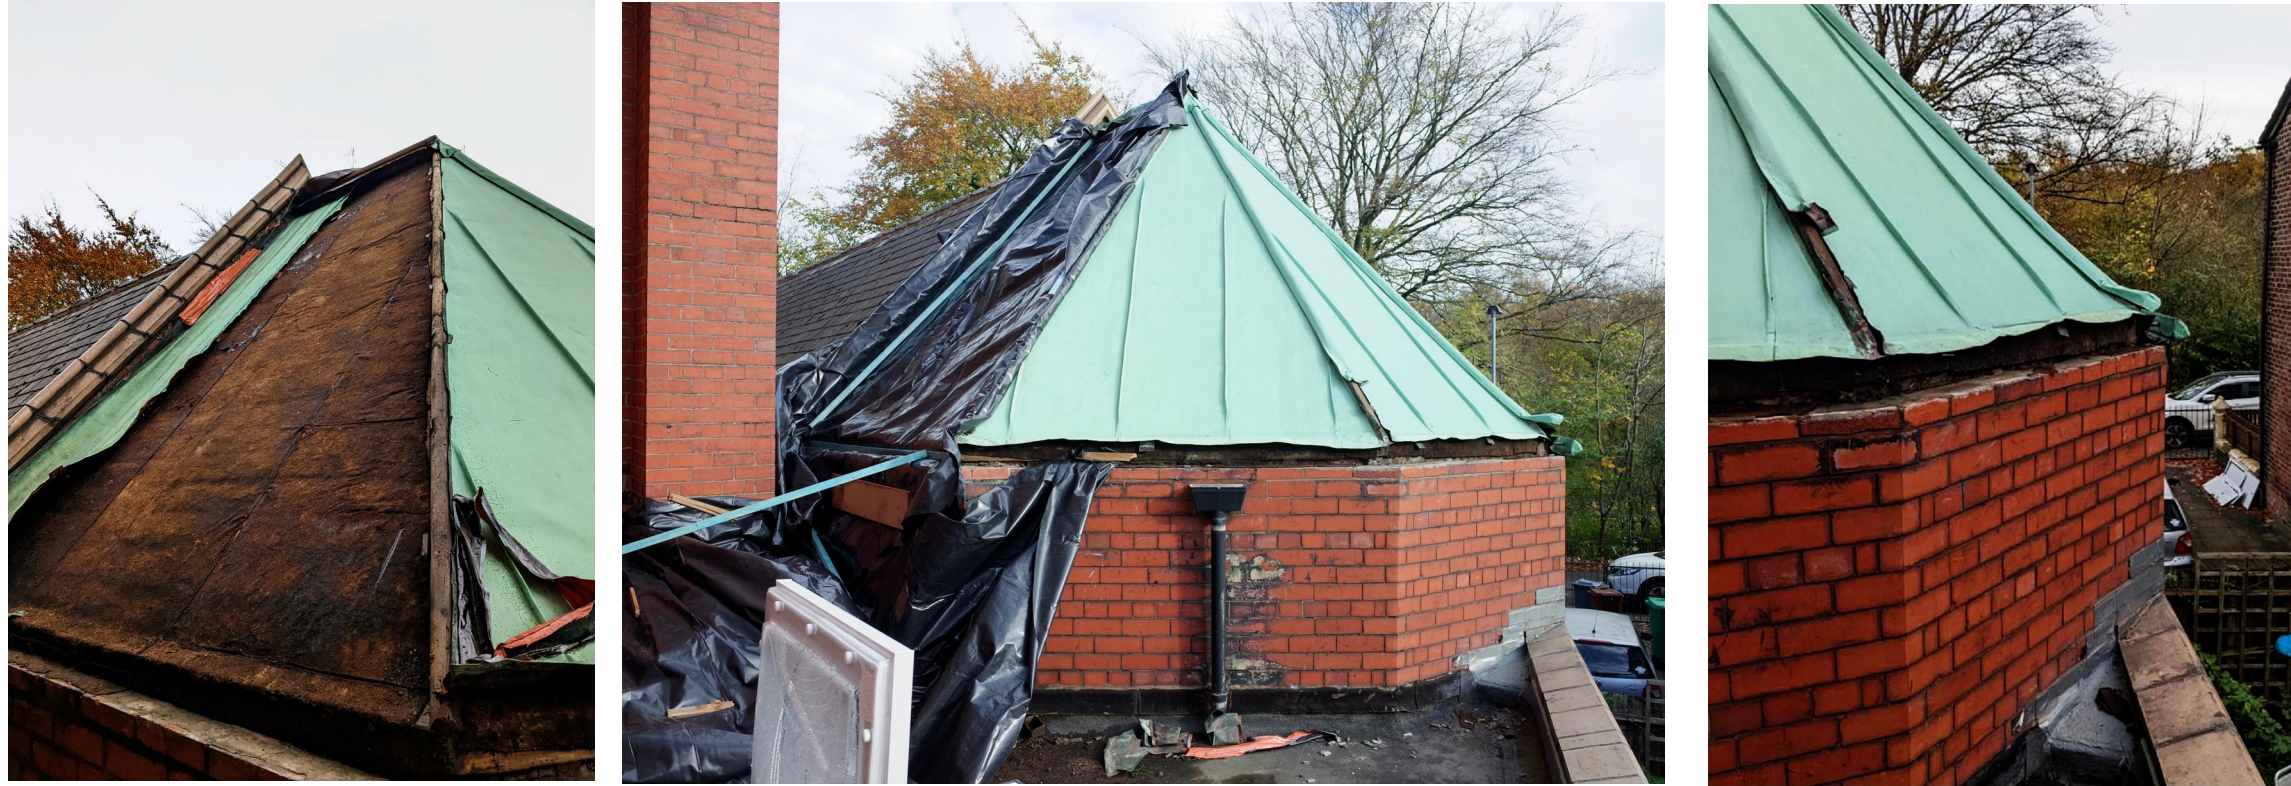
Condition following ongoing theft
