**St Margarets Chambers**  
For Charlotte Street Estates

Lightwell Elevations - Proposed Repairs and Conditions 2/2

scheme 1907  
drwg no. **P(237)**  
revision

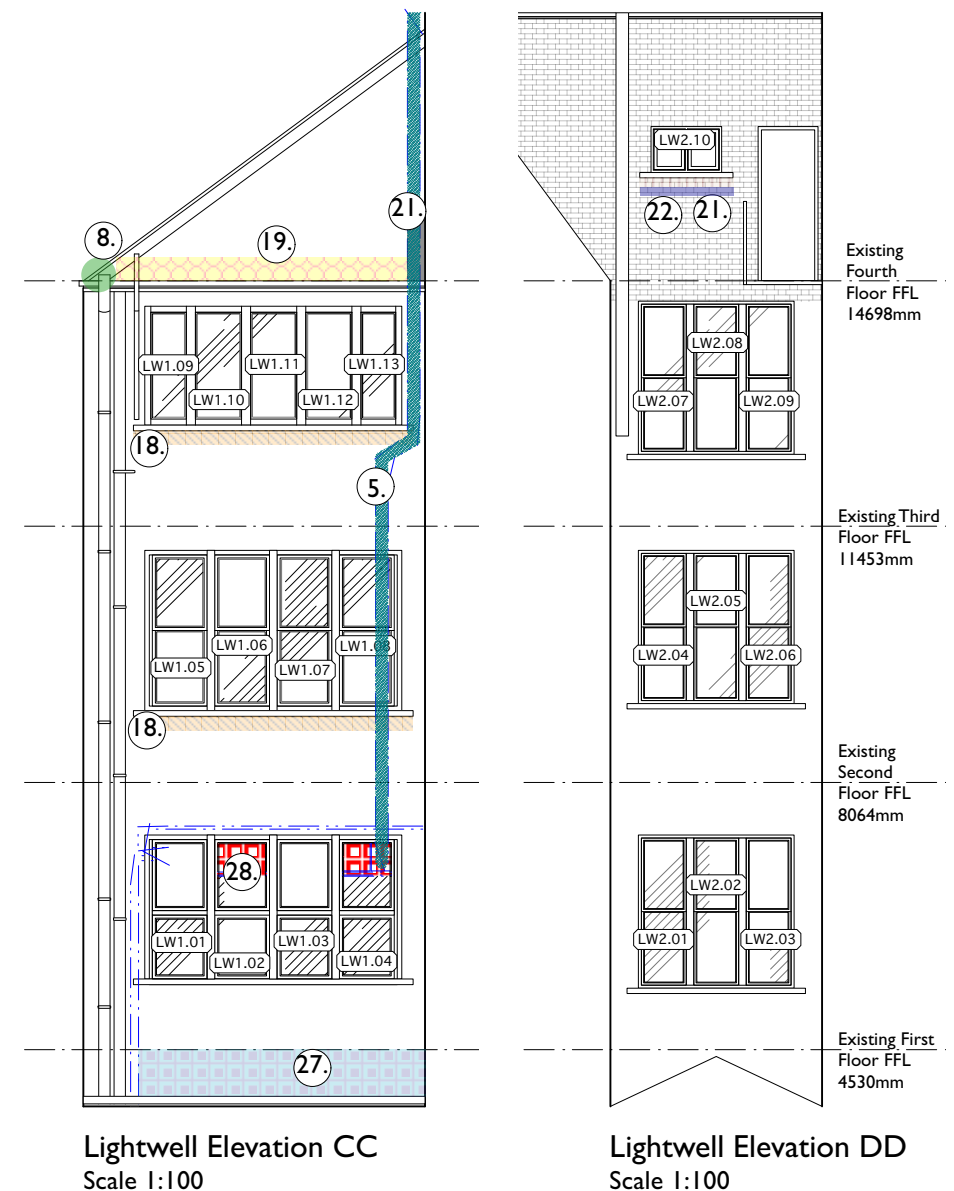
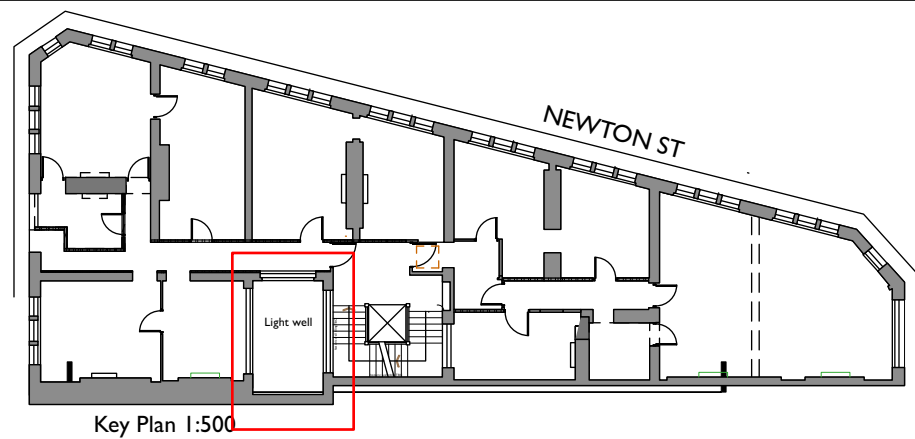
- 1 Sandstone erosion - close inspection required.
- 2 Holes left by redundant fixings - mortar fill in accordance with specification.
- 3 Gaps in brickwork. Close inspection required to inform replacement with matching material.

- 4 Missing pointing between frieze panels. Reinstall in accordance with specification.
- 5 Redundant plant equipment carefully remove and make good fabric in accordance with specification.

- 6 Eroded sandstone coping. Close inspection required. Replacement matching stone inserts may be required to prevent further deterioration.
- 7 Rusting lintels Clean off and repaint in accordance with specification.

- 8 Biological growth to be removed from roof level.
- 9 Coping water staining. May require repointing. Close inspection required.
- 10 Previous repairs to sandstone. Poorly matched aesthetic and presumed composition, but no evidence repairs are causing damage to surrounding historic fabric. Add to building maintenance plan for regular monitoring.

- 11 Biological growth to stone to be cleaned in accordance with specification.
- 12 Water staining may be caused by missing pointing. Close inspection required to inform repair strategy.

- 13 Signs of cracking. Further inspection required on site.
- 14 Redundant cables/lights/alarm box. Carefully remove
- 15 Residue from former sign to be cleaned off sandstone. Method pending site trials.

- 16 Existing timber to be carefully removed from brickwork

- 17 Clean off atmospheric dirt from glazed tiles
- 18 Redecorate cill
- 19 Clean-out gutters
- 20 Missing slate to be investigated once high level access provided
- 21 Repair and redecorate timber window frame and rotten cill
- 22 Clean concrete cill
- 23 Reinstall missing pointing
- 24 Inspect felt roof
- 25 Loose board and flashing to be repaired
- 26 inspect stone cill. Possible damage causing biological growth and staining to wall
- 27 Paint flanking and signs of damp further inspection required
- 28 Reinstall original sash configuration

Allow for the renewal of gutters and rainwater outlet to roof
