# Contaminated Land Phase One Desk Study for proposed residential development at 1133 Rochdale Road, Manchester, M9 7FW.

September 2022

Martin Environmental Solutions has been commissioned, to carry out a phase one contaminated land desk study report in relation to a proposed residential development at 1133 Rochdale Road, Blackley, Manchester, M9 7FW.

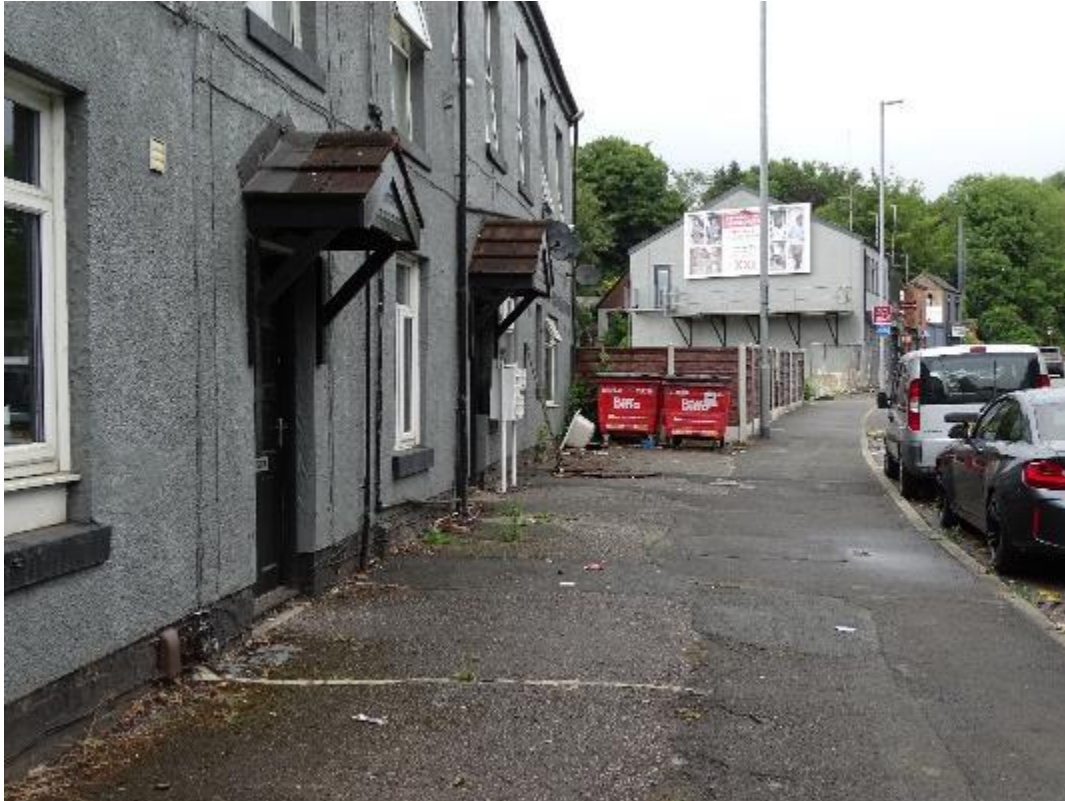
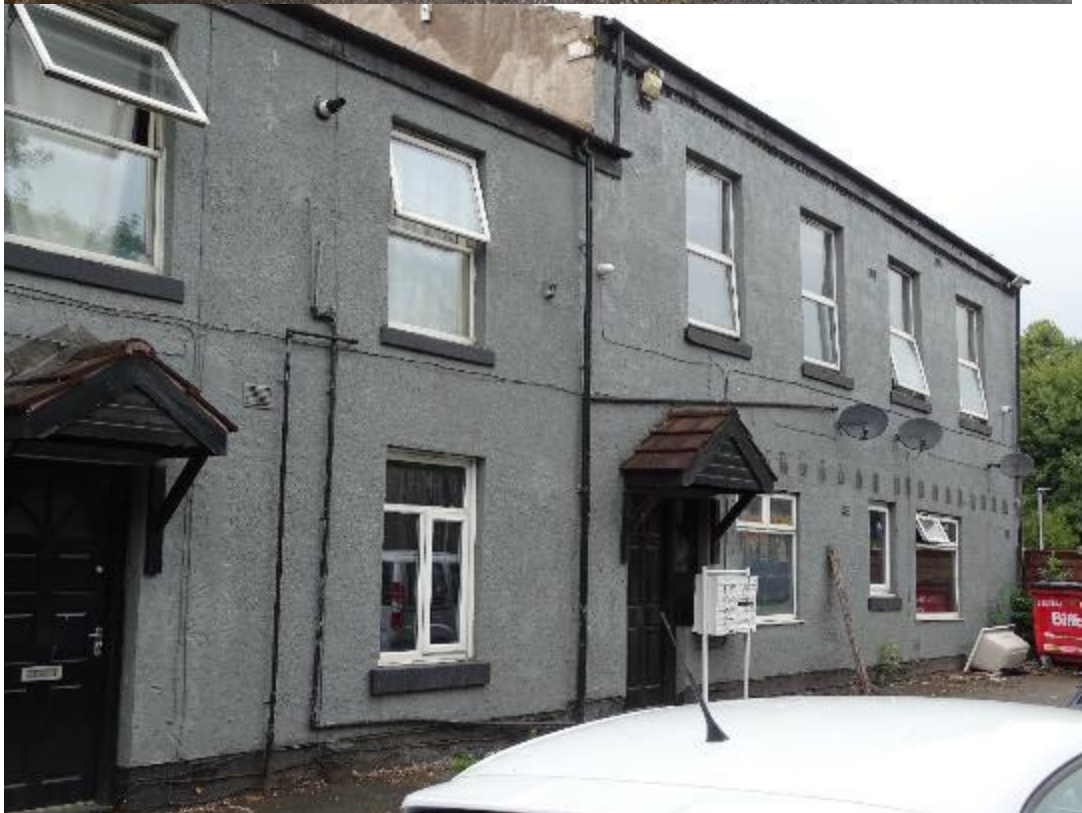
A view of the front (east) of the site onto Rochdale Road, looking north then south

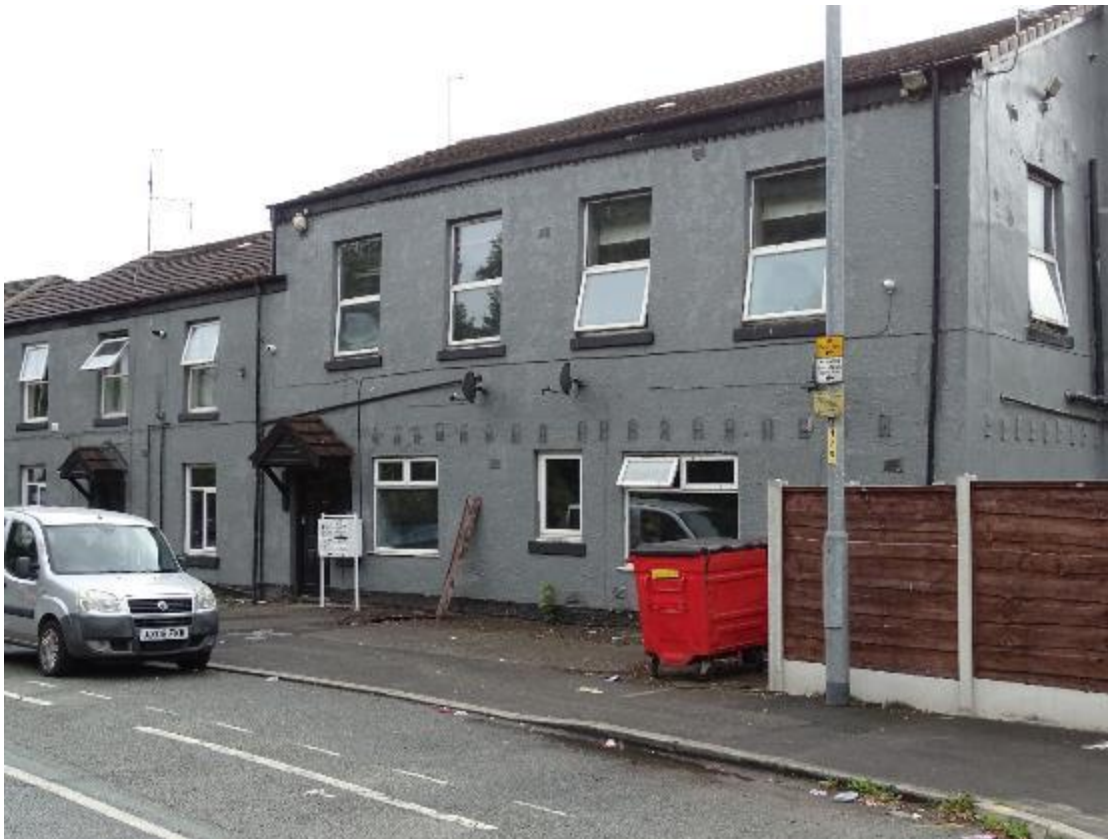
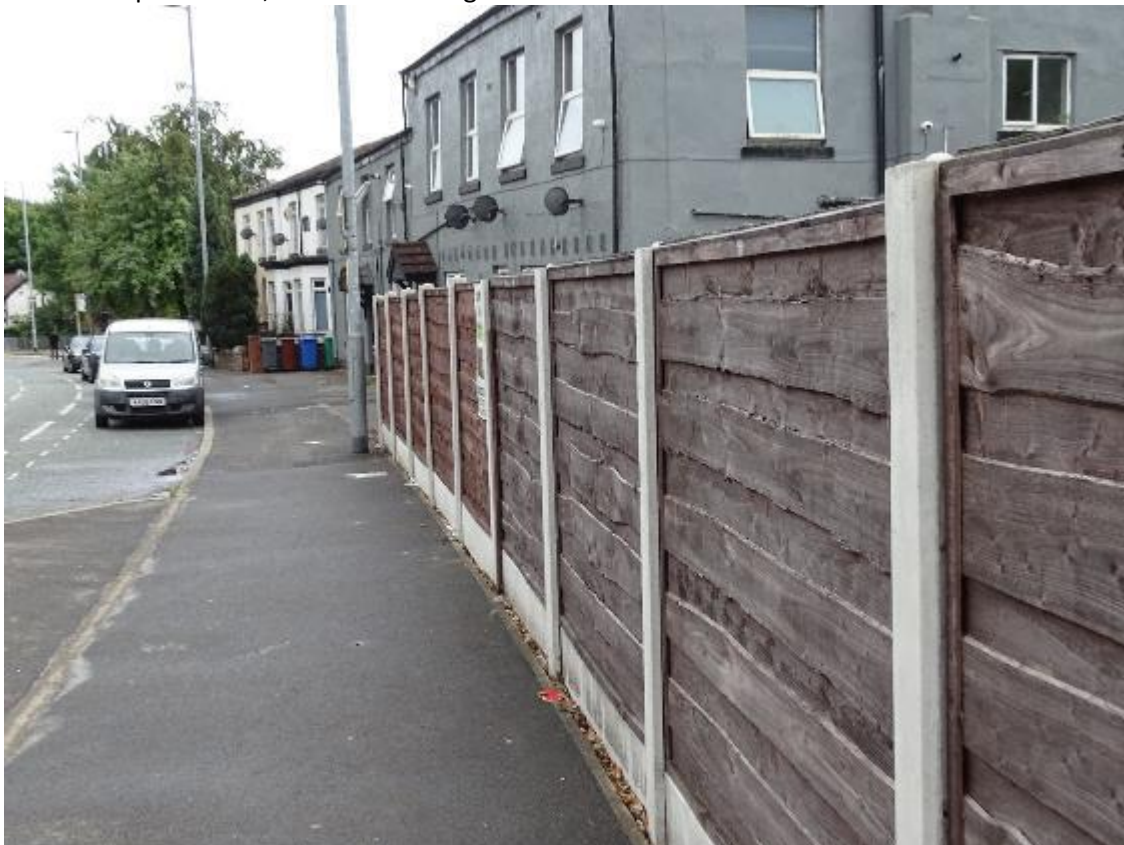
The development site, the front looking south

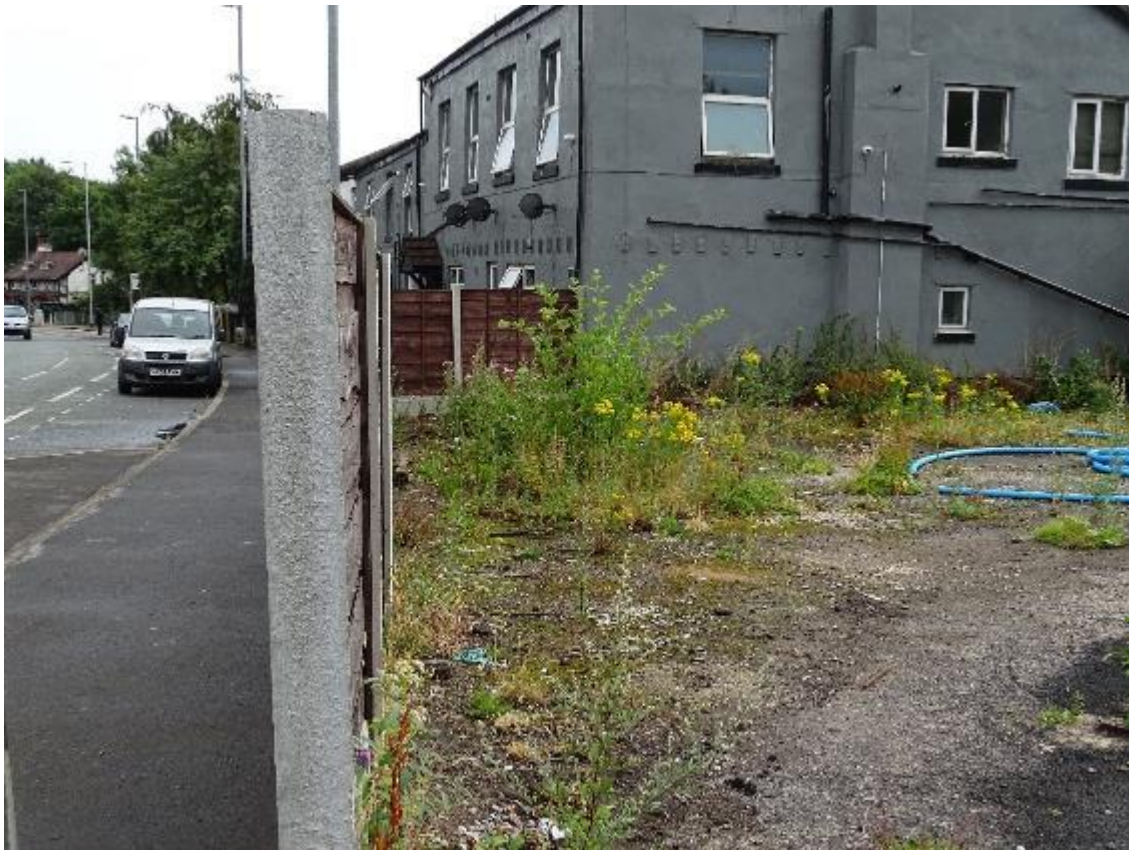
Looking west along the northern boundary

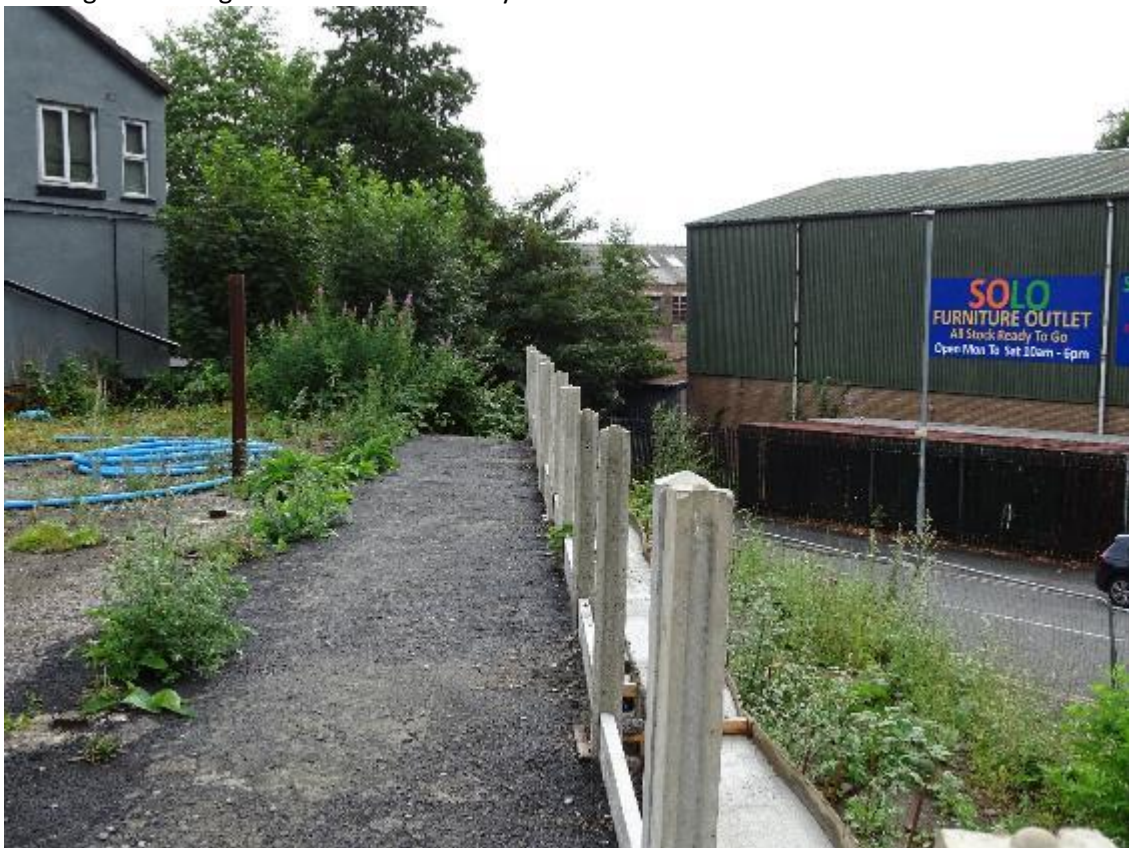
Looking east along the northern boundary

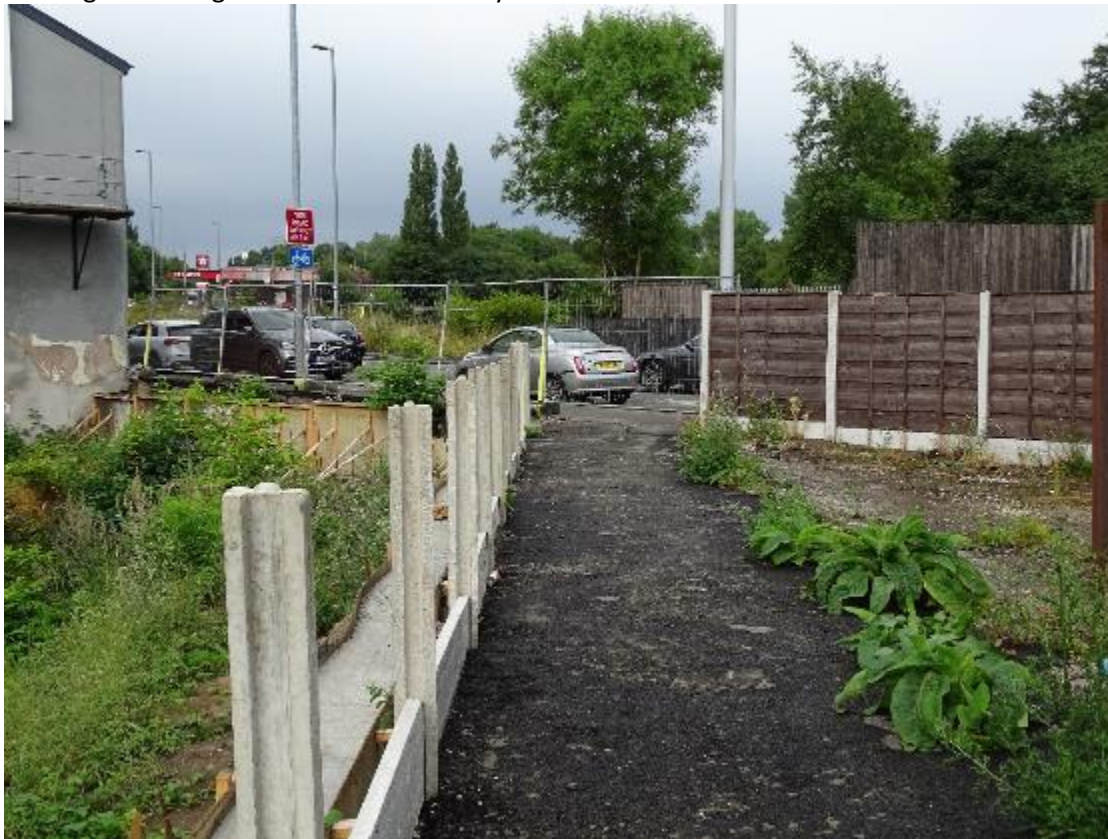
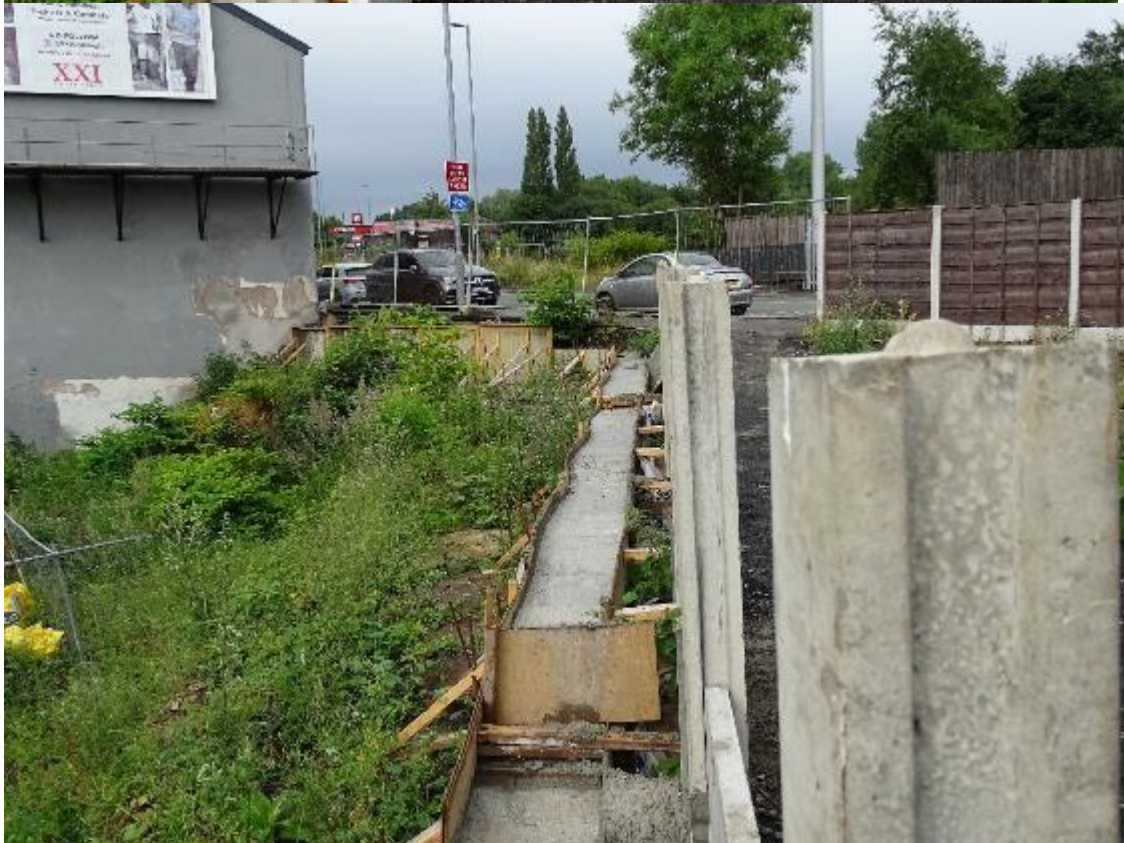
Looking across the site from rear to front south corner.

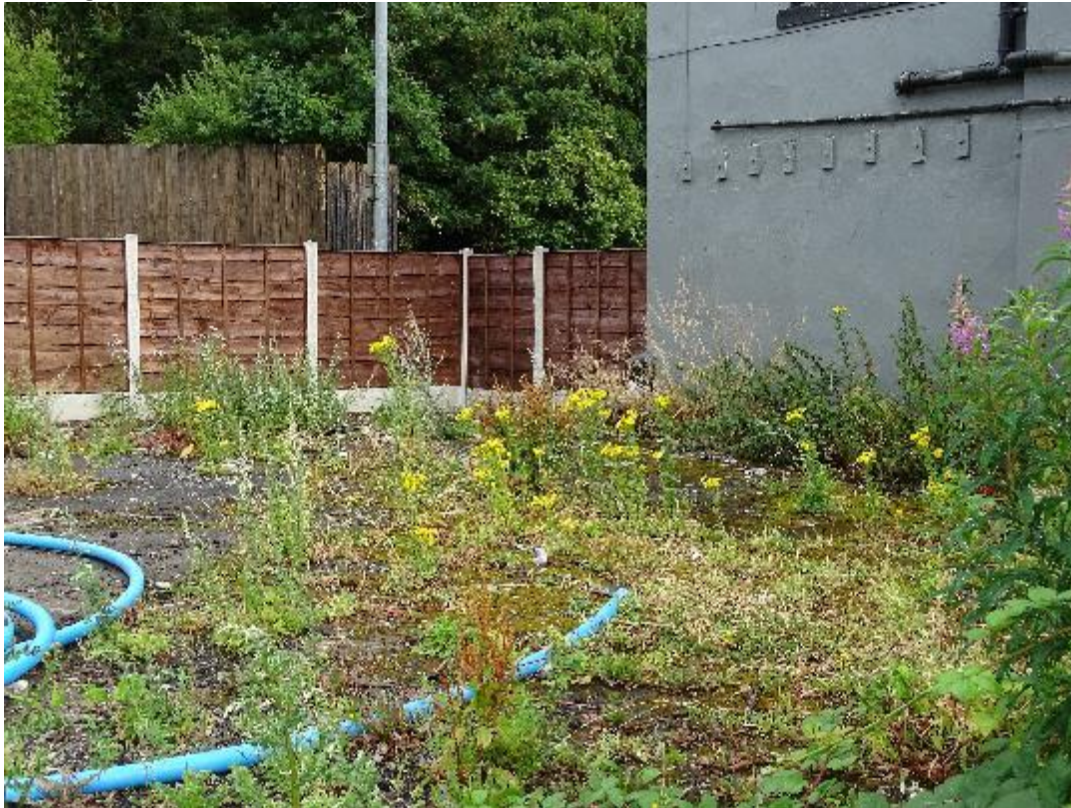
The rear of the site

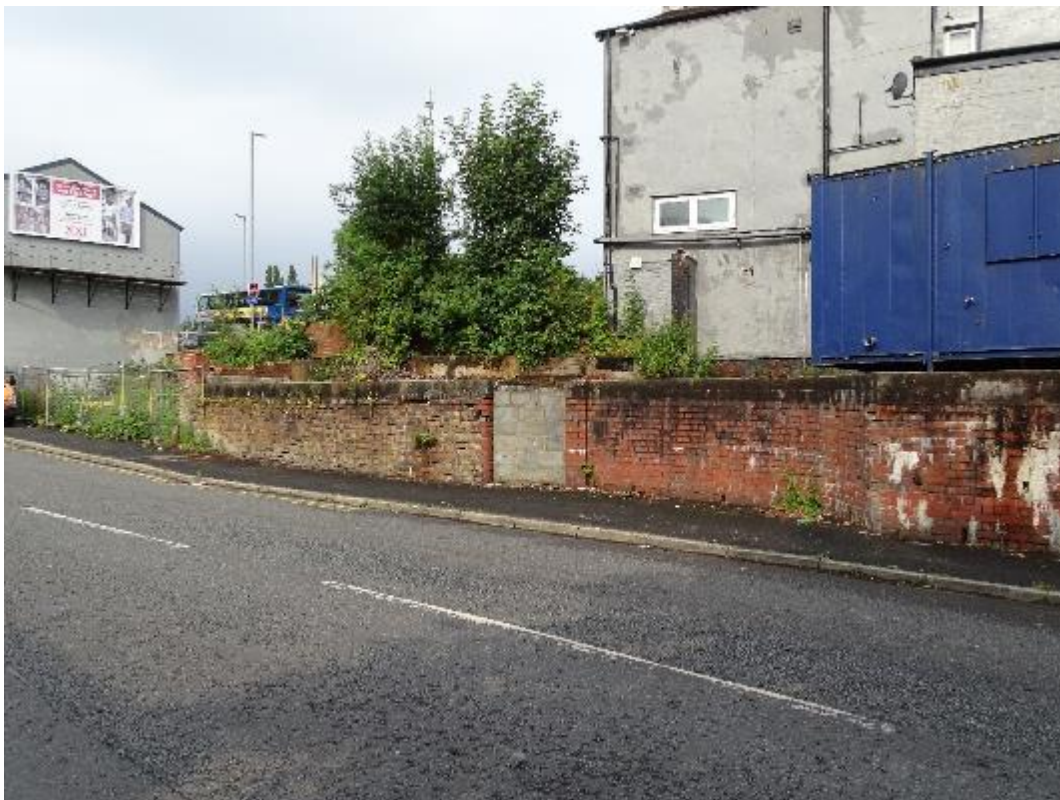
The adjacent site to the north, showing the retaining wall.
