# Asbestos Re-inspection Survey

**National Grid - Care of Mitie**

**Bradford Road  
Manchester  
Greater Manchester  
M40 7BW**

**Project Reference: P-401550**

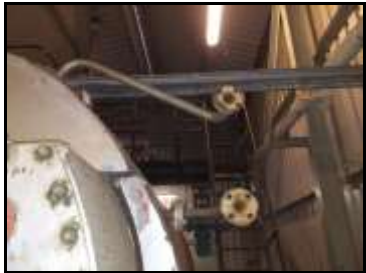
| Location: | 001 - Boiler room | Sample No / ID (Type): | P-265754/004 (Sampled) | | | | |

| | Item description: | Gaskets to front of boiler | | | | | |
| | Analysis: | Chrysotile | | | | | |
| | Material identification: | Asbestos gasket | | | | | |
| Material Score: | 5 | Priority Score | 2 | Total Score: | 7 | Risk Rating: | Low |

| Recommended action: | Monitor condition. | | | | | | |

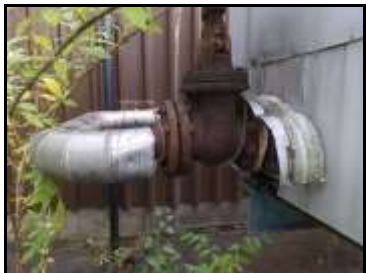
| Location: | 002 - External | Sample No / ID (Type): | P-265754/007 (Sampled) | | | | |

| | Item description: | Gasket to cold storage tank | | | | | |
| | Analysis: | Chrysotile | | | | | |
| | Material identification: | Asbestos gasket | | | | | |
| Material Score: | 5 | Priority Score | 1 | Total Score: | 6 | Risk Rating: | Low |

| Recommended action: | Monitor condition. | | | | | | |
