## HIGHWAYS DILAPIDATION SURVEY

IN SUPPORT OF APPLICATION 136892/FO/2023

**11 LADYBARN ROAD**  
MANCHESTER  
M14 6WN

JULY 2023  
JOB NUMBER: 2149

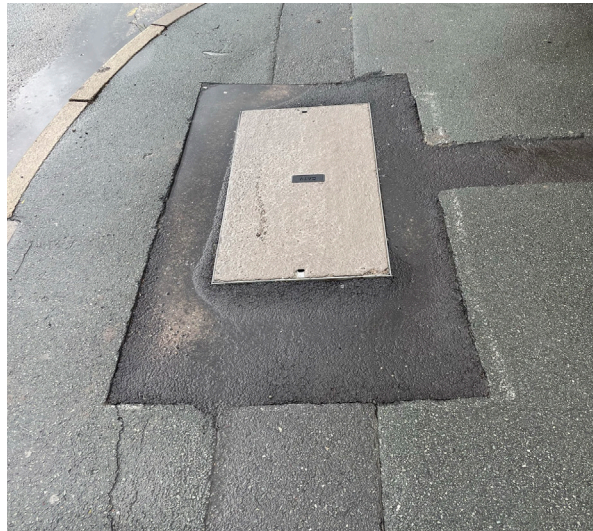
FIGURE 4: SUBSIDENCE GROUND UTILITY CONNECTIONS

- **Figure 4:** Utility works have been completed recently and the surrounding infill is showing signs of subsiding.
- **Figure 5:** Pooling present between the site entrance and the highway.
- **Figure 6:** Blocked drain with ponding formed at site entrance and kerbside.
- **Figure 7:** Blocked drain creating pooling along the kerbside.

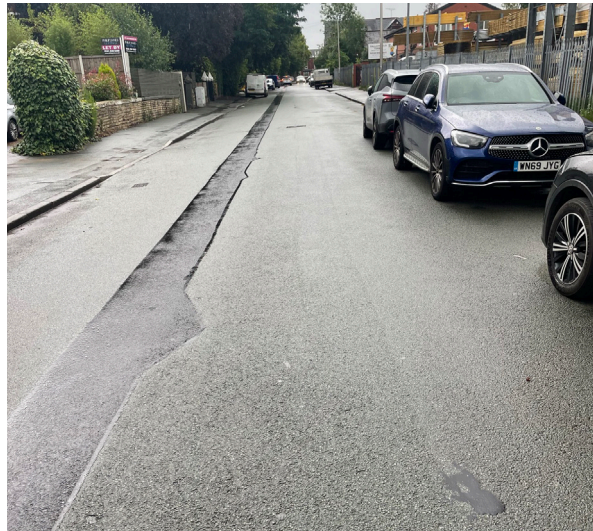
FIGURE 8: ROAD EAST FACING

- **Figure 8:** Existing road facing east with uneven ground due to utilities.
- **Figure 9:** Yellow lines on the current carriageway are faded.
- **Figure 10:** Existing road west facing showing uneven ground due to utilities.
- **Figure 11:** Existing lamppost is marked by graffiti and stickers. Cover appears loose and it is held in place with tape.

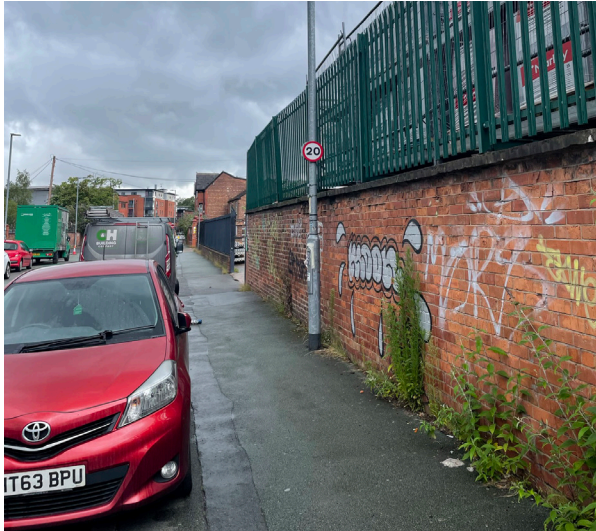
FIGURE 12 PLANT GROWTH

- **Figure 12:** Existing footpath with plant growth along the brick wall.

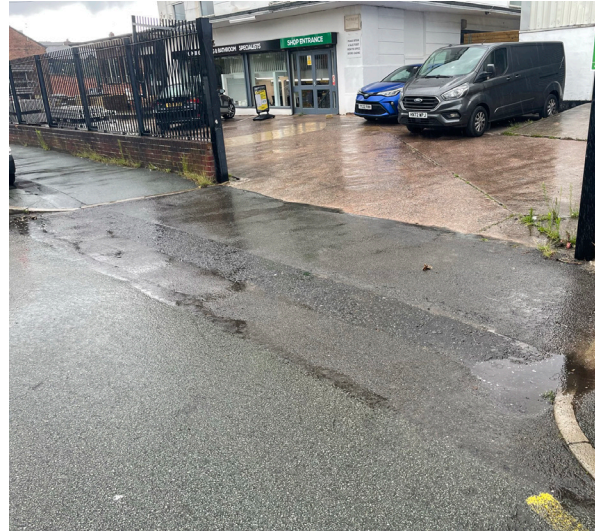
FIGURE 13: SITE ENTRANCE

- **Figure 13:** Site entrance with pooling along damaged kerb.

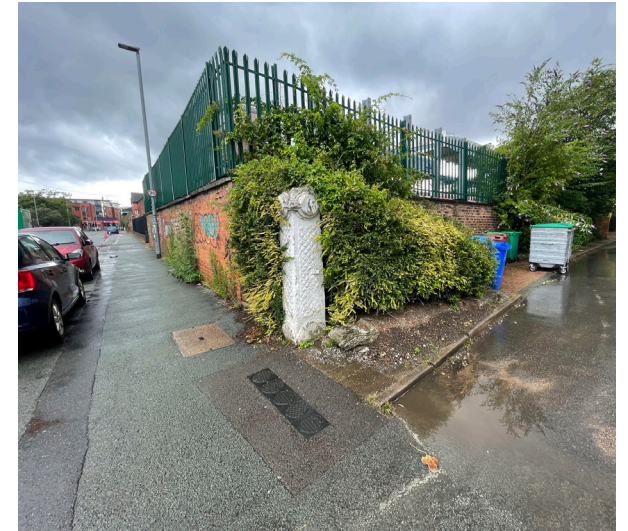
FIGURE 14: POOLING AND OVERGROWN BUSHES

- **Figure 14:** Pooling at neighbouring entrance and overgrown bushes along the site boundary.
