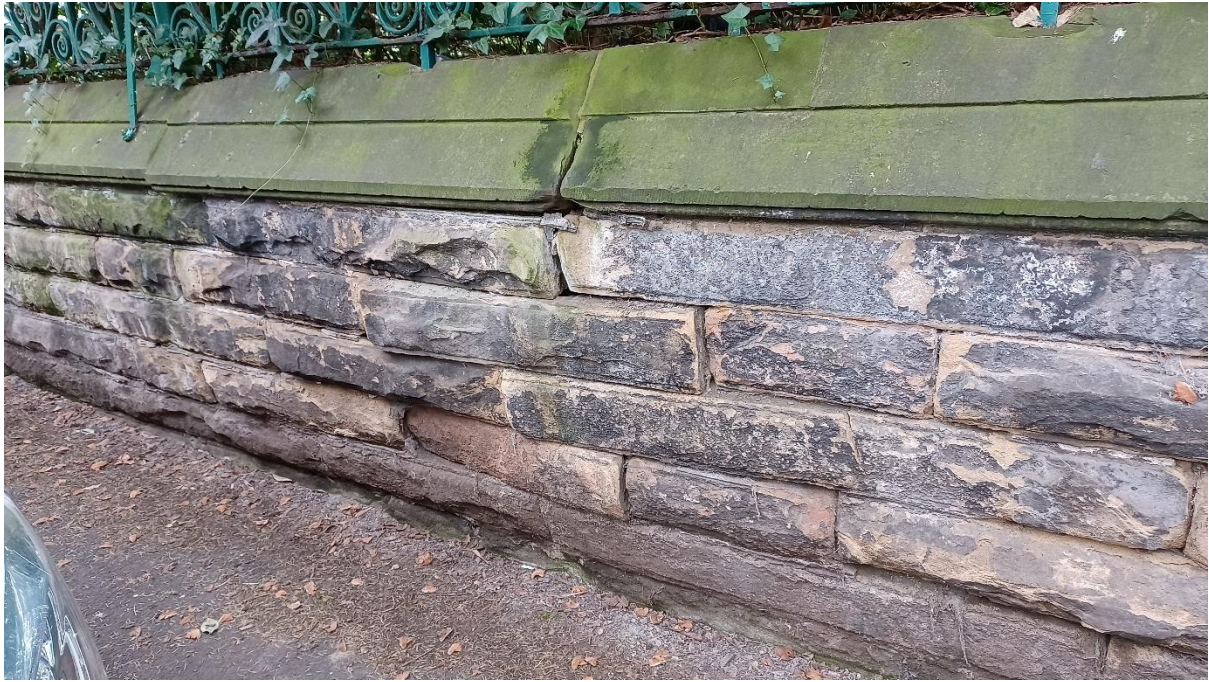
**Photo 1:** St James Church boundary/retaining wall on Stenner Lane, visible cracking and bulging of wall

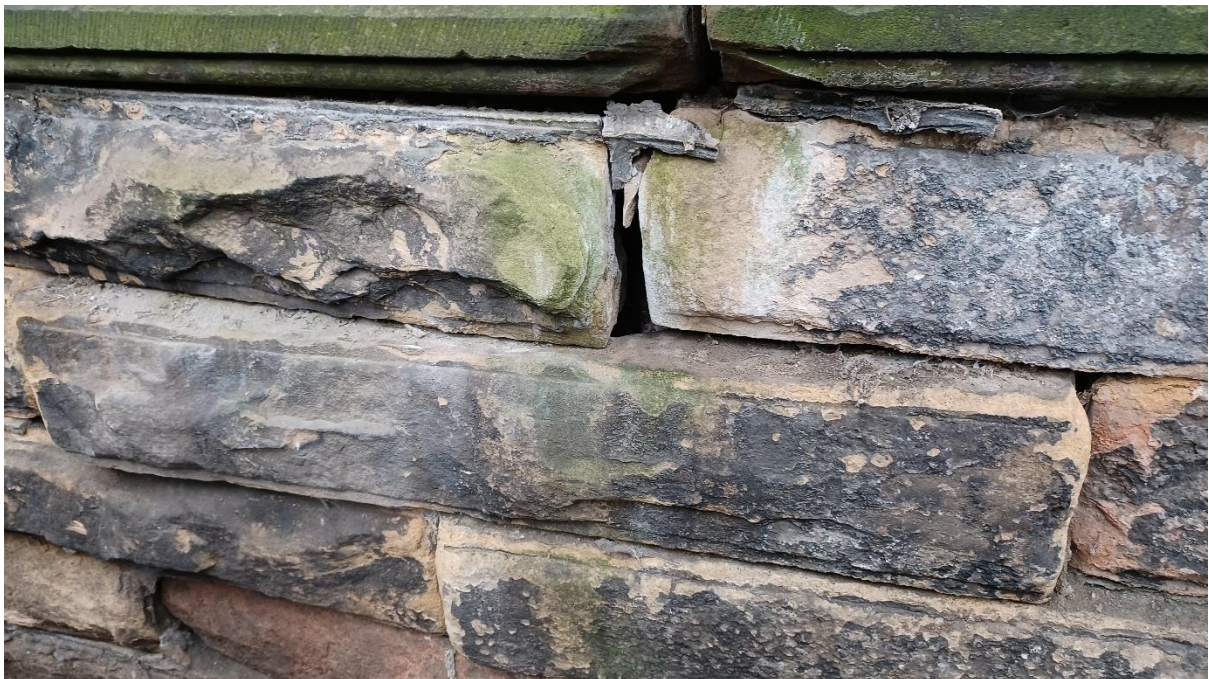
**Photo 2:** Holes and missing mortar formed in retaining wall between stone wall sections caused by movement.

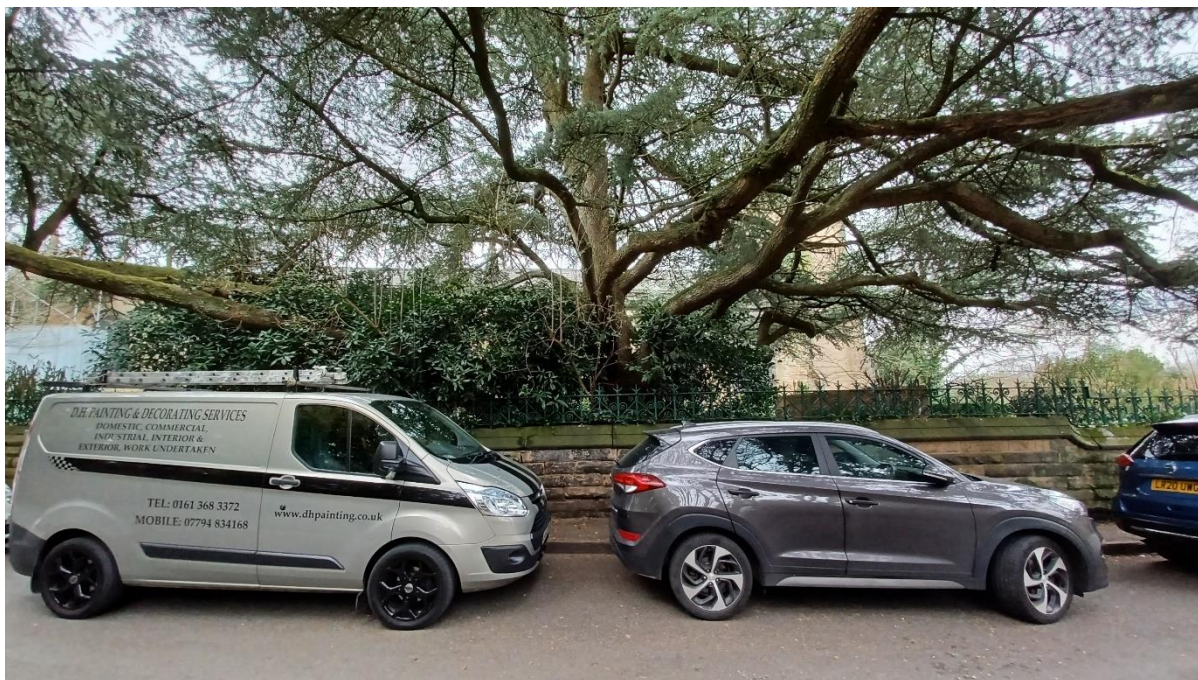
**Photo 3:** Cedar tree in St James's Church grounds approx. 1 metre from boundary wall. Photograph taken from Stenner Lane.

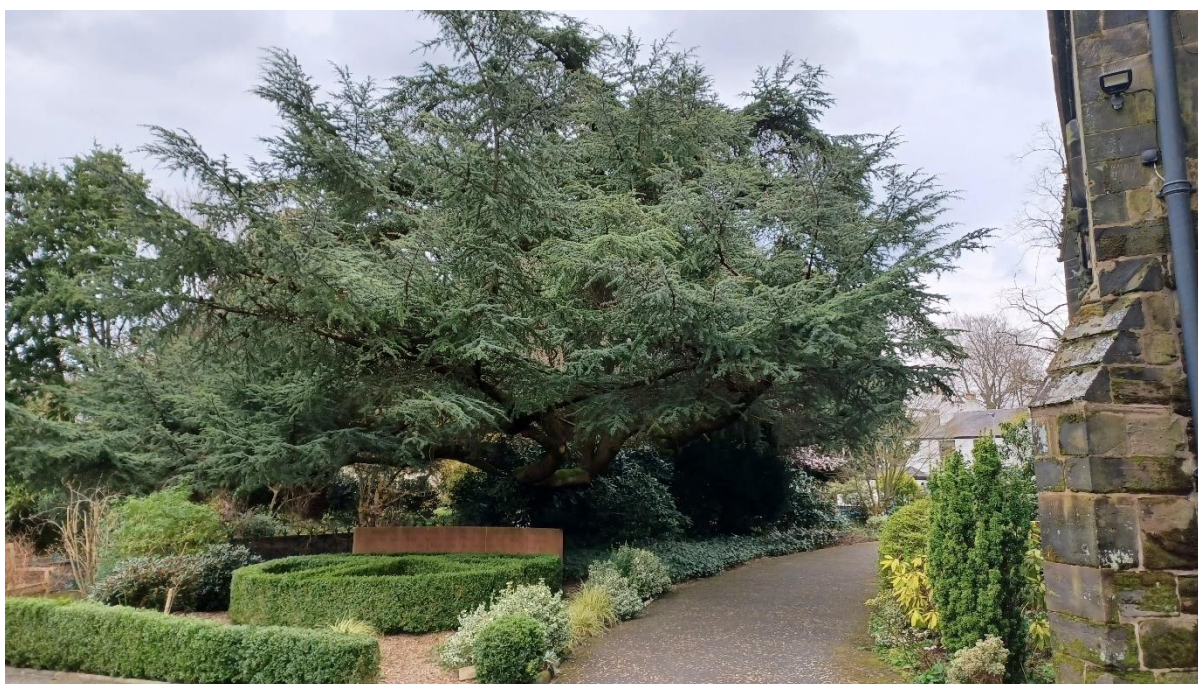
**Photo 4:** Cedar tree in St James's Church grounds photograph taken from inside church grounds.

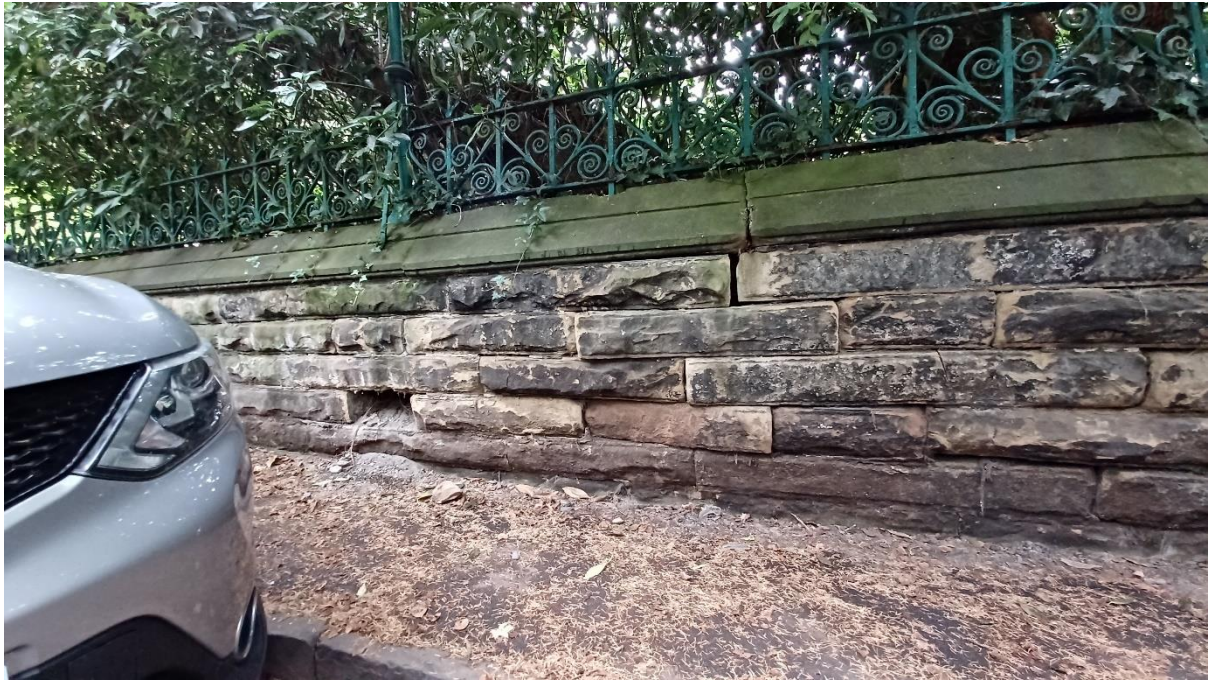
**Photo 5:** Boundary wall with missing stone and visible movement of stones, Photo taken in August 2022.

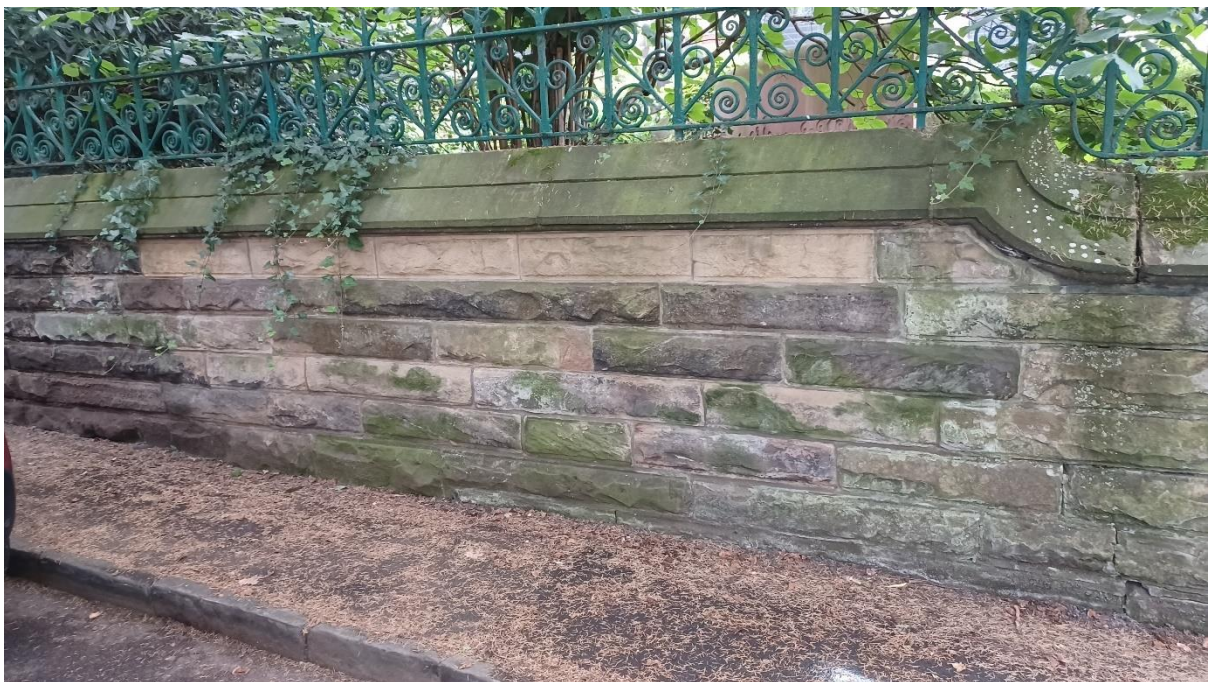
**Photo 6:** Boundary wall showing areas of previous wall repairs and stone replacement on Stenner Lane.

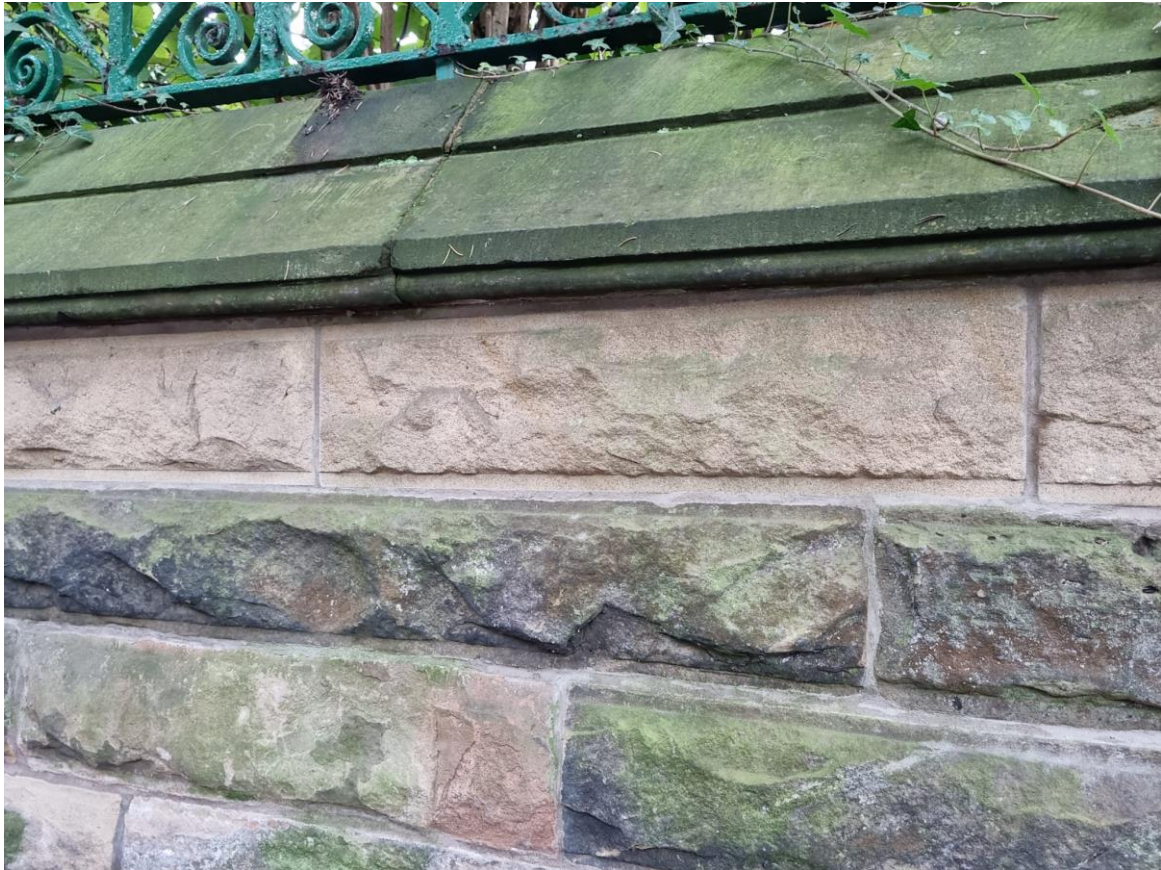
**Photo 7:** Historic wall repairs/replacement, new stones installed to top course of wall on Stenner Lane.

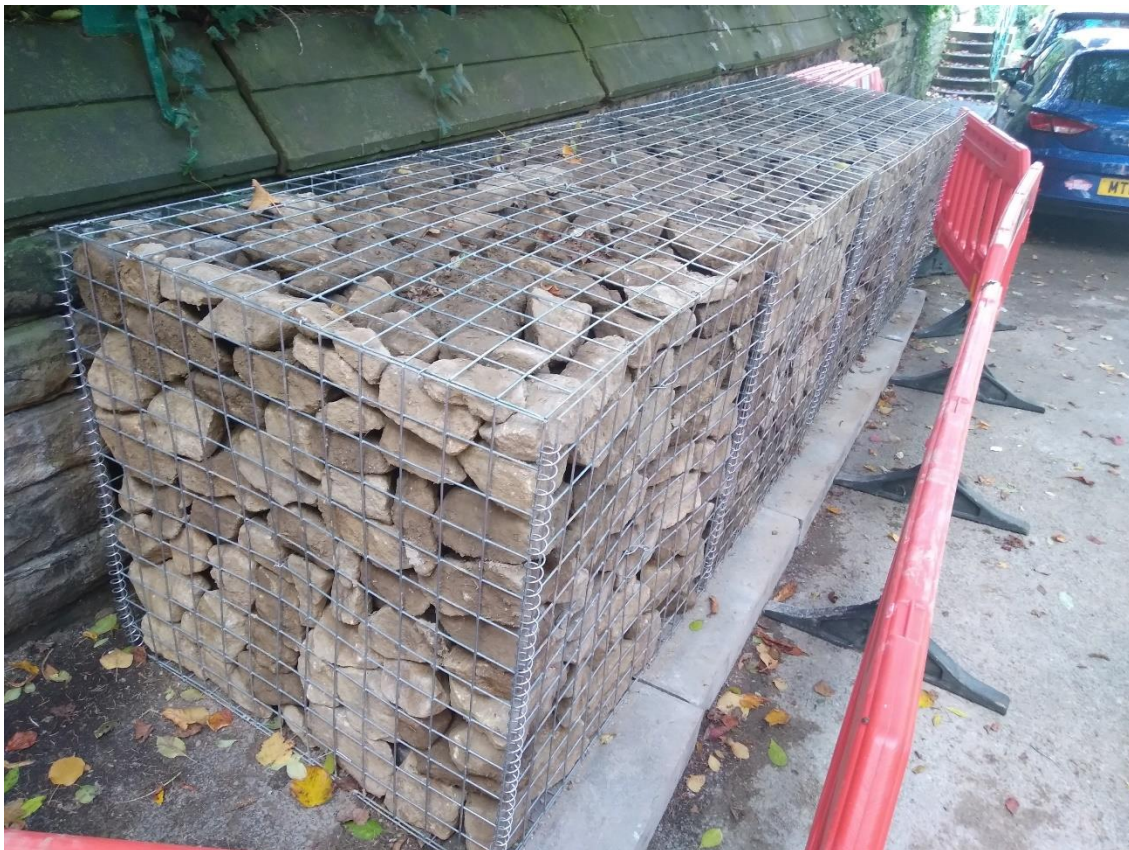
**Photo 8:** 4 [Nr] Gabion baskets installed adjacent boundary wall in October 2022.

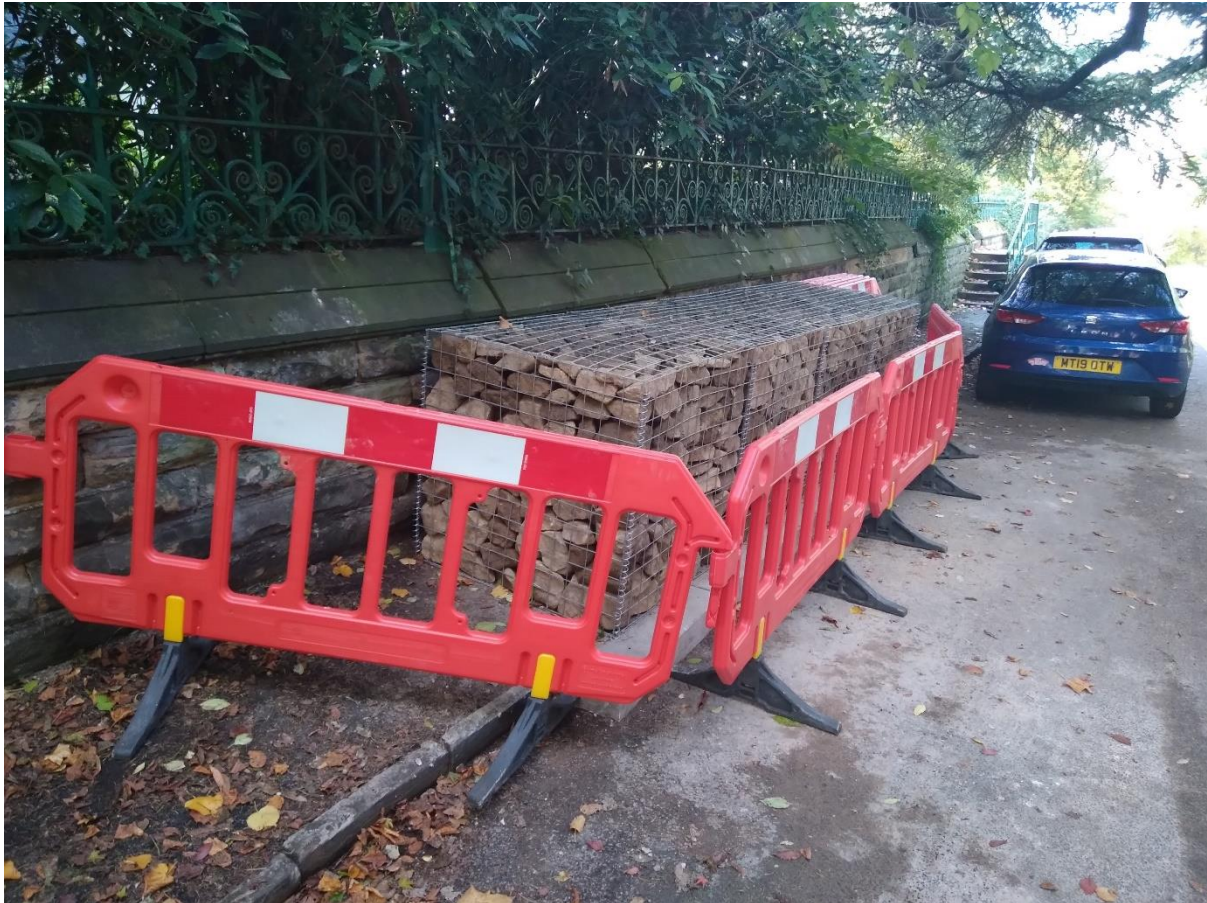
**Photo 9:** Gabion baskets with temporary fencing around. Photograph taken in October 2022.

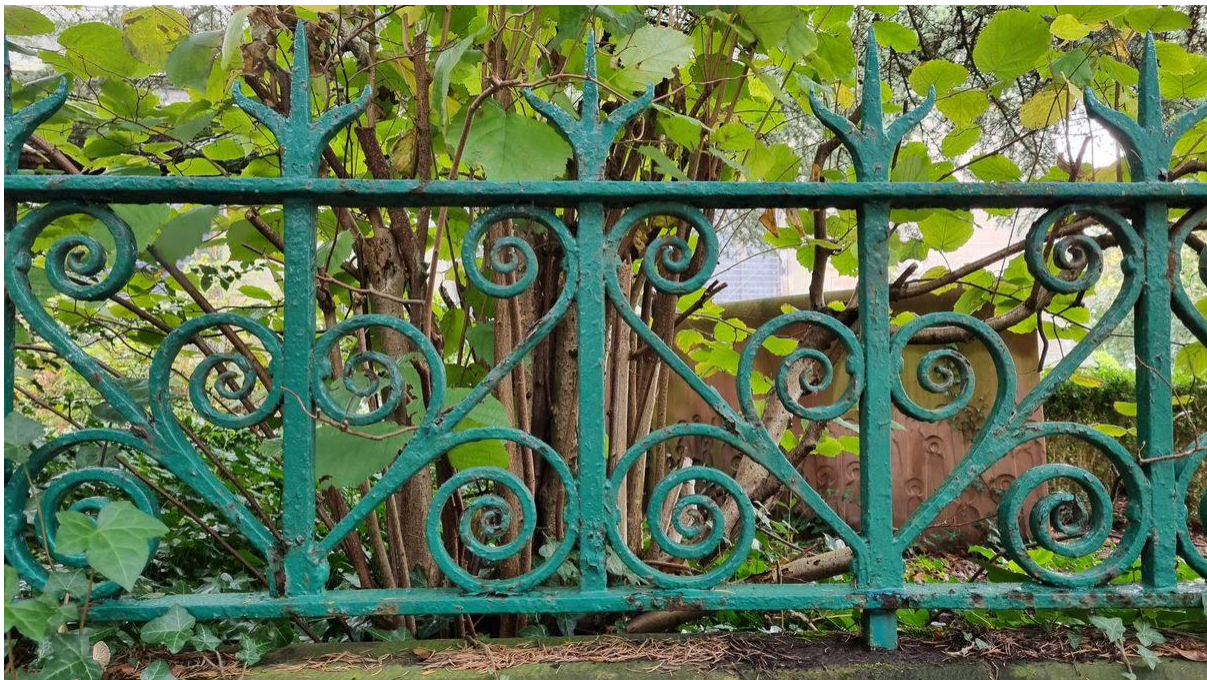
**Photo 10:** Existing cast iron railings fixed to coping stones on boundary wall at St James's Church/Stenner Lane.

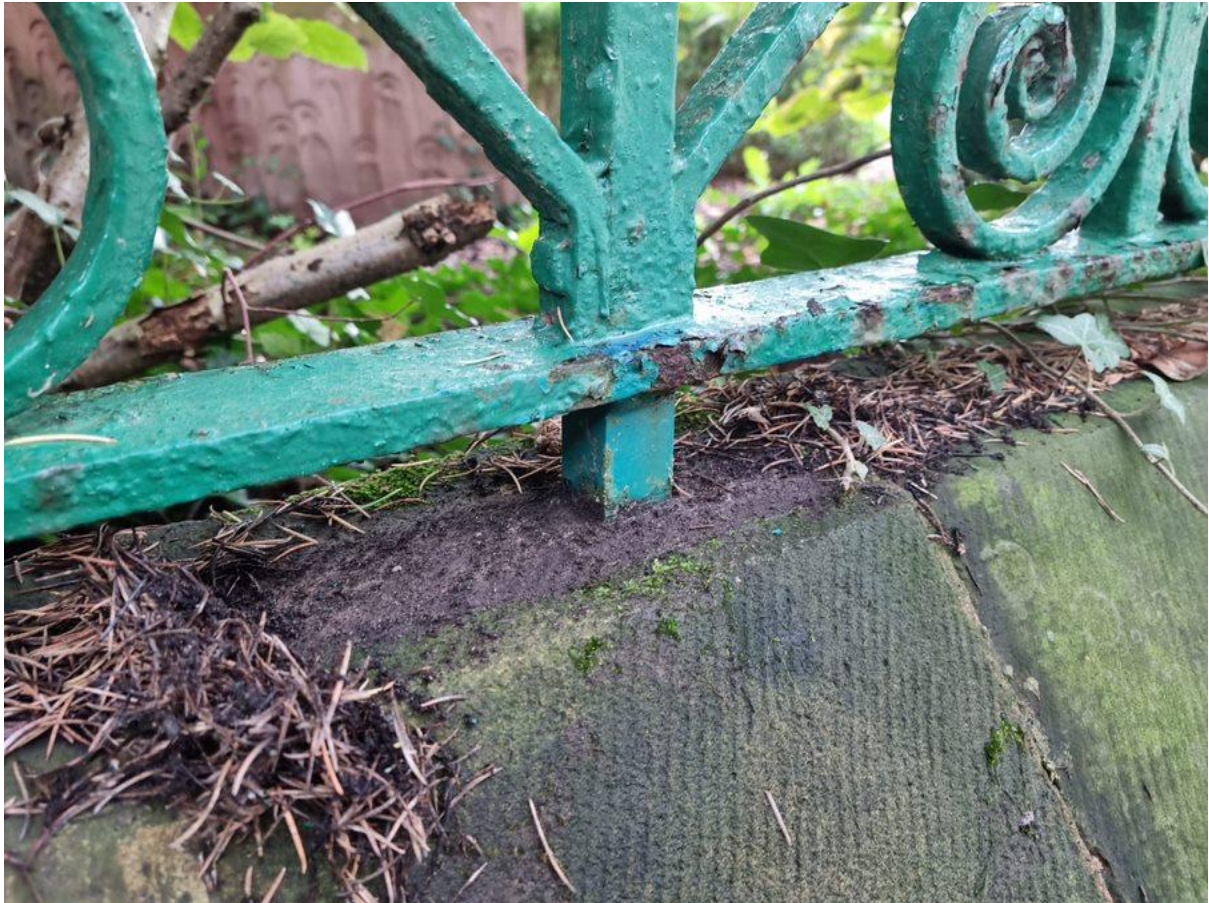
**Photo 11:** Existing cast iron railings fixed to coping stones on boundary wall at St James's Church/Stenner Lane.
