## **FENTON HOUSE, HIGHER ARDWICK, MANCHESTER**

### **CONDITION COMPLIANCE:**

#### **Specification and Method Statements (Conditions 3, 6, 8, 11-15, 17, 19 & 20)**

*Peter Jones-Hughes and Huw Davies  
MIHBC; BSc Hons Town Planning; PG Dip Blg Cons [RICS]  
Prepared 26<sup>th</sup> October 2021*

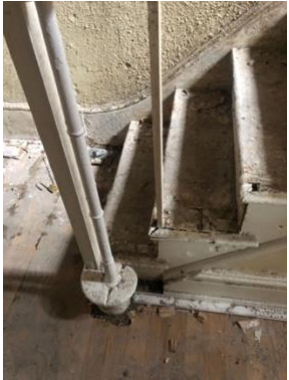
Removal of modern post

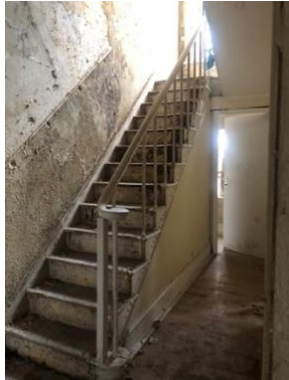
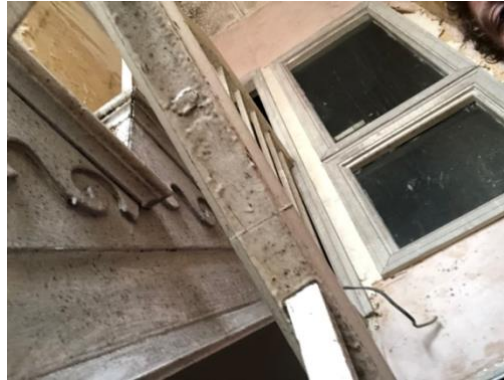
2. Replacing missing spindles

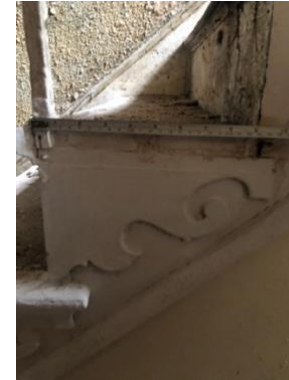
3. Replace missing nosings

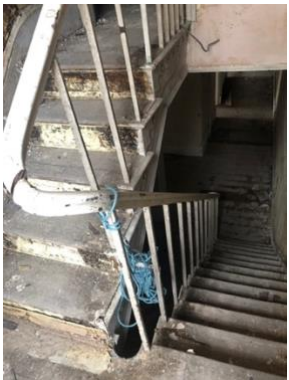
4. Repair broken handrail and reinstate turned newel

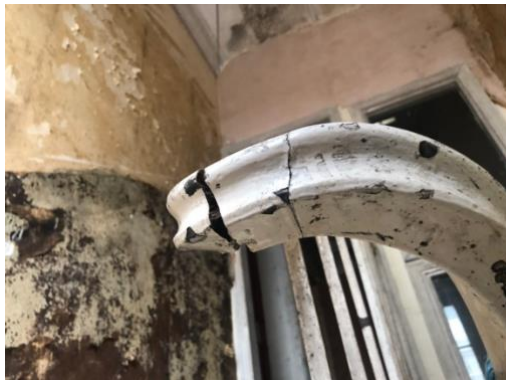
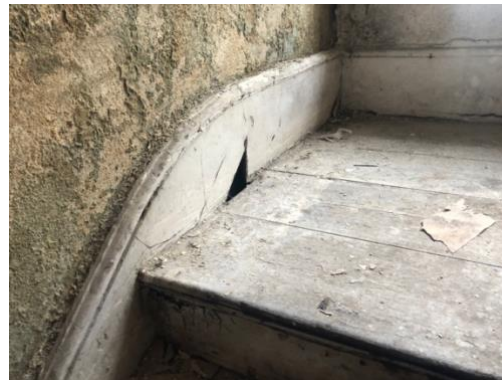
5. Repair section of skirting board
