## Roof Condition Report

### Lower Campfield

Lower Campfield,  
Liverpool Street,  
Manchester,  
M44 5AF.

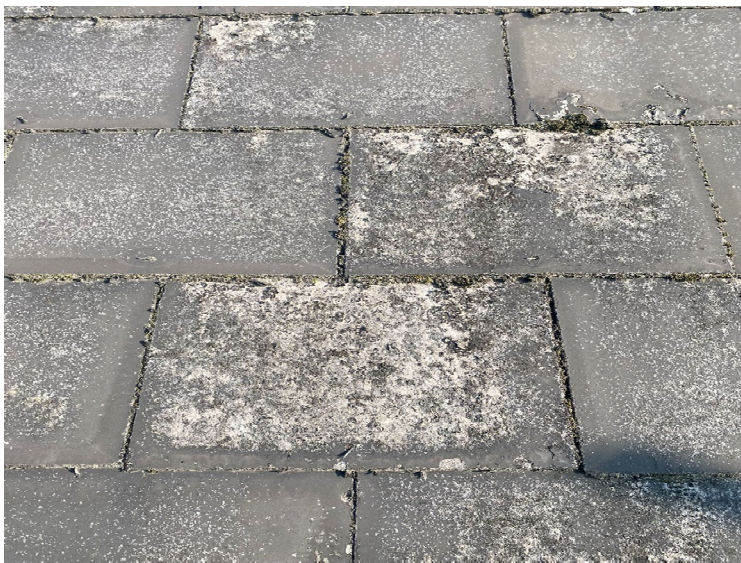
| 1. | View of perished roof tiles to section H1. | |
