**LIVERPOOL ROAD HOTEL,  
MANCHESTER**

**STRUCTURAL SURVEY REPORT**

Project No 2205-02  
November 2022  
Rev: P01  
LRH-REN-XX-XX-RP-S-00002

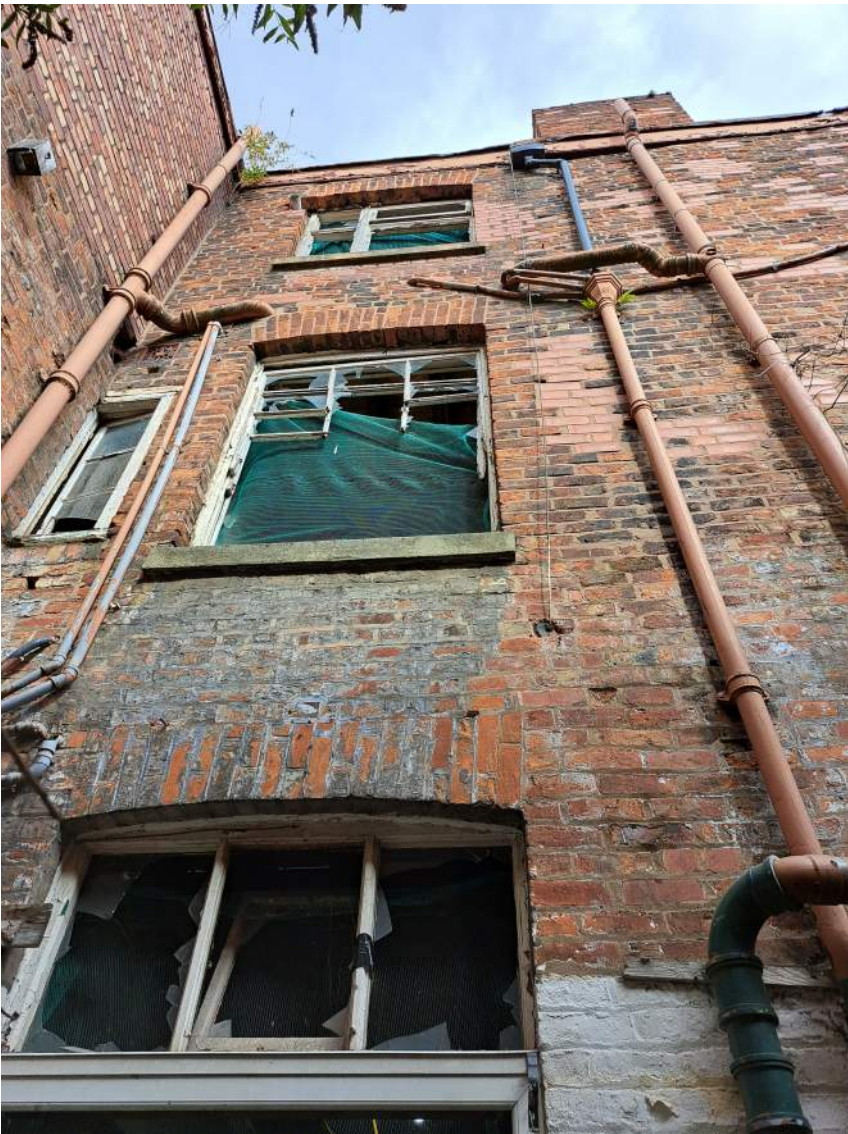
**E02/04:** The timber fascia at eaves level around the perimeter of the 19<sup>th</sup> century parts of the building is in poor condition in places. Rainwater goods are generally in poor condition.

**E02:** SOUTH ELEVATION TO 125 LIVERPOOL ROAD WITHIN COURTYARD. TIMBER FASCIA AT EAVES LEVEL AND RAINWATER GOODS ARE GENERALLY IN POOR CONDITION.

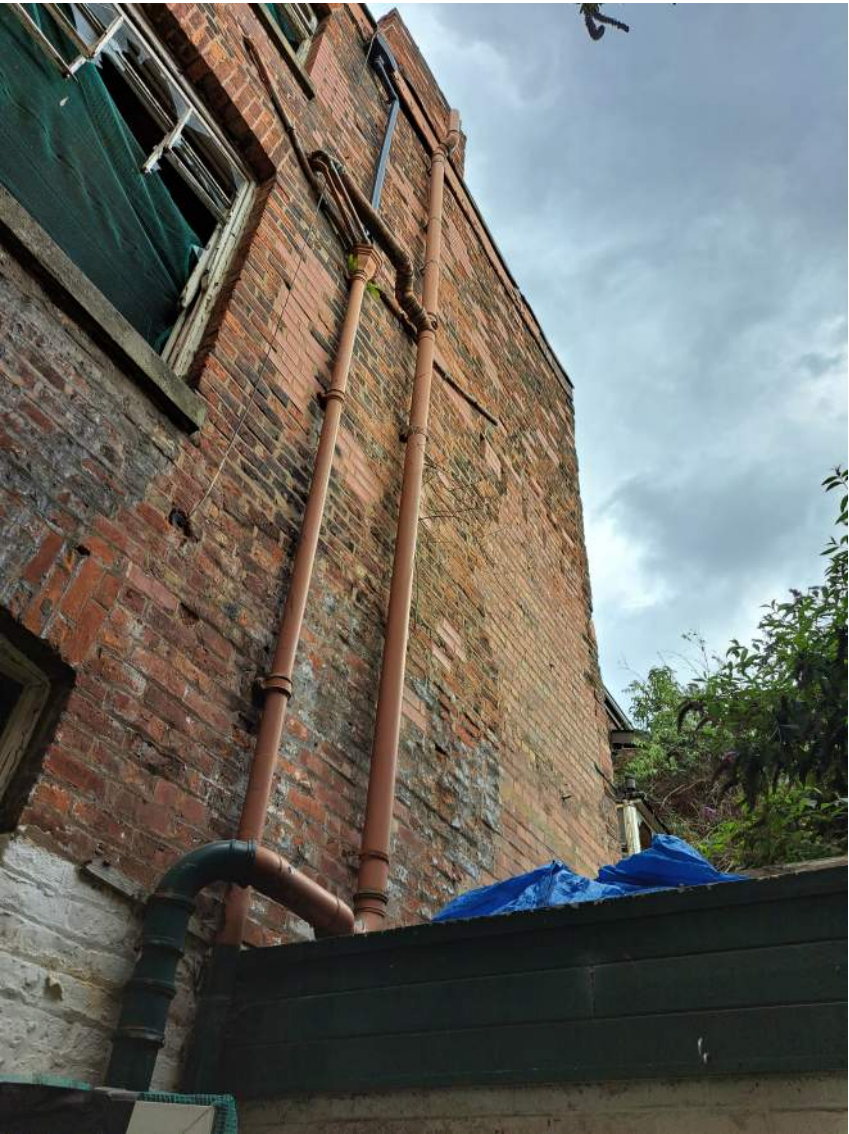
**E03:** Visibility of the south elevation to 123 and 125 Liverpool Road is limited due to significant vegetation growth on top of the 20<sup>th</sup> century extension attached to the rear of the buildings. Evidence of historic repairs/areas of re-building to the south elevation are apparent.

**E03:** VISIBILITY OF SOUTH ELEVATION TO 123 AND 125 LIVERPOOL ROAD ABOVE REAR EXTENSION IS LIMITED DUE TO SIGNIFICANT VEGETATION GROWTH. EVIDENCE OF NUMEROUS HISTORIC REPAIRS/AREAS OF RE-BUILDING.

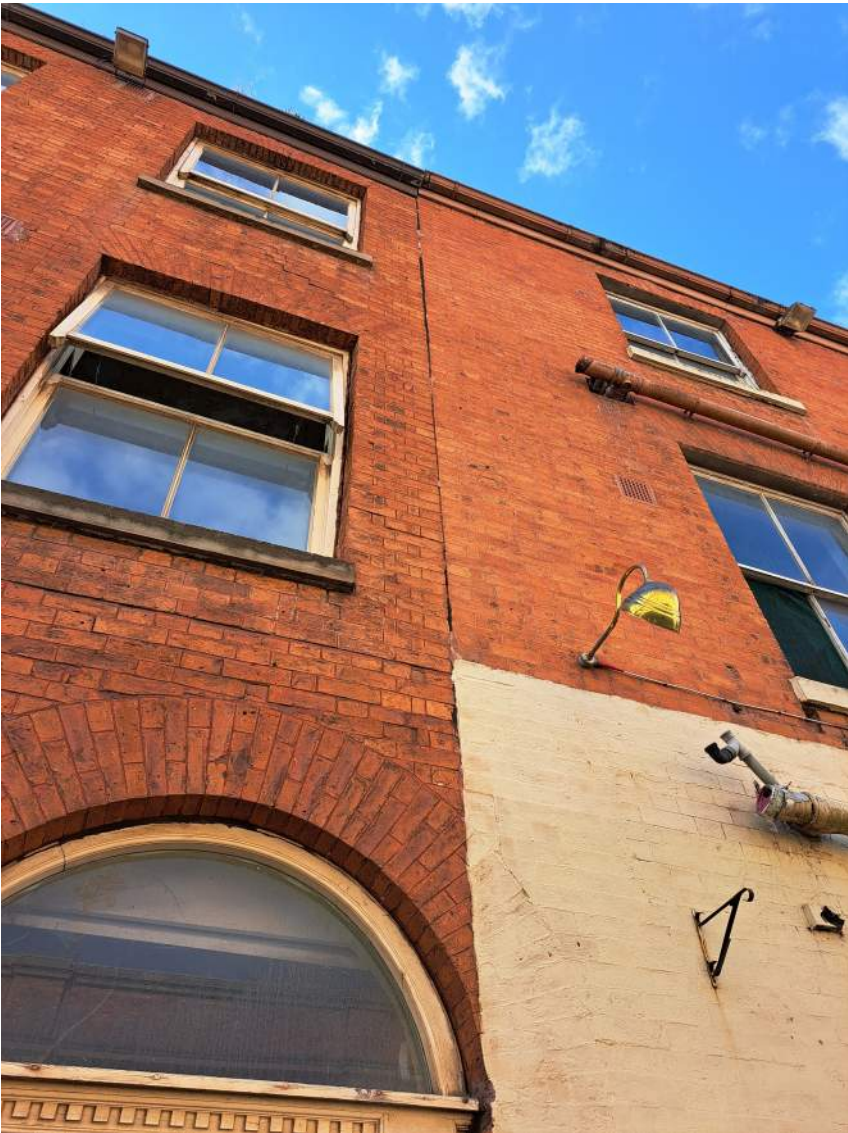
**E11:** JOINT BETWEEN 123 AND 125 LIVERPOOL ROAD. CRACKING OF MORTAR JOINTS IS VISIBLE BETWEEN THE 1ST AND 2ND FLOOR WINDOWS. EVIDENCE OF MOVEMENT IS APPARENT ABOVE 1ST FLOOR.

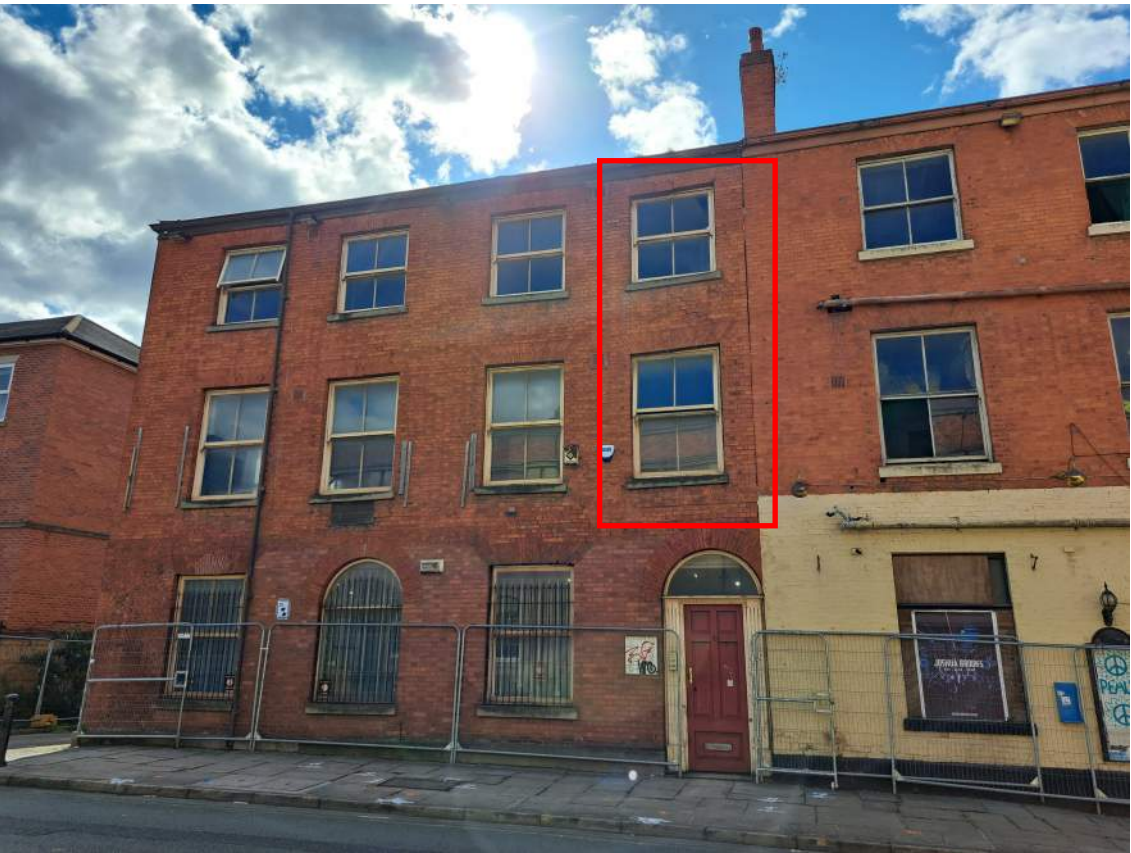
**E10:** GENERAL VIEW OF NORTH ELEVATION TO 123 LIVERPOOL ROAD. BRICKWORK APPEARS TO BE IN SOUND CONDITION GENERALLY. THERE ARE SOME SIGNS OF HISTORIC MOVEMENT, PARTICULARLY IN THE AREA INDICATED.

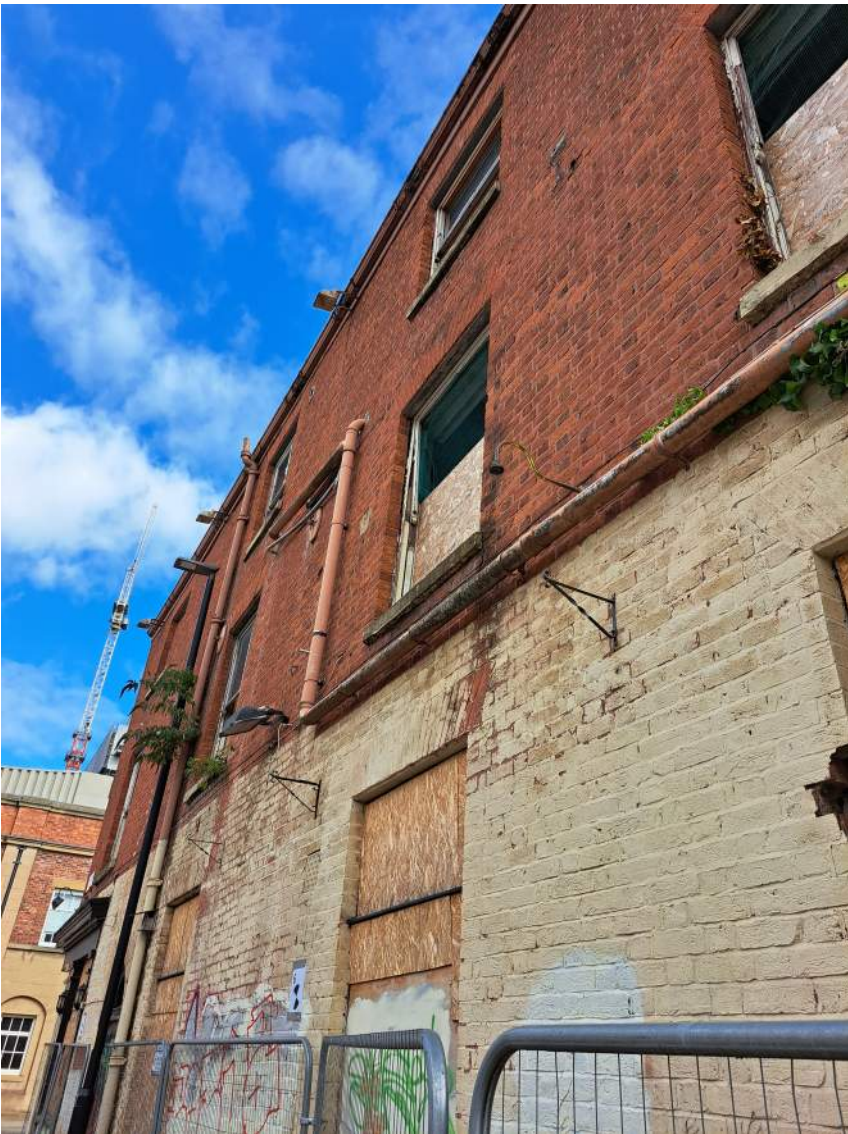
**E14:** There is a visible bow to the west elevation of the building on Woollam Place. Pattress plates have been introduced at 2<sup>nd</sup> floor with tie rods noted internally below ceiling level. The masonry and mortar joints across the east elevation of the building exhibit no obvious signs of distress. The sections of masonry which the pattress plates are tied to internally also do not appear to have moved significantly. This may suggest that the movement of the wall on the west elevation is not ongoing and is currently being resisted by the pattress plates and tie rods. However, this should be verified by monitoring.

**E14:** WEST ELEVATION TO 125 LIVERPOOL ROAD. THERE IS A VISIBLE BOW TO THE GABLE WALL AND PATRESS PLATES HAVE BEEN INSTALLED AT 2ND FLOOR. EXTERNAL DRAINAGE IS IN POOR CONDITION.

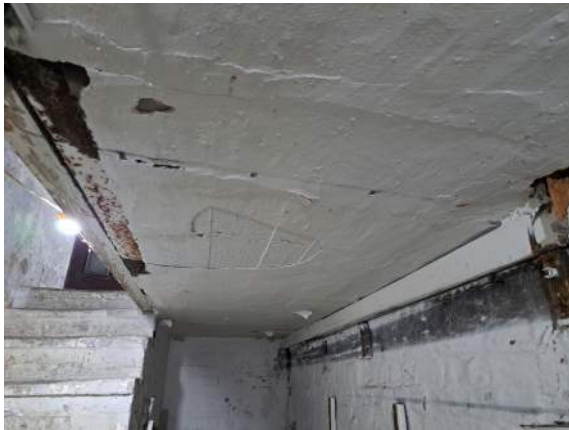
**B01:** A filler joist floor is evident over rooms B01 and B03. Signs of corrosion are noted on the underside of the steel joists where these are visible.

**B01:** FILLER JOIST FLOOR AT GROUND FLOOR OVER ROOM B01. THERE ARE SIGNS OF CORROSION ON THE UNDERSIDE OF THE STEEL JOISTS.

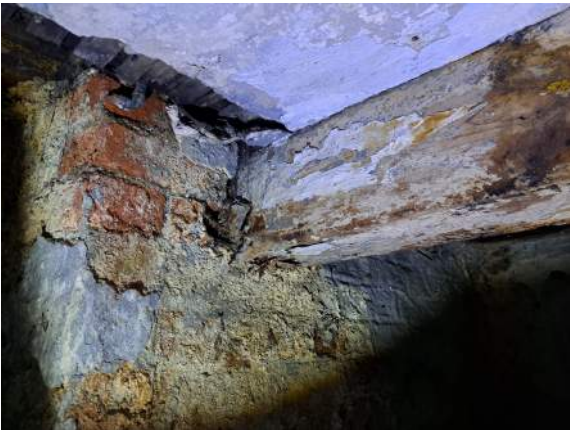
**B02/04/24:** Signs of rot are evident at the bearing points of several timber beams over the basement. This is mainly where the beams are embedded into external retaining walls through which water ingress has occurred.

**B02:** THE ENDS OF THE TIMBER BEAMS OVER ROOM B02 WHERE THEY ARE EMBEDDED INTO THE EXTERNAL WALL ON LIVERPOOL ROAD SHOW SIGNS OF DECAY.

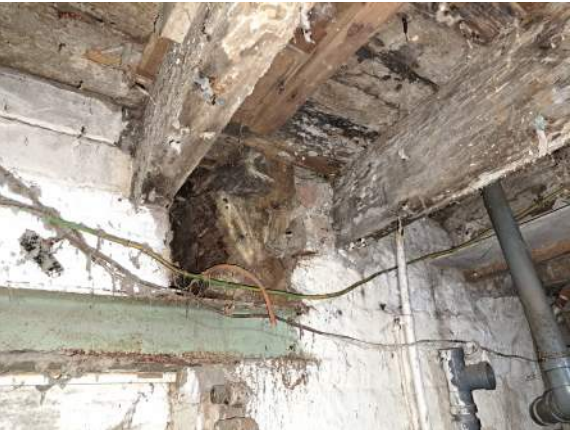
**B04:** TIMBER ROT AT THE END OF A BEAM SUPPORTING THE GROUND FLOOR OVER ROOM B04 AS VIEWED FROM THE OTHER SIDE OF THE WALL IN ROOM B05.

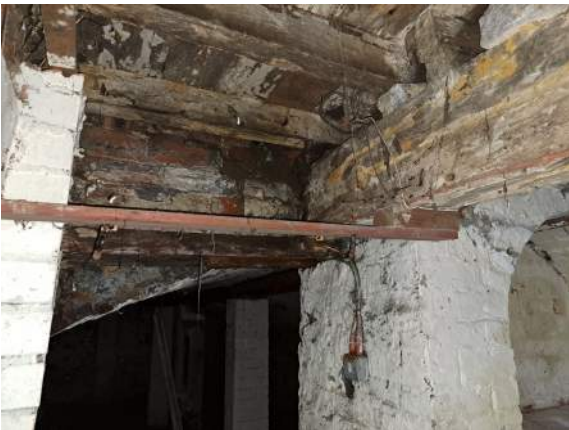
**B05:** A timber beam is being supported by the timber lintel over the door opening into room B07. The lintel appears to be decayed.

**B05:** TIMBER BEAM SUPPORTED BY LINTEL OVER DOOR OPENING INTO ROOM B07.

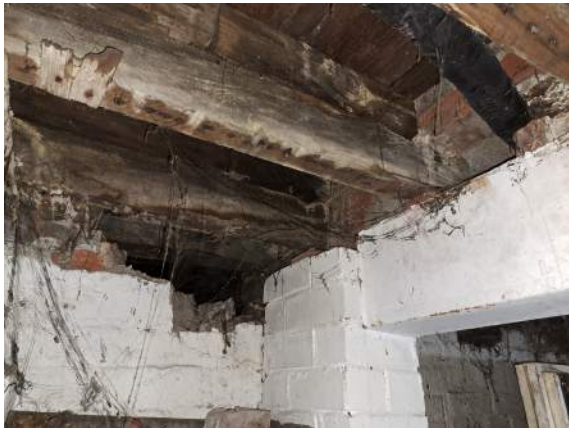
**B06:** MASONRY PIER PRESUMABLY ADDED AS REMEDIAL DETAIL TO ADDRESS LOSS OF TIMBER BEAM BEARING OVER ROOM B06. THIS WAS NOTED IN SEVERAL AREAS OF THE BASEMENT TO 125 LIVERPOOL ROAD.

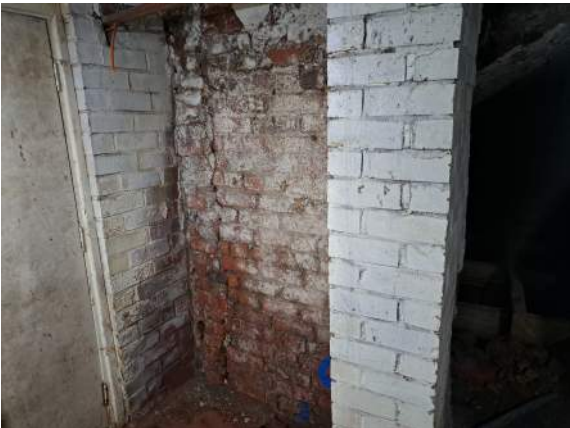
**B07:** A vertical crack has propagated through the external masonry wall adjacent to the door opening between rooms B06 and B07. This appears to line through with the back of the wall to the vaulted section of basement within room B07 and so may have been caused by differential movement between the adjacent parts of the building above.

**B07:** VERTICAL CRACK TO MASONRY WALL BETWEEN ROOMS B06 AND B07.

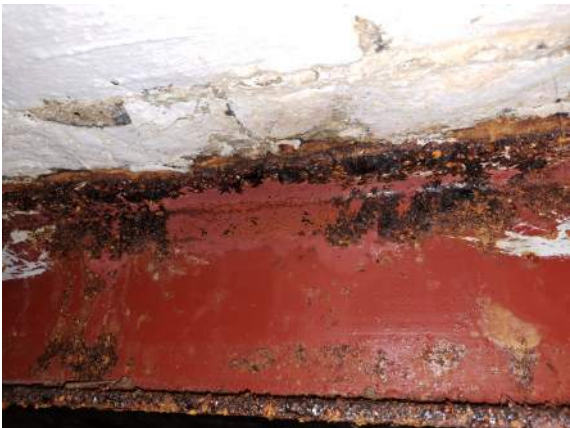
**B09/12/14:** Masonry piers and a line of steel beams have been introduced to the underside of the crown of the vaulted ceiling over room B07. This structure is likely to have been added as a remedial solution due to the crown of the vault dropping historically. There are areas where water ingress has occurred through the vaulted ceiling causing the steel beams to corrode.

**B12:** CORROSION OF THE REMEDIAL STEEL BEAMS SUPPORTING THE CROWN OF THE VAULTED CEILING OVER ROOM B07.

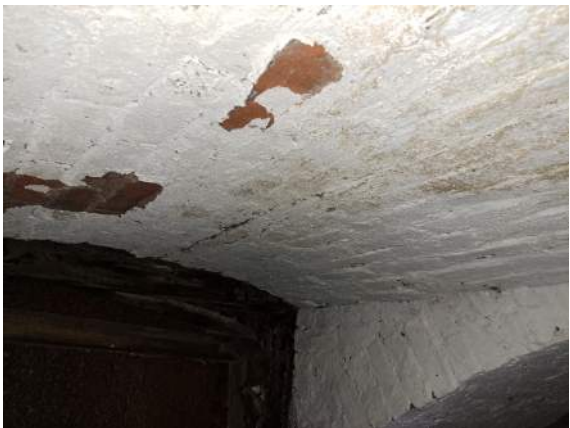
**B13:** A horizontal crack has propagated along the crown of the arch over one of the historic pavement light openings within room B07. This is likely to be a result of the crown of the arch dropping over time.

**B13:** HORIZONTAL CRACK AT THE CROWN OF A MASONRY ARCH OVER A PAVEMENT LIGHT WITHIN ROOM B07.

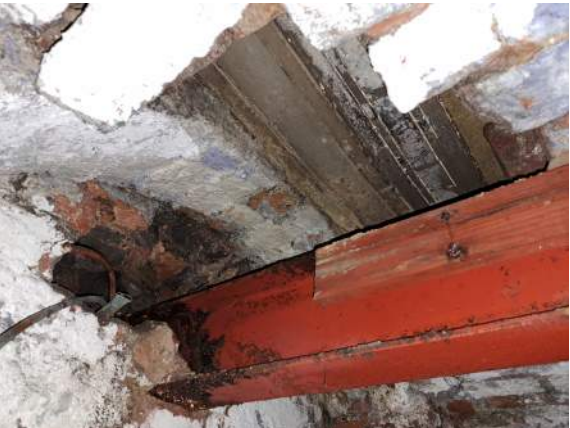
**B14:** REMEDIAL STEEL BEAM EMBEDDED INTO THE EXTERNAL END WALL OF ROOM B07. CORROSION WAS NOTED AT THE END OF THE BEAM.

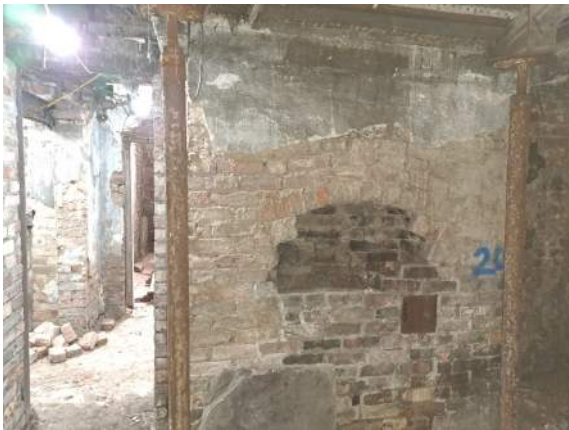
**B20:** A vertical crack has formed through the masonry chimney breast in room B10.

**B20:** VERTICAL CRACK THROUGH MASONRY CHIMNEY BREAST IN ROOM B10.

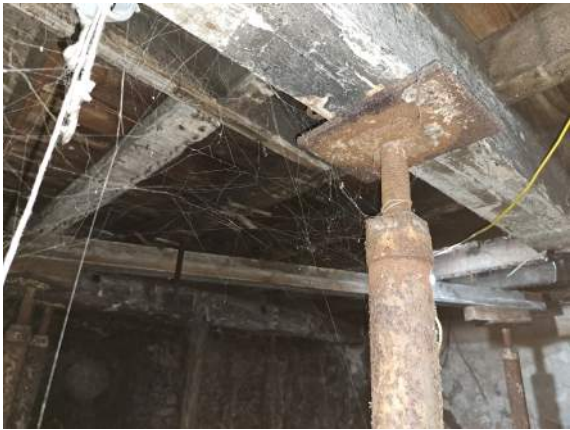
**B21/23:** Propping has been installed historically to the underside of the ground floor structure in rooms B10 and B11, consisting of adjustable metal props bearing onto the basement floor with timber spreaders above. The reason for the introduction of this propping is unknown. The timber beams and joists above these rooms appear to be in variable condition with signs of decay in places.

**B21:** HISTORIC PROPPING TO TIMBER BEAMS SUPPORTING THE GROUND FLOOR OVER ROOM B10. THE BEAMS AND JOISTS IN THIS AREA APPEAR TO BE IN VARIABLE CONDITION.

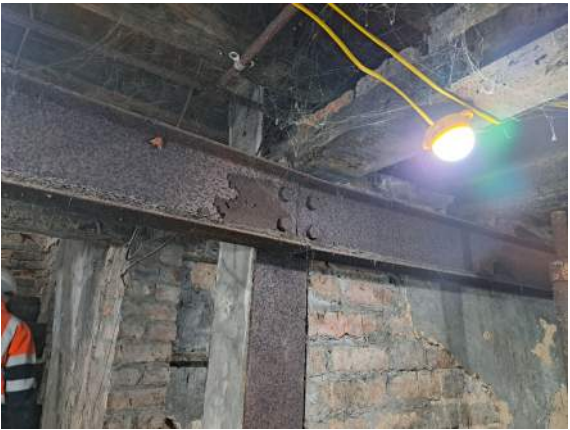
**B22:** The steel column and tie members that supporting the structure above at ground, 1<sup>st</sup> and 2<sup>nd</sup> floor are corroded.

**B22:** CORROSION OF STEEL COLUMN AND TIE MEMBERS EMBEDDED WITHIN WALL BETWEEN ROOMS B10 AND B11.

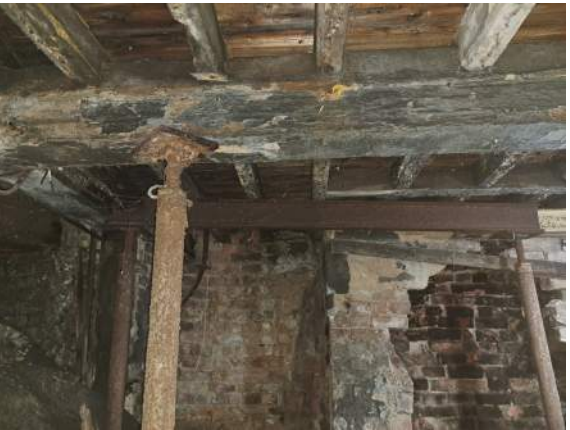
**B23:** HISTORIC PROPPING TO TIMBER BEAMS SUPPORTING THE GROUND FLOOR OVER ROOM B11. AS WITH ROOM B10, THE BEAMS AND JOISTS IN THIS AREA APPEAR TO BE IN VARIABLE CONDITION.

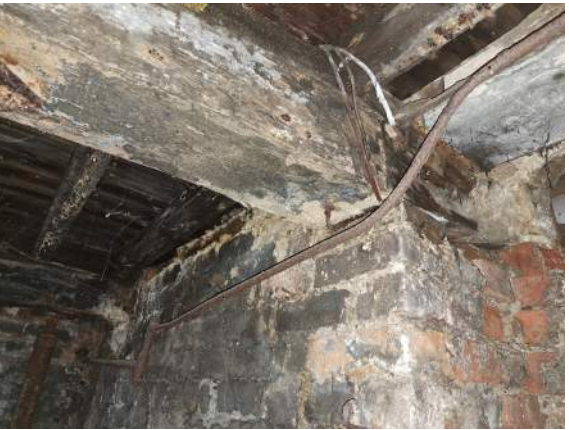
**B24:** EVIDENCE OF DECAY AT THE BEARING OF A TIMBER BEAM OVER ROOM B11 WHERE IT IS EMBEDDED INTO THE EXTERNAL WALL ON LIVERPOOL ROAD.

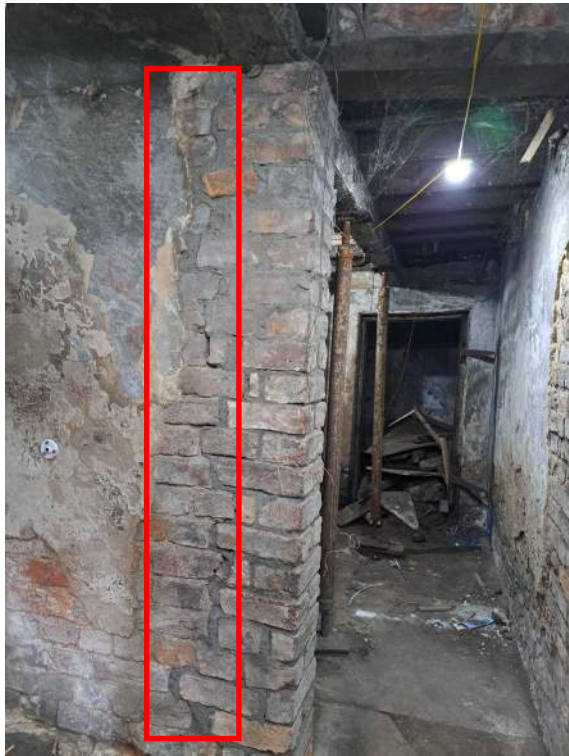
**B25:** A vertical crack has formed through a masonry wall underneath the bearing point of a timber beam adjacent to the stairs in room B09.

**B25:** VERTICAL CRACK IN WALL ADJACENT TO STAIRS IN ROOM B09 AT BEARING POINT FOR TIMBER BEAM ABOVE.

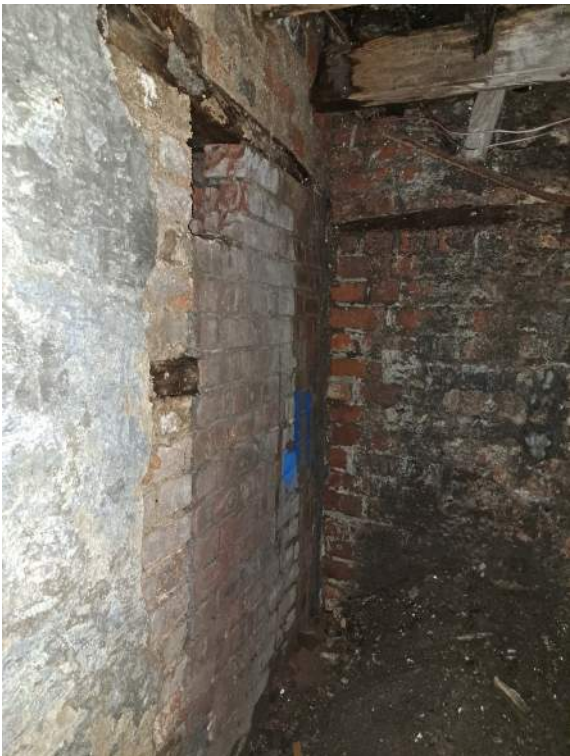
**B26:** A door opening appears to have been infilled with masonry at the end of the corridor adjacent to the stairs in room B09. Investigation through a section of missing brickwork on the infill appears to reveal rubble piled up within an inaccessible room beyond.

**B26:** HISTORIC DOOR OPENING INFILLED WITH MASONRY AT END OF CORRIDOR ADJACENT TO STAIRS IN ROOM B09. BUILD-UP OF RUBBLE BEHIND THE INFILL IS VISIBLE.

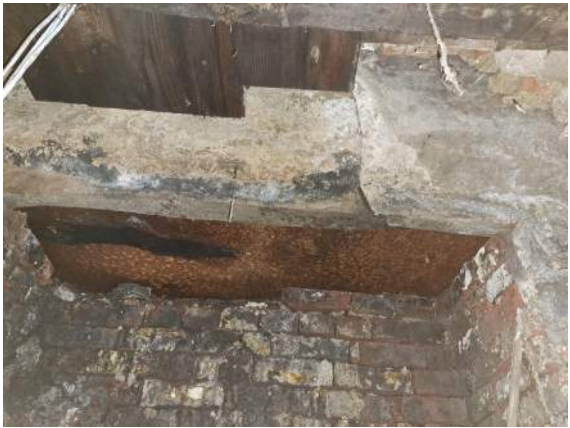
**B27:** A stone lintel over the opening for an infilled pavement light in room B13 has cracked.

**B27:** CRACK IN STONE LINTEL ABOVE INFILLED PAVEMENT LIGHT ON THE LIVERPOOL ROAD ELEVATION OF ROOM B13.

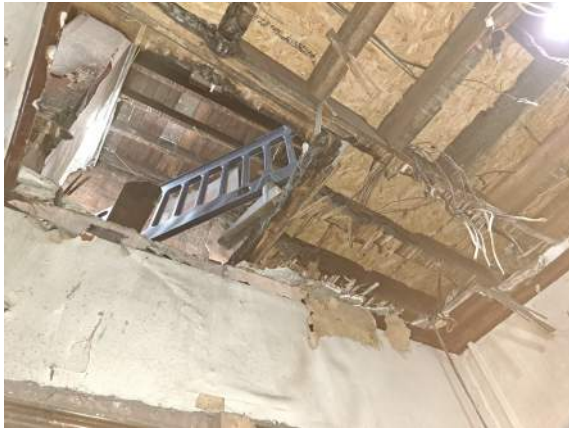
**G01:** The timber joists around a riser opening above room G02 appear to have been subject to fire damage and loss of section.

**G01:** AFIRE DAMAGE AND LOSS OF SECTION TO 1ST FLOOR TIMBER JOISTS AROUND RISER OPENING ADJACENT TO BAR ABOVE ROOM G02.

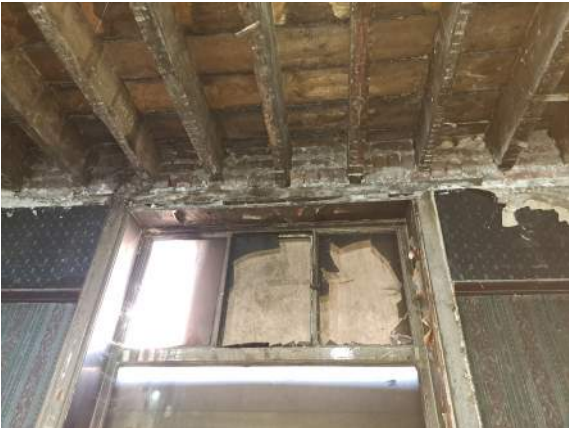
**G05:** One of the timber lintels that is visible over a window on the Liverpool Road elevation of room G02 appears to be decayed.

**G05:** SIGNS OF DECAY TO TIMBER LINTEL OVER WINDOW OPENING ON LIVERPOOL ROAD ELEVATION OF ROOM G02.

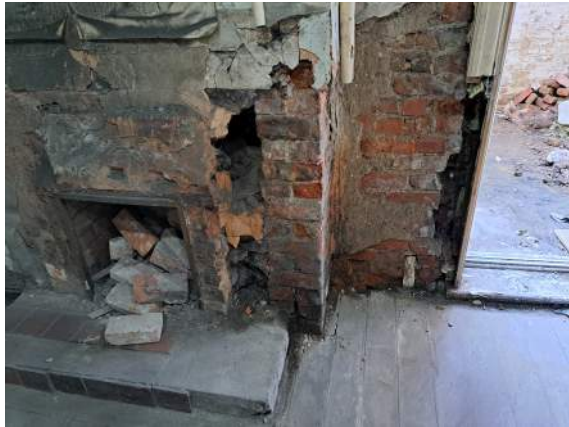
**G06:** SECTION OF MASONRY CHIMNEY BREAST HAS COLLAPSED ON REAR ELEVATION OF ROOM G02.

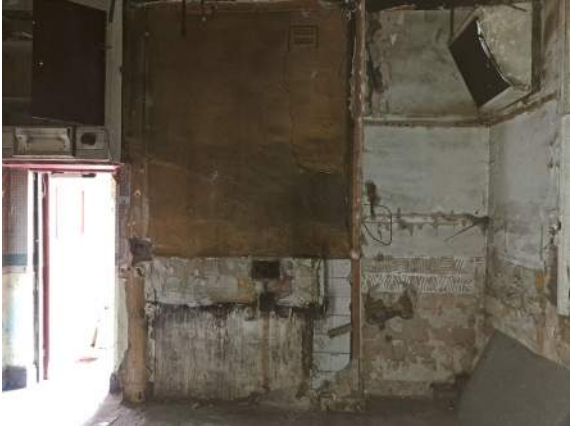
**G07:** The finishes on the internal face of the rear external wall in room G03 exhibit cracking. It is not clear whether the cracking is reflected in the masonry behind. The cracking could be a result of the vegetation growth on the external face of the wall.

**G07:** CRACKING OF FINISHES ON INTERNAL FACE OF REAR EXTERNAL WALL TO ROOM G03. IT IS NOT CLEAR WHETHER THE CRACKING IS REFLECTED IN THE MASONRY BEHIND.

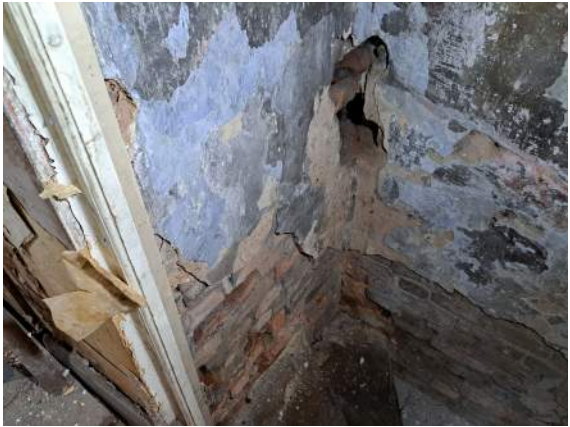
**G08:** A section of masonry is missing from a wall adjacent to the stairs from ground floor to basement in room G06.

**G08:** SECTION OF MASONRY MISSING FROM WALL ADJACENT TO STAIRS FROM GROUND FLOOR TO BASEMENT IN ROOM G06.

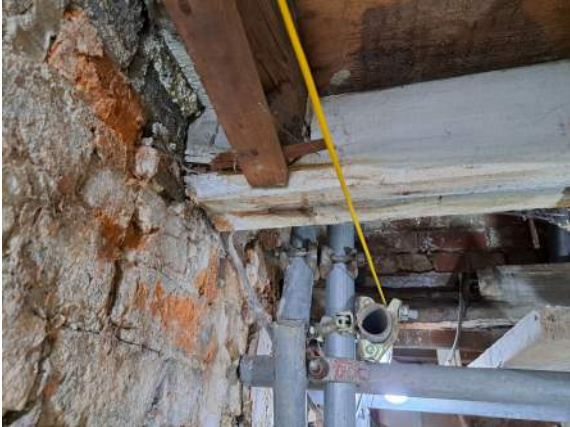
**G09:** The end bearing of a timber beam supporting the half-landing of the stairs over room G06 has failed. These stairs are due to be removed as part of the proposed works.

**G09:** FAILED END BEARING OF TIMBER BEAM SUPPORTING HALF-LANDING OF STAIRS OVER ROOM G06.

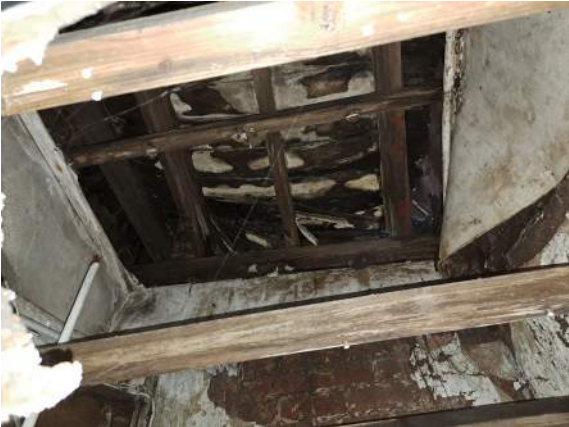
**G10:** The timber floor over the rear section of corridor in room G06 is in very poor condition with members excessively deflecting and visibly failed in areas. Significant water ingress is also apparent through the 1<sup>st</sup> floor. This part of the corridor is within the 1950/60s extension at the rear of 123 Liverpool Road. The 1<sup>st</sup> floor of this extension is inaccessible and large parts of the cladding are missing which is resulting in the water ingress visible at ground floor.

**G10:** FAILED TIMBER FLOOR OVER REAR SECTION OF CORRIDOR IN ROOM G06. SIGNIFICANT WATER INGRESS IS APPARENT IN THIS PART OF THE STRUCTURE.

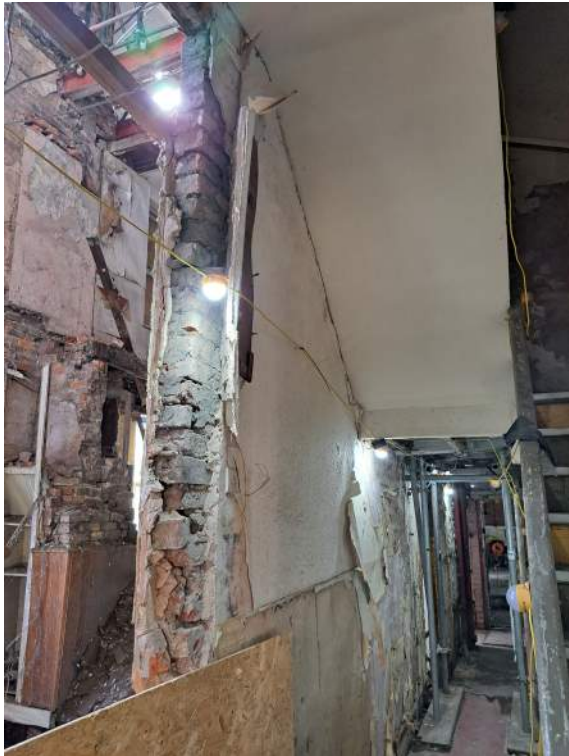
**G11:** The load-bearing masonry wall between the stairs in room G06 and the inaccessible part of room G05 is visibly bowing. The timber floors which were previously providing restraint to this wall at 1<sup>st</sup> and 2<sup>nd</sup> floor are now missing due to a collapse which has occurred in room G05. Due to the wall being of single brick thickness, the degree of lateral deflection means that the wall is likely unstable and at risk of collapse.

**G11:** VISIBLE BOWING OF LOAD-BEARING MASONRY WALL ADJACENT TO STAIRS IN ROOM G06. RESTRAINT TO WALLS FROM FLOORS HAS BEEN LOST DUE TO ADJACENT COLLAPSE WITHIN ROOM G05.

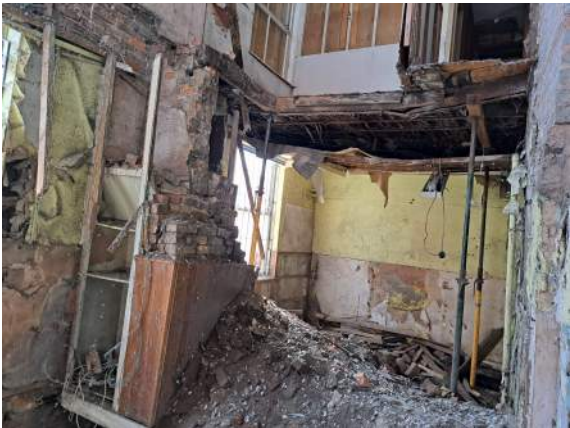
**G12:** LOAD-BEARING MASONRY WALL AND TIMBER FLOORS AT GROUND, 1ST AND 2ND FLOOR HAVE COLLAPSED. SECTION OF GROUND FLOOR IS INACCESSIBLE TO REAR OF ROOM G05. TEMPORARY PROPS HAVE BEEN INSTALLED TO SUPPORT FAILED TIMBER FLOOR ABOVE.

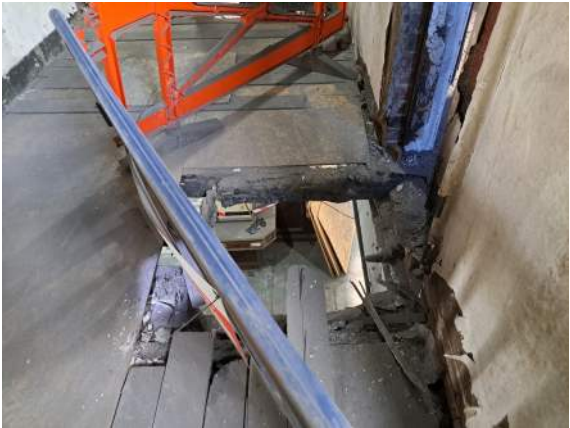
**103:** View of the fire damaged timber floor as seen in photo G01 from ground floor. Due to the fire damage, this area of the building is not safe to access and so it was not possible to inspect the adjacent bathroom during the survey.

**103:** APPARENT FIRE DAMAGE OF TIMBER JOISTS AROUND OPENING THROUGH FLOOR IN ROOM 104. ACCESS INTO ADJACENT BATHROOM IS NOT POSSIBLE DUE TO UNSAFE STRUCTURE.

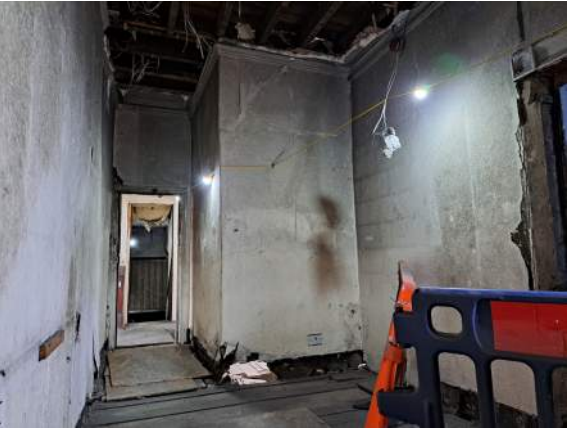
**104:** A section of masonry at the base of a load-bearing wall within room 104 is missing.

**104:** SECTION OF MASONRY MISSING AT BOTTOM CORNER OF LOAD-BEARING WALL WITHIN ROOM 104.

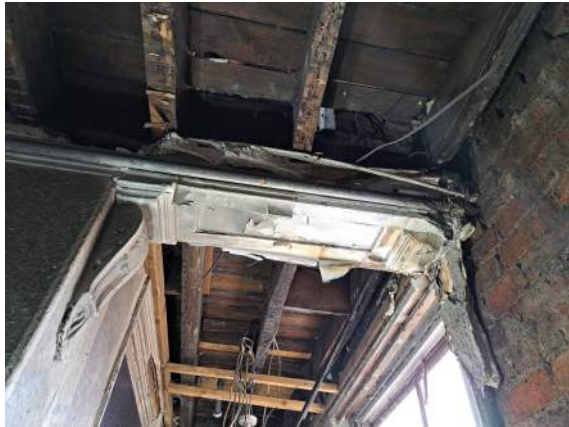
**106:** A tie rod is visible to the underside of 2<sup>nd</sup> floor concealed within a section of cornice over room 104. The end of the tie rod where it passes through the external wall on Woollam Place has corroded.

**106:** TIE ROD TO UNDERSIDE OF 2ND FLOOR HAS BEEN CONCEALED WITHIN CORNICE OVER ROOM 104. SIGNS OF CORROSION WHERE ROD PASSES THROUGH EXTERNAL WALL ON WOOLLAM PLACE.

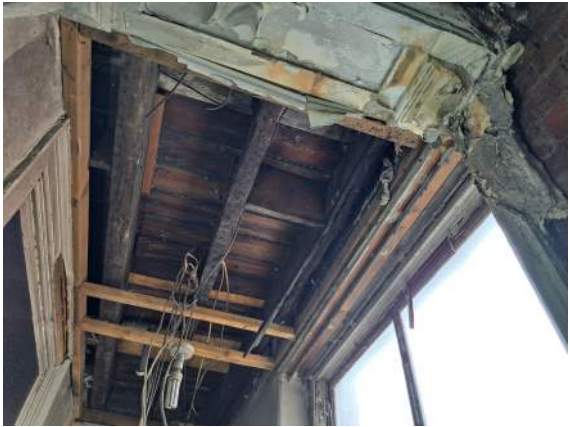
**107:** TIMBER JOIST OVER ROOM 104 ADJACENT TO EXTERNAL WALL ON WOOLLAM PLACE HAS DECAYED DUE TO WATER INGRESS.

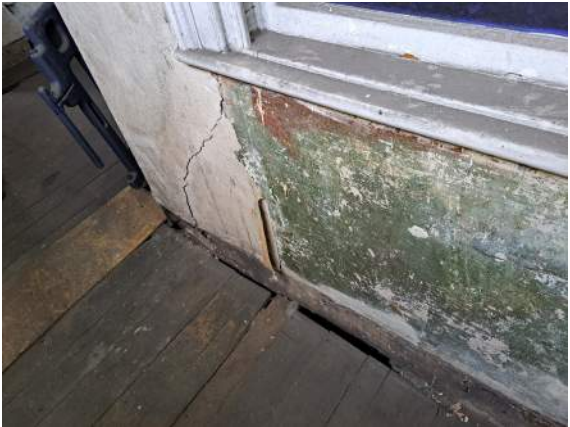
**108/10:** Minor cracking of wall finishes is apparent in some locations at 1<sup>st</sup> floor within 125 Liverpool Road. It is not clear whether this cracking is also present in the masonry behind.

**108:** CRACKING UNDER INTERNAL WINDOW OPENING SEPARATING ROOM 104 FROM INACCESSIBLE BATHROOM.

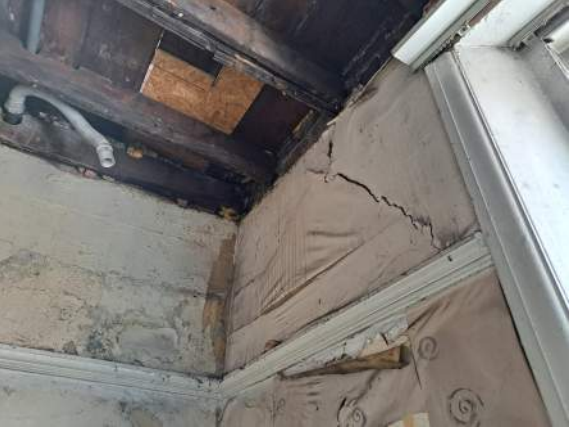
**110:** CRACKING OF FINISHES ON INTERNAL FACE OF EXTERNAL WALL ON WOOLLAM PLACE IN ROOM 105.

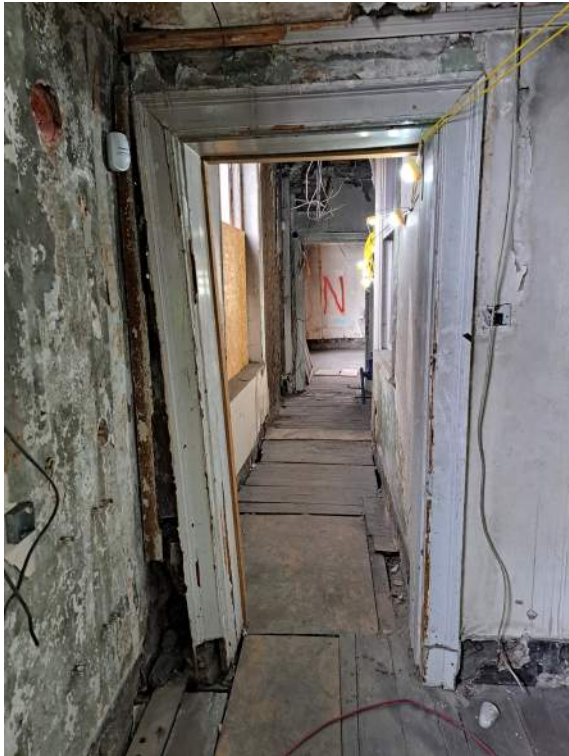
**111:** VISIBLE DISTORTION OF DOOR FRAME BETWEEN ROOMS 104 AND 109 IN RELATION TO ADJACENT EXTERNAL WALL ON WOOLLAM PLACE WHICH SHOWS SIGNS OF MOVEMENT.

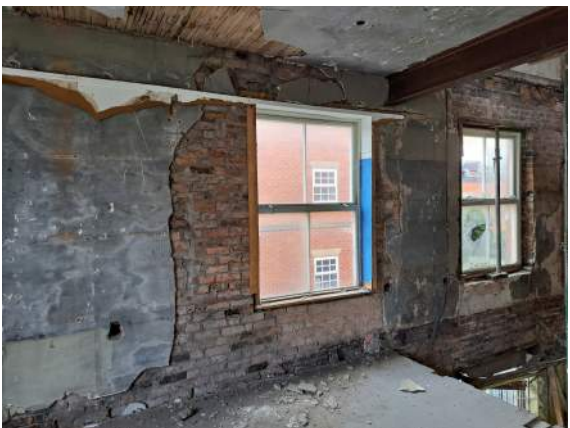
**113/14:** The masonry on the internal face of the external wall on Old Medlock Street adjacent to the inaccessible part of room 107 is in variable condition with cracking above a window opening also noted.

**113:** CRACKING OF MASONRY OVER WINDOW OPENING WITHIN INACCESSIBLE AREA OF ROOM 107 ON OLD MEDLOCK STREET ELEVATION.

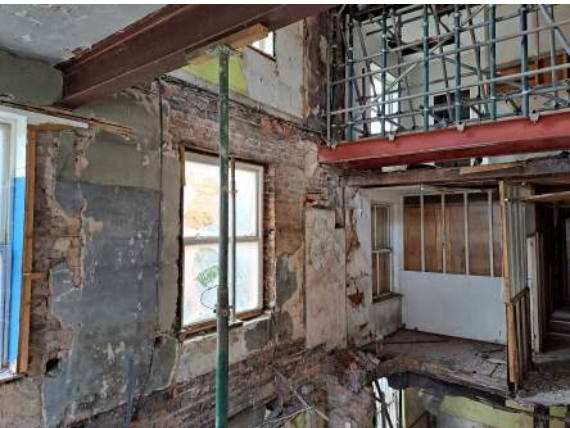
**114:** MASONRY ON INTERNAL FACE OF EXTERNAL WALL IS IN VARIABLE CONDITION ADJACENT TO COLLAPSE ZONE WITHIN REAR SECTION OF 123 LIVERPOOL ROAD. EVIDENCE THAT TIE RODS HAVE ALSO FAILED WHEN FLOOR HAS COLLAPSED.

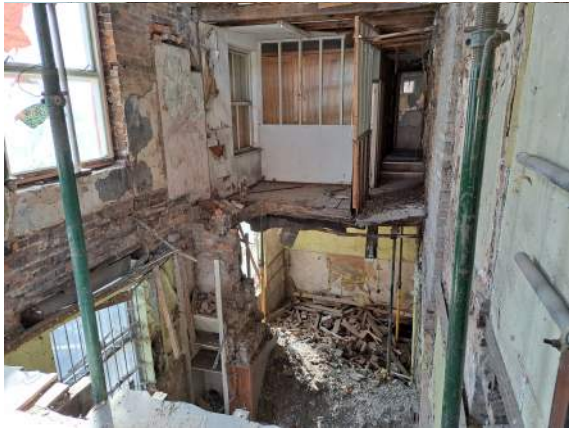
**115:** The partition walls to the rear of the inaccessible part of room 107 appear to be unstable due to the partial failure of the underlying joists that remain adjacent to the line of the load-bearing wall that has previously collapsed.

**115:** 1ST FLOOR HAS COLLAPSED IN ROOM 107. THE PARTITION WALLS WITHIN THE INACCESSIBLE AREA TO THE REAR OF 123 LIVERPOOL ROAD APPEAR TO BE UNSTABLE DUE TO FAILURE OF TIMBER JOISTS BELOW.

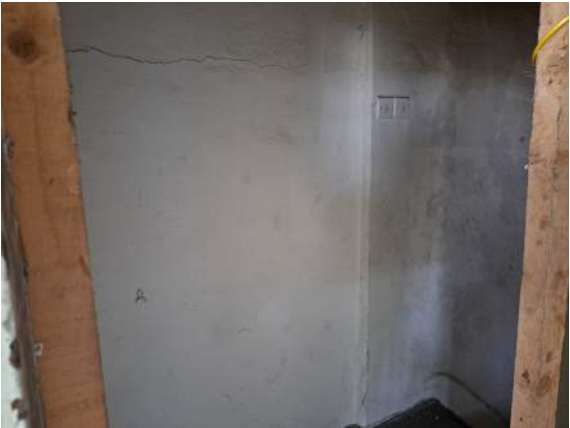
**116:** Horizontal cracking has formed across the face of the load-bearing wall within the stair core adjacent to the inaccessible part of room 107. This suggests that a failure mechanism is occurring similar to that in the lower portion of the wall shown in photo G11.

**116:** HORIZONTAL CRACK ACROSS THE FACE OF THE LOAD-BEARING MASONRY WALL FROM WITHIN THE STAIRS ADJACENT TO THE INACCESSIBLE PART OF ROOM 107.

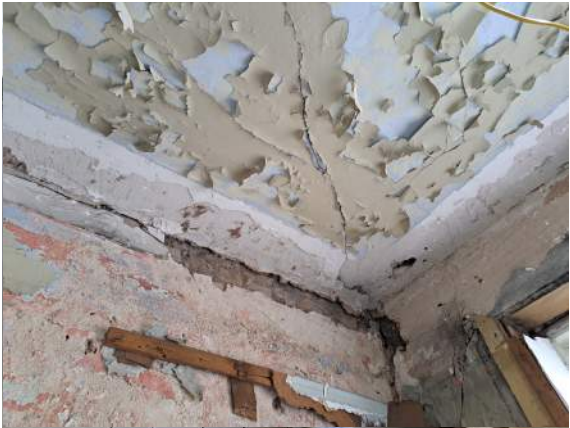
**117:** The ceiling finishes over room 107 exhibit extensive cracking. However, there is no sign of structural distress in the floor finishes at 2<sup>nd</sup> floor above. A gap has also opened up between the ceiling and the internal wall separating 123 and 125 Liverpool Road.

**117:** EXTENSIVE CRACKING OF CEILING FINISHES OVER ROOM 107. A GAP ALSO APPEARS TO HAVE OPENED UP BETWEEN THE CEILING AND THE INTERNAL WALL SEPARATING 123 AND 125 LIVERPOOL ROAD.

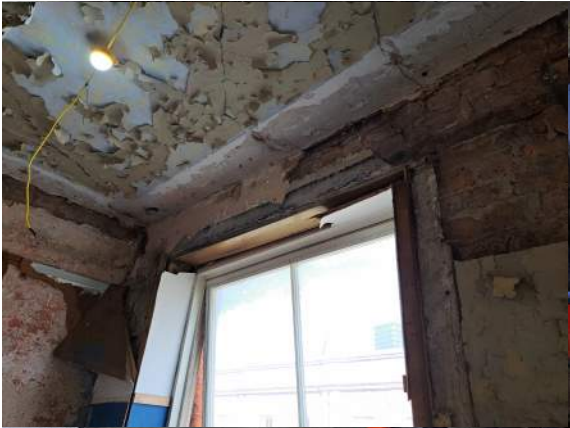
**118:** THE LINTEL AND MASONRY OVER A WINDOW OPENING ON THE LIVERPOOL ROAD ELEVATION OF ROOM 107 APPEARS TO HAVE DIPPED AT ONE END.

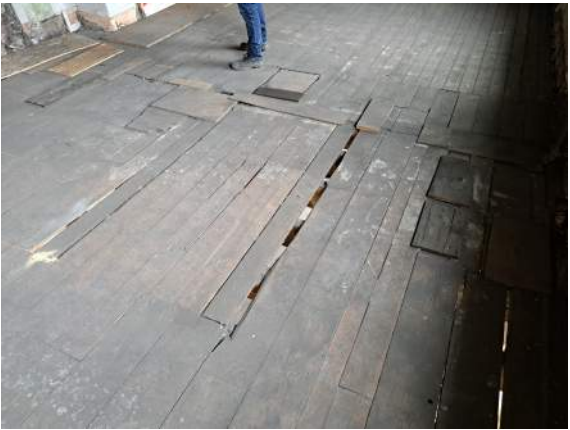
**202:** The floorboards within room 203 are in variable condition and have been subject to patch repairs. This is a recurring issue throughout the 1<sup>st</sup> and 2<sup>nd</sup> floor of 125 Liverpool Road.

**202:** FLOOR BOARDS WITHIN ROOM 203 ARE IN VARIABLE CONDITION AND HAVE BEEN SUBJECT TO PATCH REPAIRS.

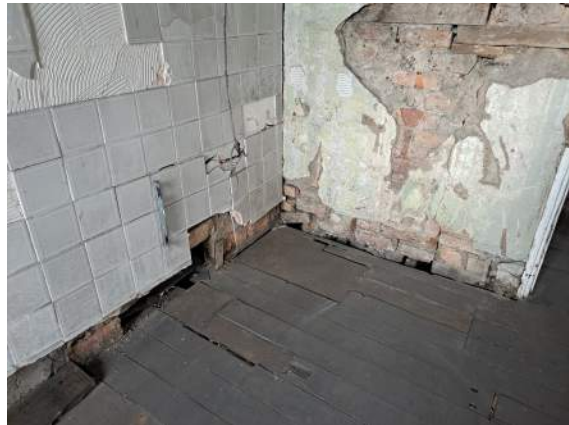
**206:** The masonry partitions through the 2<sup>nd</sup> floor of 125 Liverpool Road are in variable condition.

**206:** DAMAGE TO MASONRY PARTITIONS IN ROOM 204. THE PARTITIONS ARE IN VARIABLE CONDITION THROUGHOUT THE 2ND FLOOR OF 125 LIVERPOOL ROAD.

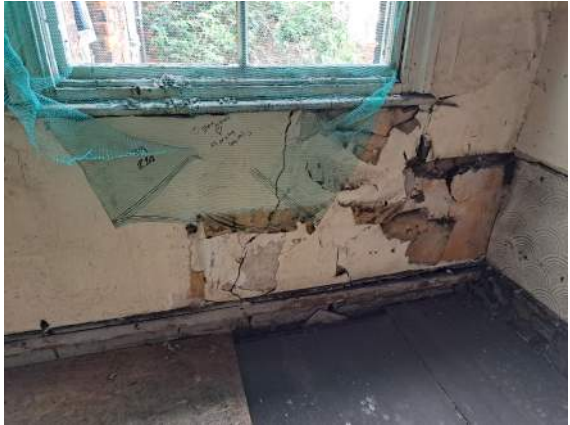
**207:** VERTICAL CRACK UNDER WINDOW OPENING ON THE EAST ELEVATION OF ROOM 204.

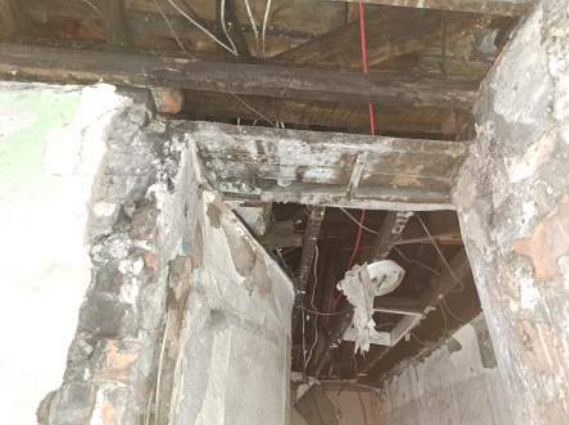
**210:** TIMBER LINTEL OVER DOOR OPENING BETWEEN ROOMS 202 AND 206 IS DECAYED.

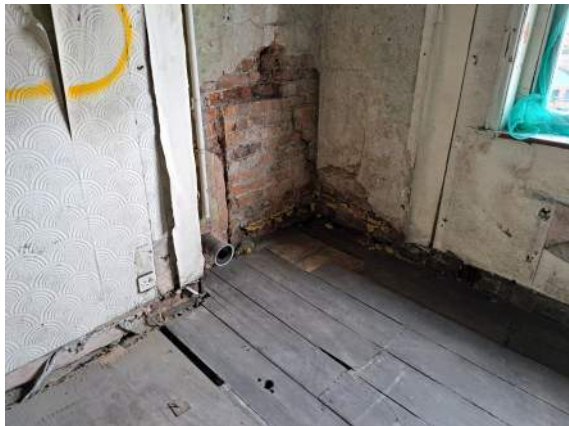
**211:** CRACKING OF MASONRY ON REAR ELEVATION OF ROOM 206.

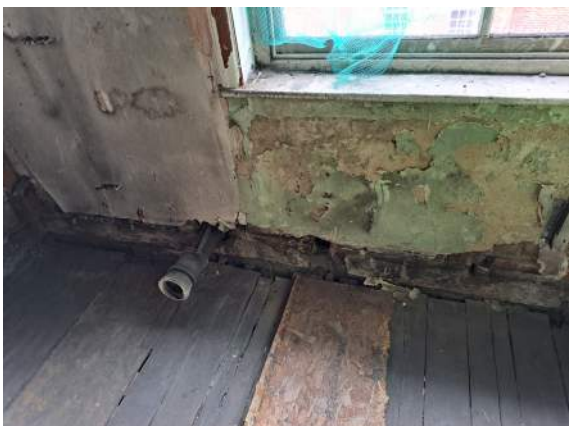
**212:** GAP BETWEEN TIMBER FLOOR AND EXTERNAL WALL ON WOOLLAM PLACE IN ROOM 205.

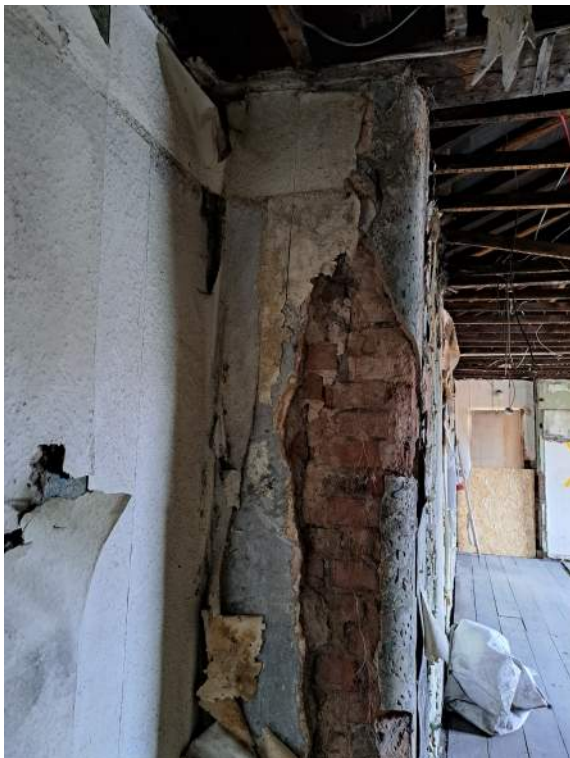
**214:** VERTICAL CRACK IN MASONRY ADJACENT TO DOOR OPENING INTO ROOM 206 AS SEEN FROM ROOM 202.

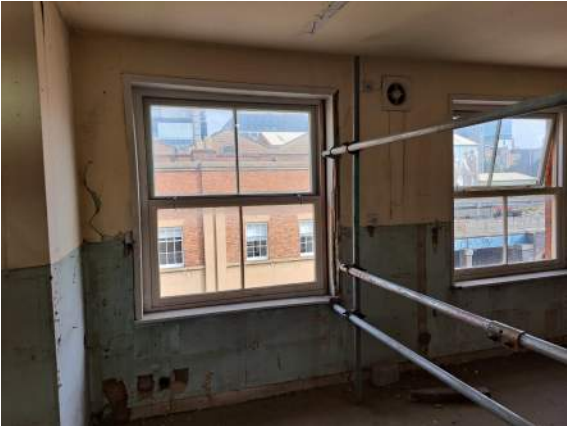
**216:** MINOR CRACKING AROUND WINDOW OPENING IN EXTERNAL WALL ON LIVERPOOL ROAD AS VIEWED FROM WITHIN ROOM 208.

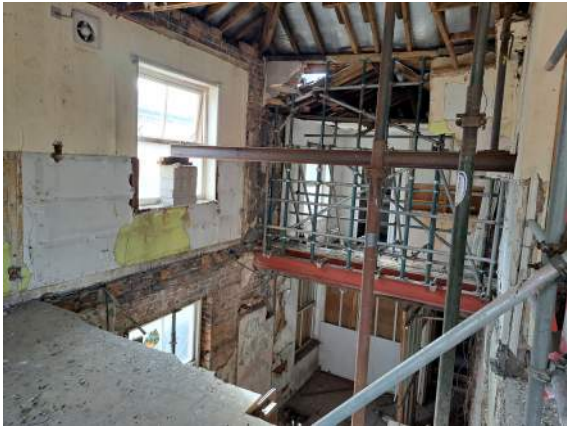
**217:** VIEW OF COLLAPSE AT 2ND FLOOR. RENAISSANCE HAVE DESIGNED TEMPORARY PROPPING TO SUPPORT SECTION OF ROOF ON LINE OF COLLAPSED WALL AS PART OF INITIAL MAKING SAFE WORKS. PROPPING HAS ALSO BEEN INSTALLED HISTORICALLY DESIGNED BY OTHERS.
