**PHASE II GEOENVIRONMENTAL SITE INVESTIGATION  
AND INTERPRETATIVE REPORT  
OF LAND AT  
DEANSGATE 325  
MANCHESTER**

**GeoCon Site Investigations Ltd  
Suite 2 Marple House,  
39 Stockport Road,  
Marple  
Stockport  
SK6 6BD**

**March 2023  
Ref: GSI 1813 HH GI Report V1**

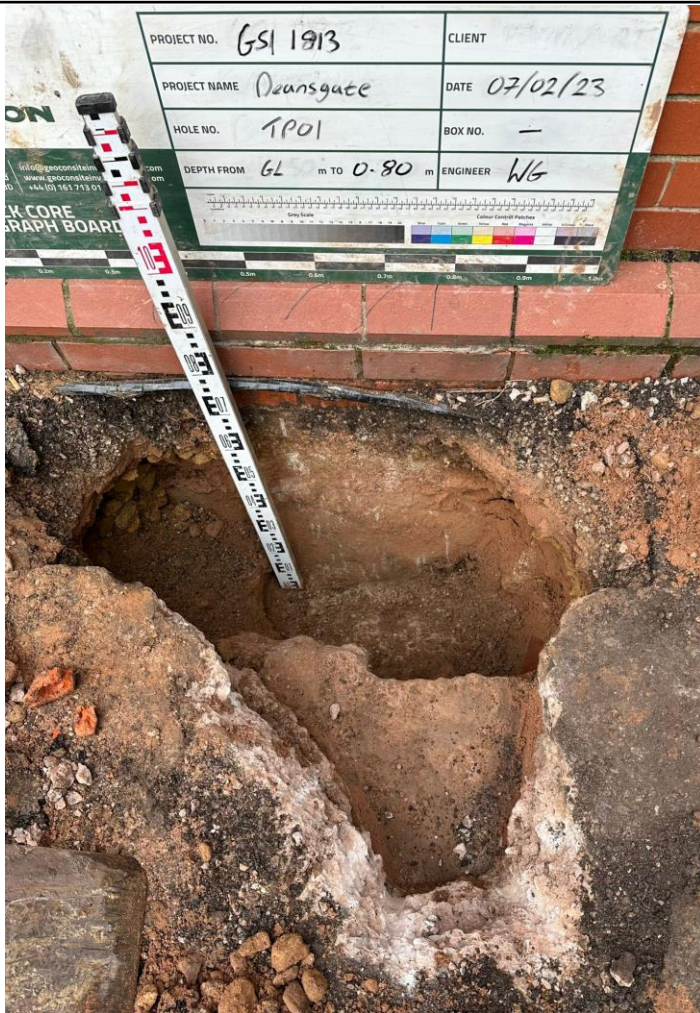
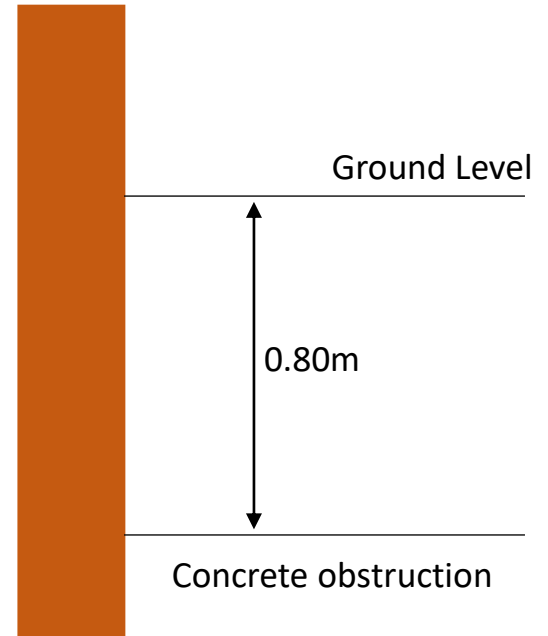
TP01: 0.00 – 0.80mbgl

| Remarks: Location broken out. Location hand excavated to 0.80mbgl where concrete observed. | | | | | | | | |

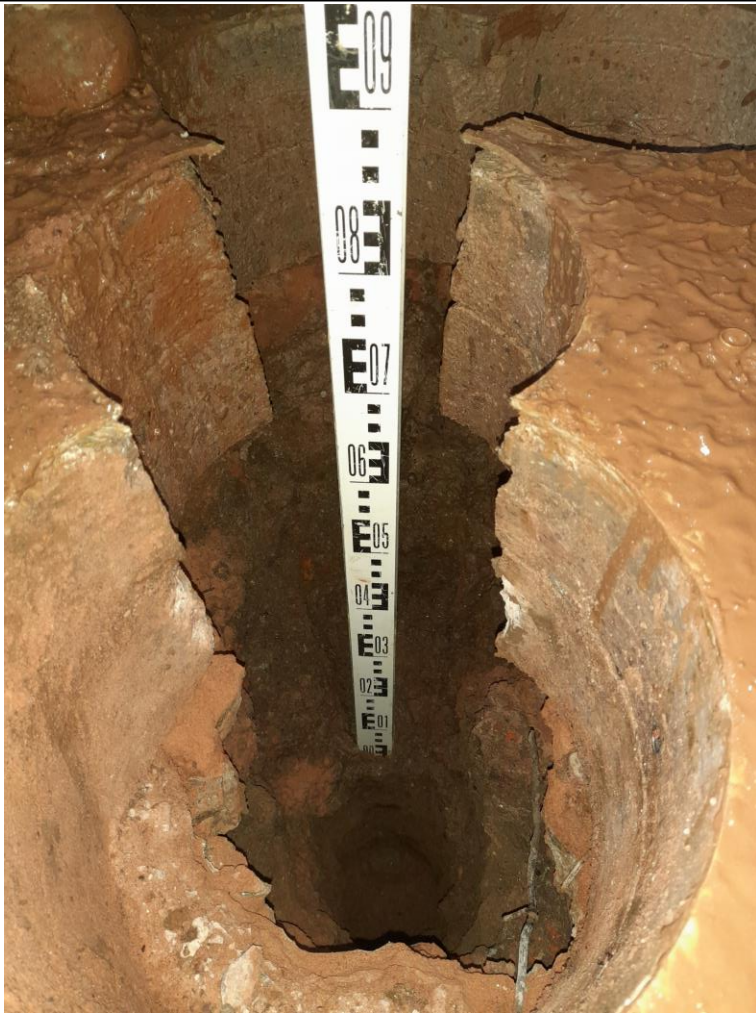
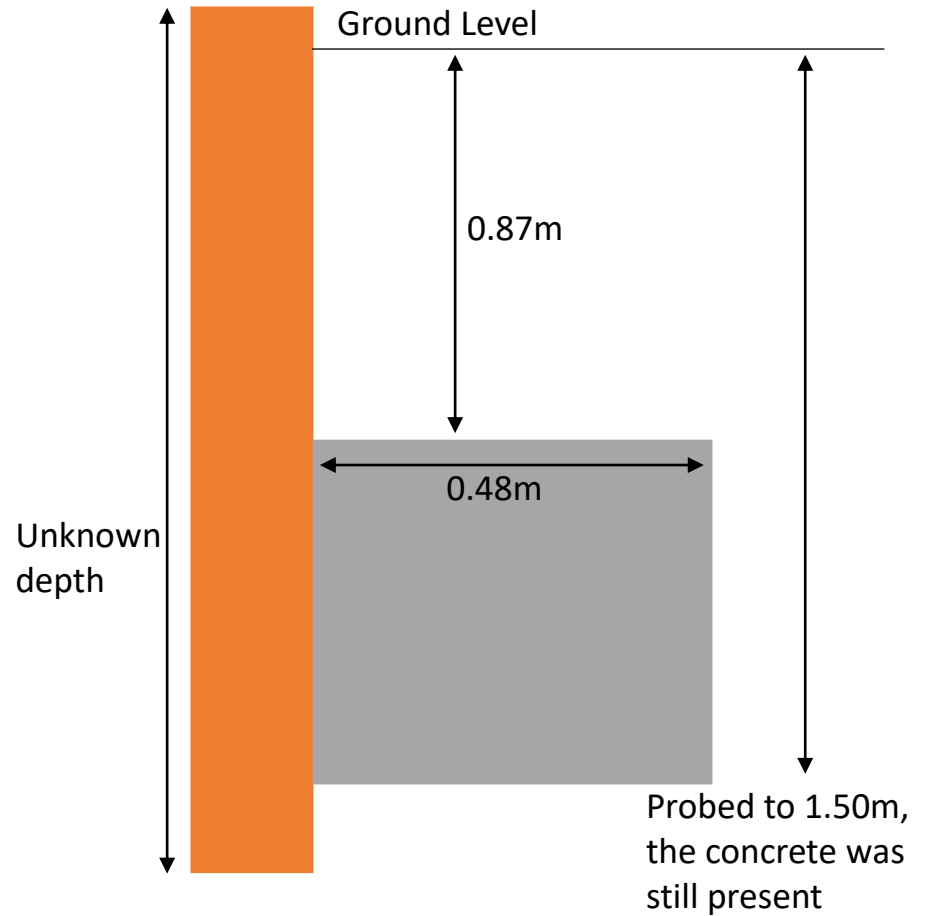
TP03: 0.00 – 1.25mbgl

| Remarks: Location concrete cored. Location hand excavated to 0.87mbgl where concrete observed. Hand excavated down the side of the concrete to 1.25mbgl, from this depth probing carried out to 1.50mbgl where concrete still present. No step out of concrete. | | | | | | | | |

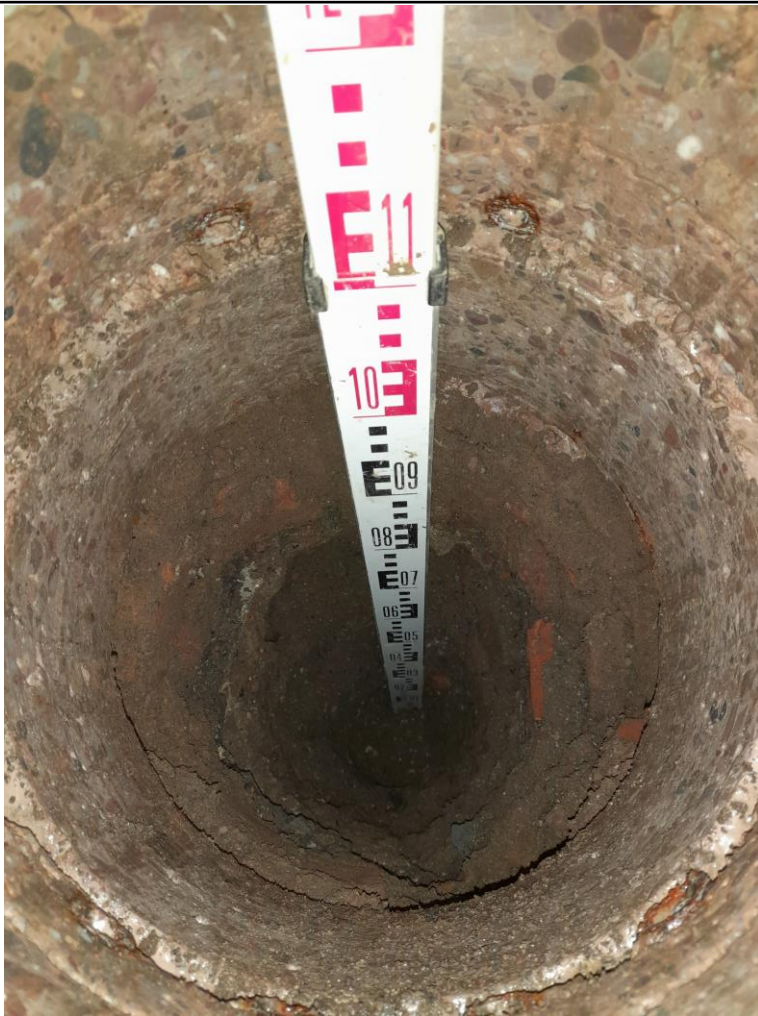
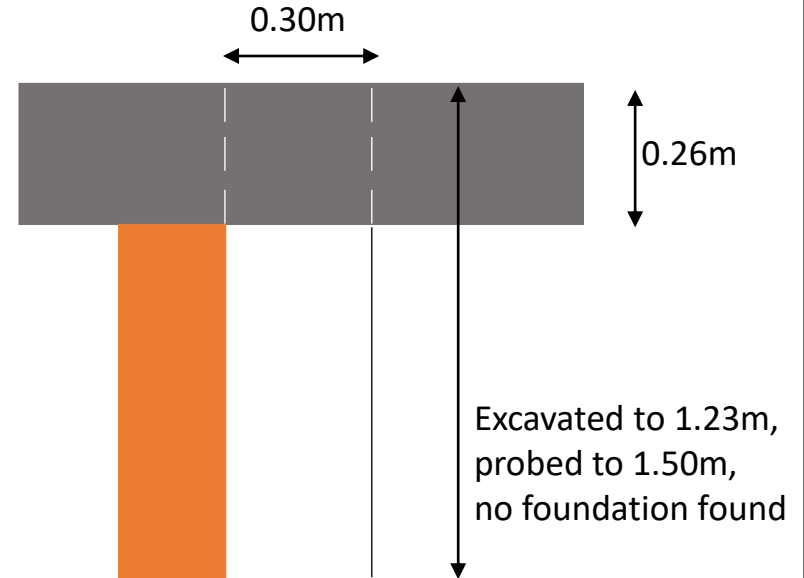
TP04: 0.00 – 1.23mbgl

| Hole Diameter | | Casing Diameter | | Chiselling | | | | Inclination and Orientation | | | | Drilling Flush | | | | | |
|---|---|---|---|---|---|---|---|---|---|---|---|---|---|---|---|---|---|
| Dynamic probe advanced through TP04 to locate foundation. | | | | | | | | | | | | | | | | | |

| Remarks: Location concrete cored. Location hand excavated to 1.23mbgl, from this depth probing carried out to 1.50mbgl where no concrete observed. | | | | | | | | |

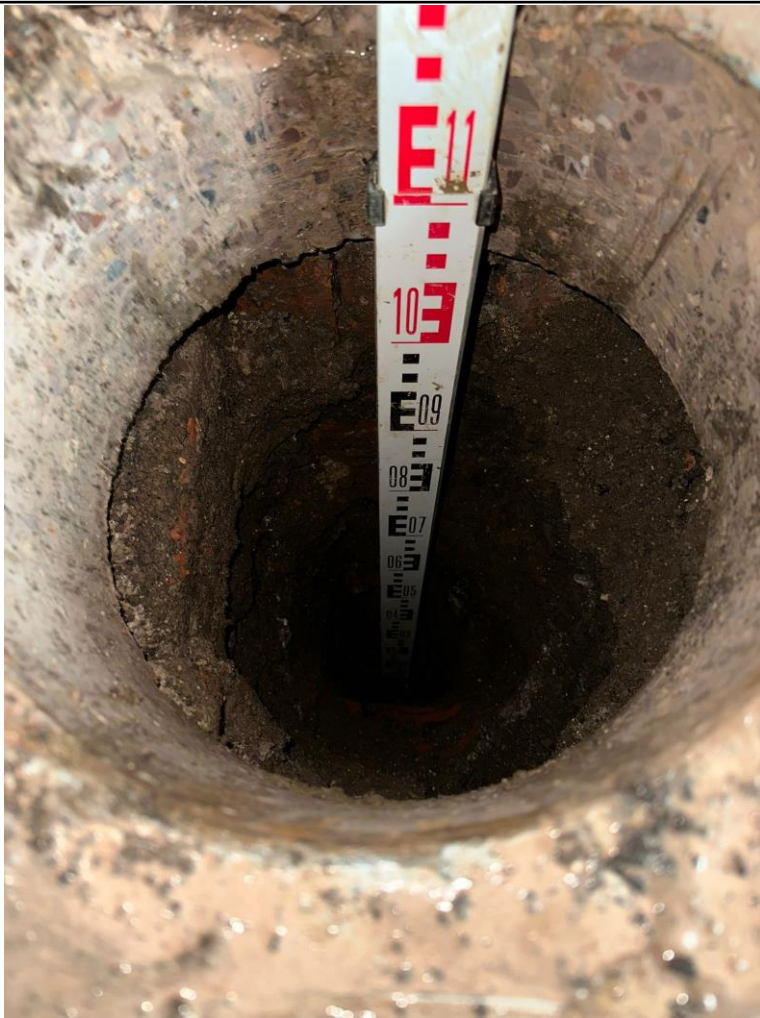
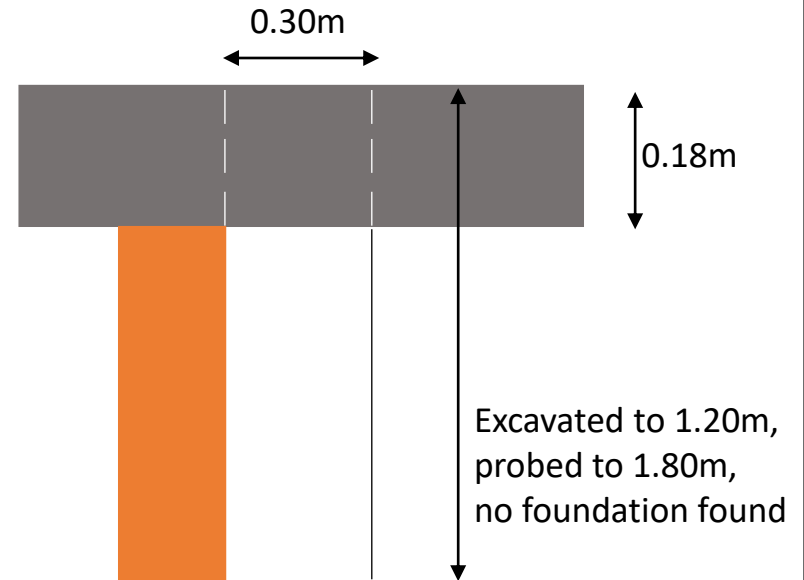
TP05: 0.00 – 1.20mbgl

Dynamic probe advanced through TP05 to locate foundation.
