## Technical Note 3

| Project Name: | Fraser House |
| Document No: | LM21346-DYSE-XX-ZZ-TN-S-0003 |
| Content: | Sustainable Urban Drainage Strategy |

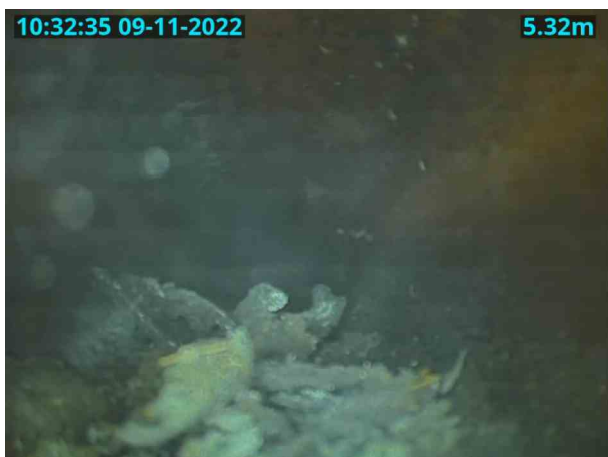
| Scale: | 1:53 | Position [m] | Code | Observation | MPEG | Photo | Grade |
|---|---|---|---|---|---|---|---|
| | | 5.32 | DES | Settled deposits, fine, 10% cross-sectional area loss | 00:00:38 | RE 1X_529fea-f0-5f7e-49 | 3 |

1X\_529feaf0-5f7e-4972-b3bc-b78d09d2556a\_20221126\_1034  
53\_712.jpg, 00:00:38, 5.32 m

Settled deposits, fine, 10% cross-sectional area loss

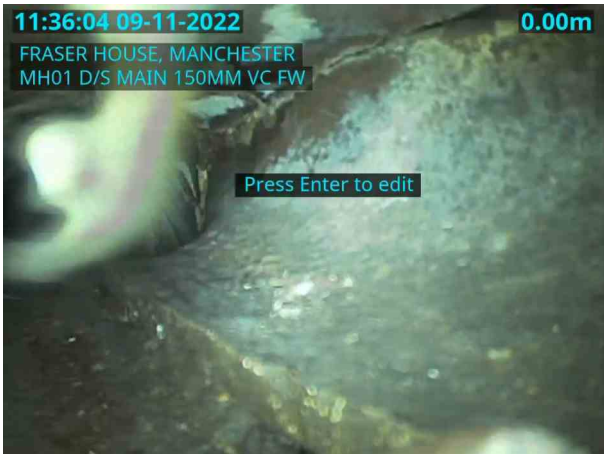
| Scale: | 1:50 | Position [m] | Code | Observation | MPEG | Photo | Grade |
|---|---|---|---|---|---|---|---|
| | | 0.01 | B | Broken pipe from 2 o'clock to 6 o'clock | 00:00:05 | MH 01X_9495520f-13f5- | 4 |

MH  
01X\_9495520f-13f5-4970-9f07-6edb2390ad7b\_20221126\_10  
5153\_408.jpg, 00:00:05, 0.01 m  
Broken pipe from 2 o'clock to 6 o'clock

Grade 4: Best practice suggests consideration should be given to repairs to avoid a potential collapse.

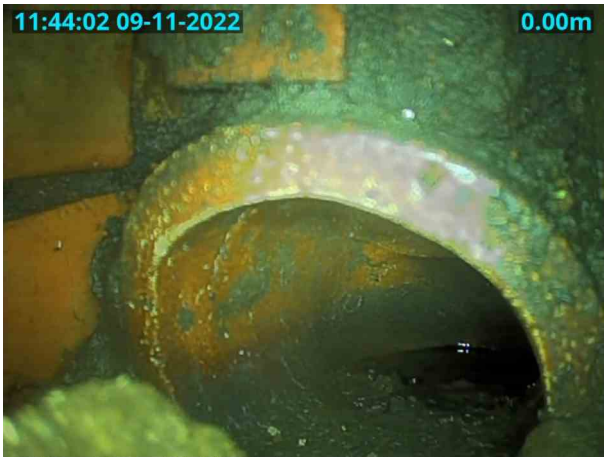
A  
PIPEX\_64e917a8-7065-458f-a29d-cb9614f4c08a\_20221126\_  
105820\_790.jpg, 00:00:18, 0.50 m  
Survey abandoned, DEBRIS

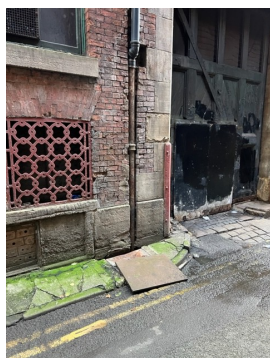
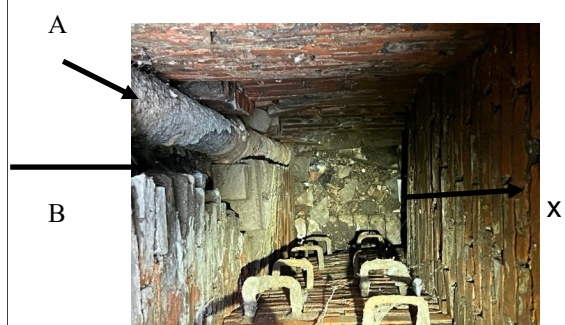
Remarks: Cover broken Step irons poor  
Chamber full of debris- requires cleaning

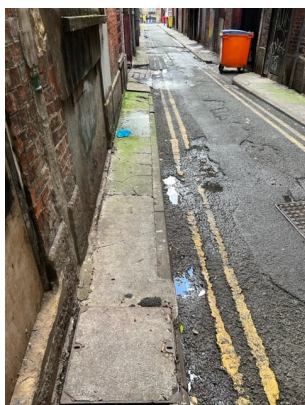
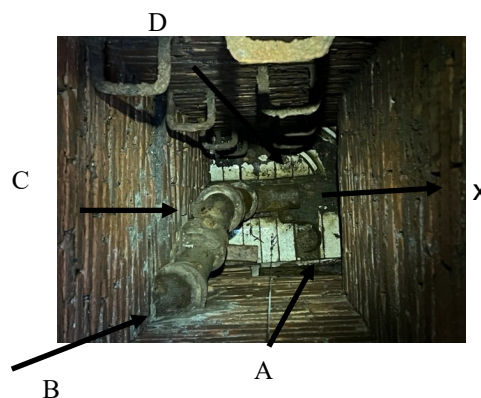
Remarks: NO CONFINED SPACE ENTRY DUE TO ACCESS SPACE 350X450mm

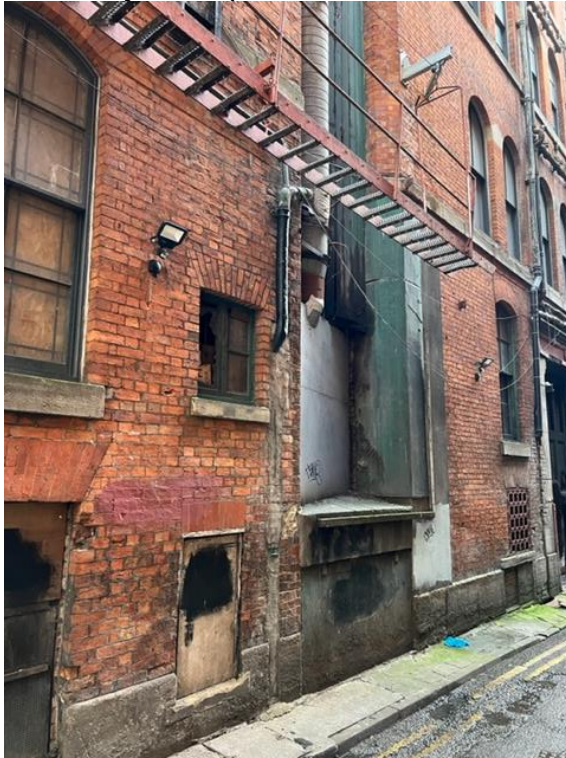
Photo 1, A number of external pipes located to the side of the building, ultimately end up in MH01 and MH02

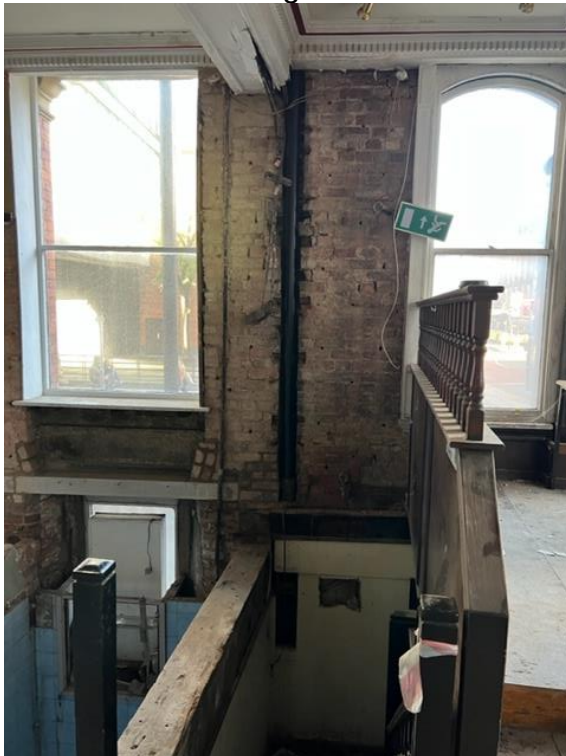
Photo 2, A number of rainwater pipes have been exposed in the wall - assumed to discharge to MH02 and MH01

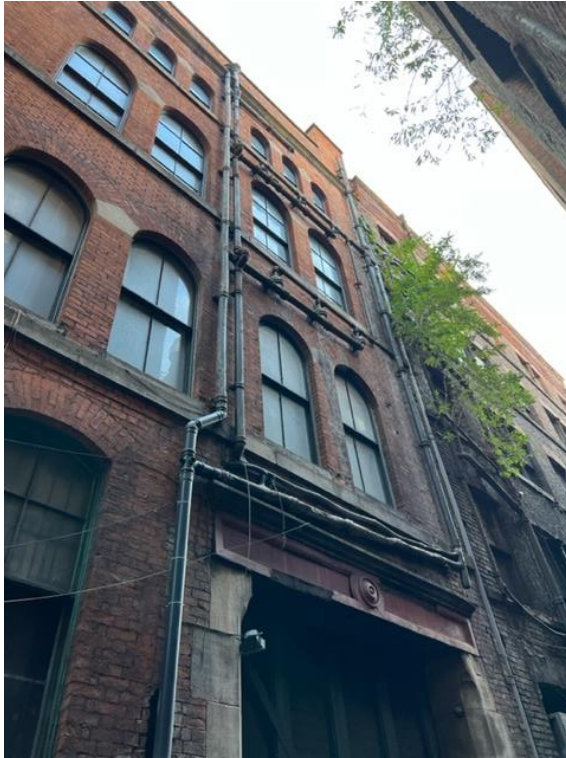
Photo 3, All foul water drainage from upper floor levels is located on the external walls.

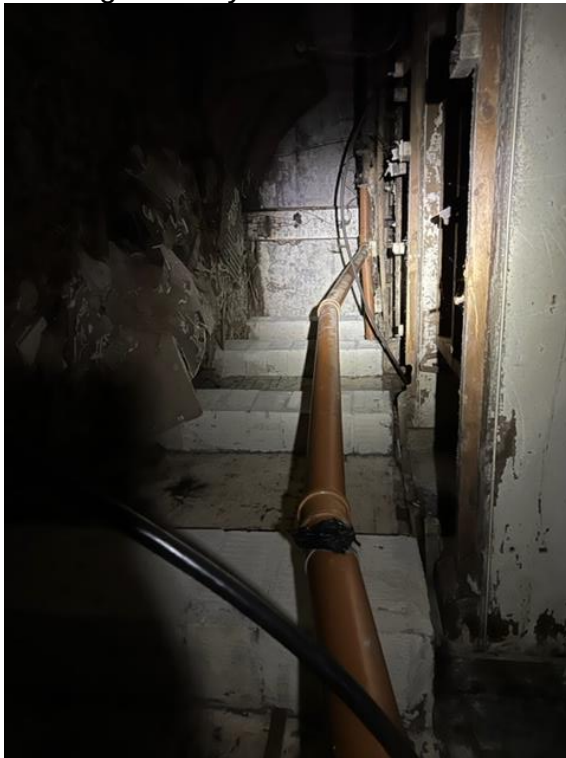
Photo 4, Drainage located in basement - RE1 and RE2 from the CCTV Drainage Survey

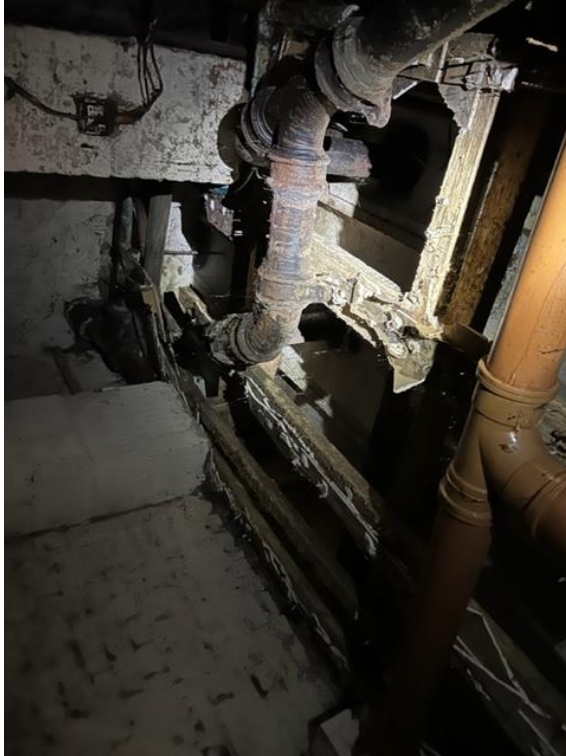
Photo 5, Drainage located in basement - RE2

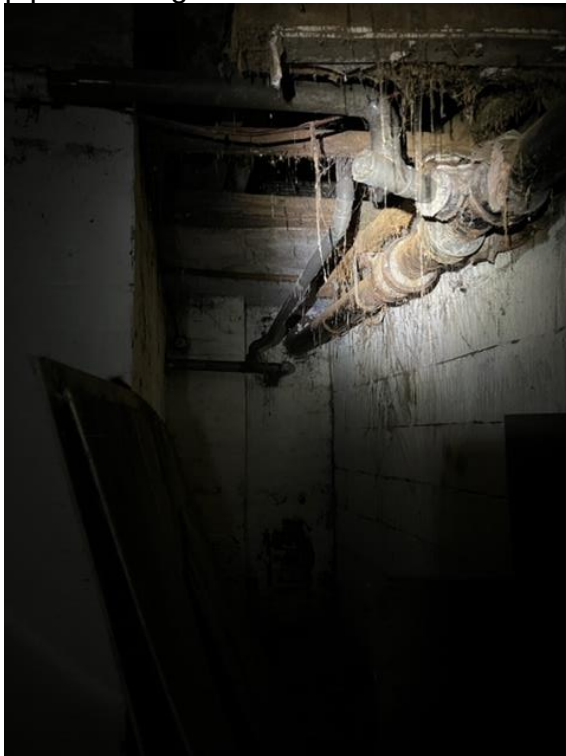
Photo 6, Drainage located in basement - this picture shows the main outfall pipe heading towards MH01

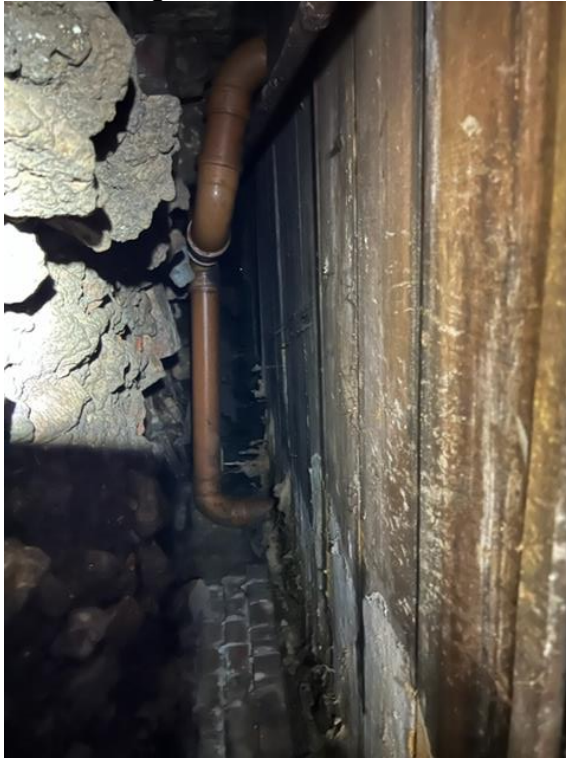
Photo 7, Drainage pipes under the Lower Ground Floor - previously served the existing toilets

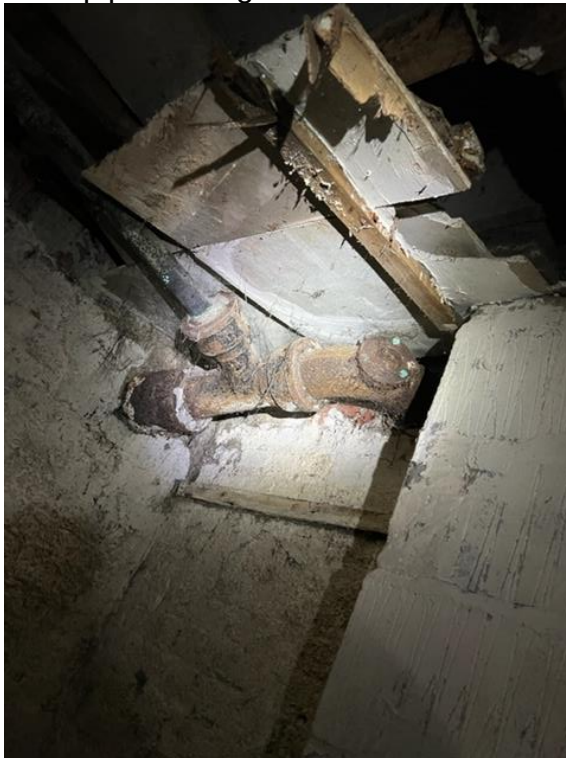
Photo 8, Picture shows the point where the basement sump connects to the main pipe leaving site

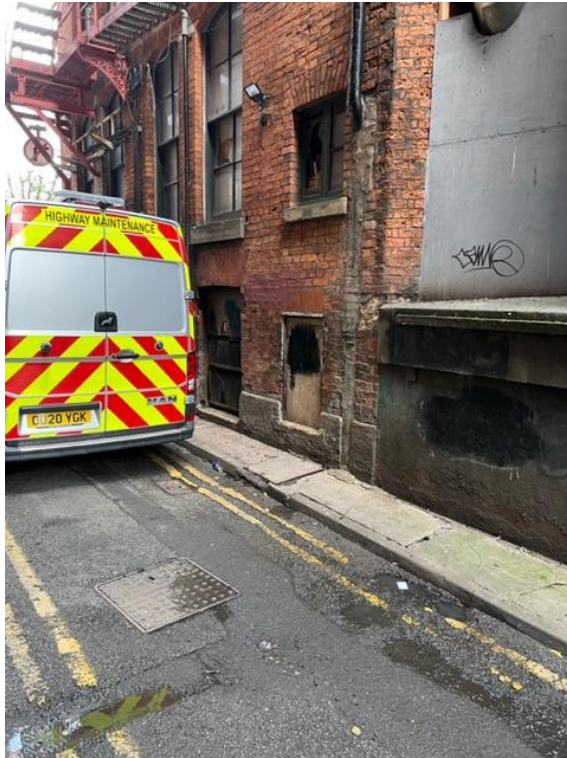
Photo 9, Public sewer manhole location

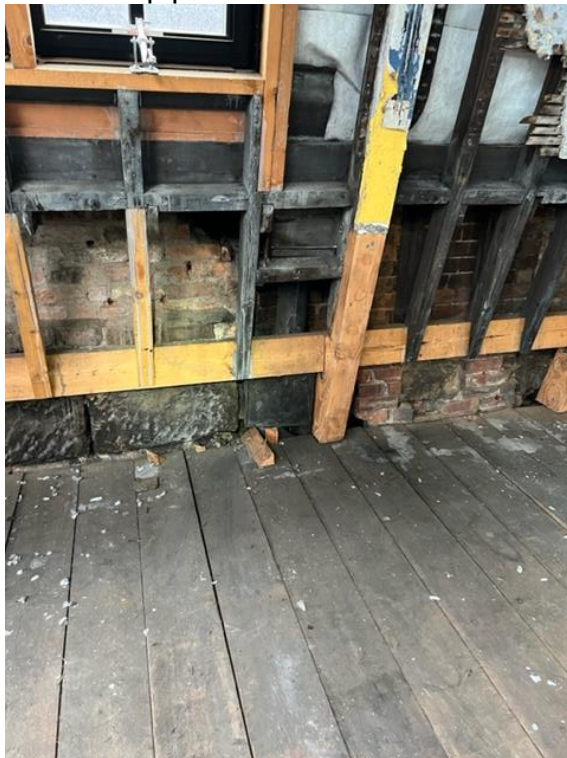
Photo 10, Rainwater pipe hoppers located on the top floor of the building, all discharge directly down to below ground drainage. No access points to rainwater pipes.

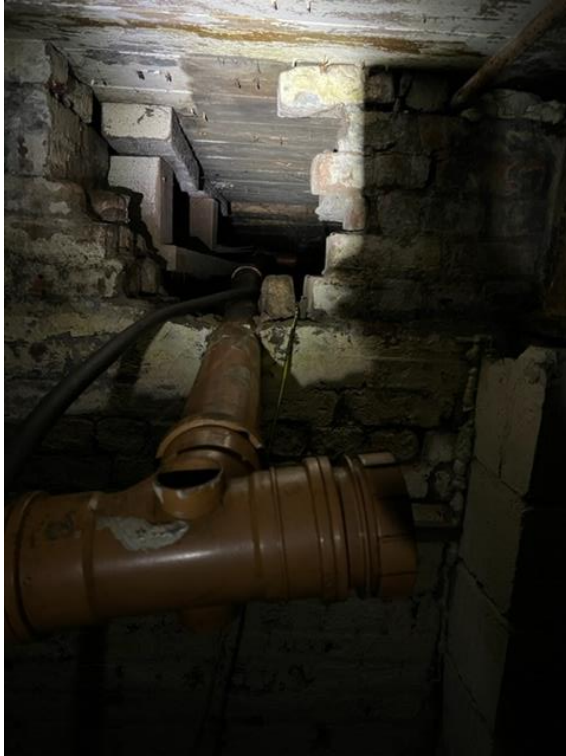
Photo 11, RE1 (rodding point 1) view heading up towards existing toilets

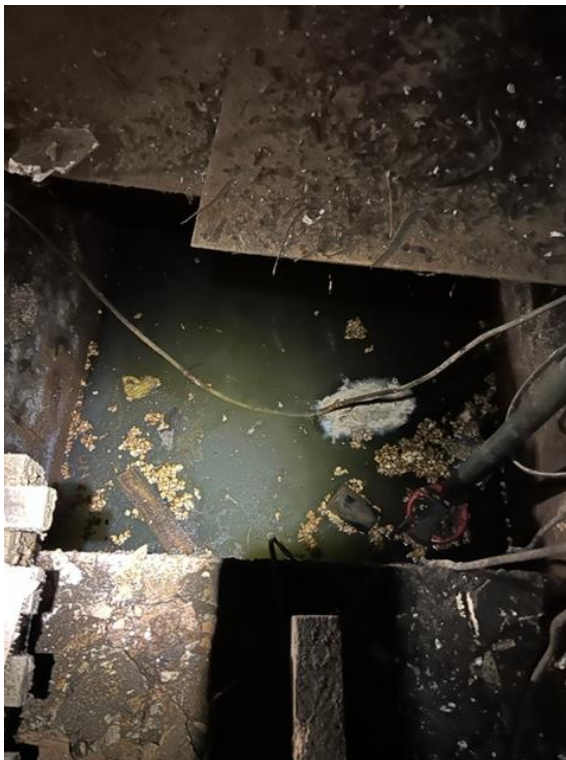
Photo 12, Sump pit located in basement - pumps out to MH2. Believed to be abandoned and disconnected.

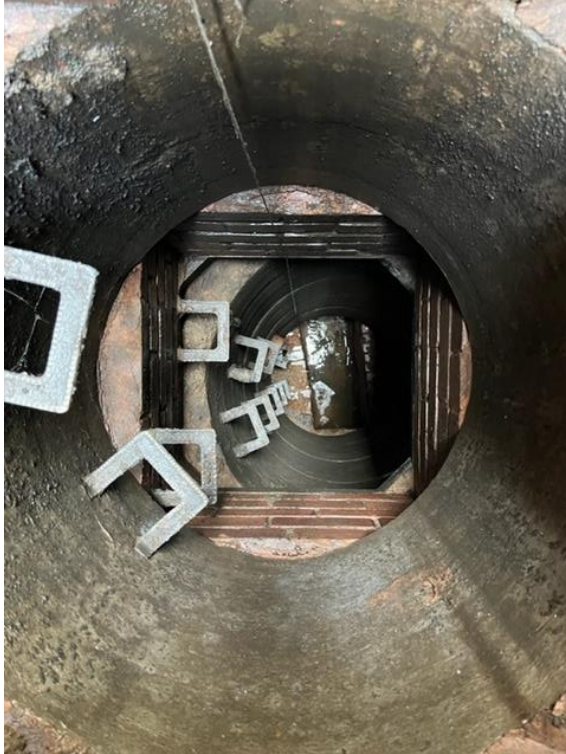
Photo 13, View down public sewer manhole - depth of manhole is 5.18m
