**LOWER CAMPFIELDS BUILDING**  
**LIVERPOOL ROAD, MANCHESTER**  
**STRUCTURAL APPRAISAL OF EXISTING ROOF**  
**SECOND ISSUE**

**JANUARY 2023**

**PROJECT REF: TM/22/1334**

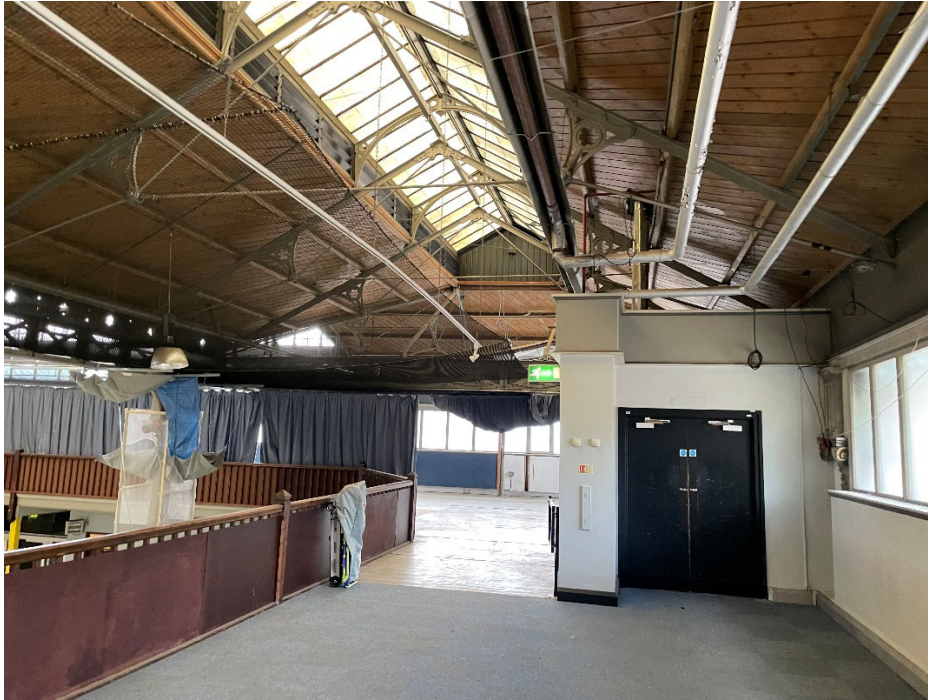
**Figure 4 - Tiled Duo Pitch Roof to Perimeter**

A tiled roof covering is provided to all pitched roof areas and to the lower section of the glazed central arched lantern roof. The remaining roof areas comprise glazing supported by glazing bars bearing on to the structure. The tiled areas are underdrawn with solid timber boarding assumed 25mm thick arranged in a chevron formation. It is assumed that the existing tiles are supported on tiling battens directly affixed to the boarding. It is these areas which are considered for the new roof covering.

It is assumed that the insulation will be introduced between the solid board under-drawing and the tiled finish. This will require the existing tiling battens to be removed and the new tiles being supported on a raised system above the insulation such a rails or battens on a 'helping hand' bracket system.

It is therefore proposed that the replacement roof covering be of a similar lightweight construction. The following Eternit 'Rivendale' fibre cement tiles have been assumed as typical of this type of material, salient product details are indicated below in Figure 7

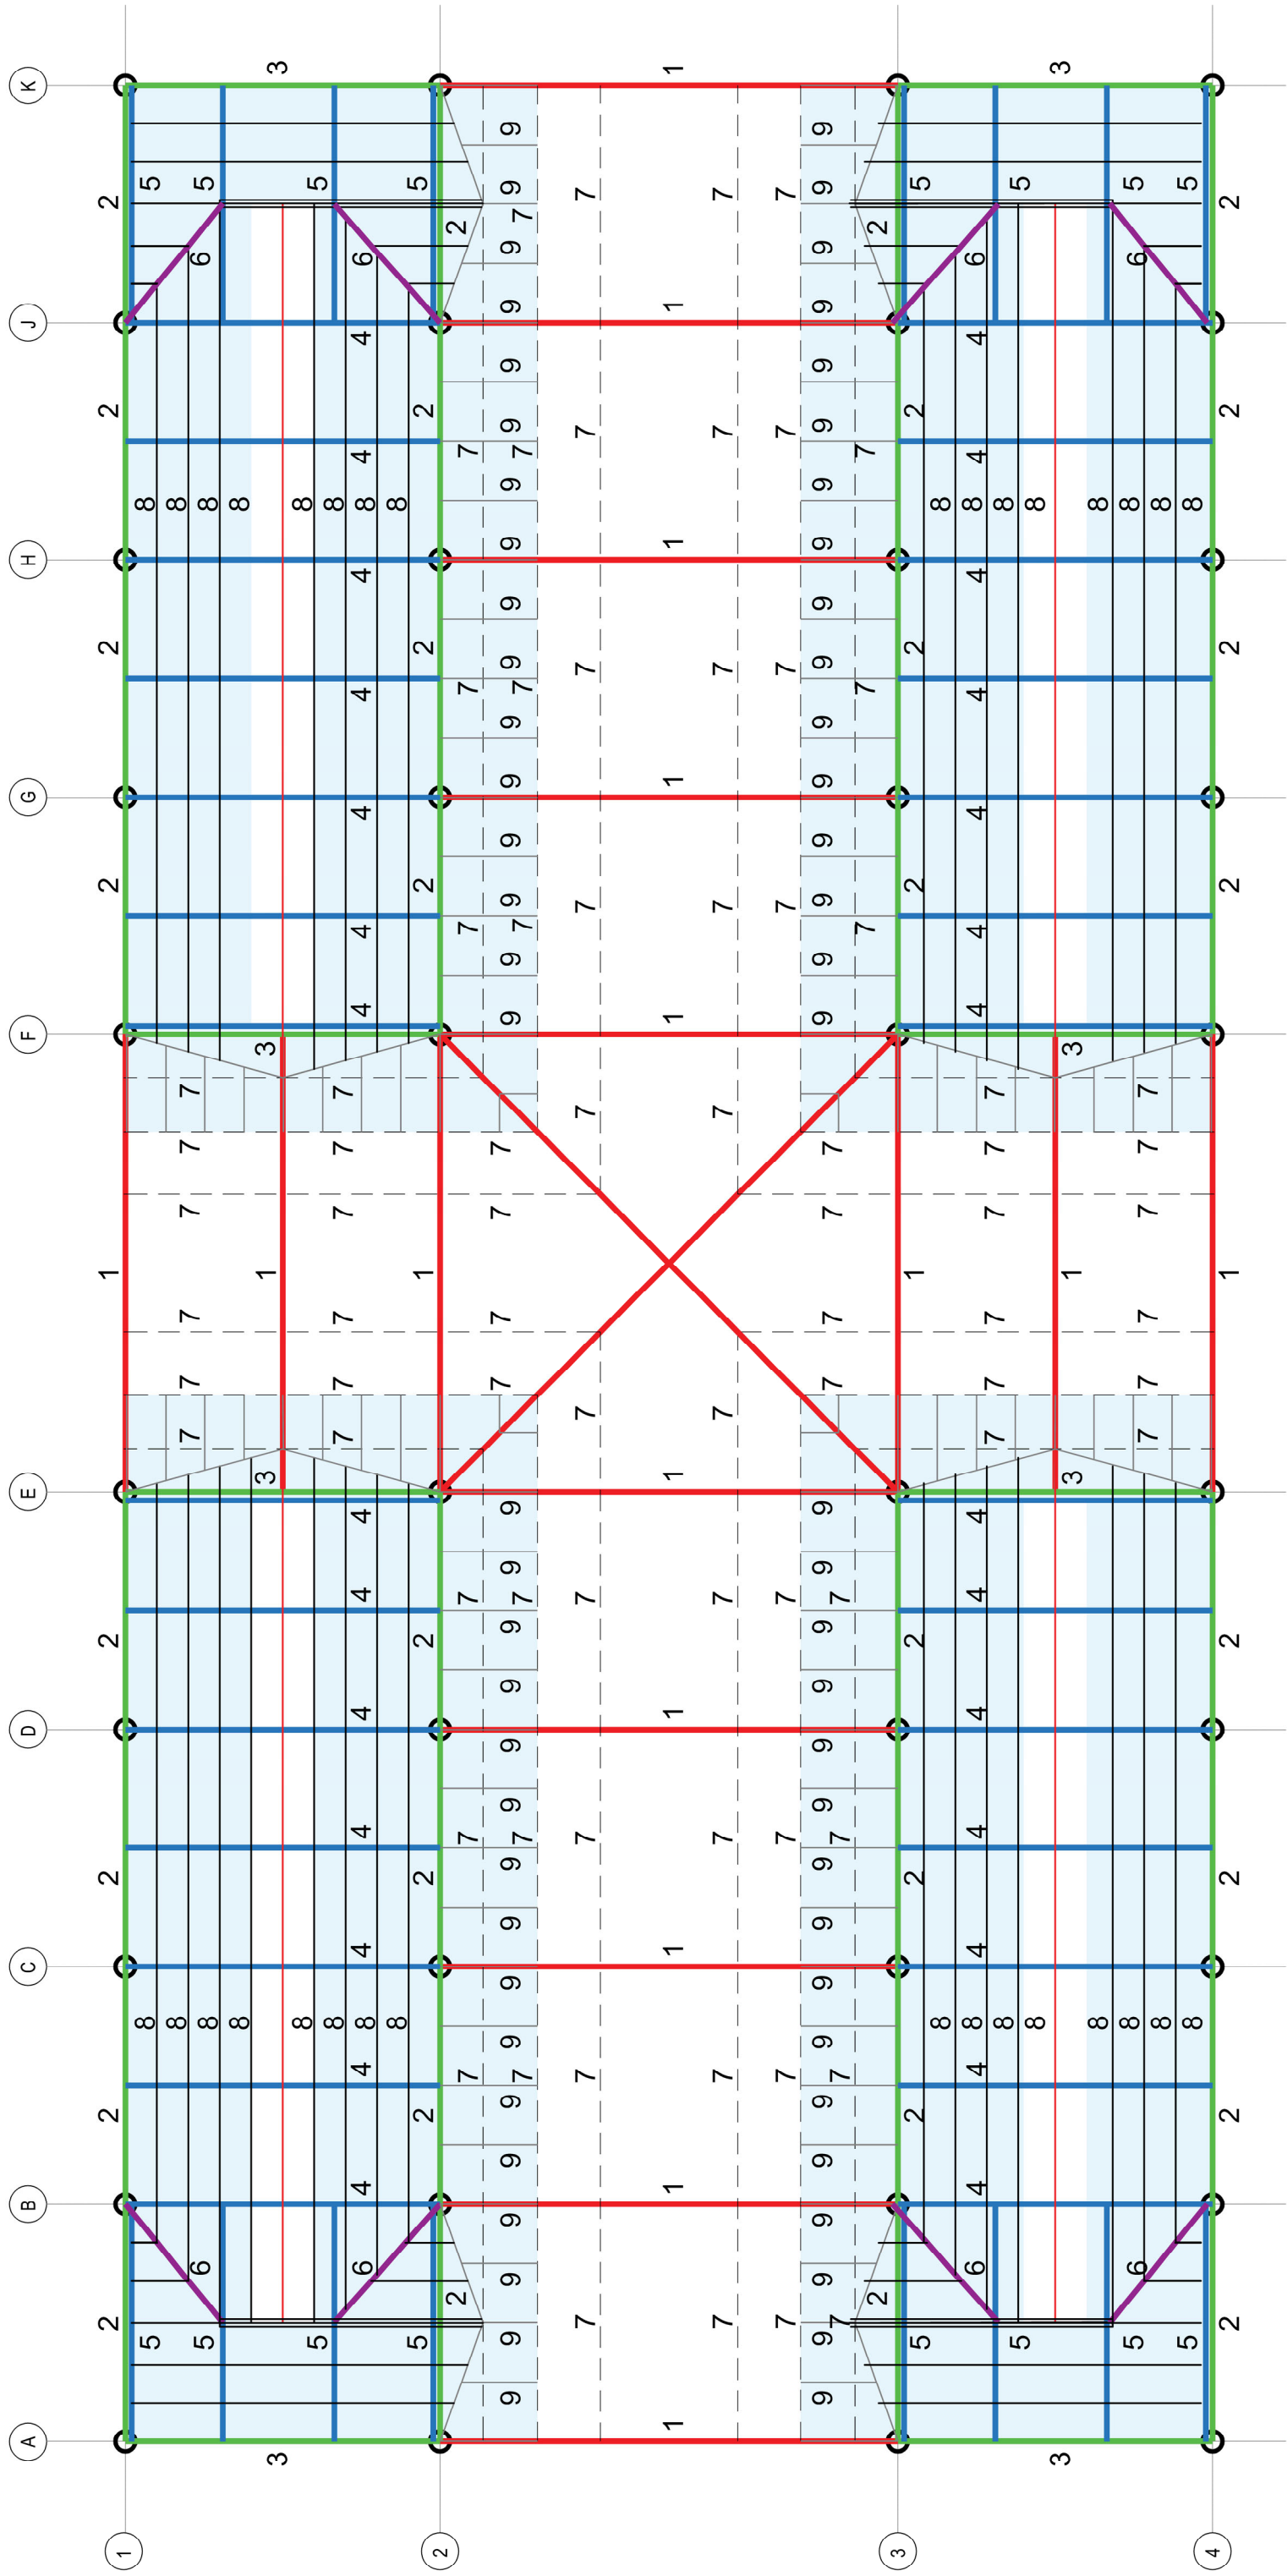
Roof Structural Arrangement Plan

One exception to the statement above occurred on the top rafter member of the duo-pitch trusses to each long elevation. The point loads imposed on the inclined members is causing elevated bending stresses however it should be appreciated that the analysis model is very conservative as it does not fully replicate the additional restraint or support afforded by the cast iron internal member.

Even considering the conservative nature of the analysis the factor of safety reduction in the rafter member material is minimal and therefore in our consideration is acceptable.
