# Freight Island Event Space

## PHASE 2 SITE INVESTIGATION

Mayfield Freight Island

Mayfield Partnership Ltd

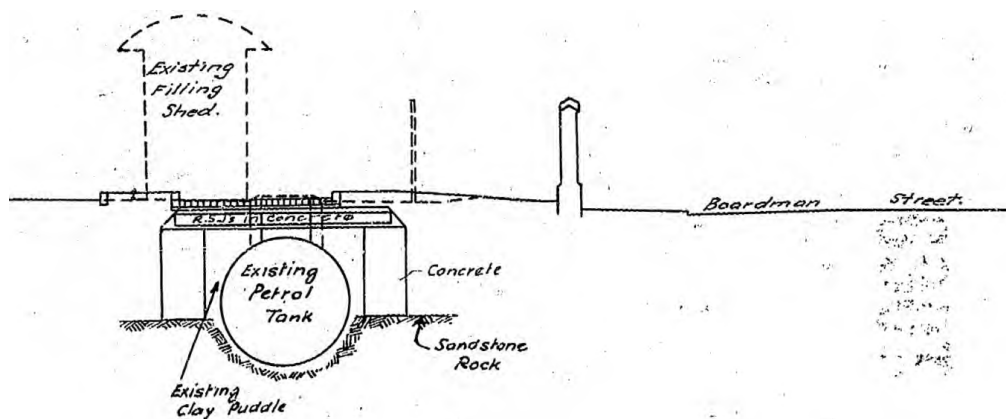
**Fig 3.0: Extract from LMSR Plan relating to Road Motor Petrol Depot improvement works**

- 3.3.4 The gantry structure in the centre of the site was a fuel office building with associated fuel pumps beneath a canopy roof, two fuel storage tanks were located below ground in this area. The structure in the east of the site was a filling shed with a tank located underneath. The plans appear to relate to planned improvement works and a schematic section of a new below ground fuel storage tank is provided (and reproduced below).

- 3.3.5 Records indicate the petrol tanks were contained below ground within a concrete trench structure partially cut into the Sandstone bedrock. The tanks themselves were enclosed within puddle clay, likely to contain any spillage or leakage. The records show tank locations from the original Road Motor depot construction as well as alterations associated with the proposed improvement works. The plans indicate the original below ground tanks were to be removed and replaced. An overlay showing current site features and proposed improvement works (drawing ES300) has been provided within Appendix A.
