**Condition Report and Repair Schedule**  
27-33 King Street West, The Carriage Works and Warehouse

This Condition Report and Repair Schedule has been produced on behalf of Property Alliance Group to accompany the Planning and Listed Building Consent application for the redevelopment of 27-33 King Street West, The Carriage Works and Warehouse.

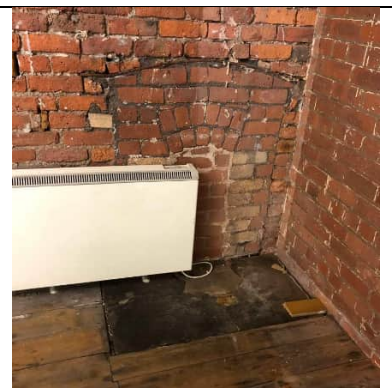
X24

| Item | Feature – Timber floor |

| Specification | Specialist contractor to advise |

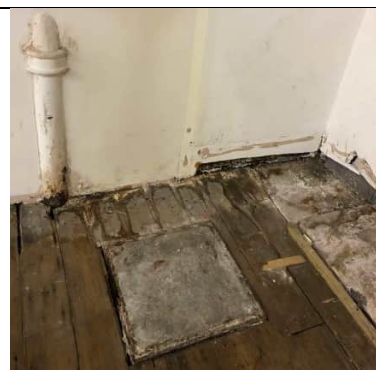
X29

| Item | Fire Hearth |

| Specification | Specialist contractor to advise |

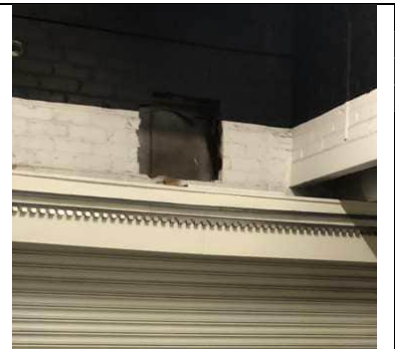
G04

| Item | Missing mortar |

| Specification | (MAS-002) Masonry repointing |

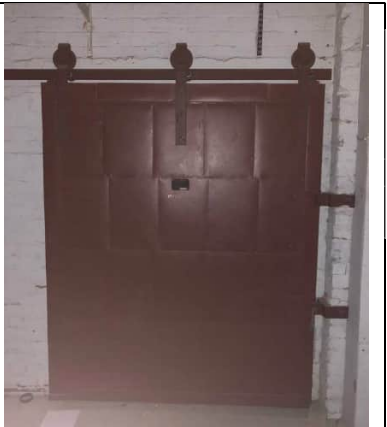
G08

| Item | Sliding metal fire door | |
| Description | 08 - Fire rated metal sliding door with feature rail and rollers was noted to the west of the room.<br>09 – Metal hinged double door.<br>The proposed plans show the host walls and doors being removed; door identified for record purposes only. | |
| Condition | 01 | |

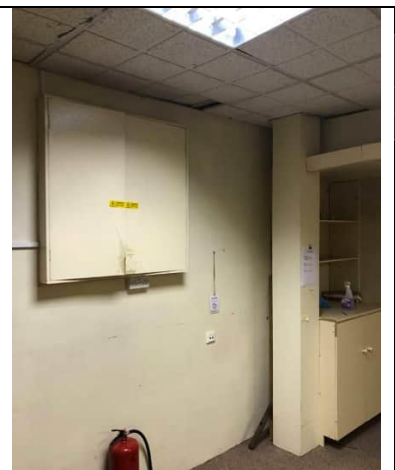
G11

| Item | Feature - Cast iron column |

| Specification | <b>(PNT-100)</b> Paintwork sample / redecoration |

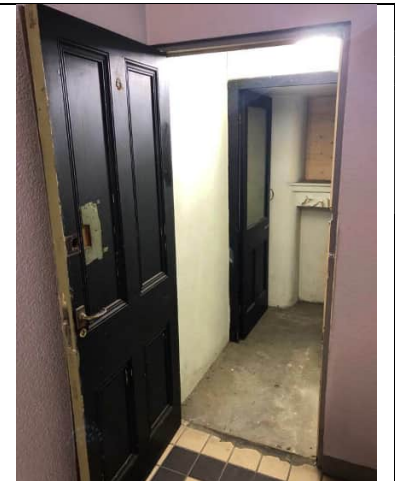
G16

| Item | Spalling paint to base of external brickwork wall |

| Specification | (PNT-100) Remove paintwork<br>(where Architect notes exposed brickwork) |

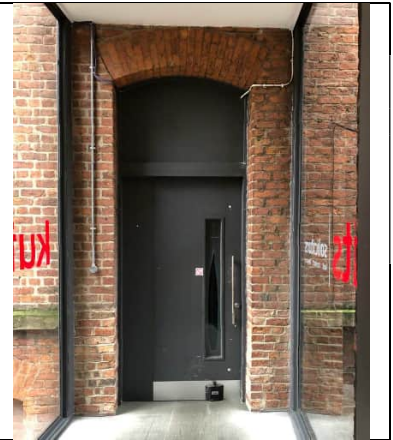
1.05

| Item | Reinstate window, brickwork and cill |

| Specification | <b>(MAS-001)</b> Masonry repair<br><b>(MAS-002)</b> Masonry repointing<br><b>(MAS-003)</b> New masonry<br><b>(WIN-100)</b> Replacement Window |

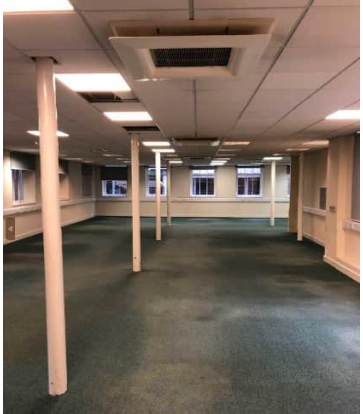
1.06

| Item | Feature - Columns | |
| Description | Original cast iron structural columns, assumed to have profiled heads above ceiling with supporting timber beams and joists. | |
| Condition | 01 | |

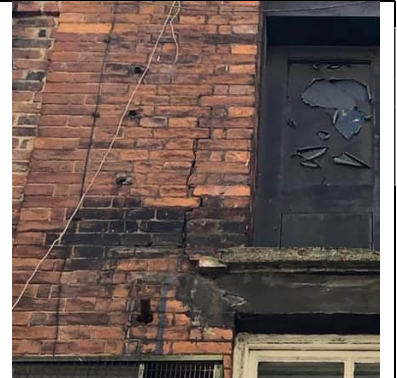
E  
102

| Item | Damaged stone cills |

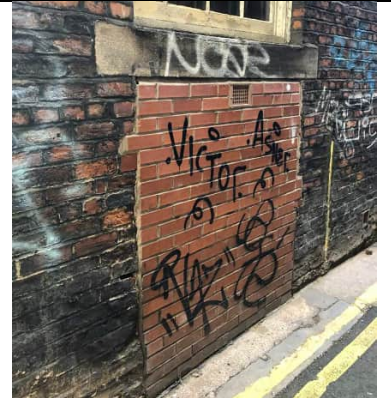
E  
201

| Item | upvc pipework |

| Specification | (REM-100) Remove pipework<br>(IRN-100) Replacement iron pipework<br><br>Replacement pipework to be specified by others |

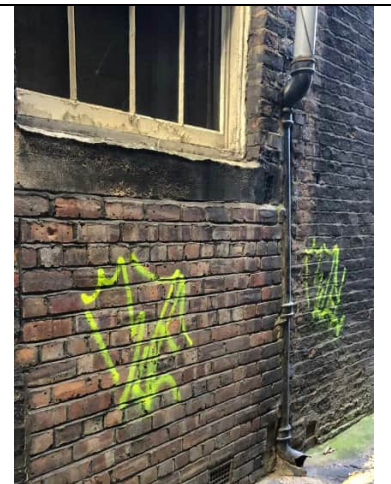
E  
202

| Item | Stone cill spalling |

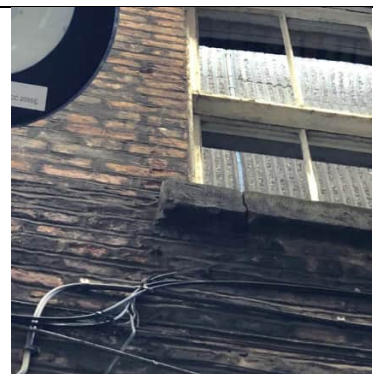
E  
205

| Item | Missing bricks |

| Specification | (MAS-001) Masonry repair<br>(MAS-002) Masonry repointing |

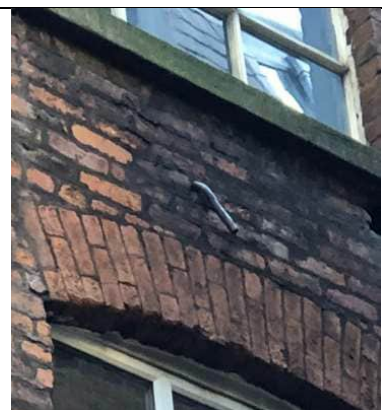
E  
216

| Item | Loose brickwork |

| Specification | (MAS-001) Masonry repair |

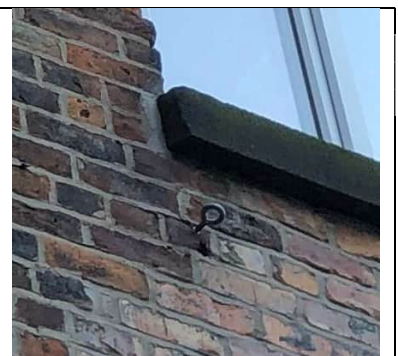
E  
302

| Item | Poor quality brick infill |

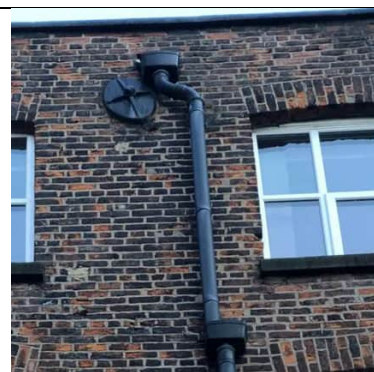
E  
304

| Item | Damaged brickwork |

| Specification | <b>(MAS-001)</b> Masonry repair<br><b>(MAS-002)</b> Masonry repointing |

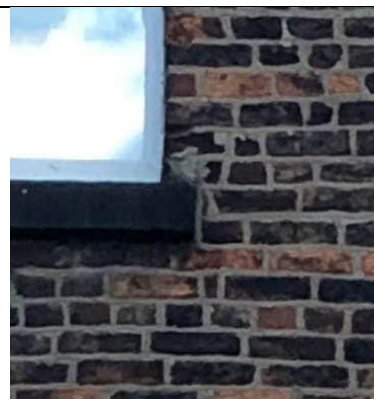
E  
305

| Item | Damage to external stone cill |

| Specification | <b>(MAS-001)</b> Masonry repair |

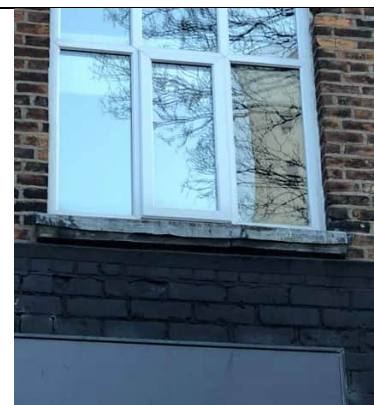
E  
307

| Item | Damage to external stone cill |

| Specification | (MAS-001) Masonry repair |

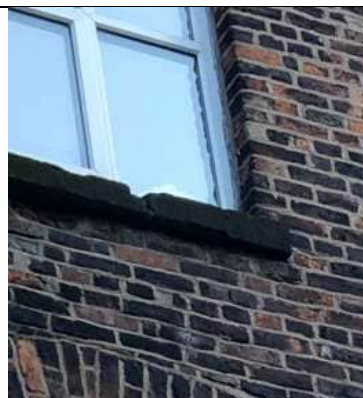
E  
309

| Item | Eroded coping |

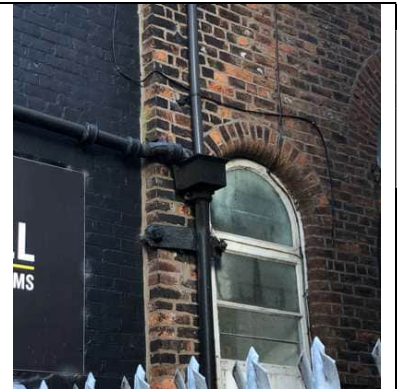
E  
401

| Item | Widespread brick spalling |

| Specification | (REM-100) Remove cement mortar pointing<br>(MAS-001) Masonry repair<br>(MAS-002) Masonry repointing<br>(SEL-001) Masonry sealer |

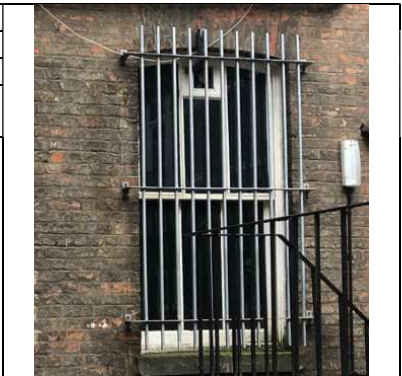
E  
602

| Item | Damage to external stone cill |

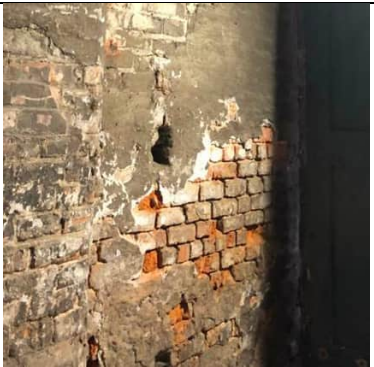
| E<br>708 | Item | Damaged brickwork and eroded pointing | |
| | Description | Deteriorated plaster and limewash | |
| | Condition | 02 | |
