# Detailed Unexploded Ordnance (UXO) Threat & Risk Assessment

Meeting the requirements of CIRIA C681 “Unexploded Ordnance (UXO) – A guide for the Construction Industry” Risk Management Framework

**6 Alpha Project Number:** P4938  
**Landmark Order Number:** 74907346\_1  
**Client Reference:** 1011906  
**Site:** Plots 6, 7 & 8., First Street, Manchester

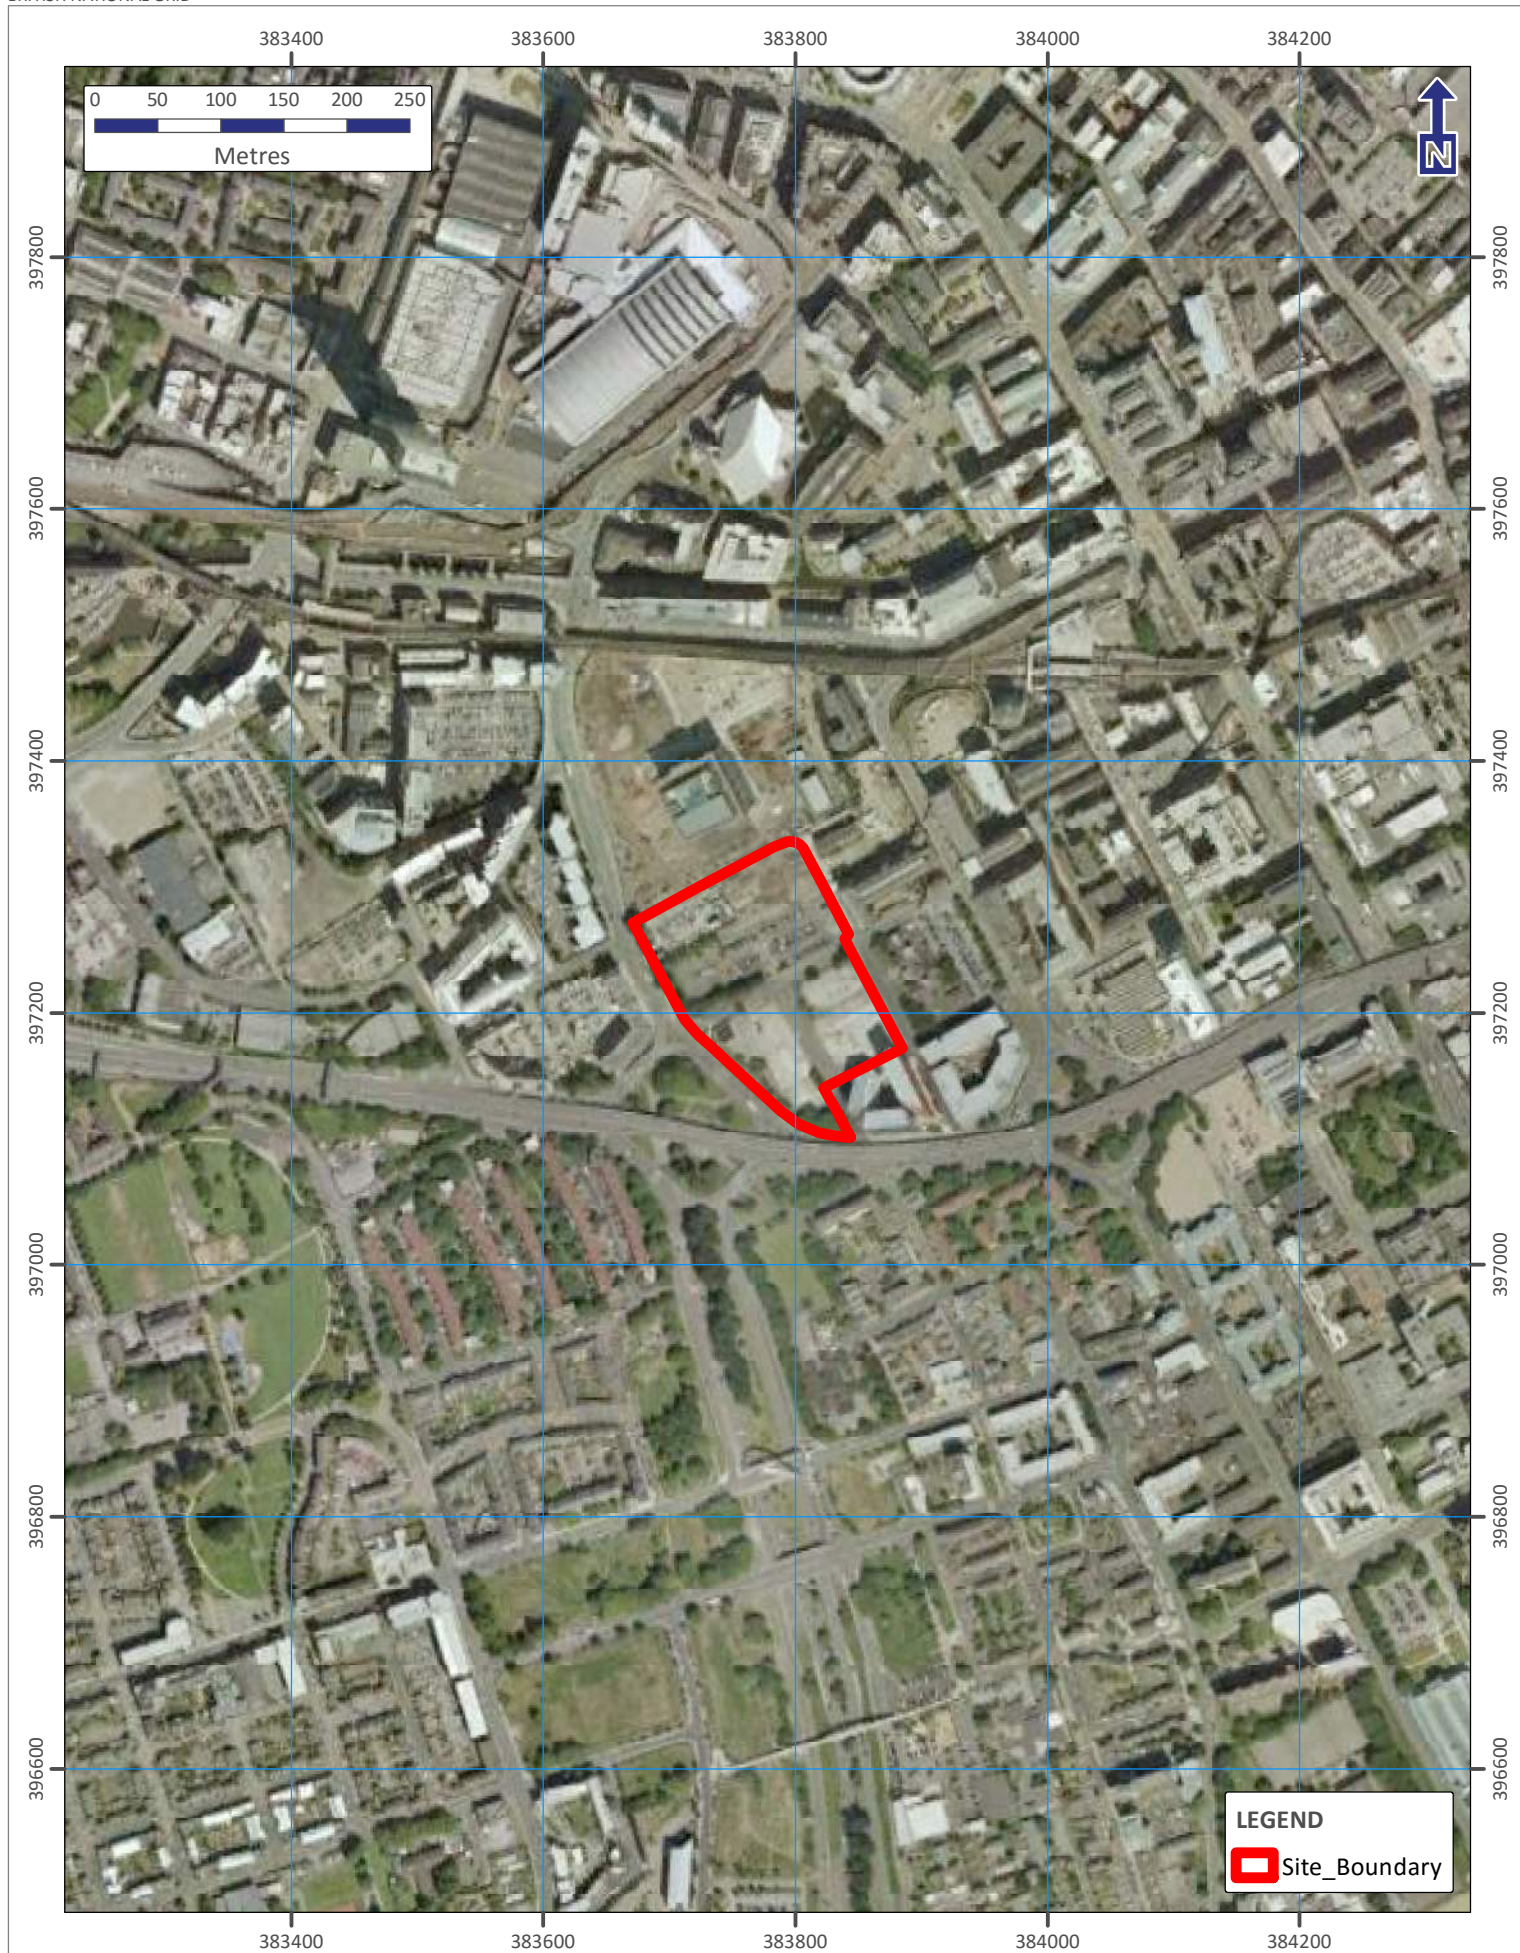
## Aerial Photography (2009)

Current aerial photography corroborates with the information above and shows that the Site is situated within a densely developed urban area. .

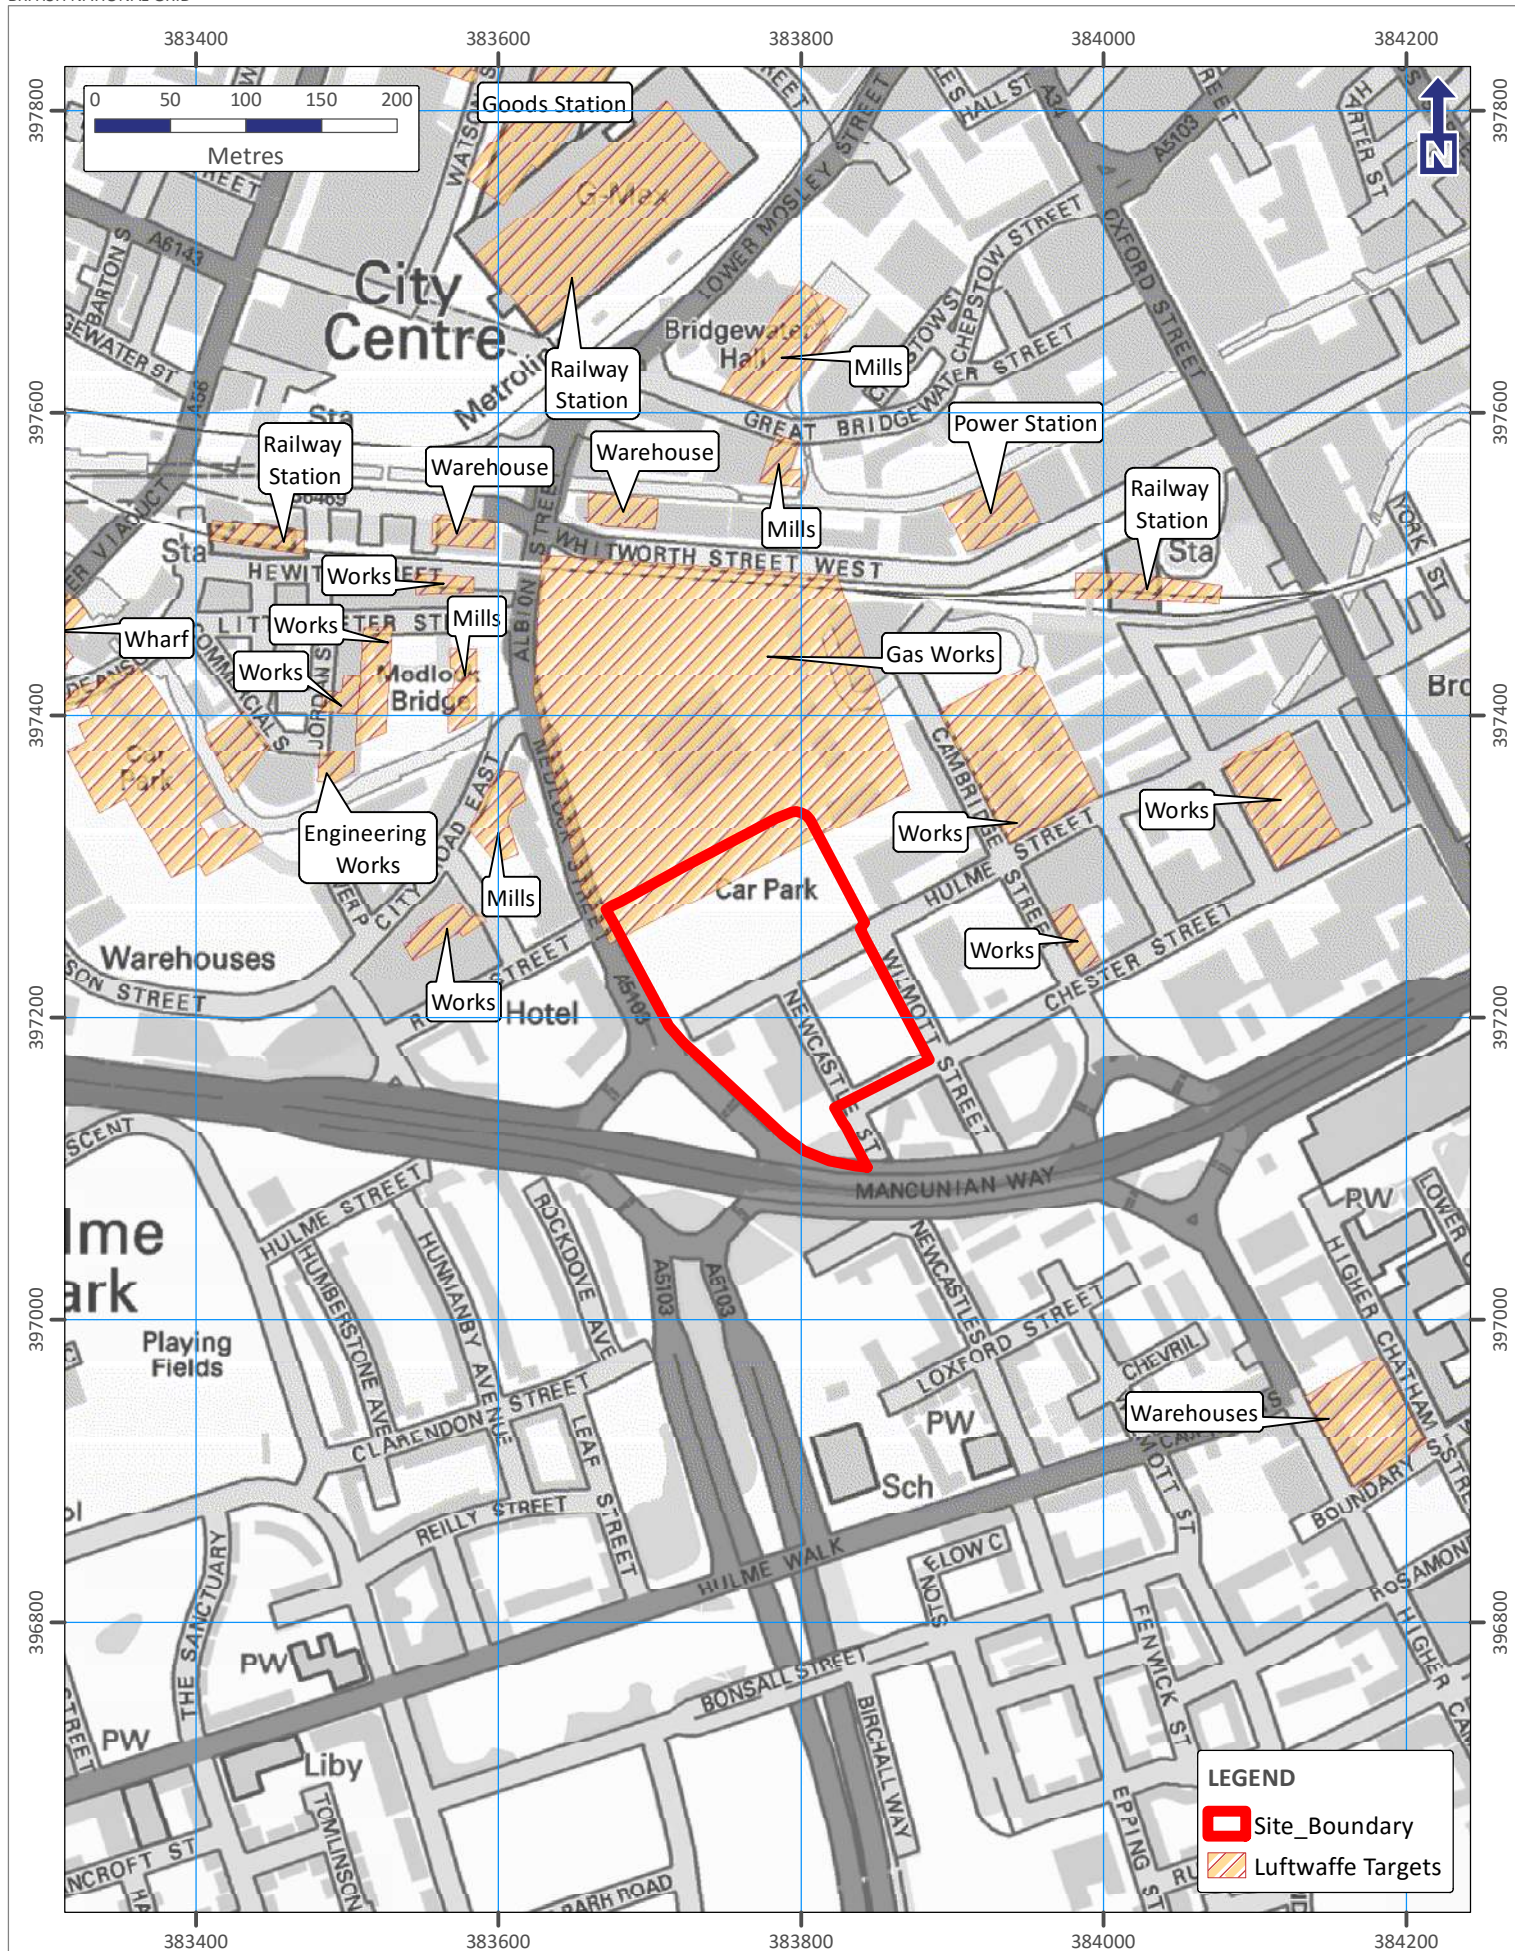
### WWII Luftwaffe Bombing Targets

Prior to WWII, the *Luftwaffe* conducted numerous aerial photographic reconnaissance missions over *Britain*, recording key military, industrial and commercial facilities for attack, in the event of war. In addition, logistics infrastructure and public services, such as railways, canals, power stations, reservoirs, water and gas works were also considered viable bombing targets.

*Luftwaffe* aerial reconnaissance photography associated with the Site identified *Gaythorn Gas Works* located partially on Site and immediately to the north as a primary bombing target. In addition, numerous works, mills, warehouses and railway stations in the vicinity may have been considered secondary bombing targets.

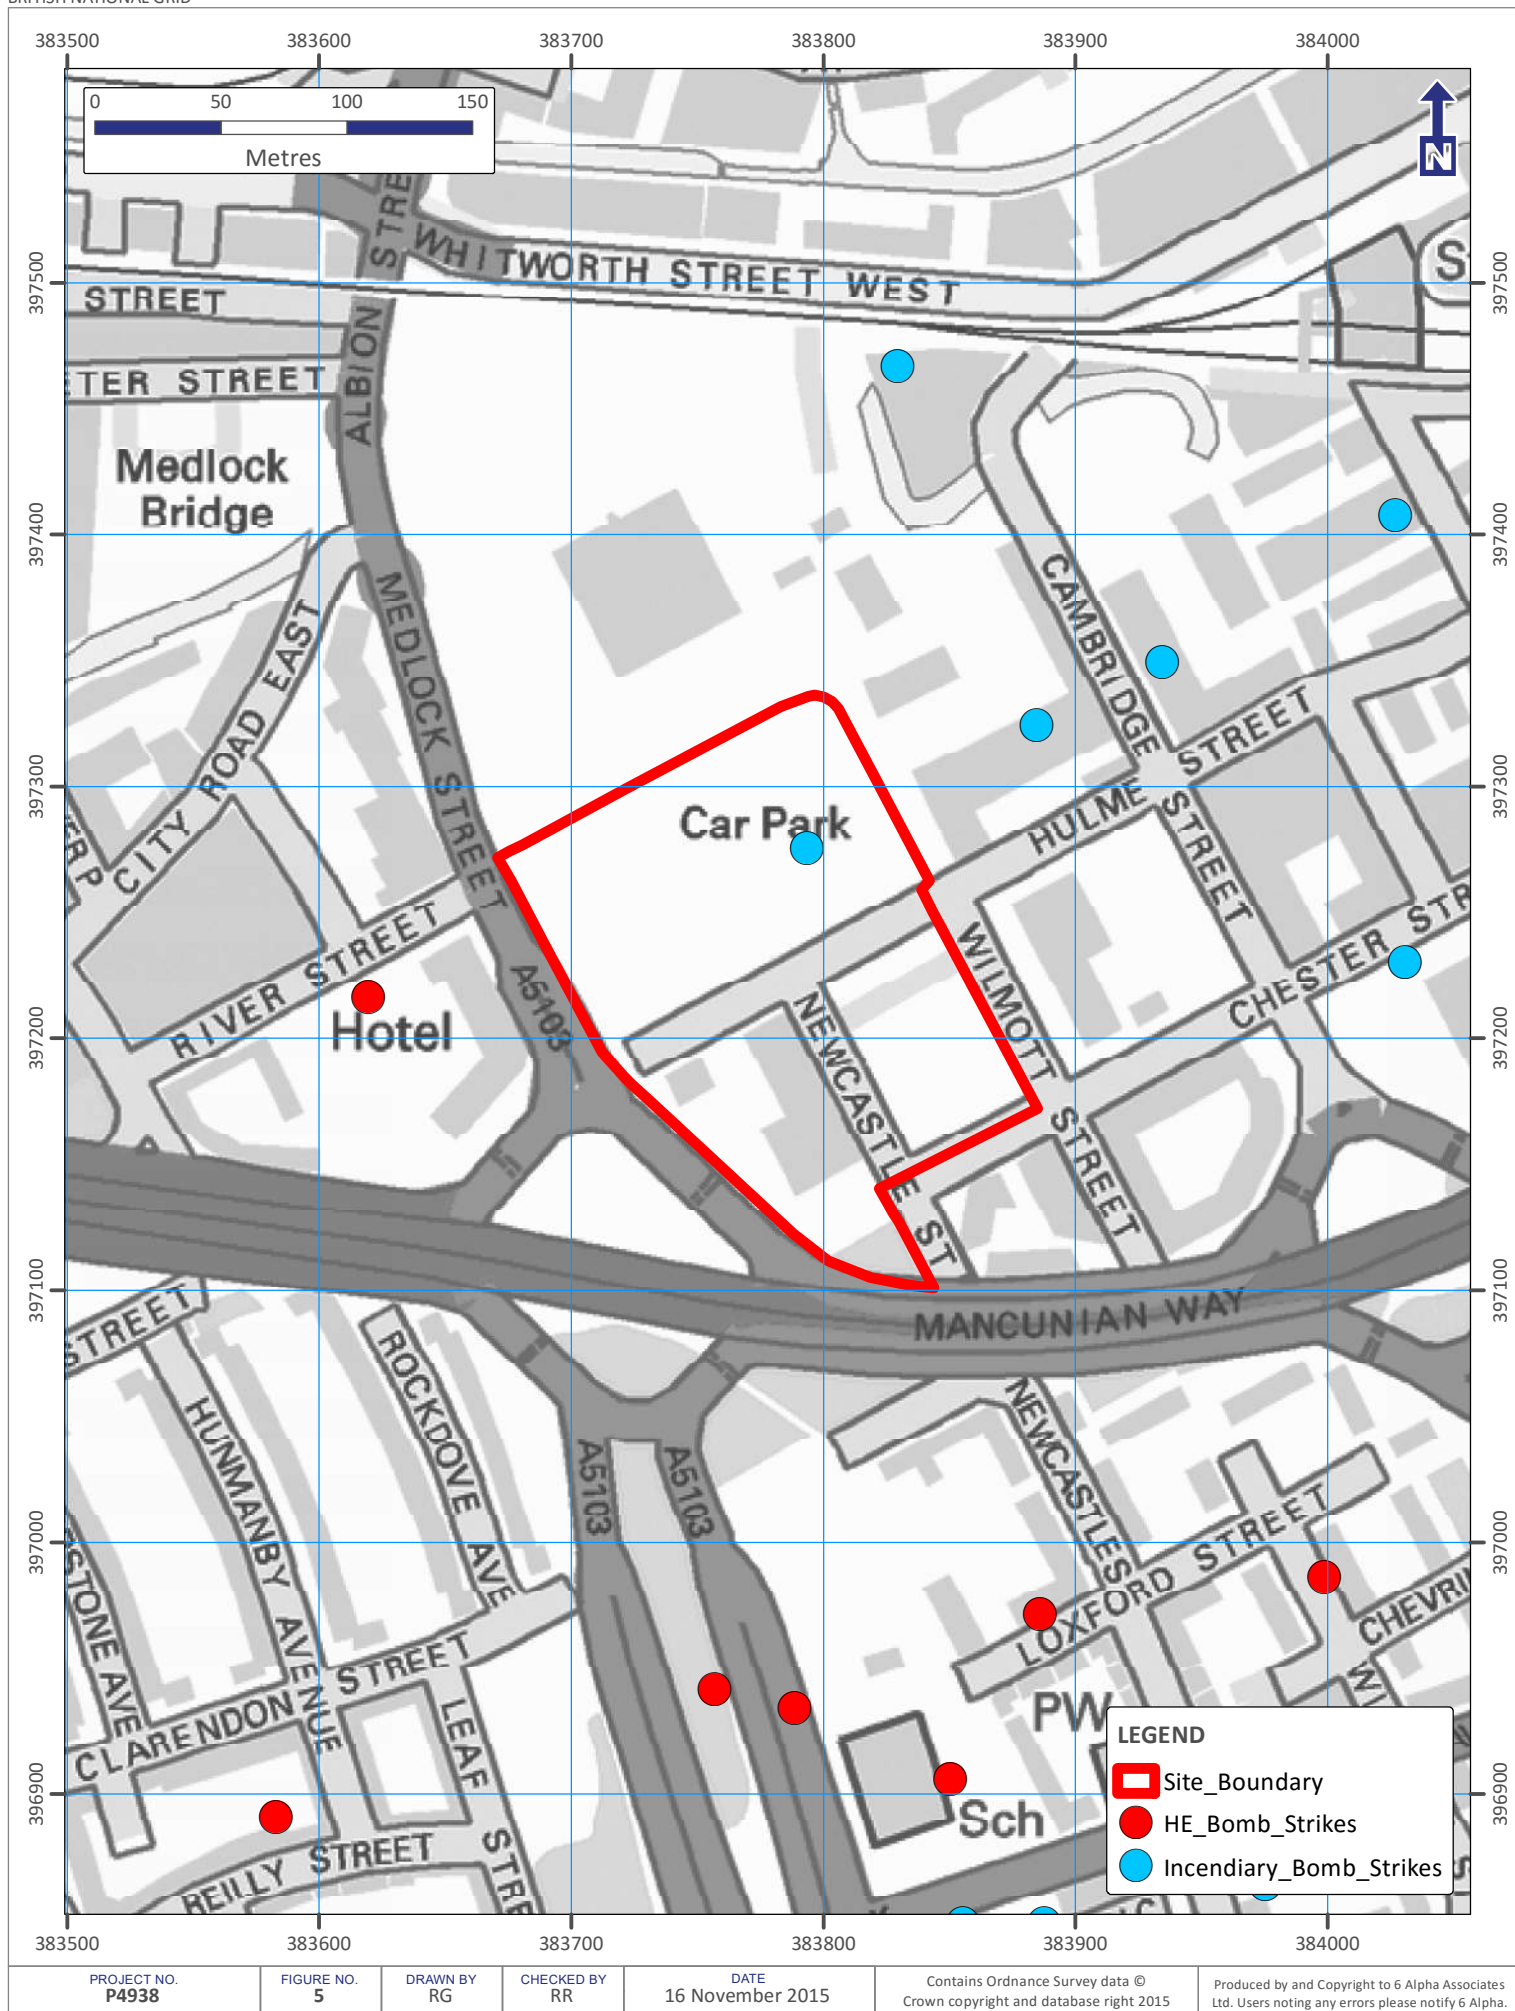
## WWII Consolidated Bomb Strikes

During WWII, ARP wardens compiled detailed logs of bomb strikes across their respective districts. However, ARP records associated with the Site did not register any HE bomb strikes within it, however seven were recorded; 60m to the west, 315m to the southwest and 135m, 180m, 190m, 190m and 190m to the south. Furthermore, whilst IBs may have fallen within the Study Site, they fell in such large numbers they were considered ubiquitous and accurate record keeping was either non-existent or perfunctory. Despite this, ARP records associated with the Site registered one IB within the Site's north-eastern section. In addition, eight were recorded; 60m, 115m and 155m to the east; 135m and 225m to the northeast; 240m, 250m and 275m to the south.

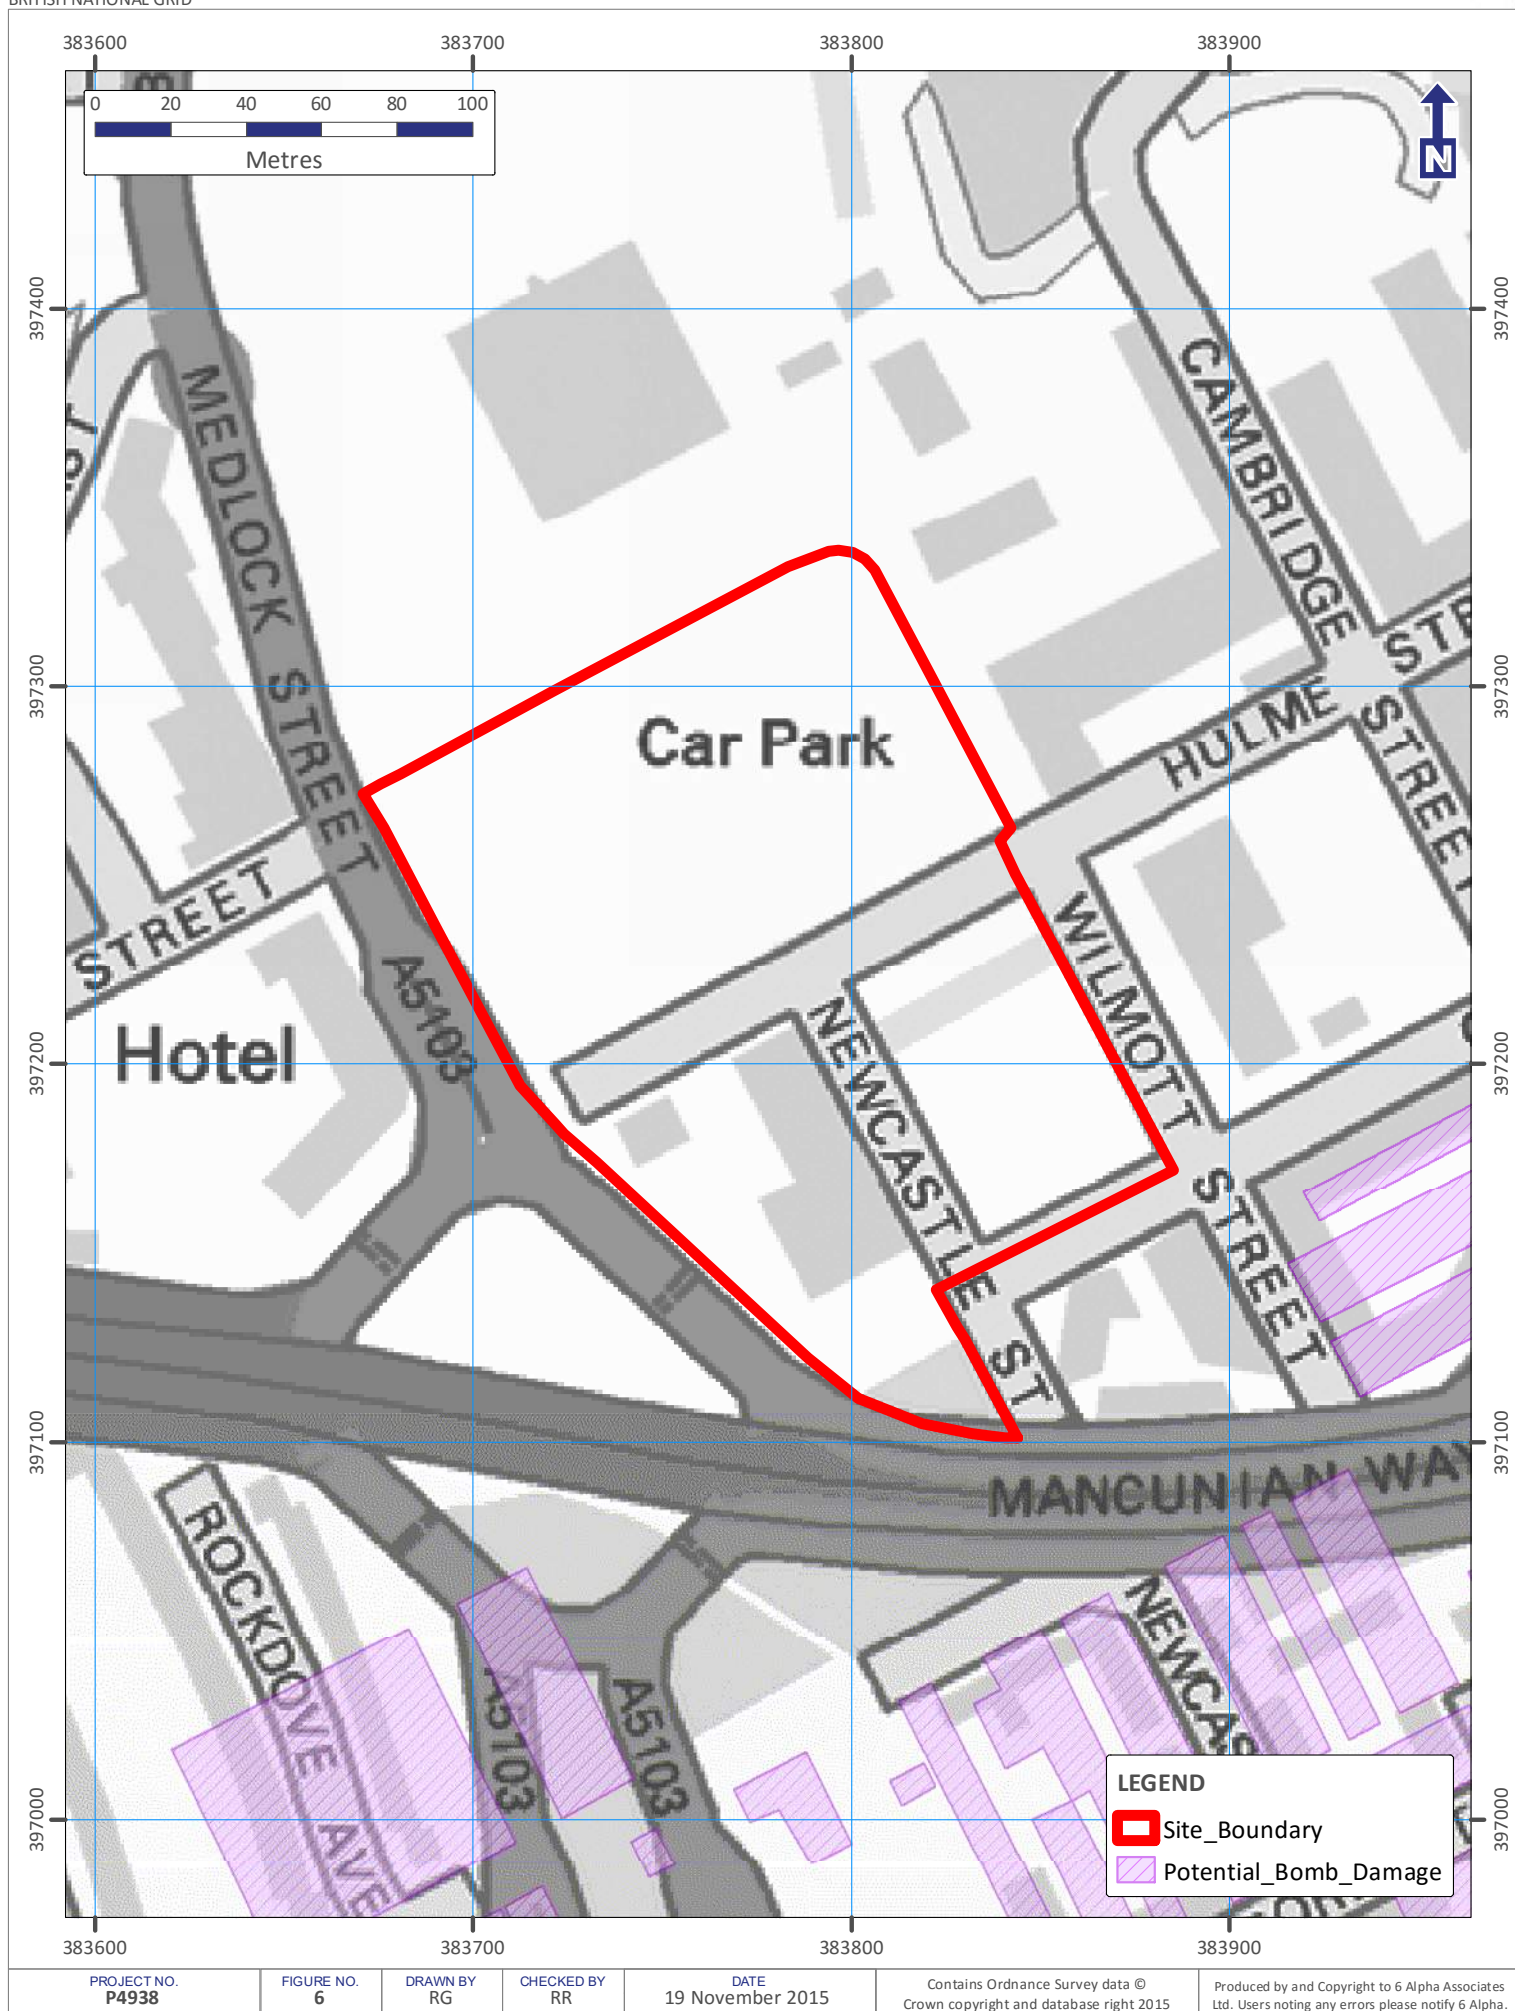
### WWII Potential Bomb Damage

Official bomb damage maps associated with the Site could not be located. Nonetheless, an analysis of pre and post war mapping has identified several 'missing houses', which could be attributed to bomb damage. However, the validity of these 'missing houses' being associated with bomb damage is compromised as further research suggests that the area underwent mass slum clearance during the late 1930s into the 1950s. As such, the areas of 'missing houses' may actually represent an amalgamation of both bomb damage and slum clearance.

Possibly; official bomb damage maps associated with the Site could not be located. Nonetheless, an analysis of pre and post war mapping has identified several ‘missing houses’, which could be attributed to bomb damage. However, the validity of these ‘missing houses’ being definitively associated with bomb damage is compromised as further research suggests that the area underwent mass slum clearance during the late 1930s into the 1950s. As such, the areas of ‘missing houses’ may actually represent an amalgamation of both bomb damage and slum clearance.

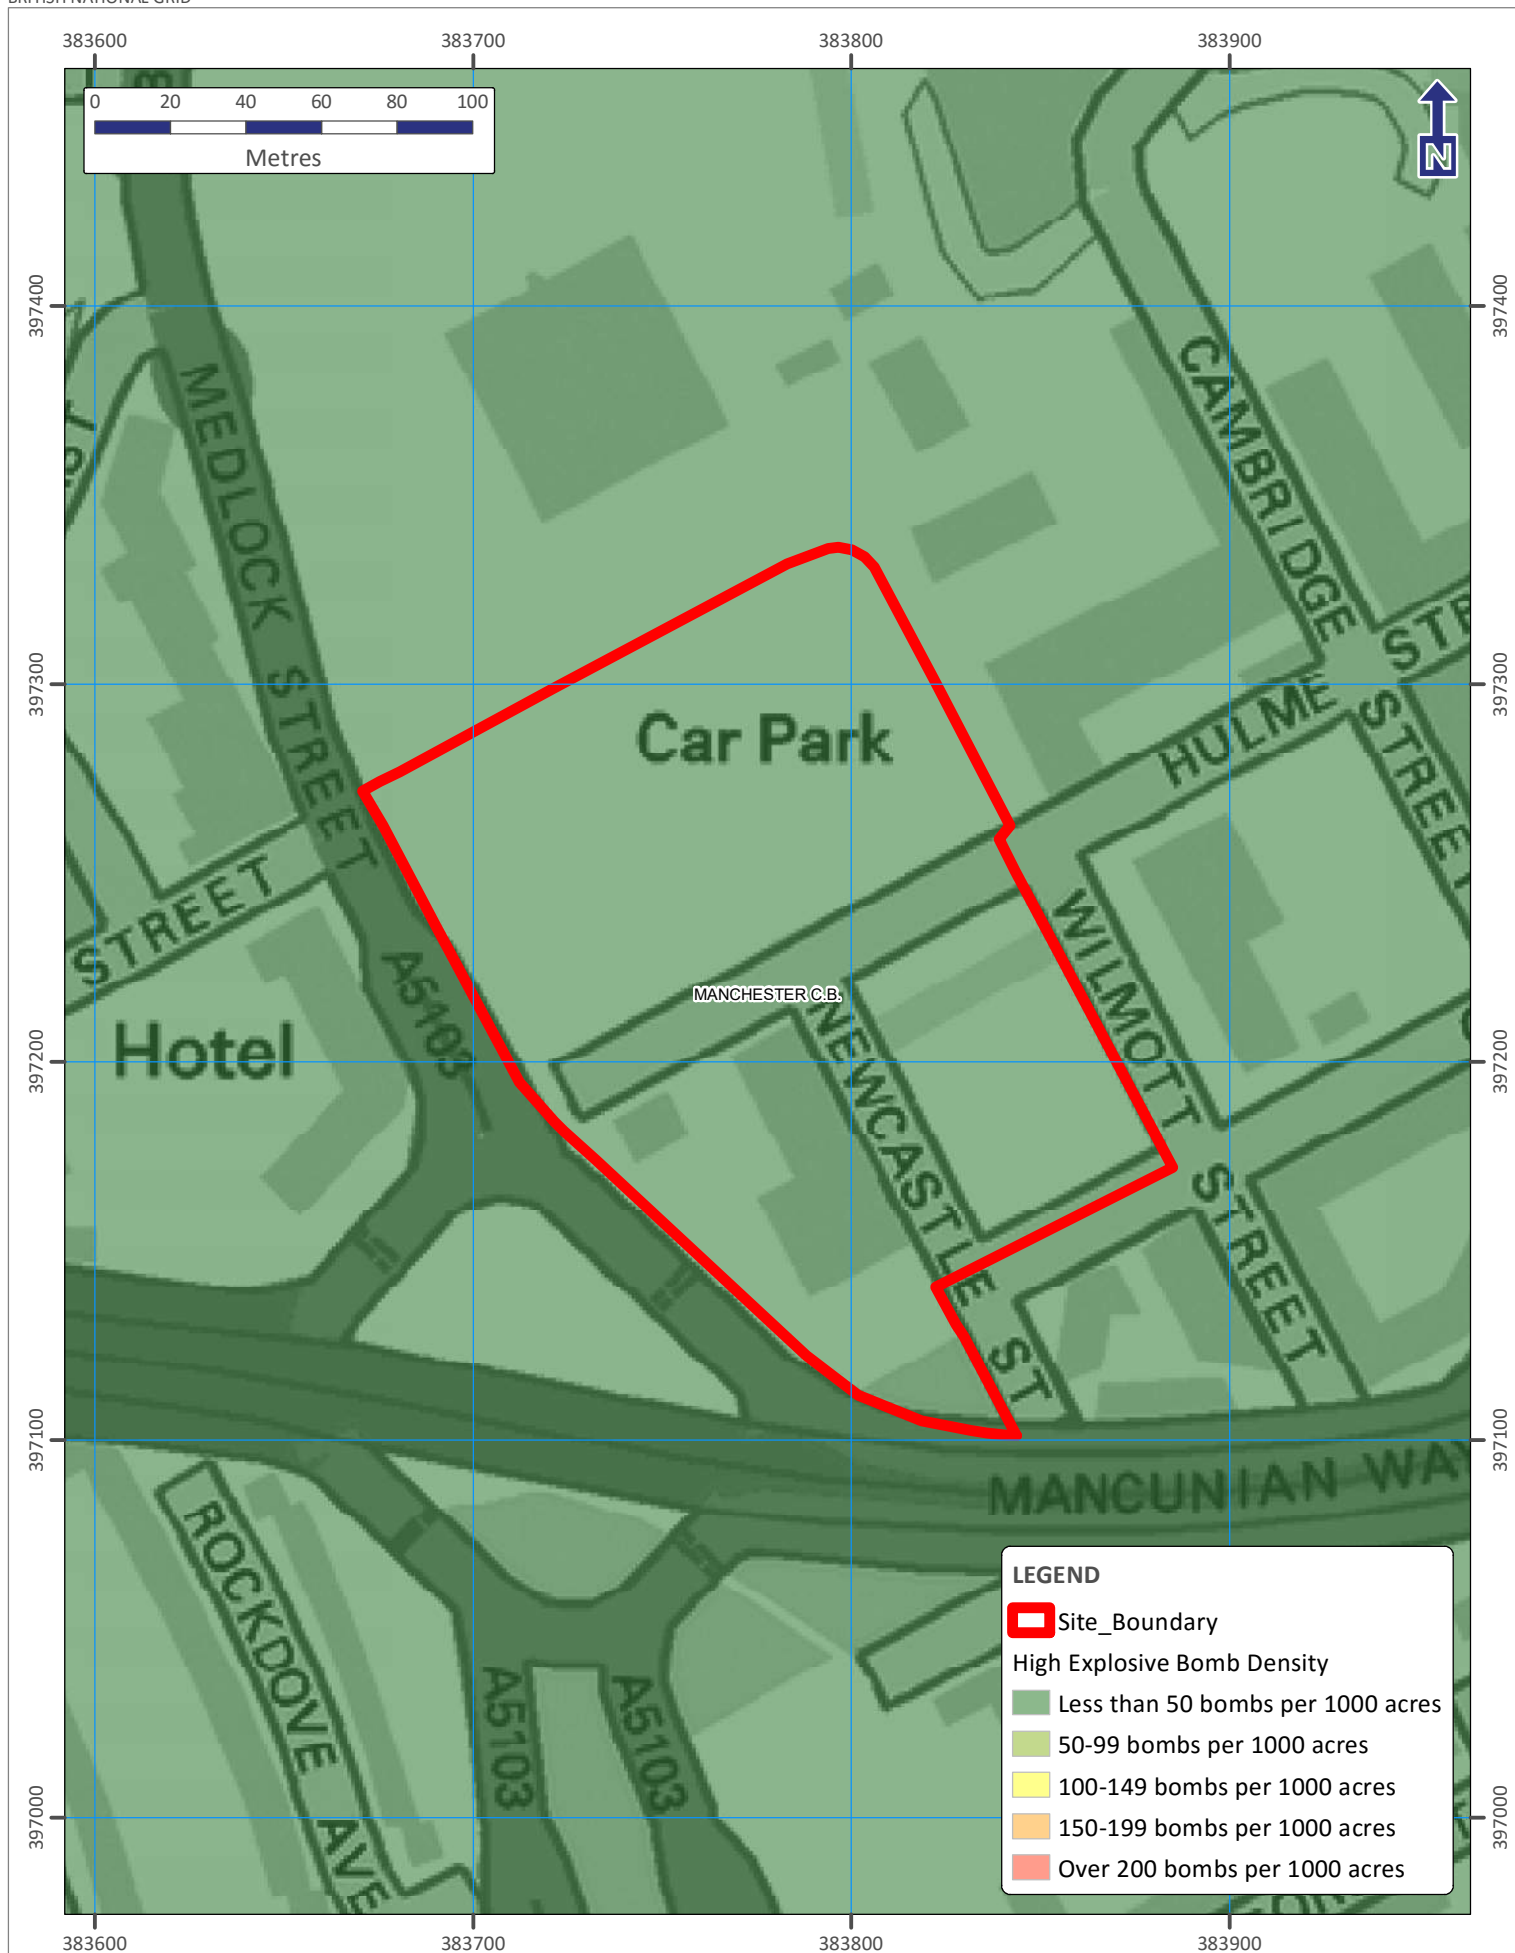
## WWII High Explosive Bomb Density

The Study Site was located within *Manchester County Borough*, which recorded 26 HE bombs per 1,000 acres, a relatively low level of bombing. However, given that the Site was situated partially within a primary bombing target during WWII, the localised bombing density may in fact have been much greater.
