# 40 – 46 Princess Street, Manchester

## Conservation Condition/Repair Report

### Windows 2023 update

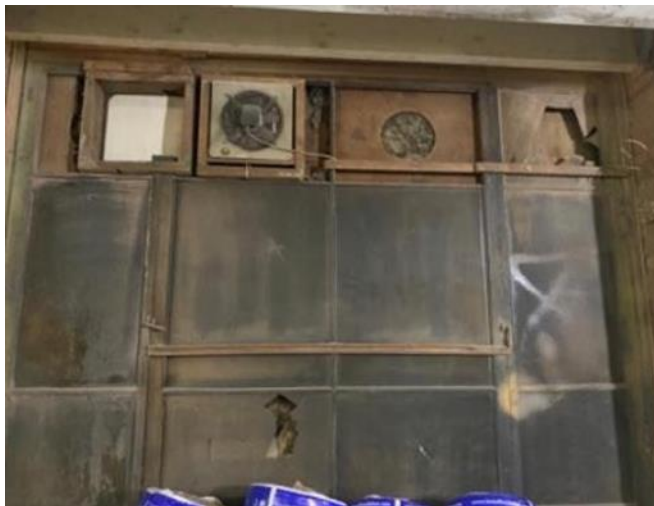
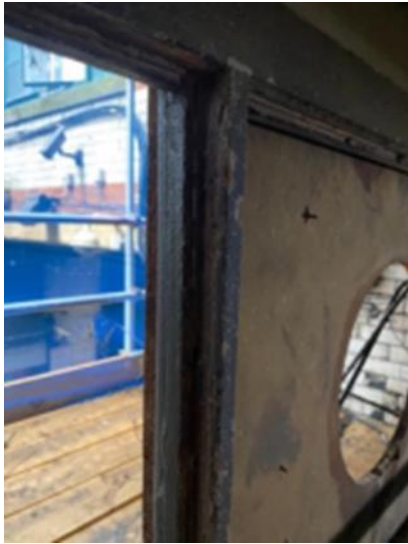
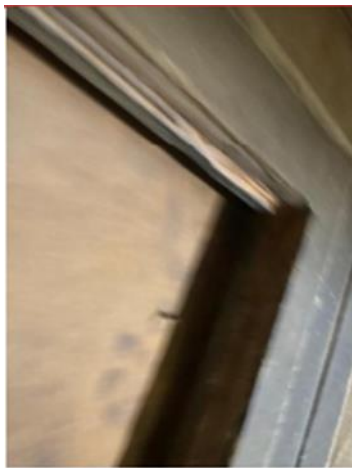
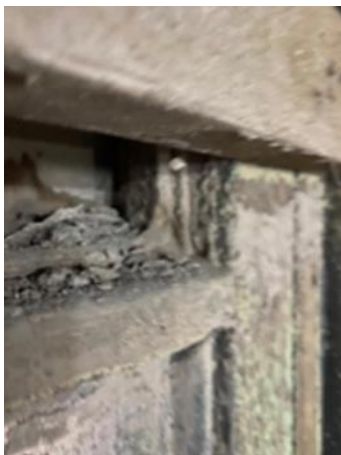
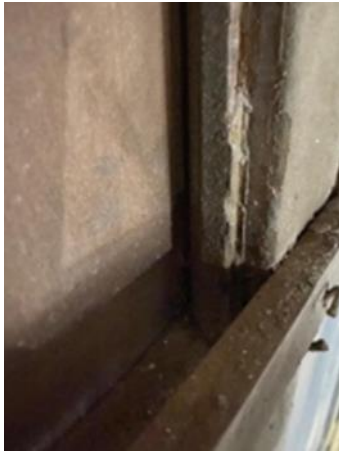
- Five Pane Glass Missing
- 1 Meter Mullion Missing
- 1 Sash badly damaged
- 10 Meter Glazing bead missing
- External Cill rotten in areas
- Window full of redundant screws and nails, to be removed
- 3 Meter Glazing bead damaged in areas

The Heritage Contractor has proposed that a replica timber casement windows, single glazed is solution for this window.

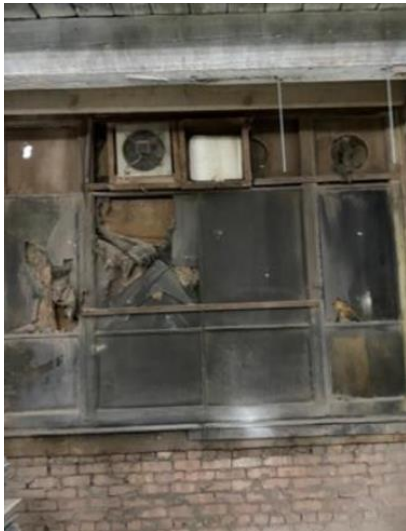
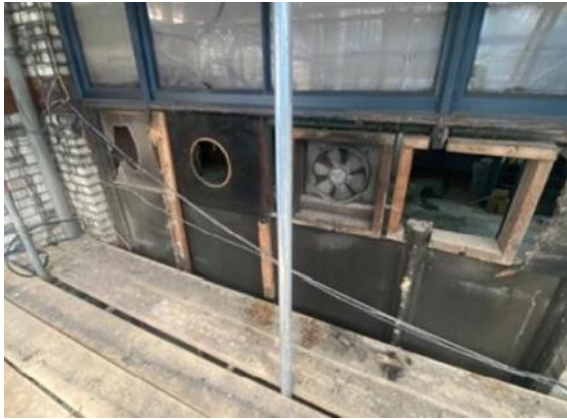
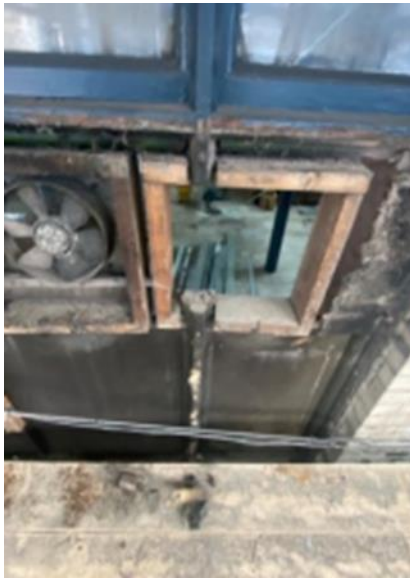
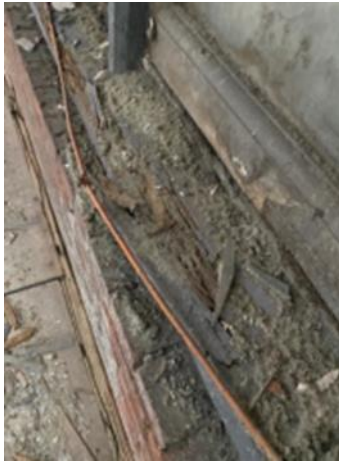
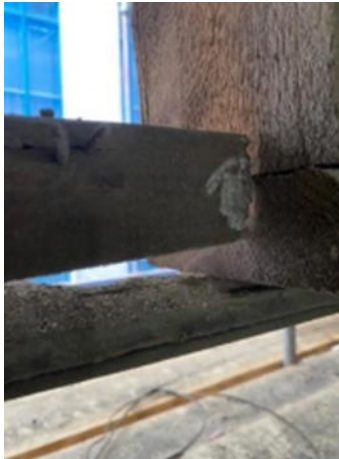
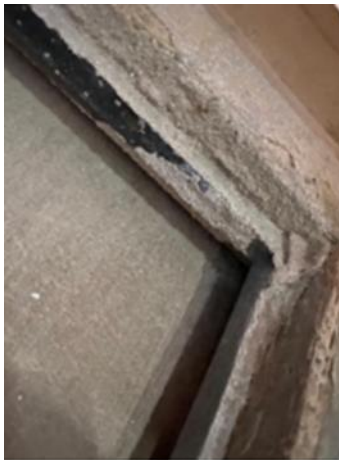
- 8 Pane Glass Missing
- 10 Meter Glazing bead damaged
- 1m Glazing bar
- Window board down stand badly damaged
- Window board needs splicing
- External Cill rotten in areas
- Window full of redundant screws and nails, to be removed

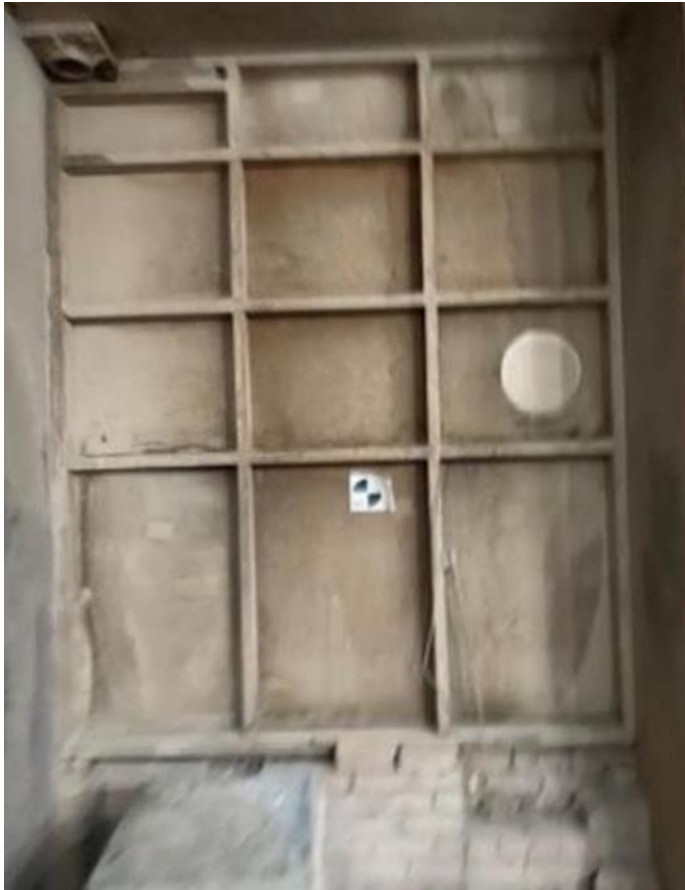
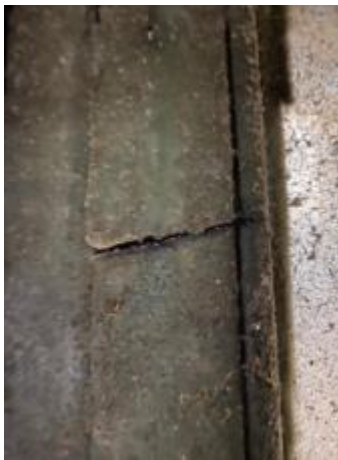
- No Window present

The heritage contractor has proposed that a replica timber casement windows, single glazed is solution for this window.

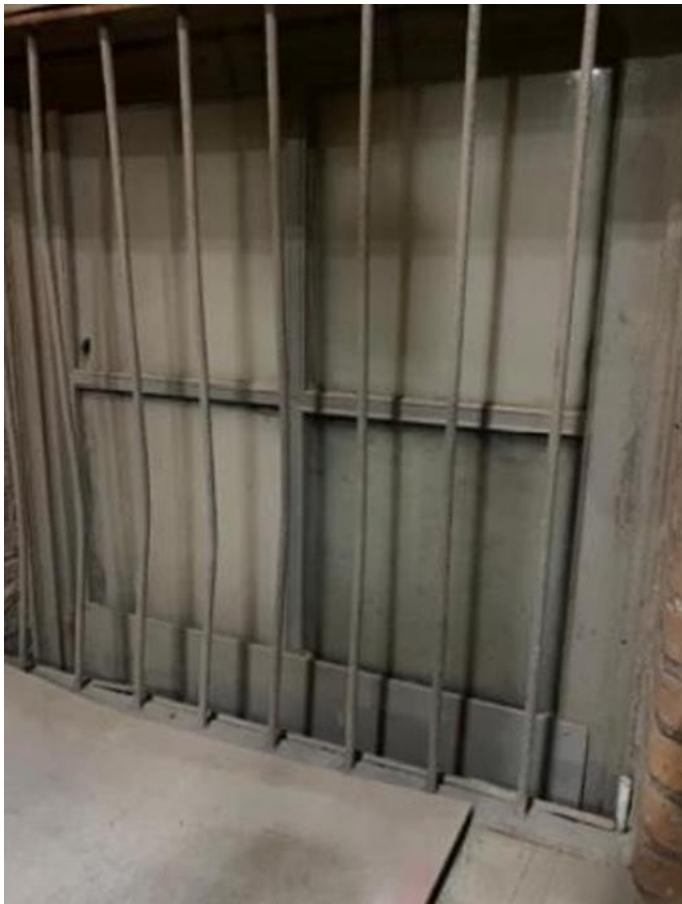
Figure 39: WP.0.10 Internal (Credit Fairhurst 2022)

- New pane of glass.
- 6m of glazing bead damage.
- External Cill rotten in areas.
- 6m glazing beads damage.
- Window full of redundant screws and nails, to be removed.

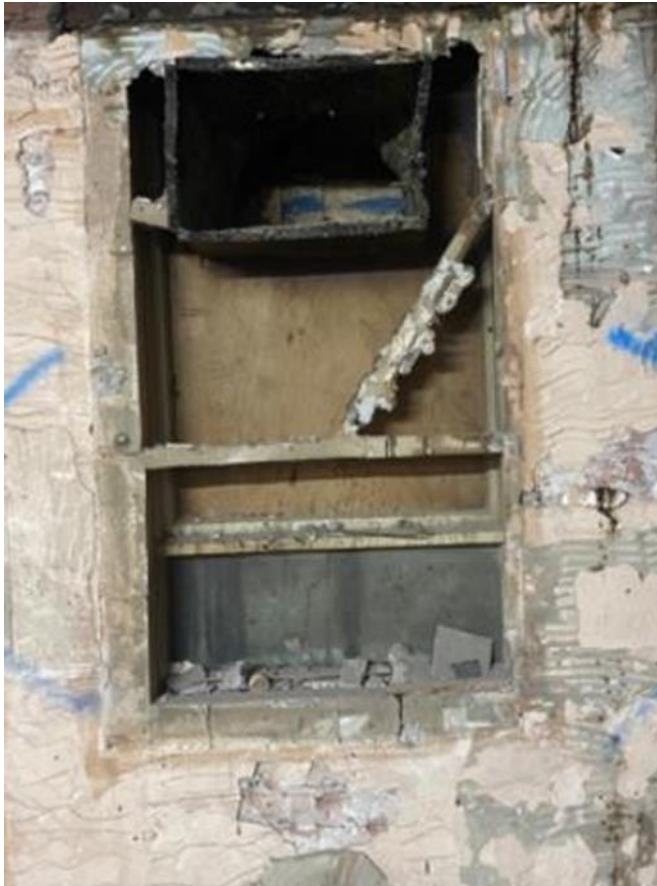
Figure 42: WP.0.12 (Credit Fairhurst 2022)

- Further survey required as the small window to the internal and external side is bricked up.

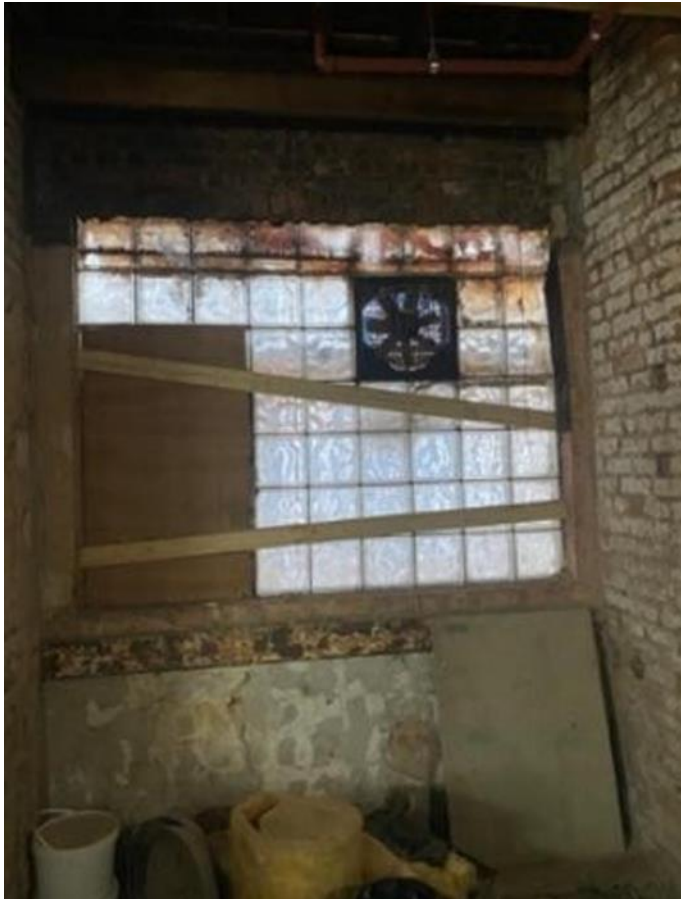
Figure 43: WP.0.11 (Credit Fairhurst 2022)

- Glass blocks in the window opening

The Heritage Contractor has proposed timber frame, fixed light, single glazed.

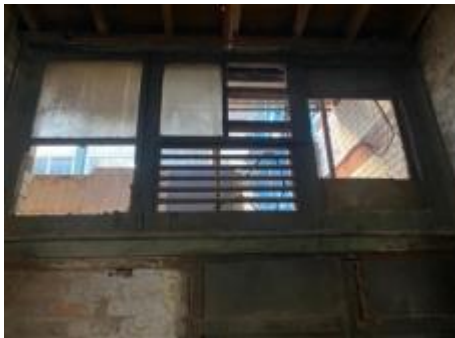
Figure 50: WP.0.13 (Credit Fairhurst 2022)

- Four Panes of Glass are missing
- 10 m glazing bead damaged
- Stays missing
- Window full of redundant screws and nails, to be removed.

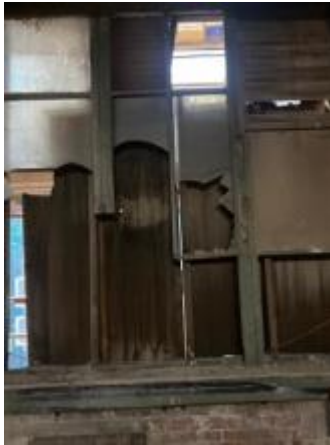
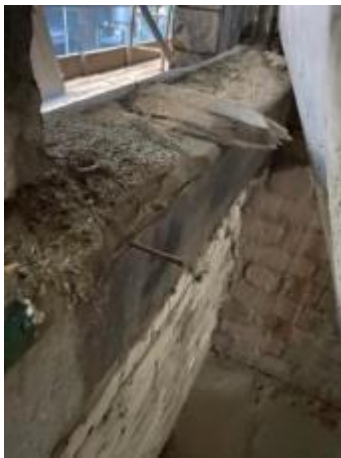
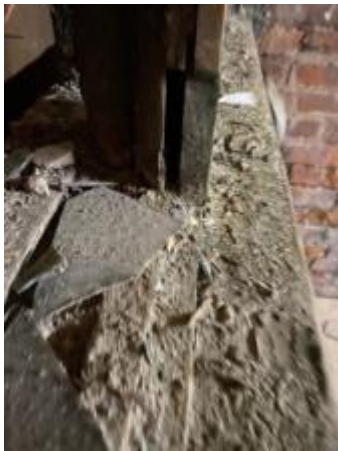
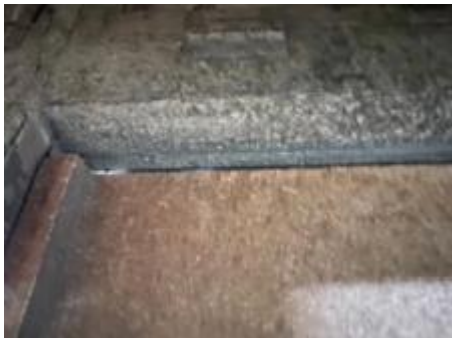
- Mullion missing
- 1nr sash missing
- 1nr sash badly damaged
- Bottom rail to window missing
- 6no panes of glass missing
- 6m glazing bead missing
- Stays missing
- External window Cill rotten

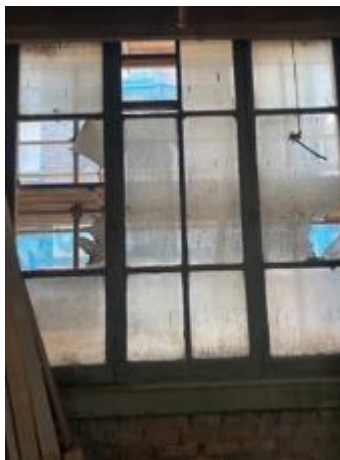
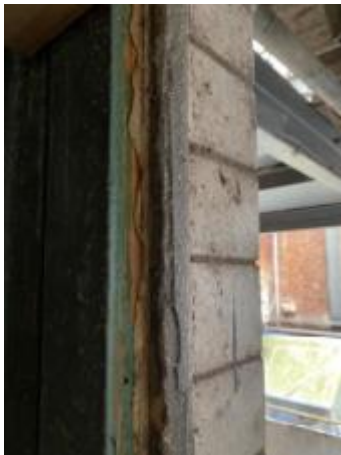
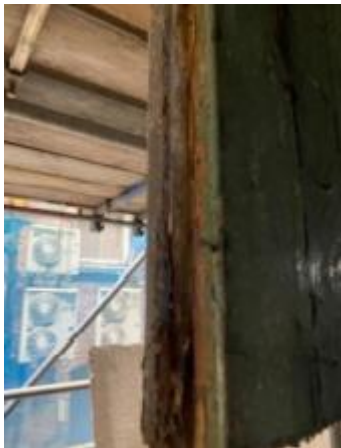
- Window generally in poor condition
- 1 sash missing
- 1 sash badly damaged
- Bottom rail to window missing
- 6no Panes of glass missing
- 6m Glazing bead missing
- Window board beyond repair
- Stays missing
- Mullion missing
- External window cill rotten

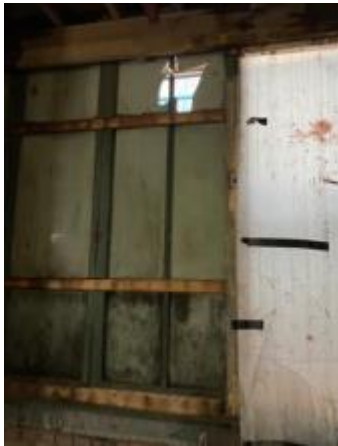
Figure 73: WP.0.16 (Credit Fairhurst 2022)

- Five Panes of glass missing
- 2 Sash stays missing
- 6m of glazing bead miss
- External cill 1.5m rotten
- ng/damaged
