**RE: RENAISSANCE HOTEL, BLACKFRIARS STREET, MANCHESTER, M3 2EQ**

**CCTV SURVEY – VAULTS DRAINAGE**

**blackfriars st manchester alliance group - CCTV Survey Report : 06/07/21**

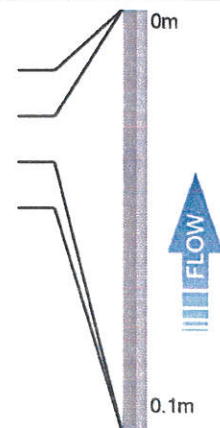
| Position | Code | Description | CD | Pic | Video Ref |
|---|---|---|---|---|---|
| 00.10m | LUF | Line of drain/sewer deviates up [full] | | | |
| 00.10m | SA | Survey abandoned | | | |

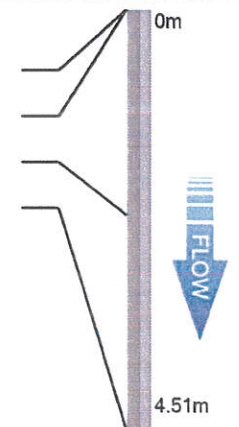
A defect [hole] was identified from MH SW04 – SW05 [a hole at 2.2 Metres], however this drain is to be removed & therefore no further action required.

| Position | Code | Description | CD | Pic | Video Ref | |
|---|---|---|---|---|---|--|
| 02.20m | B | Broken pipe 0 | | | | |

| Pos | Video Ref | Code | Description | Image |
|---|---|---|---|---|
| 02.20m | | B | Broken pipe - Severity 4 | |

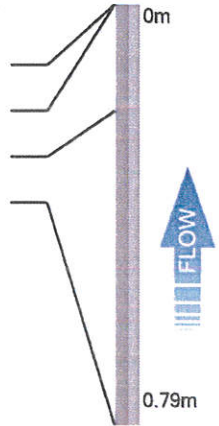
| Position | Code | Description | CD | Pic | Video Ref | |
|---|---|---|---|---|---|--|
| 00.20m | LUF | Line of drain/sewer deviates up [full] | | | | |
| 00.79m | SA | Survey abandoned | | | | |

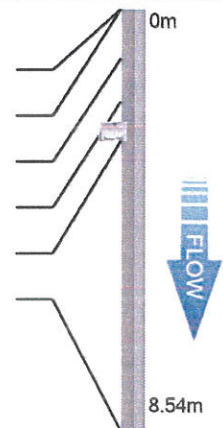
For the surface water system, we were unable to complete a visual survey due to severe bends in the 100mm diameter cast drain from SW06 [located in the plant room]. We did however dye test the system, to find it runs down to the underground car park to SW02 & then out to the river.

| Pos | Video Ref | Code | Description | Image |
|---|---|---|---|---|
| 08.54m | | SA | Survey abandoned<br>unable to push rodder due to severe bends, dye tested and found all surface water in units goes to sw02 in under ground car park | |
