## M&E Services Visual Report

Millennium Powerhouse, Moss Side  
140 Raby Street  
Manchester  
M14 4SL

**PROJECT NAME:** Millennium Powerhouse, Moss Side  
**REPORT NAME:** Visual Survey Report  
M&E Services Report  
**ISSUE STATUS:** For Information  
**GLD REFERENCE:** J295/MEP/RP01

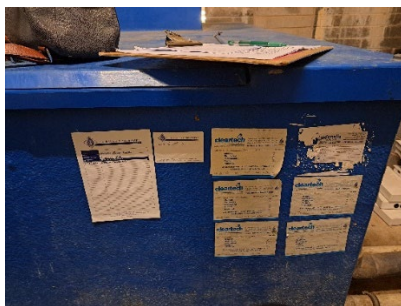
*Cold water tank in  
ground floor zone 4  
plant room*

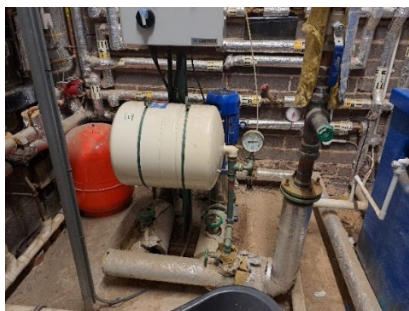
*Cold water booster  
pump set arrangement  
in zone 4 ground floor  
plant room*

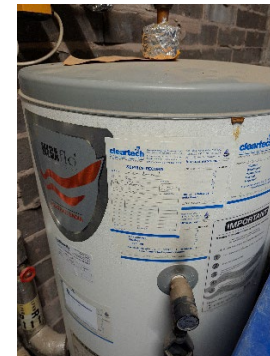
*Hot water storage  
cylinder ground floor  
zone 4 plant room*

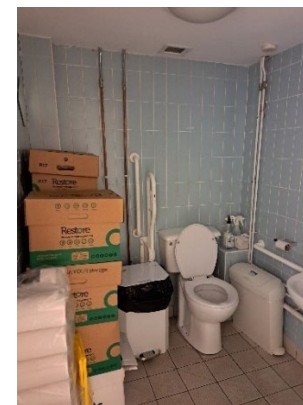
*Disabled WC  
within Zone 5*

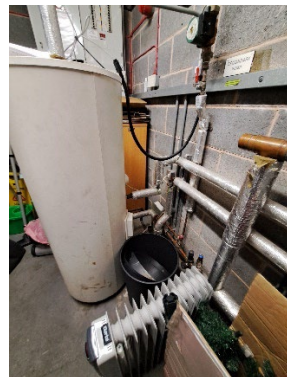
*Zone 5 ground  
floor plant  
room hot water  
cylinder*

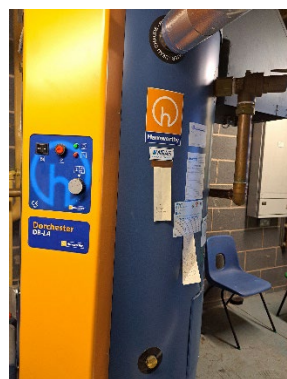
*Zone 7 plant  
room hot water  
cylinder*

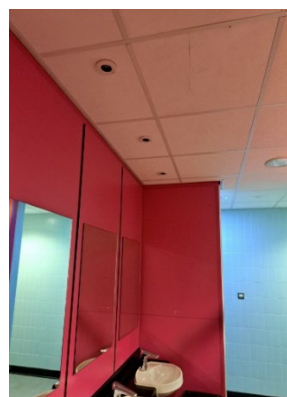
*WC within  
Zone 2*

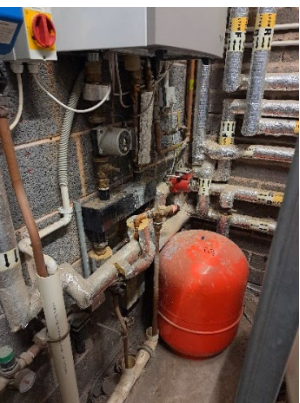
There were no obvious signs of disrepair to any of the systems located within the ground floor Zone 4 plant room and all of the equipment appeared to be in working order.

*Gas fired boiler and  
pressurisation unit in  
ground floor zone 4  
plant room*

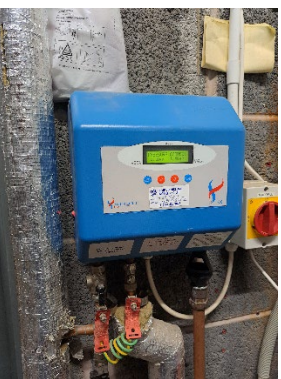
*Microfill boiler  
pressurisation unit in  
zone 4 ground floor  
plant room*

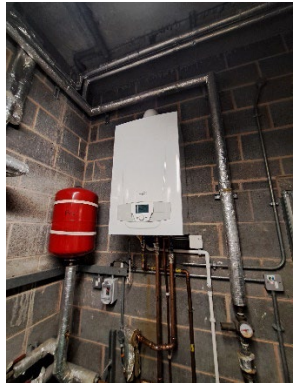
The heating in zones 5 and 8 is provided by the gas fired LPHW boiler located in the zone 5 ground floor plant room. This boiler is a Potterton Sirius 3 WH-50 45KW and is in new condition. We understand from the building manager that this boiler has recently been replaced.

*New gas fired  
boiler within zone  
5 ground floor  
plant room*

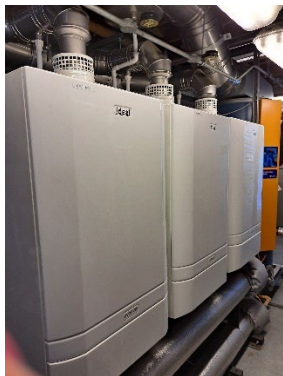
The main entrance building heating is served via 3 number Ideal Evomax boilers located in the Zone 7 first floor plant room (unable to determine size during survey). Gas and water services rise to this plant room via a service riser from the ground floor. Pipework is distributed below ground from the zone 4 plant room externally to this riser position.

*First floor zone 7  
plant room gas  
fired boilers*

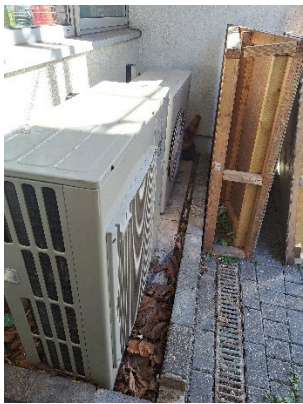
*Ground mounted VRF units serving meeting and library area*

The above units are Mitsubishi Mr Slim units PUHP100YHA with R410A refrigerant. The use of this refrigerant gas is being phased out and will not be available for new systems and this will affect some smaller existing systems moving forward. The building owner should be looking to either replace the gas in these units or replace the units within the next 3 years.

The location of the outdoor equipment in front of these condensers will be restricting the airflow around the units and they will not be working effectively with this arrangement.

| Code | Observation | Recommendation |
|---|---|---|
| 1 | Cooling units in some areas are in a state of disrepair and require replacement. Replacement refrigerant gas will be required within the next 5 years. Some areas suffering from overheating require attention. | This units should be considered for replacement. |

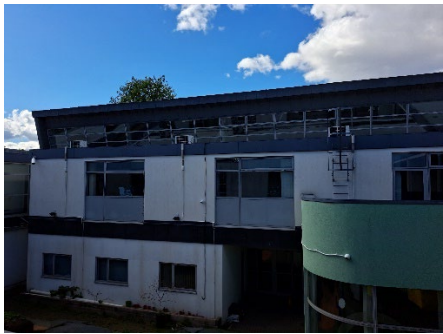
*Roof mounted VRF units serving offices*

The CAPS and / or the TYSS offices are served via VRF systems that are roof mounted. The details of these units were not determined during the survey.

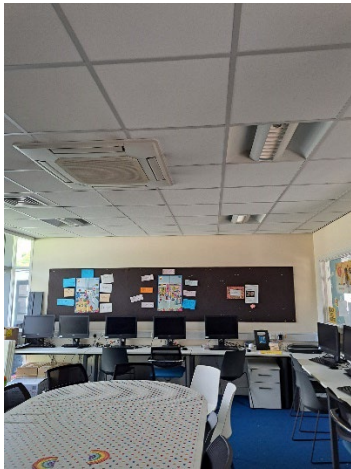
*Library AC and  
ventilation*

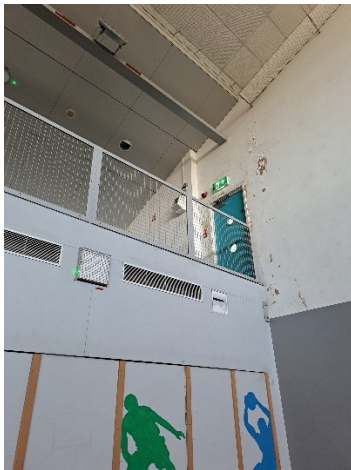
*Supply air distribution  
to the sports hall.*

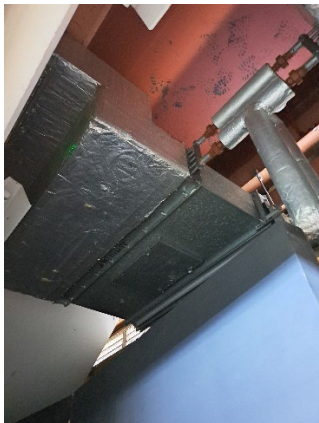
*Supply air ventilation  
units with LPHW  
heater batteries  
located inside  
storage of sports hall*

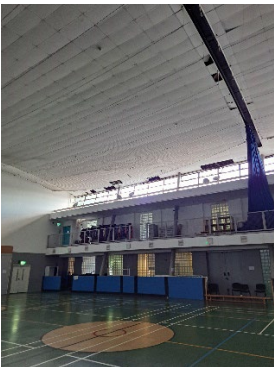
*Sports Hall high level window actuators for extract.*

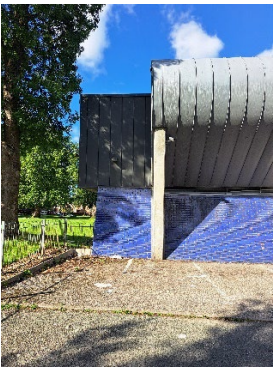
*Sports Hall ventilation grilles between wall and grey cladding*

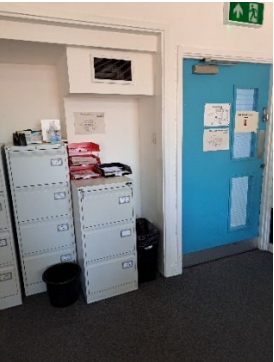
*Supply ventilation grilles served from high level concealed ductwork in dance studio (now used as an office).*

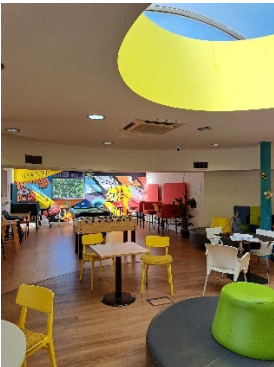
*Supply ventilation grilles served from high level concealed ductwork in circular area at first floor.*

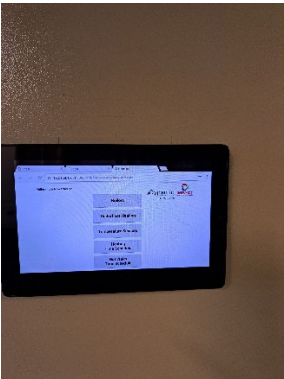
The mechanical services systems are provided with an automatic control system. An LCD display screen has been retrofitted into the mechanical controls panel to allow easier user control of the system. The system appeared to be in good working order.

*LCD display screen for mechanical system controls*

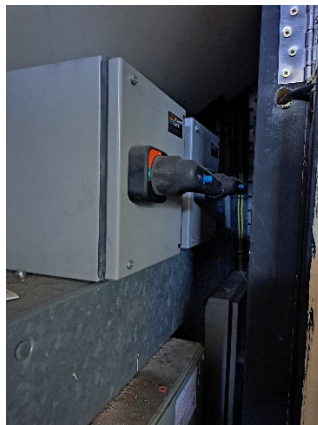
The building is served via an LV incoming supply which enters the building at the sports hall side with the meter and main switches located within one of the side storage units. Equipment was seen to be stored directly in front of the distribution so access was not available, and the building manager should consider some form of partition at least 1m in front of the equipment to allow step back and prevent equipment being stored within the required maintenance zone.

*Incoming supply point distribution within Sports Hall storage area. This is also the main meter location.*

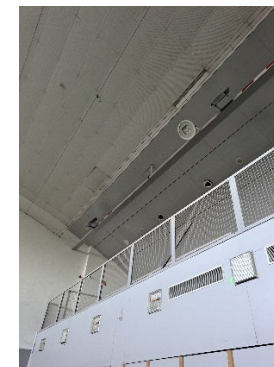
*Hi level LED flood lights located on building structure understood to be Whitecroft and installed within the last 5 years. Recessed asymmetric wall washers also provide some illumination within the sports hall. Surface mounted panels for emergency, recessed downlights on balconys.*

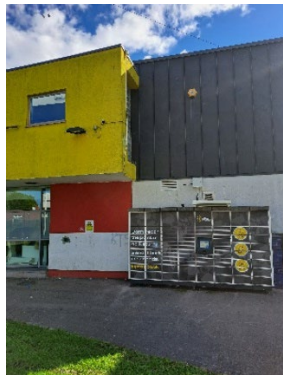
*Wall mounted  
external floodlights*

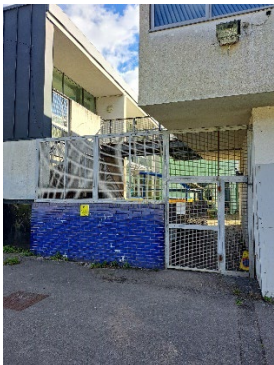
*Non matching  
external floodlights  
and surface mounted  
fluorescents on  
external stair landing  
/ balcony*

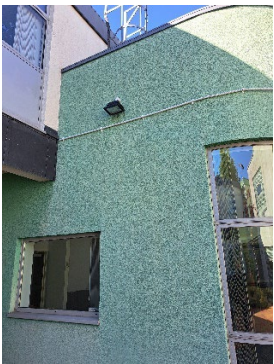
*External courtyard  
floodlight with  
surface mounted  
conduit*

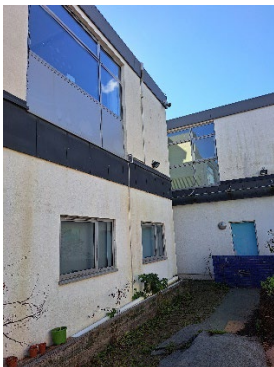
*External courtyard  
showing surface  
bulkhead luminaires,  
brick lights and  
floodlights*

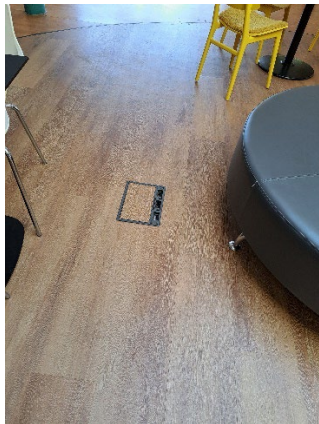
*Floorbox located  
within circular area  
on first floor*
