# **Asbestos Risk Management**

## **Asbestos Refurbishment and Demolition Survey Report**

**Victoria Park Probation Centre  
Laindon Road  
Manchester  
M14 5YJ**

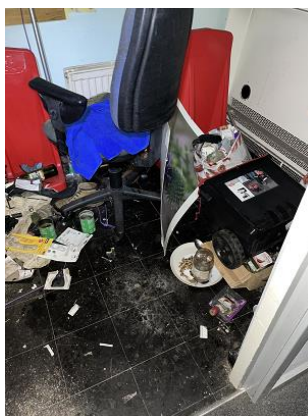
**Vinyl tiles** visible in small store

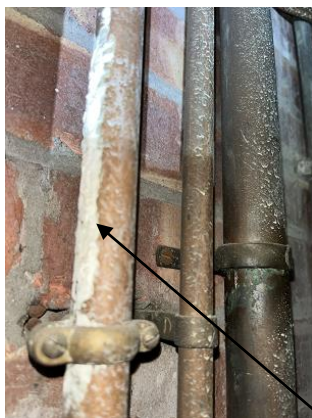
Sample LR02, NADIS

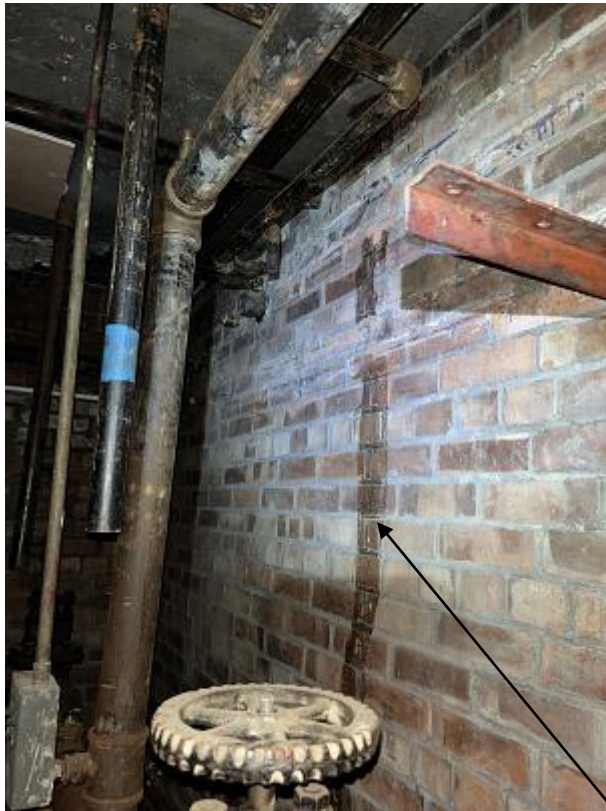
Enclosure glue and duct tape

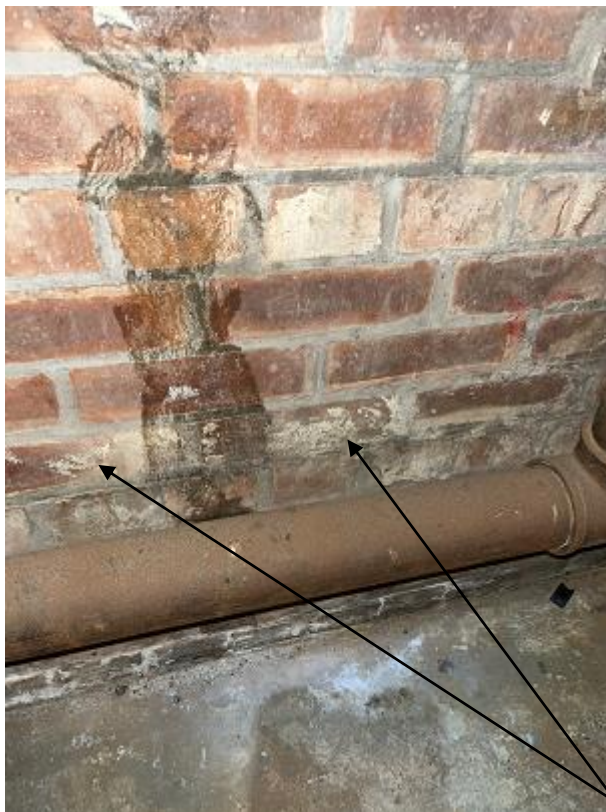
Sample LR06 Asbestos thermal  
insulation debris, Amosite

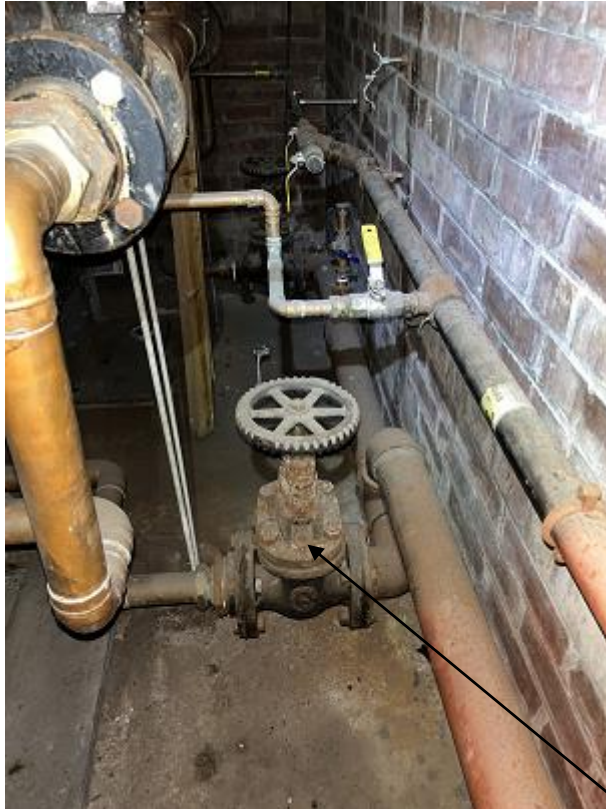
Sample LR05 Asbestos thermal

insulation debris, Amosite

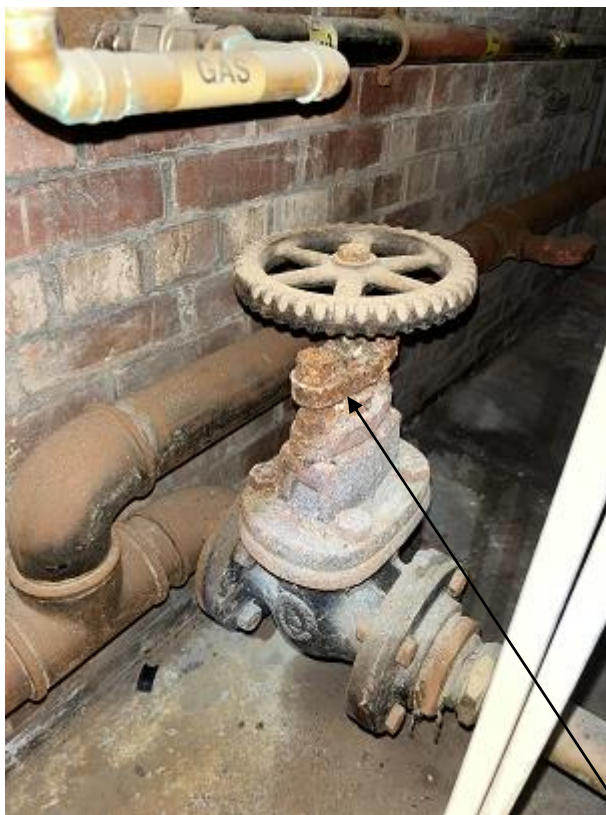
Sample LR05 Asbestos thermal

insulation debris, Amosite

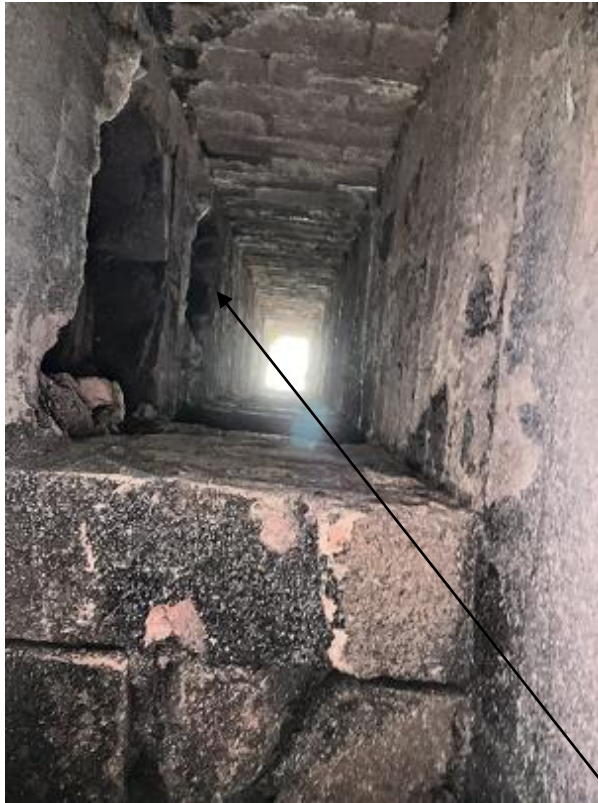
Presume remnant of AC flue in wall

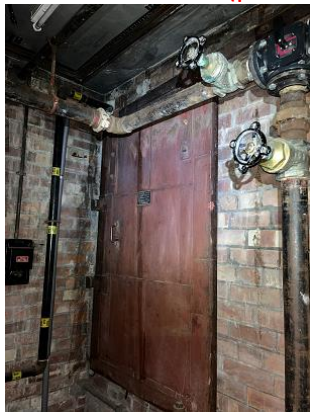
Curfew fire door (presume ACMs)

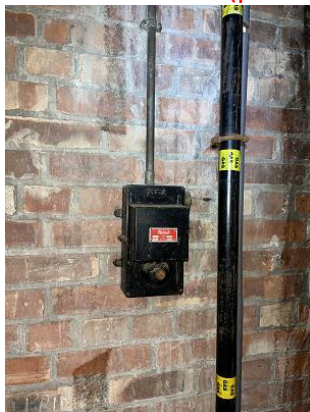
Walsall fuse unit (presume ACMs)

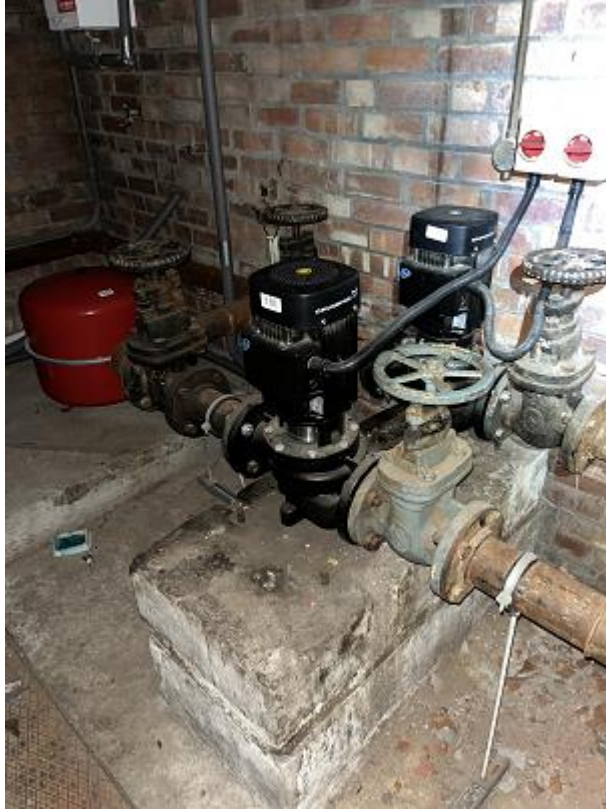
Presume ACMs to valve gaskets (Sample L404 NADIS)

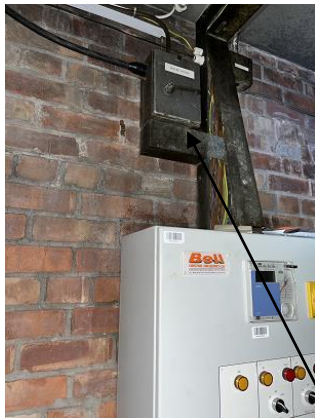
Presume ACMs to fuse unit

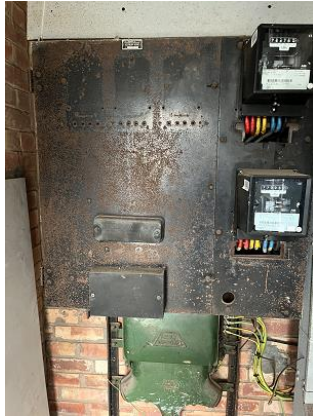
Presume ACMs to original electrical installation

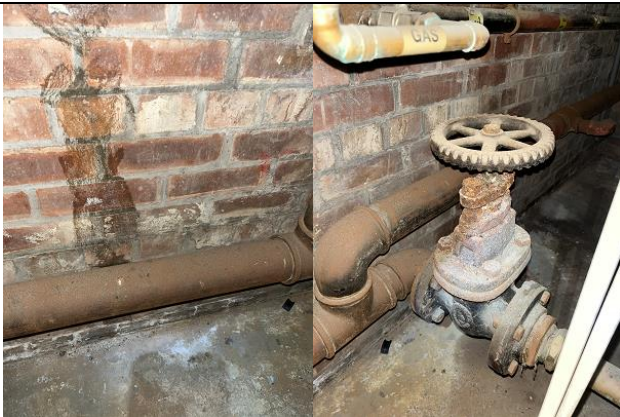
| Insulation residues | |
| <b>Material Details</b><br><br><b>Material type:</b> Asbestos thermal insulation<br><br><b>Sample no.:</b> LR04 and LR05<br><br><b>Extent:</b> Small amounts but widespread distribution to original pipework/ valves and walls behind pipework | |
| <b>Material Risk Score</b><br><br><b>Product type:</b> Asbestos thermal insulation<br><br><b>Extent of damage/deterioration:</b> High<br><br><b>Surface treatment:</b> Visible debris<br><br><b>Asbestos type:</b> Chrysotile<br><br><b>Material Risk Score</b> | <b>Risk Score</b><br><br>3<br><br>3<br><br>3<br><br>2<br><br>11<br><br><b>Risk Level: High potential to release fibres</b> |

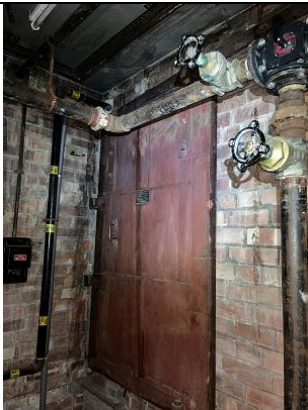
| Curfew fire door | |
| <b>Material Details</b><br><br><b>Material type:</b> Asbestos insulation<br><br><b>Sample no.:</b> Strongly presumed<br><br><b>Extent:</b> Interior of fire door | |
| <b>Material Risk Score</b><br><br><b>Product type:</b> Asbestos insulation<br><br><b>Extent of damage/deterioration:</b> Low<br><br><b>Surface treatment:</b> Encapsulated in door<br><br><b>Asbestos type:</b> Crocidolite<br><br><b>Material Risk Score</b> | <b>Risk Score</b><br><br>3<br><br>1<br><br>2<br><br>3<br><br>9<br><br><b>Risk Level: Medium potential to release fibres</b> |

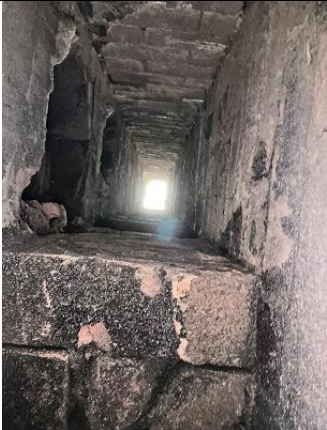
| <b>Possible remnant of AC flue (from original boiler) in chimney wall</b> | |
| <b>Material Details</b><br><br><b>Material type:</b> Asbestos Cement<br><br><b>Sample no.:</b> Presumed<br><br><b>Extent:</b> Small amounts – possible remnant in chimney | |
| <b>Material Risk Score</b><br><br><b>Product type:</b> Asbestos cement<br><br><b>Extent of damage/deterioration:</b> Medium<br><br><b>Surface treatment:</b> None<br><br><b>Asbestos type:</b> Chrysotile<br><br><b>Material Risk Score</b> | <b>Risk Score</b><br><br>1<br><br>1<br><br>1<br><br>1<br><br>4<br><br><b>Risk Level: Very low potential to release fibres</b> |

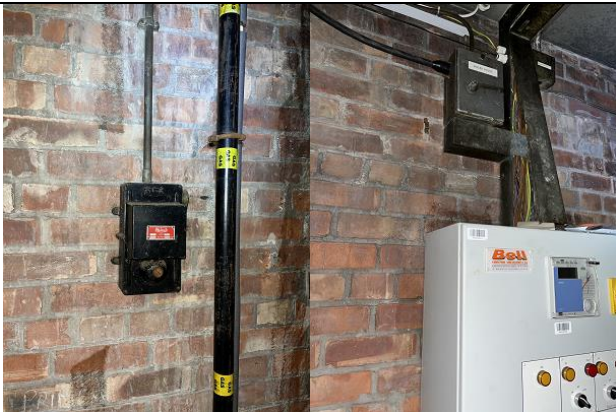
| 2 fuse units | |
| <b>Material Details</b><br><br><b>Material type:</b> Asbestos textiles/gaskets<br><br><b>Sample no.:</b> Presumed<br><br><b>Extent:</b> Small amounts to 2 fuse units | |
| <b>Material Risk Score</b><br><br><b>Product type:</b> Textiles<br><br><b>Extent of damage/deterioration:</b> Low<br><br><b>Surface treatment:</b> Encapsulated in fuse unit<br><br><b>Asbestos type:</b> Chrysotile<br><br><b>Material Risk Score</b> | <b>Risk Score</b><br><br>2<br><br>1<br><br>1<br><br>1<br><br>5<br><br><b>Risk Level: Low potential to release fibres</b> |

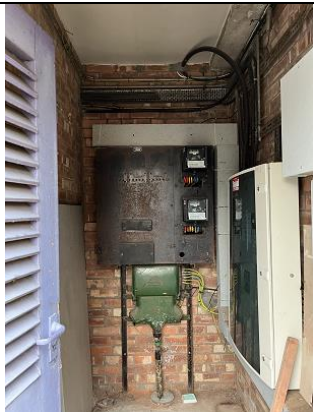
| <b>Material Details</b><br><br><b>Material type:</b> Asbestos textiles/gaskets/Millboard<br><br><b>Sample no.:</b> Presumed<br><br><b>Extent:</b> Small amounts to original electric installation | |
| <b>Material Risk Score</b><br><br><b>Product type:</b> Textiles<br><br><b>Extent of damage/deterioration:</b> Low<br><br><b>Surface treatment:</b> Encapsulated in fuse unit<br><br><b>Asbestos type:</b> Chrysotile<br><br><b>Material Risk Score</b> | <b>Risk Score</b><br><br>2<br><br>1<br><br>1<br><br>1<br><br>5<br><br><b>Risk Level: Low potential to release fibres</b> |

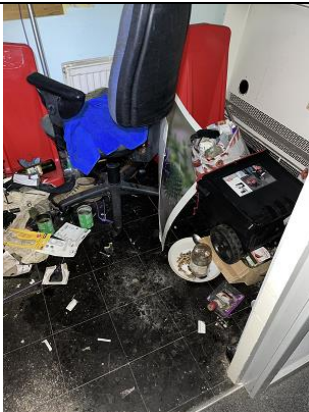
| <b>Material Details</b><br><br><b>Material type:</b> Asbestos Composites<br><br><b>Sample no.:</b> Previously Sampled<br><br><b>Extent:</b> Large amounts – area to be confirmed by contractor | |
| <b>Material Risk Score</b><br><br><b>Product type:</b> Vinyl tiles and bitumen adhesive<br><br><b>Extent of damage/deterioration:</b> low<br><br><b>Surface treatment:</b> Composite<br><br><b>Asbestos type:</b> Chrysotile<br><br><b>Material Risk Score</b> | <b>Risk Score</b><br><br>1<br><br>1<br><br>0<br><br>1<br><br>3<br><br><b>Risk Level: Very low potential to release fibres</b> |

Remove and dispose of as asbestos waste under appropriate HSE Guidelines
