## **Mayfield Regeneration**

### **Geoenvironmental and Geotechnical Desk Study Report**

**035548**

10 August 2017

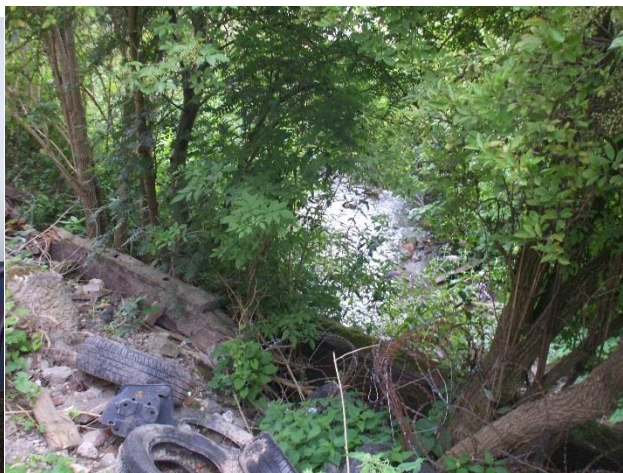
Photograph 10

- Through a gate to the south of the compound: Heavily overgrown area adjacent to the River Medlock, which is at a lower level. Fly tipping (old tyres, brick and concrete rubble) present. River wall in poor state of disrepair. Knotweed present on riverbank but not noted on upper level. (Photograph 10)

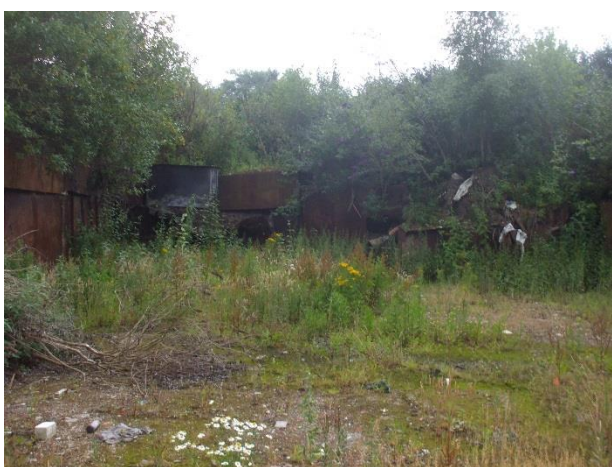
Photograph 11

- Western area: Former scrapyards, now vacated. Metal structures, ~2 m high, present around the edge of the Site, filled with Made Ground/fly tipping. (Photograph 11) Vacant industrial building in west of yard, joined onto Mayfield Station.

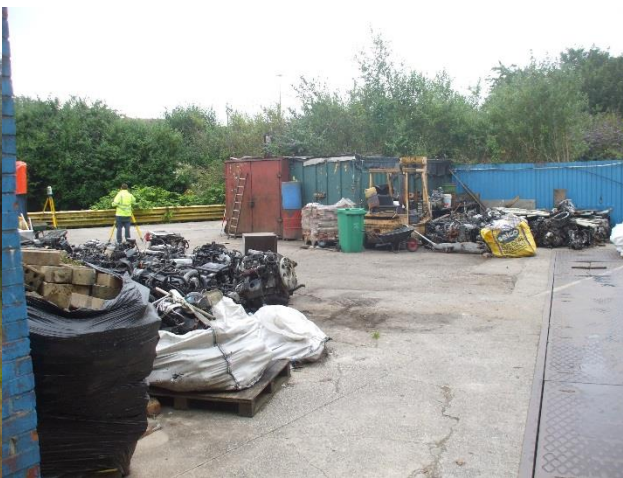
Photograph 12

- Eastern area: Yard with small 2 storey brick structure, metal containers, and numerous car parts/engines on the ground. Large metal weighbridge present (Photograph 12), Large quantities of knotweed in river channel, but appears not to have encroached into the yard.

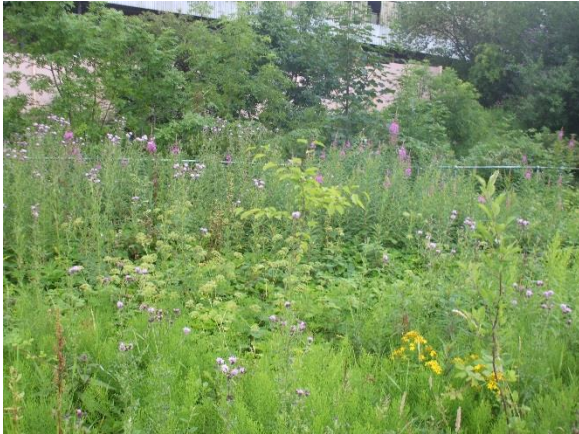
Photograph 15

- TFGM car park (east of Baring Street)
  - Very overgrown in northern portion of car park adjacent to River Medlock. (Photograph 15)
  - Car park surfaced with tarmac.

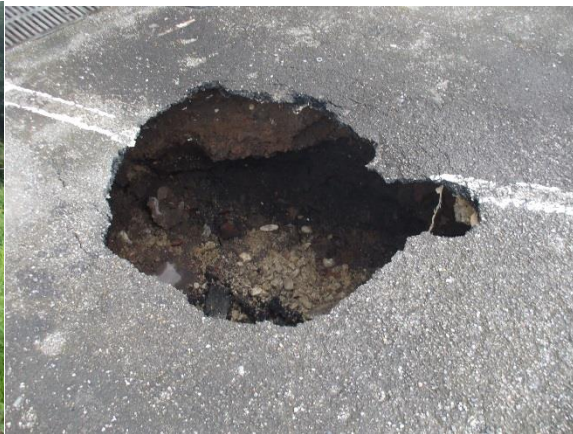
Photograph 16

- Void recently opened up in car park outside Unit 4 (Section 3.5 refers). Cordoned off by barriers at time of walkover. (Photograph 16)
- Area north of Chapelfield Road and east/south of Hoyle Street: Yard with vehicles parked (including tracked excavators). Sign outside advertising 'Free tipping of clean hardcore'. River culverted under this yard. (Photograph 17)

In June 2017, a void (~1.50 m diameter x ~5.00 m deep) appeared in the car park of the Transport for Greater Manchester (TfGM) building (Unit 4), close to the culverted River Medlock. The cause is currently unknown and is under investigation. The void appears to be connected to existing drainage, and there may have historically been a chamber in the locality. Further assessment, including a CCTV survey, is currently being undertaken, and appropriate repair/remediation measures will be undertaken once better understood. Bulging and cracking to the nearby car park retaining wall was also noted, with a depression to the tarmac adjacent to the wall. A Design Note has been prepared by BuroHappold and is included as Appendix C.

A void (~1.50 m diameter x ~5.00 m deep) appeared in the car park of the Transport for Greater Manchester (TFGM) building (Unit 4), directly above the culverted River Medlock during the recent Site walkover. The cause is currently unknown. Further assessment, including a CCTV survey, is currently being undertaken, and appropriate repair/remediation measures will be undertaken once better understood. Bulging and cracking to the nearby car park retaining wall was also noted, with a depression to the tarmac adjacent to the wall. A Design Note has been prepared by Buro Happold and is included as Appendix C.

| Voids | Unstable ground | Potential harm to structures and human life. Cost of repairs. | 4 | 4 | 16 | Voids have opened up on / near Site (Section 3.5 refers). Investigation required to establish extent, cause and mitigation. |

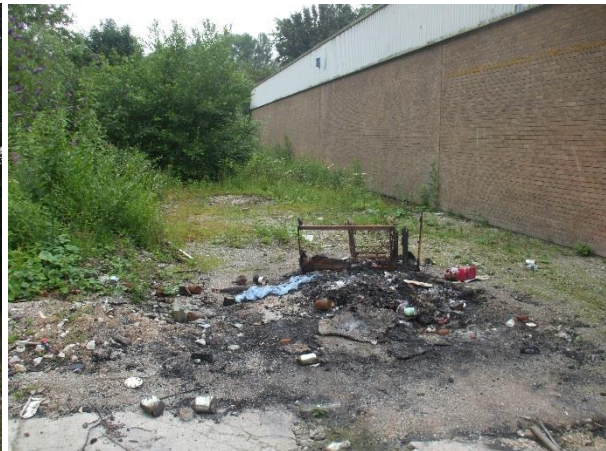
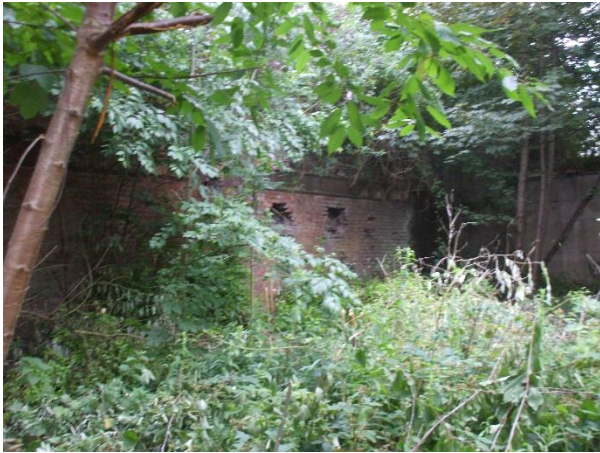
- N and E of building: Overgrown. Fly tipping and evidence of burning (ashes, charred material). Brick/concrete walls border the plot in the eastern area; poor state of disrepair. (Photographs 21 and 22)

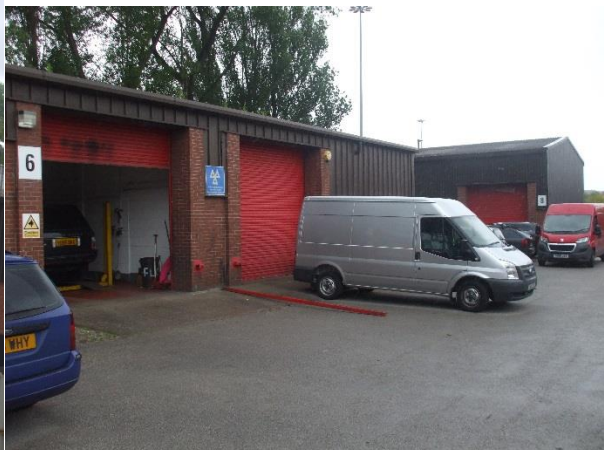
Photograph 27

- JS advised high risk of sharps, needles etc. in the area, and presence of drug users and prostitutes
- Hoyle Street Industrial Estate (Photograph 27)

Sharps and Needles were identified on Site during the Site walkover. It is recommended that a sharps and needle disposal specialist is consulted with regards to identifying the extent of and appropriate measures for Site management and/or removal of these items prior to the start of any construction works. It is also recommended that the site is secured prior to any such removal to prevent further sharps being dumped on site.

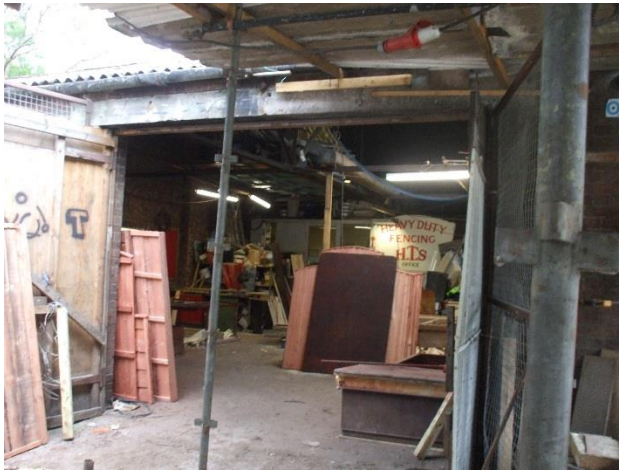
Photograph 28

- Timber yard and car depot
- Western portion of yard full with timber, old vehicles (Photograph 28)
- Eastern portion of yard piled up with doors, oil drums, fridges, rubble, insulation etc. (Photograph 29)
