Eagle House, Manchester  
Second Floor Photographic Survey  
May 2023

## 2.0 – Second floor room key

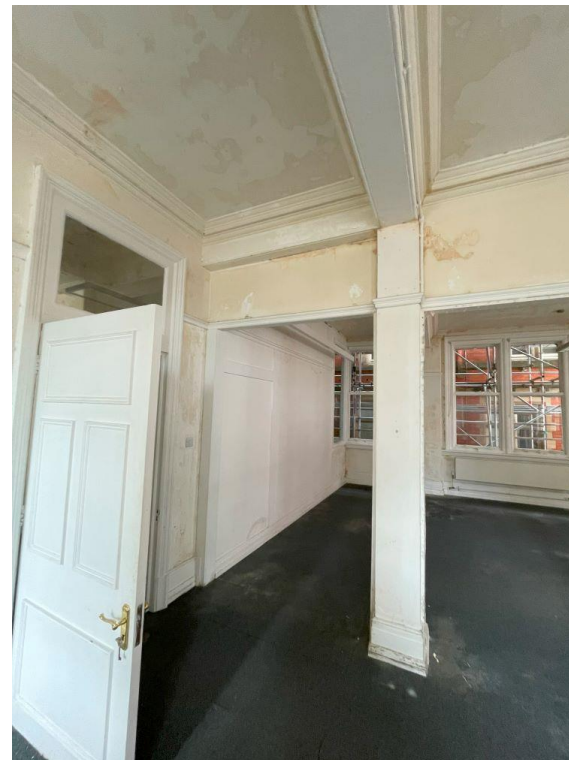
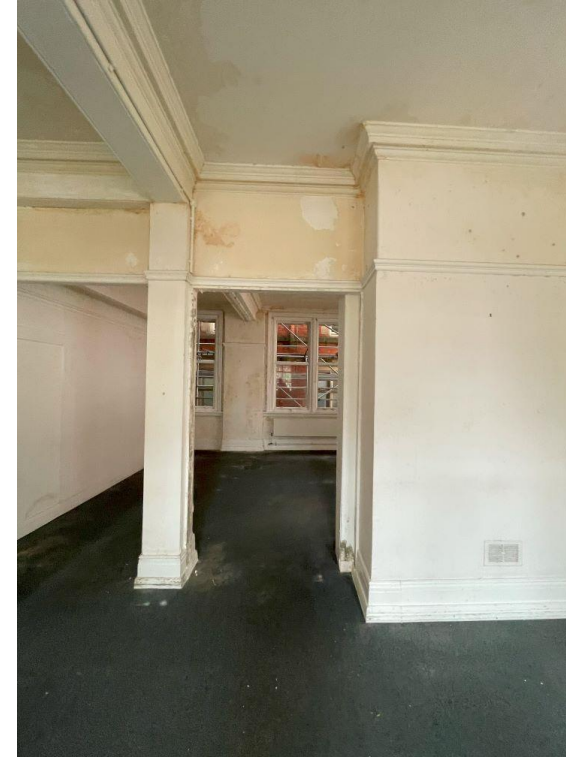
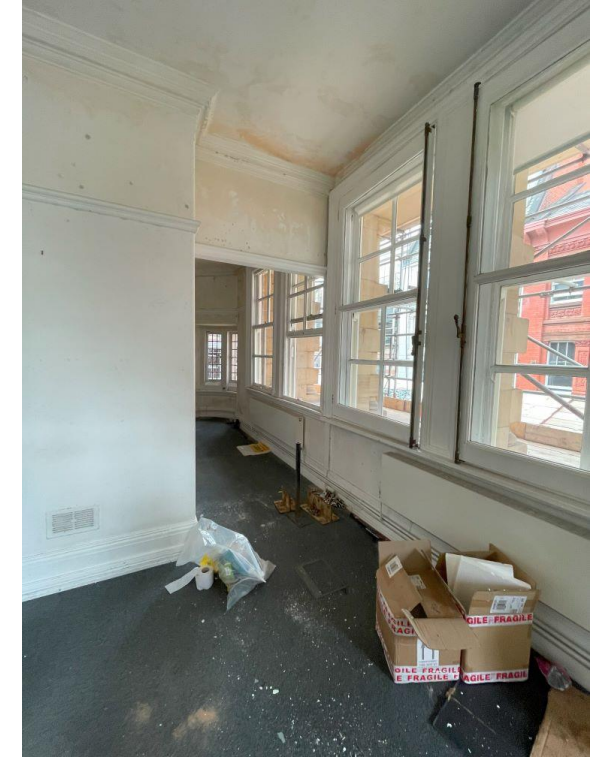
Photos 1, 2 and 3 – Elevation 1

From archival research this partition is original to the building, but at some stage crude openings have been formed at low level. Cornicing exists to the top of these high level partitions which ties in with and continues around the remainder of the space. It is therefore proposed to retain this partition and incorporate it into the design proposals so as to not further erode the historic fabric of the building

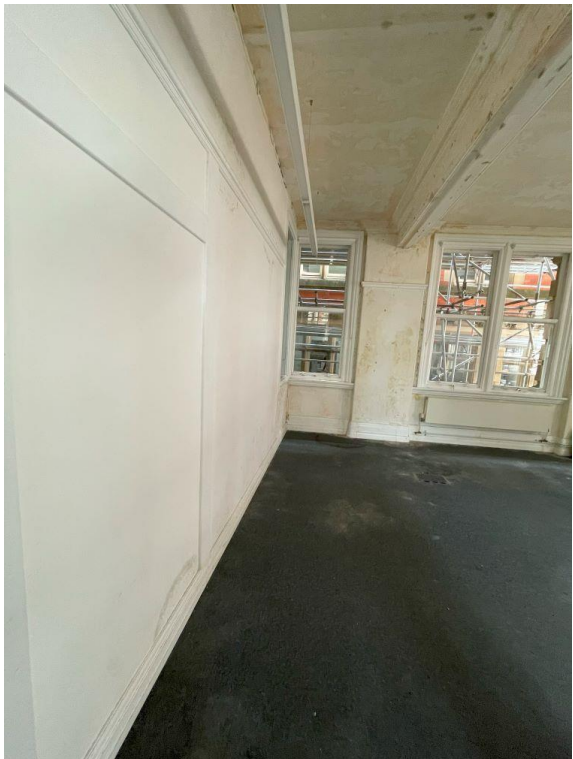
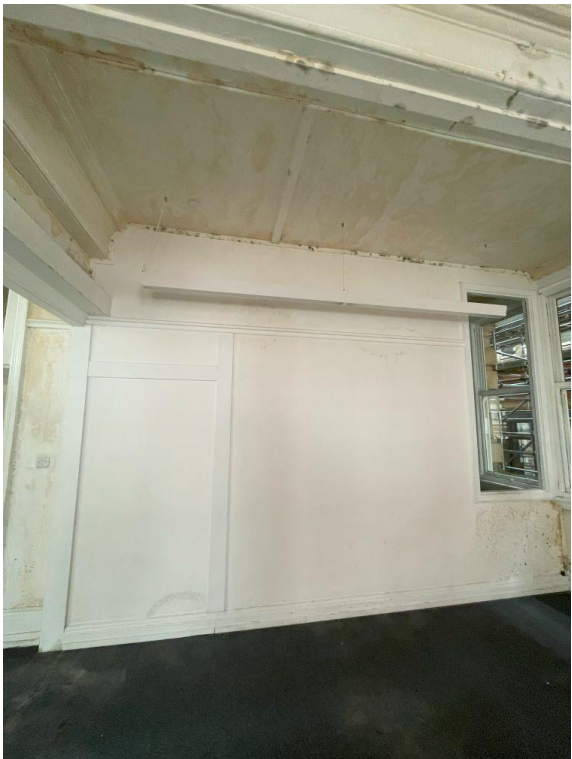
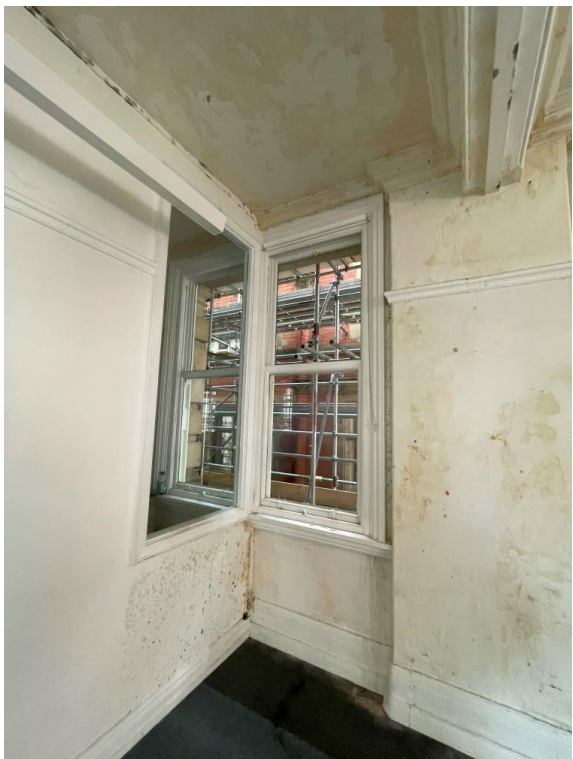
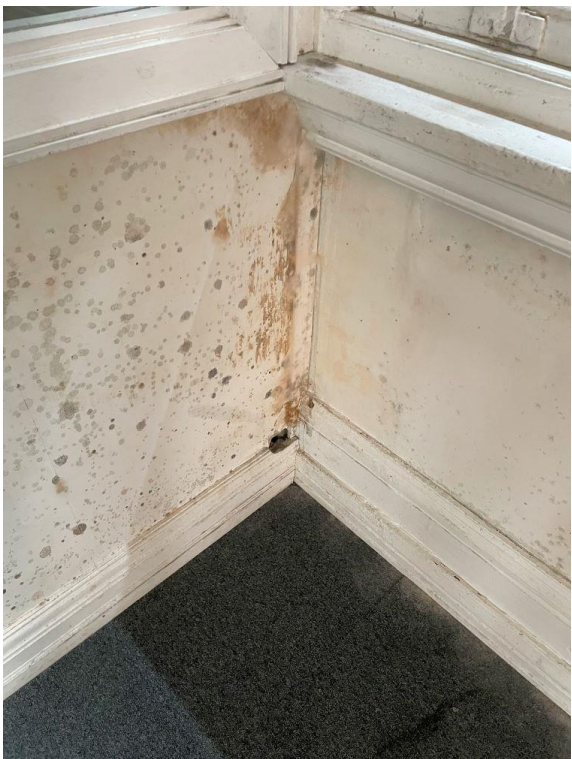
These photographs focus on the dividing wall between the current main office and the tea prep area. The partition is not original to the building and junctions crudely with the window mullion. The partition also has an awkwardly placed glazed screen, the skirting does not match that to the perimeter and has no cornicing.

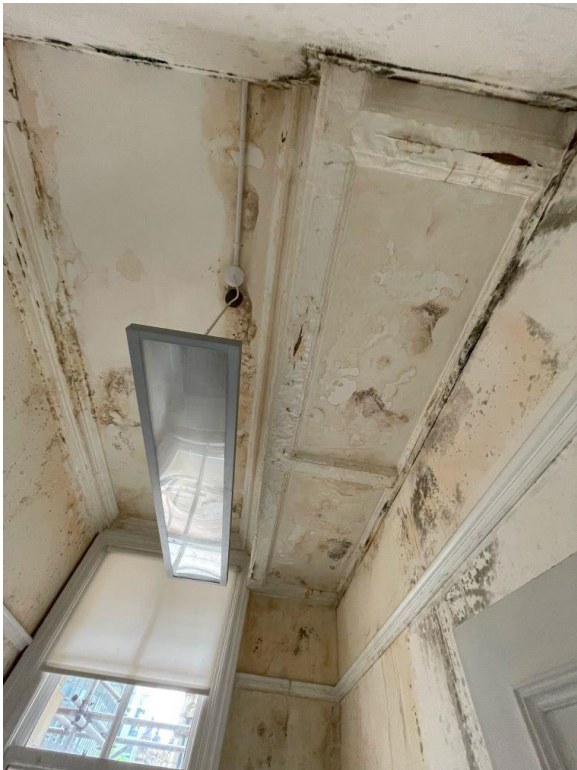
Photo 1

Photos 1 and 2 focus on the ceiling and the junction with the ceiling. Photograph 4 shows the corridor wall with smaller skirting than original and no visible cornicing

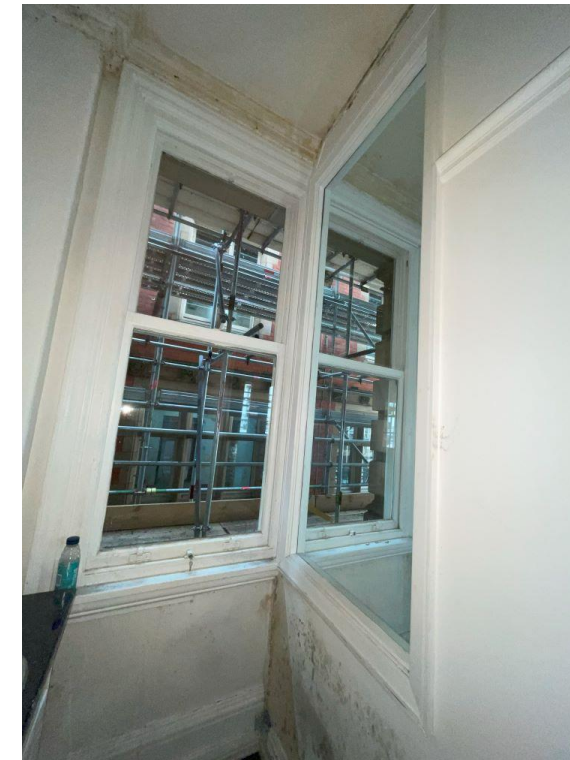
Photos 1 and 2 look towards the external wall and window. Photo 2 shows the window between the tea prep area and the main office which junctions crudely with the window mullion. This wall and the corridor wall shown in photo 4 have no cornicing present.

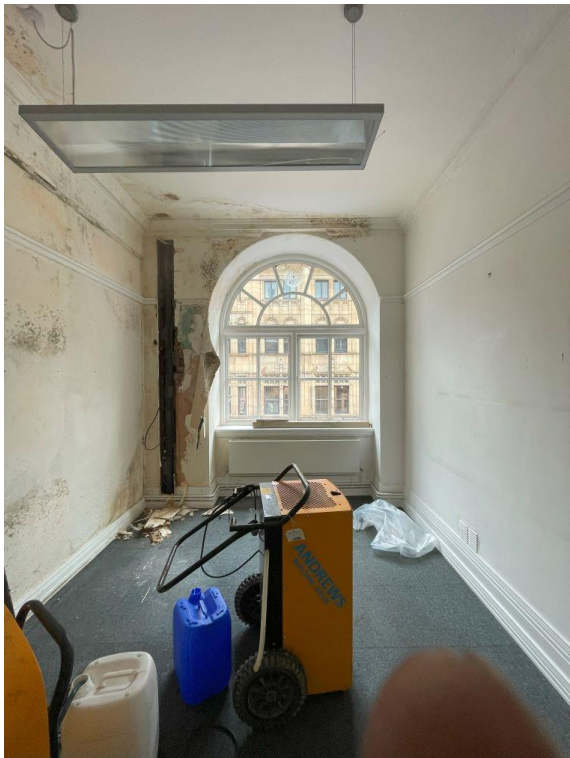
Photo 1 shows the corridor partition which has no cornicing, and skirting does not tie in with existing

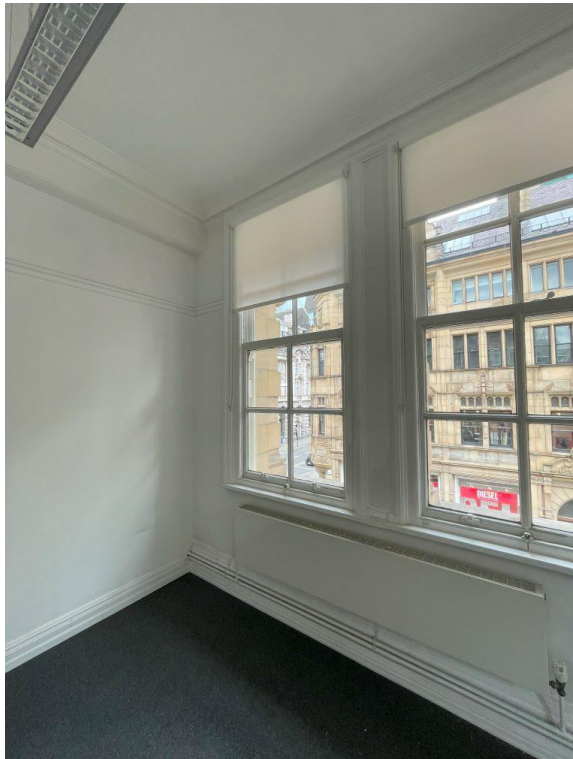
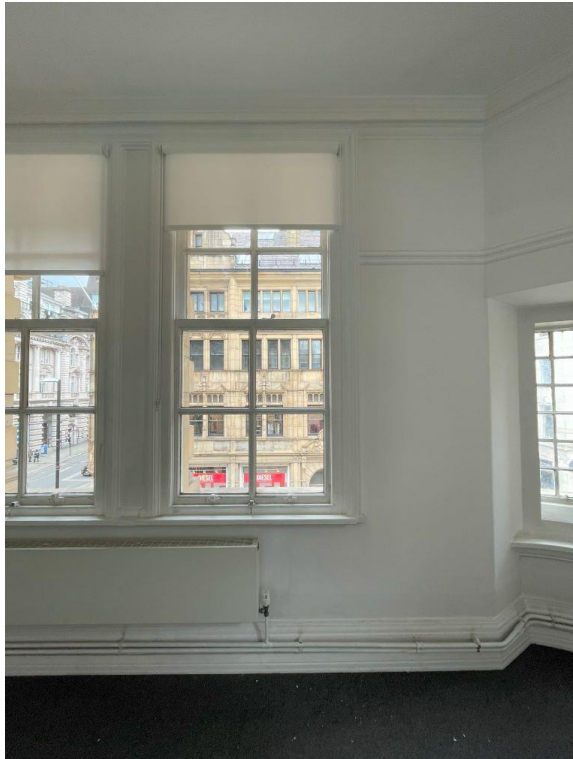
The partitions forming the entrance way to this room have no cornicing and crudely abut the cornicing which is in place.

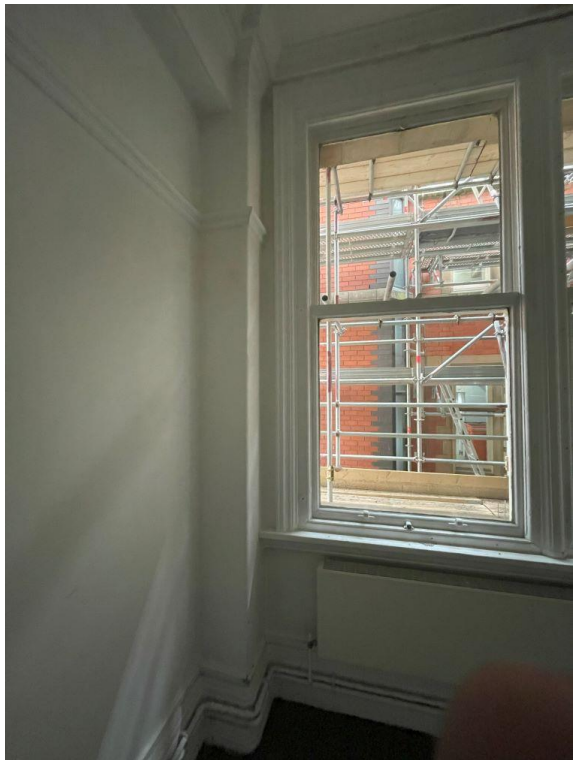
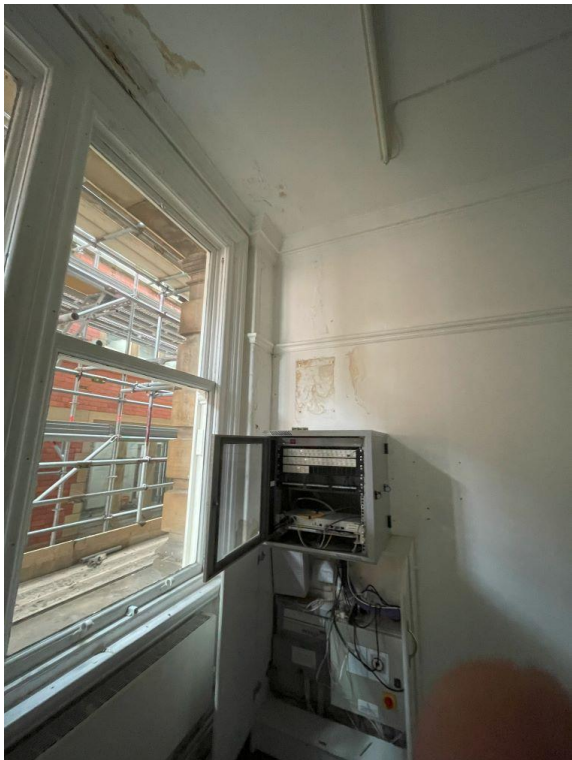
From disruptive survey this partition appears to be an older addition to the building. Through consultation with City of Manchester council it has been determined that this partition should remain and has been incorporated into the design proposals.

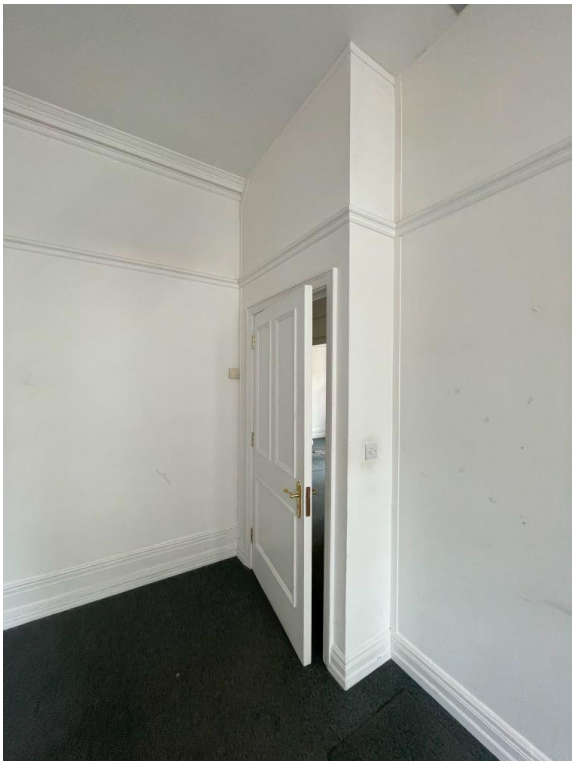
Photo 1 shows the corridor partition which has no cornicing, and skirting does not tie in with existing

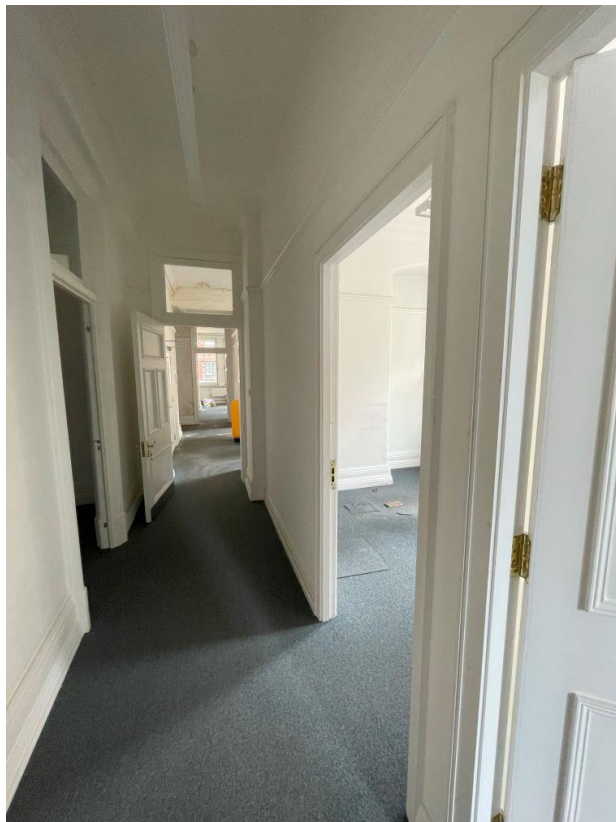
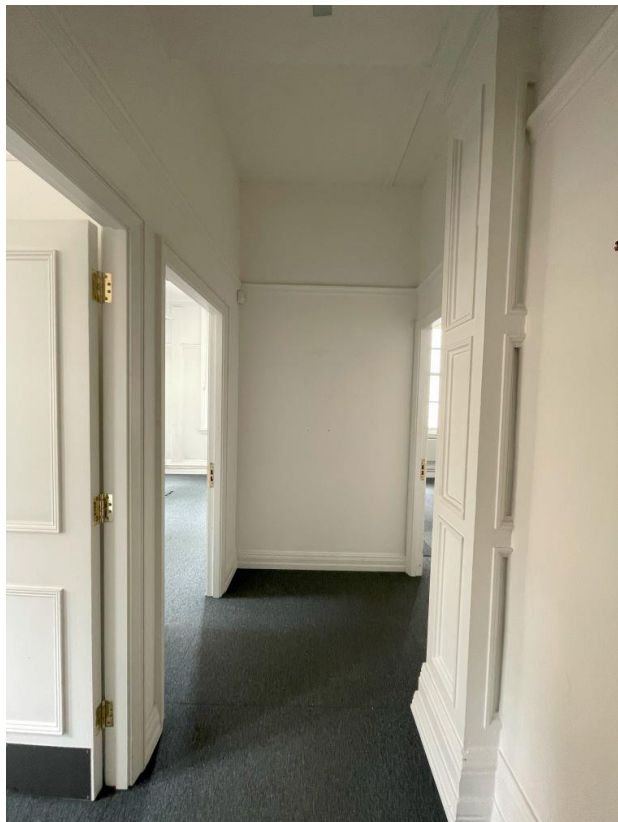
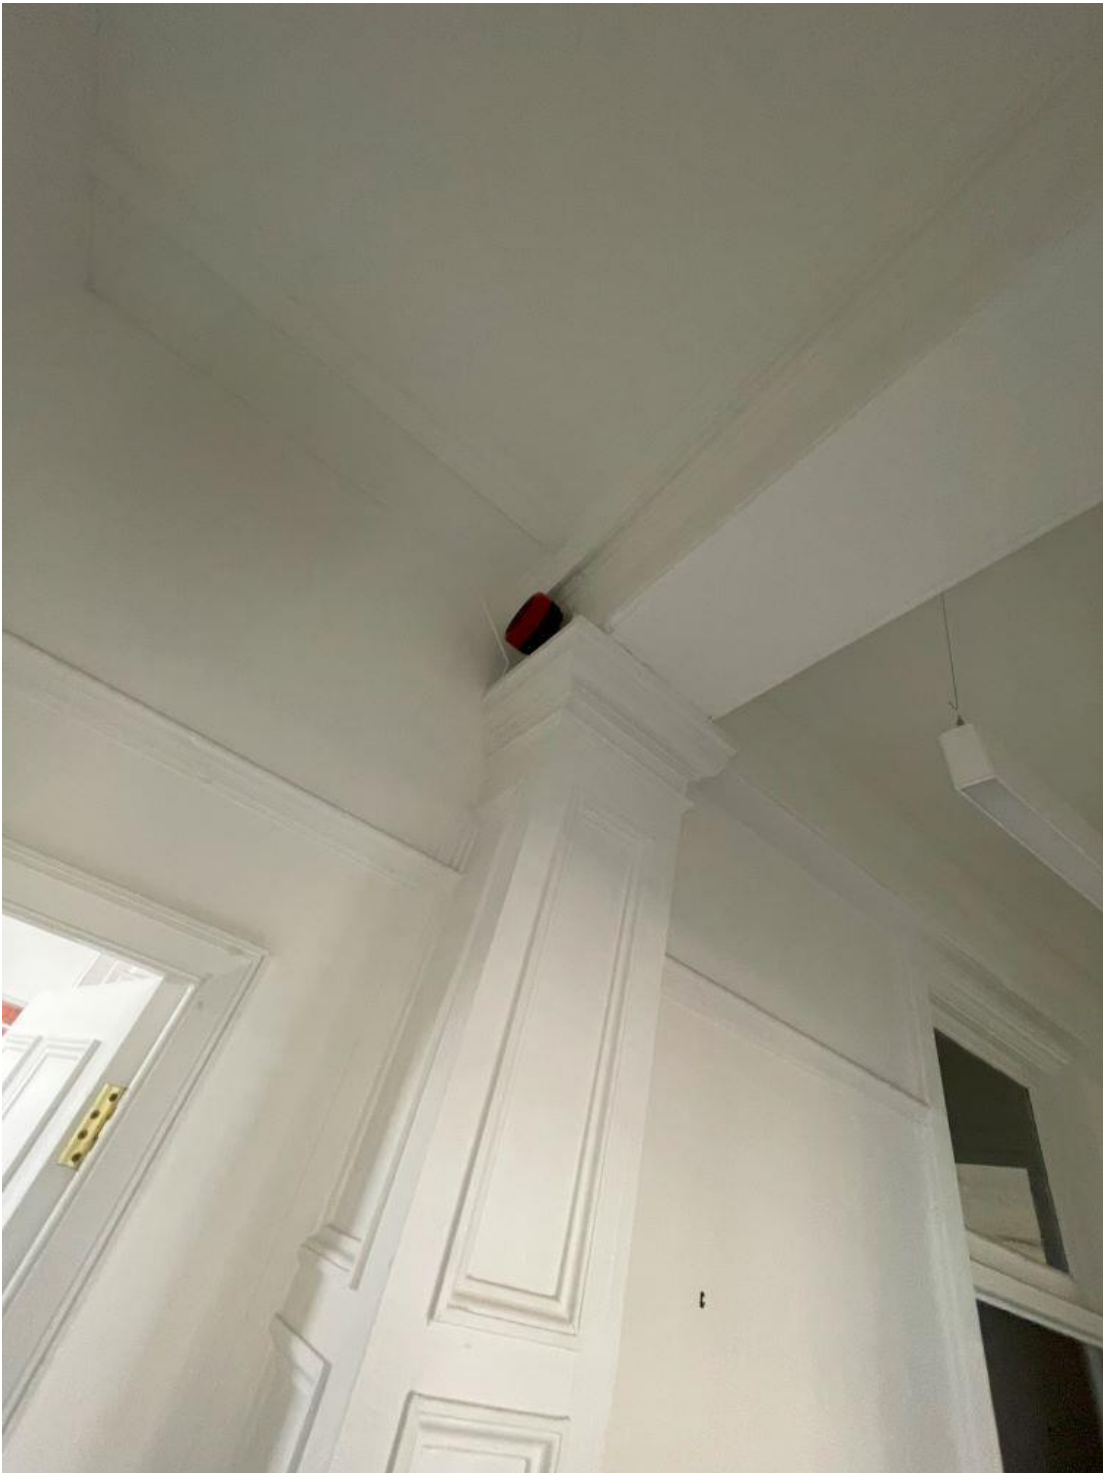
Photos show modern plasterboard partitions to the majority of the corridor.
