**84 Princess St, Manchester**

Facade Repairs

Elevations (Princess St) - Condition Survey and Proposals

| drwg no. | <b>P(210)</b> |

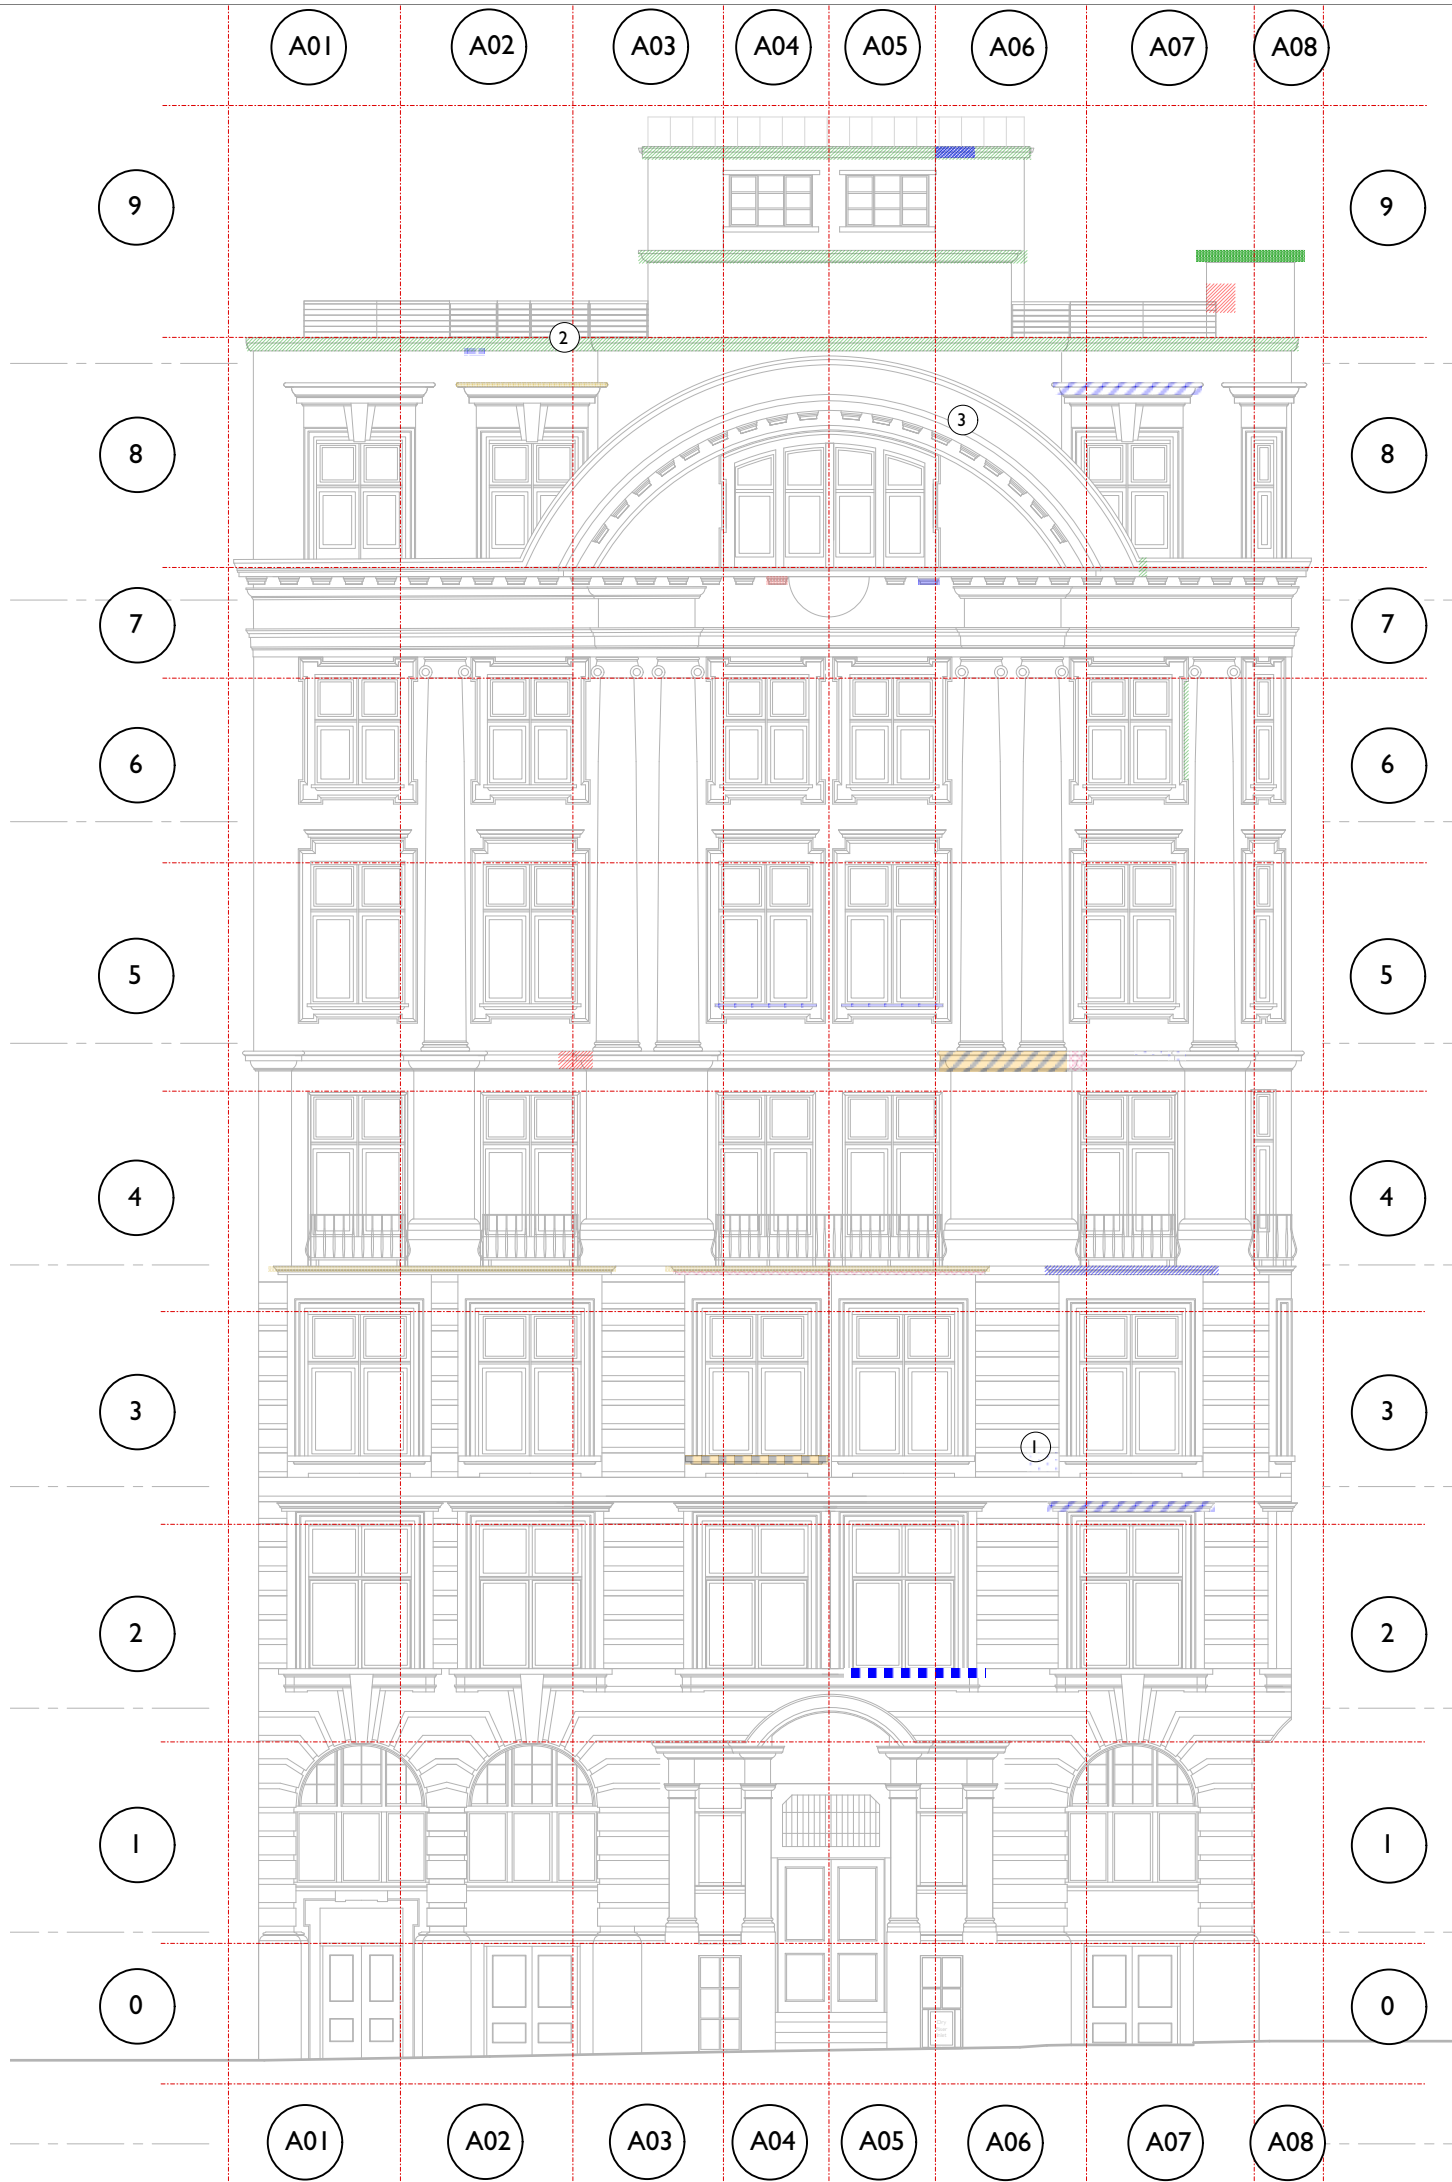
- Location tag may be incorrect as the photo is of an internal corner to a cill.
- Remediate repointing to halt degradation at A02,8 (1) below.
- Previously installed lead coping along curved and flat cornice at this level.

General atmospheric dirt to masonry faces. No sign of causing damage to underlying fabric. Propose no action.

- Method 1 - Loose stone. Structural repair: Resin bound dowel to prevent movement.
- Method 2 - Loose stone. Structural repair: Resin bound dowel to refix.

- Method 3 - Cill erosion, replacement stone cill
- Method 4 - Delaminating stone. Defrass and then localised indent of new matching stone.
- Method 6 - Stone erosion. Replacement cornice/coping
- Method 7 - Missing/broken stone. Replacement with matching stone indent.
- Method 10 - Scaffold fixing hole. Mortar repair to fill.
- Method 13 - Localised eroded stone. Localised indent of new matching stone
- Method 17 - Localised eroded stone (horizontal surface). Localised indent of new matching stone
- Method 19 - Eroded stone. Replacement window head stone.
- Method 21 - Biological growth, eroded horizontal stone, missing pointing. Steam clean, and localised stone indents, repointing.
- Method 22 - Cracked stone. Replacement with matching stone indent.
- Method 23 - Cill face missing. Replacement matching stone fixed with resin bound dowels.

- Method 8 - Biological growth. High pressure steam cleaning.
- Method 9 - Biological growth and damaged cement screed. Steam cleaning and then localised removal of loose cement and matching stone indent repairs as required.
- Method 14 - Works omitted.
- Method 15 - Biological growth./heavy atmospheric soiling. High pressure steam cleaning.
- Method 18 - Biological growth., missing or degraded pointing. High pressure steam cleaning and localised repointing.

- Method 5 - Degraded pointing. Repointing. Also covers method 12 - Localised eroded stone due to failed pointing above
- Method 11 - Cracked and missing chimney flaunching. Remove cement flaunching and replace with lime based over brick/stone pieces.
- Method 12 - see 5 above.
- Method 20 - Cement mortar over crack. Remove mortar and fill crack with lime mortar.

- Method 16 - Loose/friable stone surface. Brushdown.
