Karl McDonald  
Manchester And Cheshire Construction

# MOH 11/07/2023

MJC site visit

Tuesday, 11 July 2023

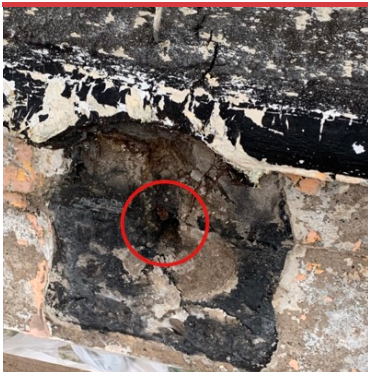
### LOCATION REF 27

One of the gargoyles has fell off the building due to perished steel retaining rods.

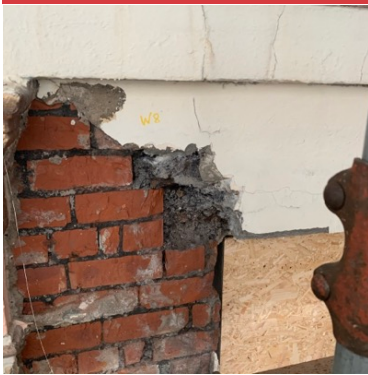
### LOCATION REF 27

Gargoyle location showing corroded steel, detail required for re fixing.

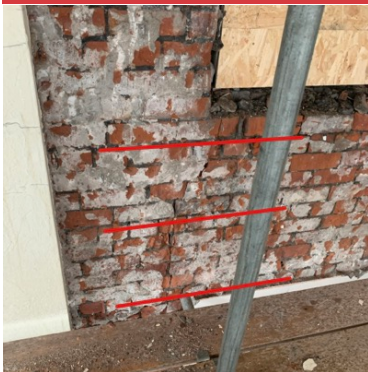
### LOCATION REF 28

Lintel over W8 needs remedial detail, steelwork is heavily corroded and internally showing signs of dropping/ movement.
