# Contaminated Land Phase One Desk Study for proposed residential development at land off, Robin Hood Street, Cheetham Hill, Manchester, M8 9JG.

Prepared for

Tang & Associates Architecture Ltd,  
10/F, 1 City Approach,  
Albert Street,  
Eccles,  
Manchester,  
M30 0BG.

July 2023

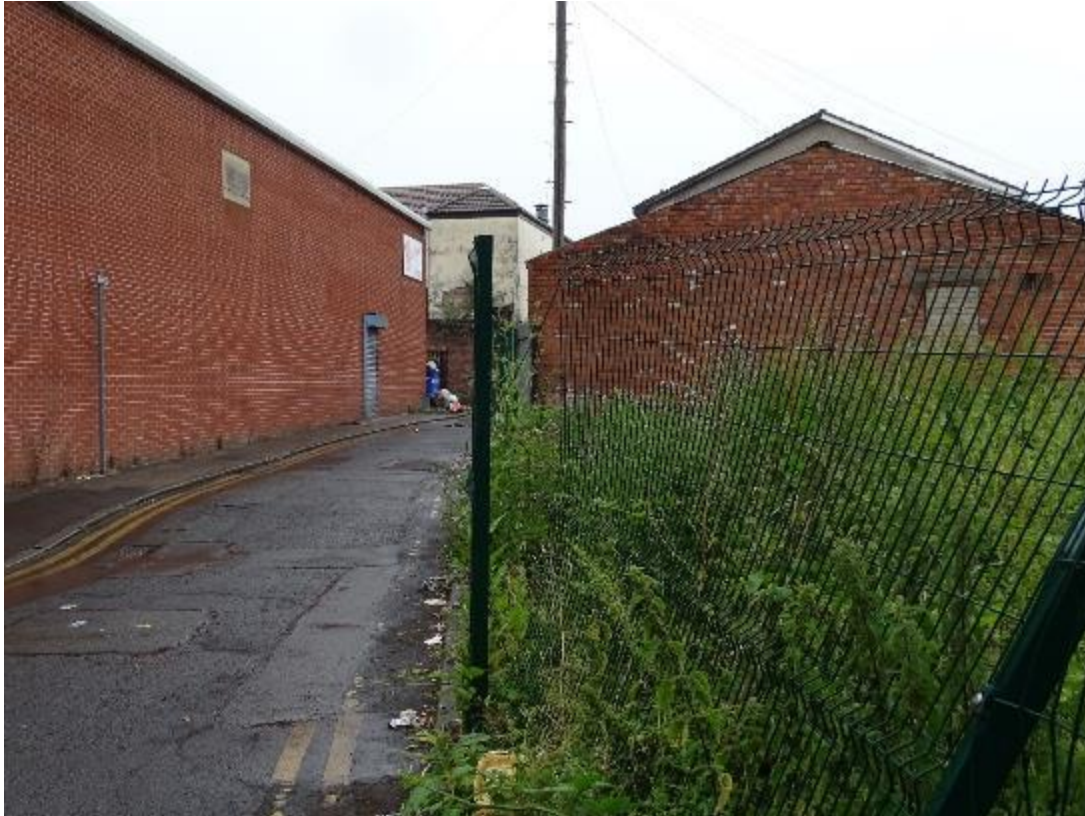
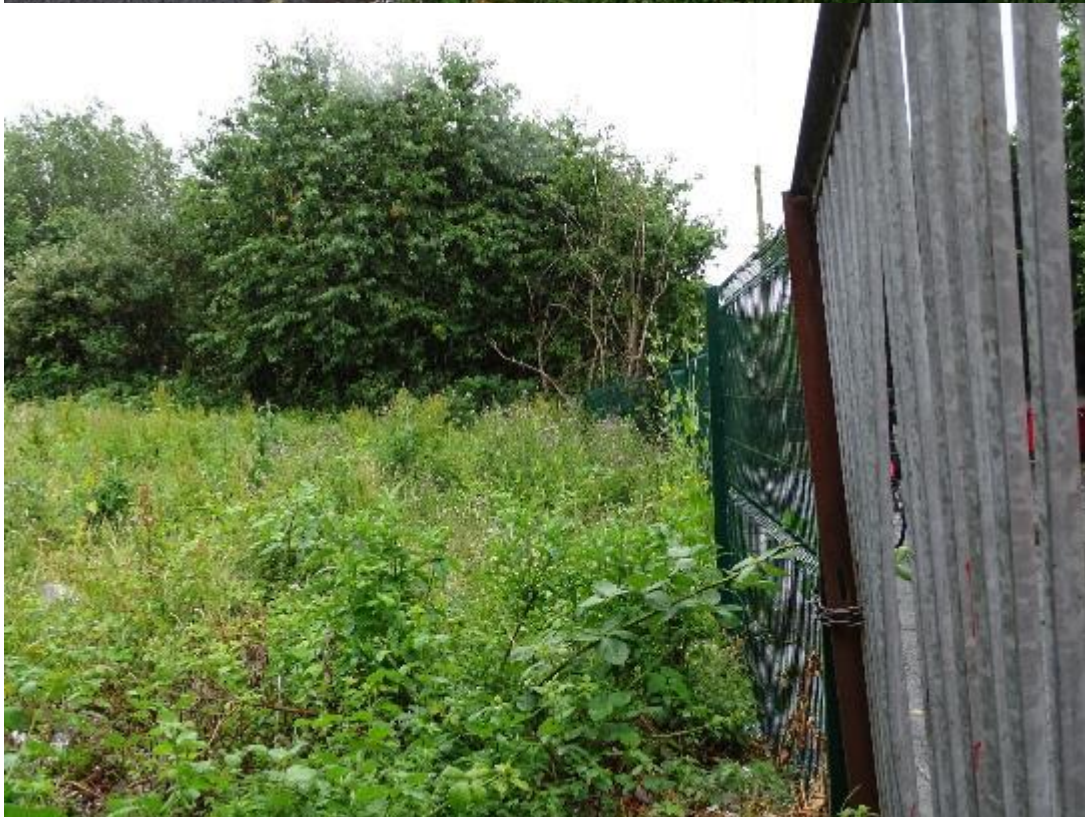
The site can be accessed from either Robin Hood Street to the south or St Marks Street to the north. To the north the site sits slightly elevated above the road with evidence of rubble on the ground. The site is overgrown, with no signs of dead or dying vegetation.

The northern boundary looking east and then west.

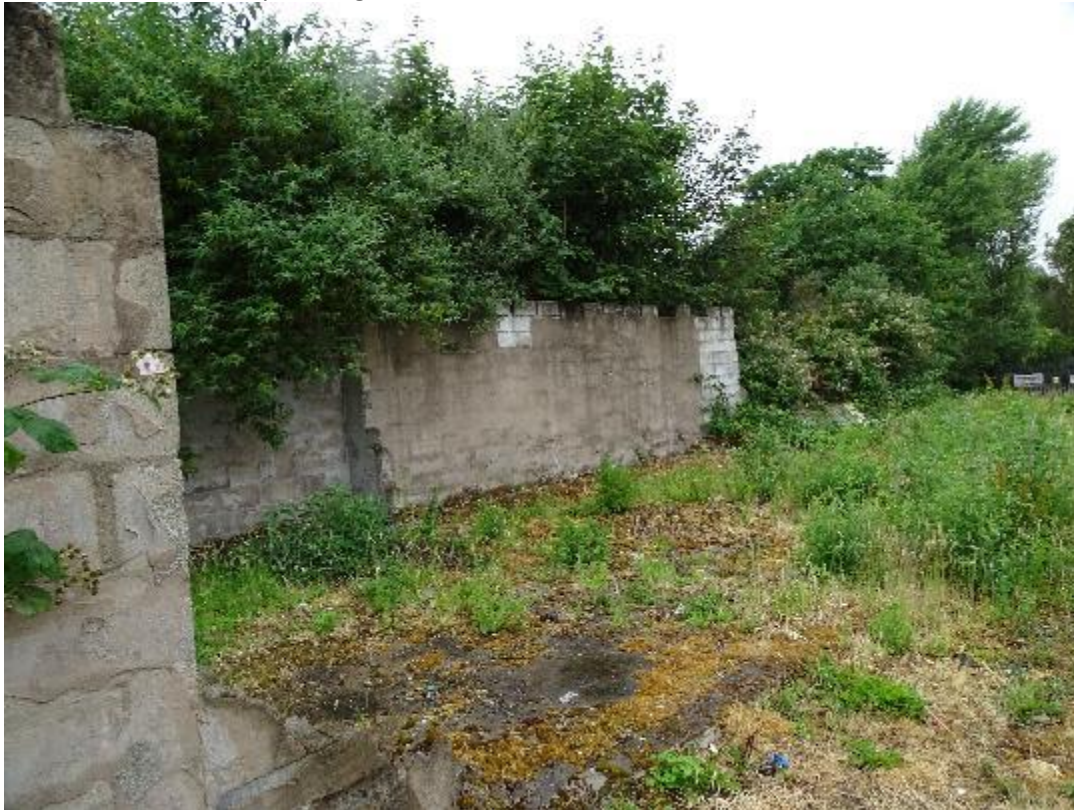
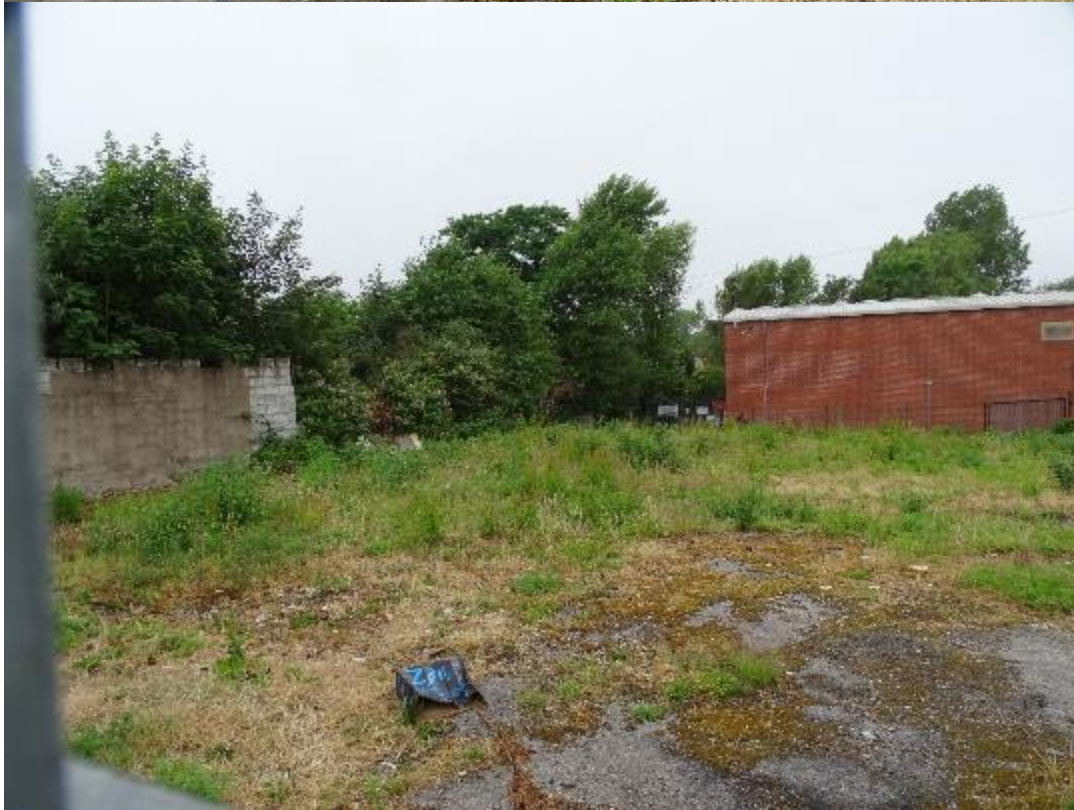
The western boundary looking north.

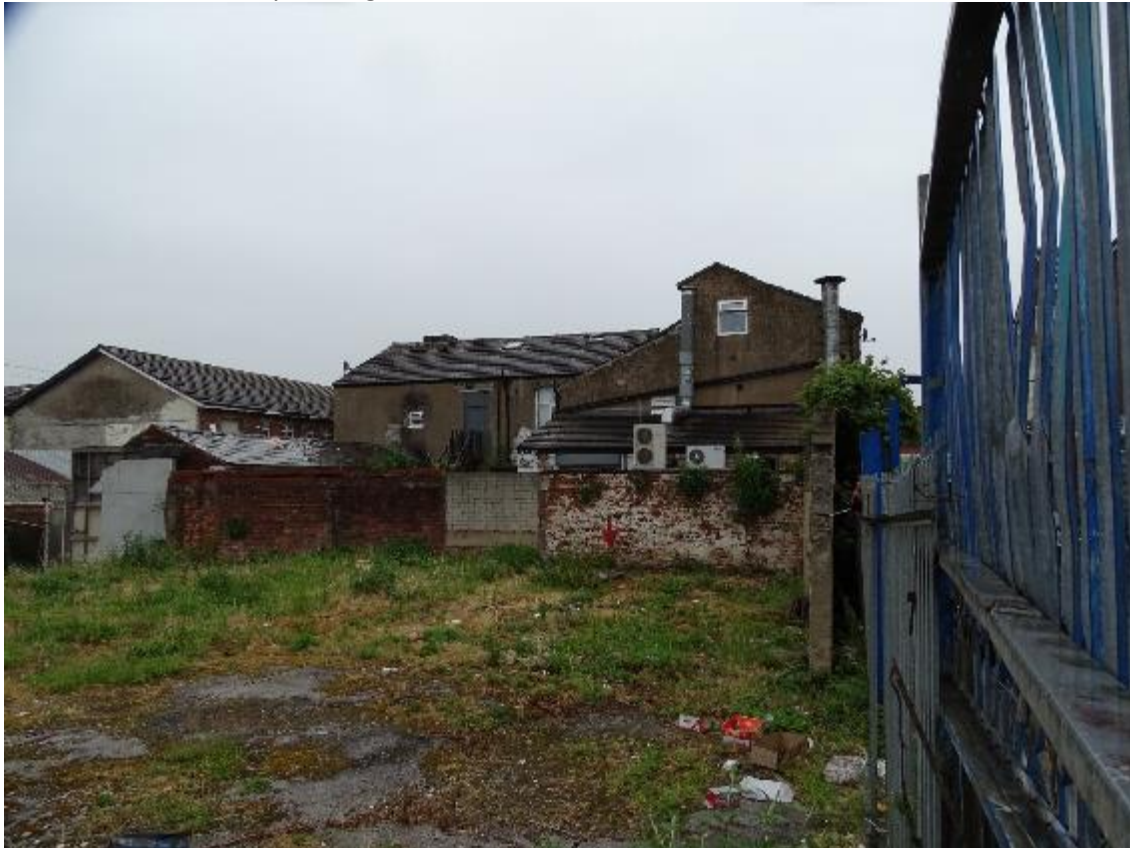
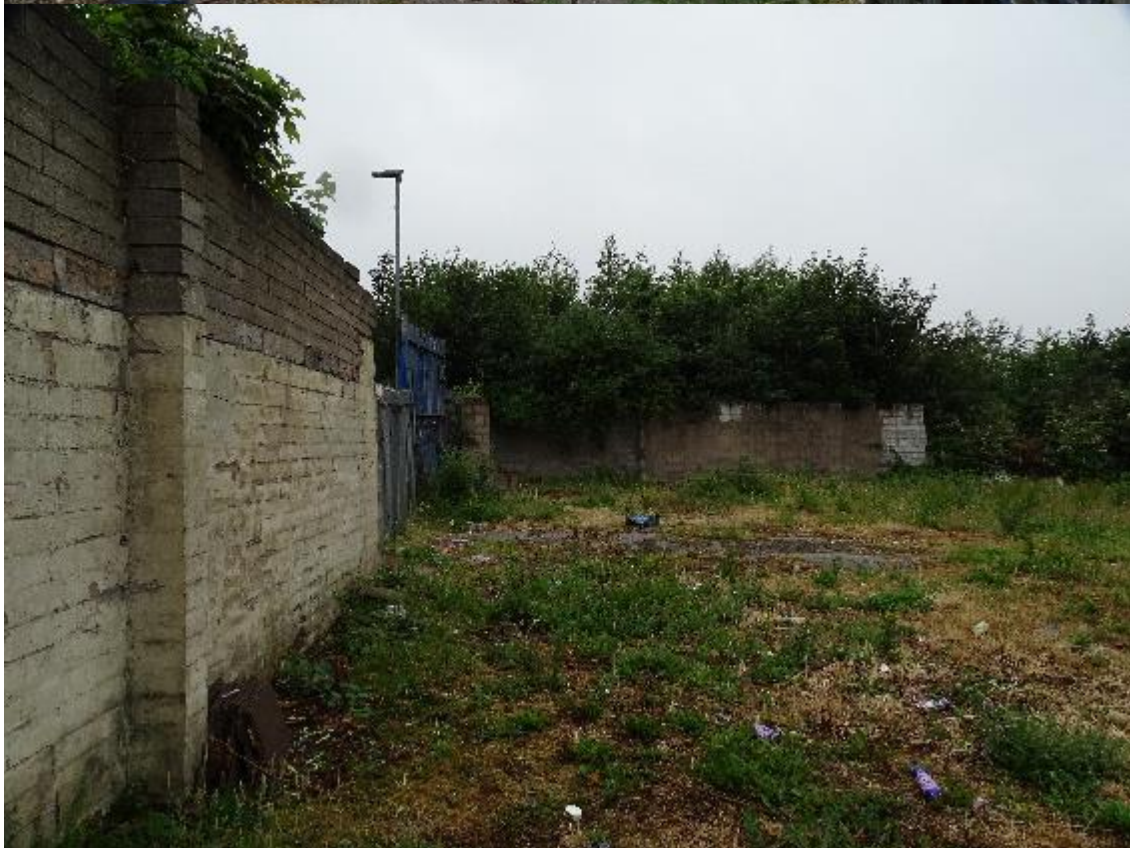
To the centre and south of the site overgrown hard standing is present in the form of asphalt and concrete. To the southeastern corner is a partial covered and partial infilled rectangular pit, approx. 1.5m<sup>2</sup>.

The southern boundary looking east then west

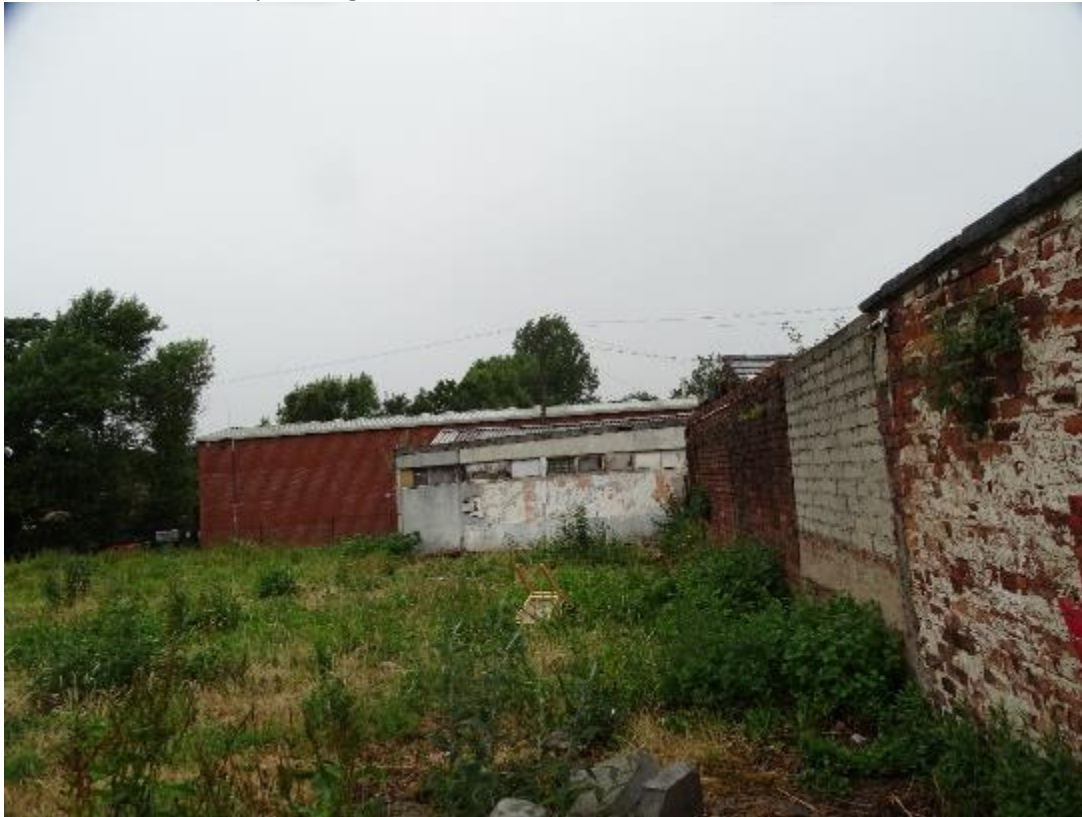
The eastern boundary looking north.

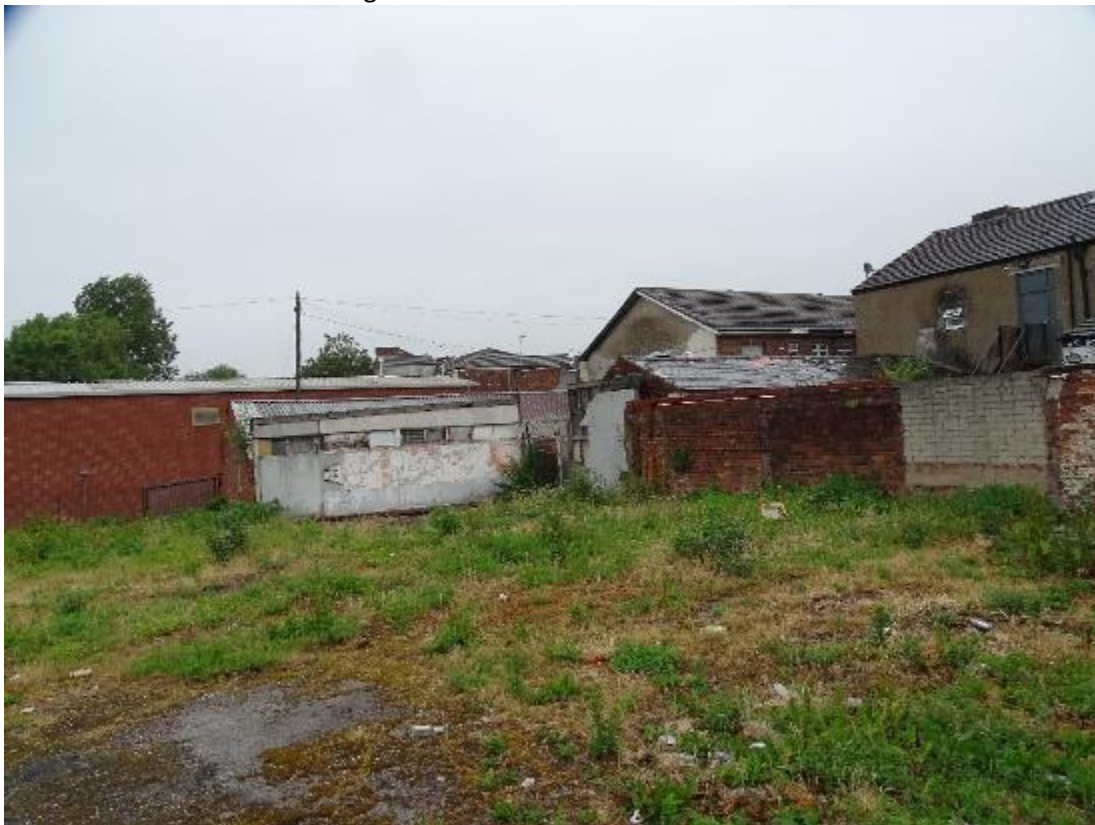
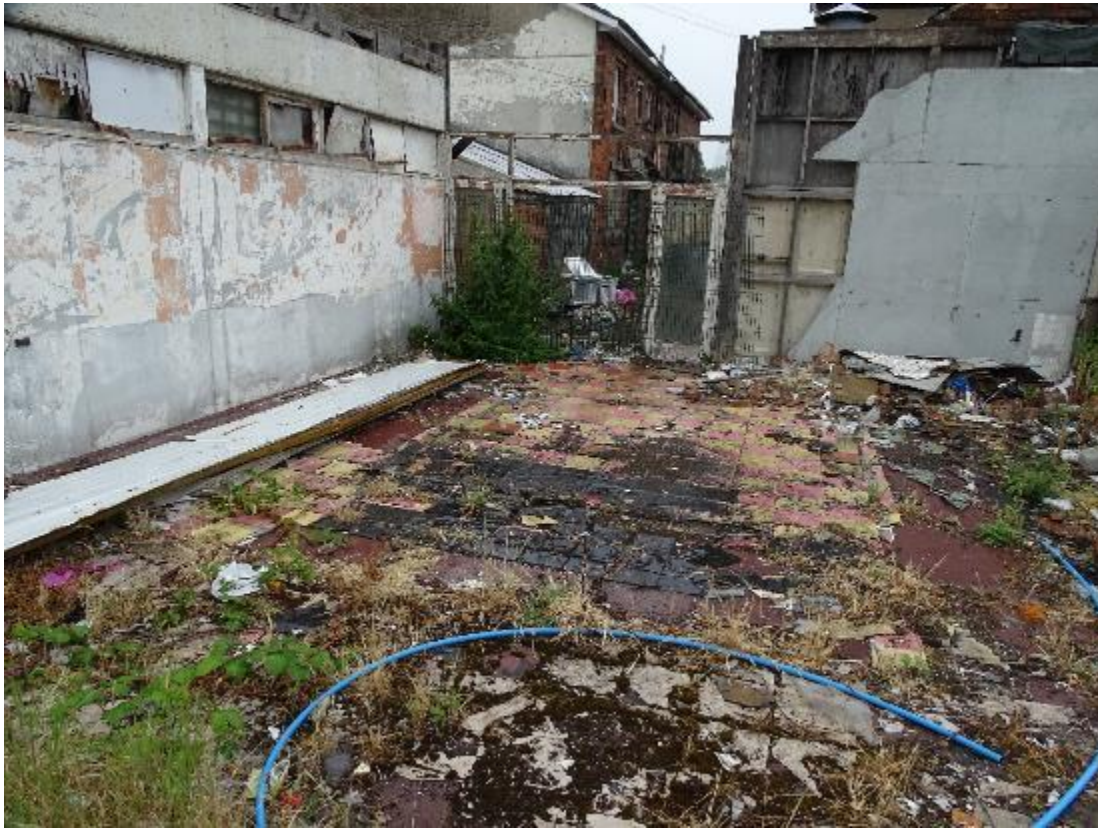
An old brick built single storey building, currently used as a car resprayer sits to the northeast of the site the boundary wrapping around this building. The footprint of the former building in the northeast can still be seen with the remains of floor tiles still present.

The area of the former building to the northeast

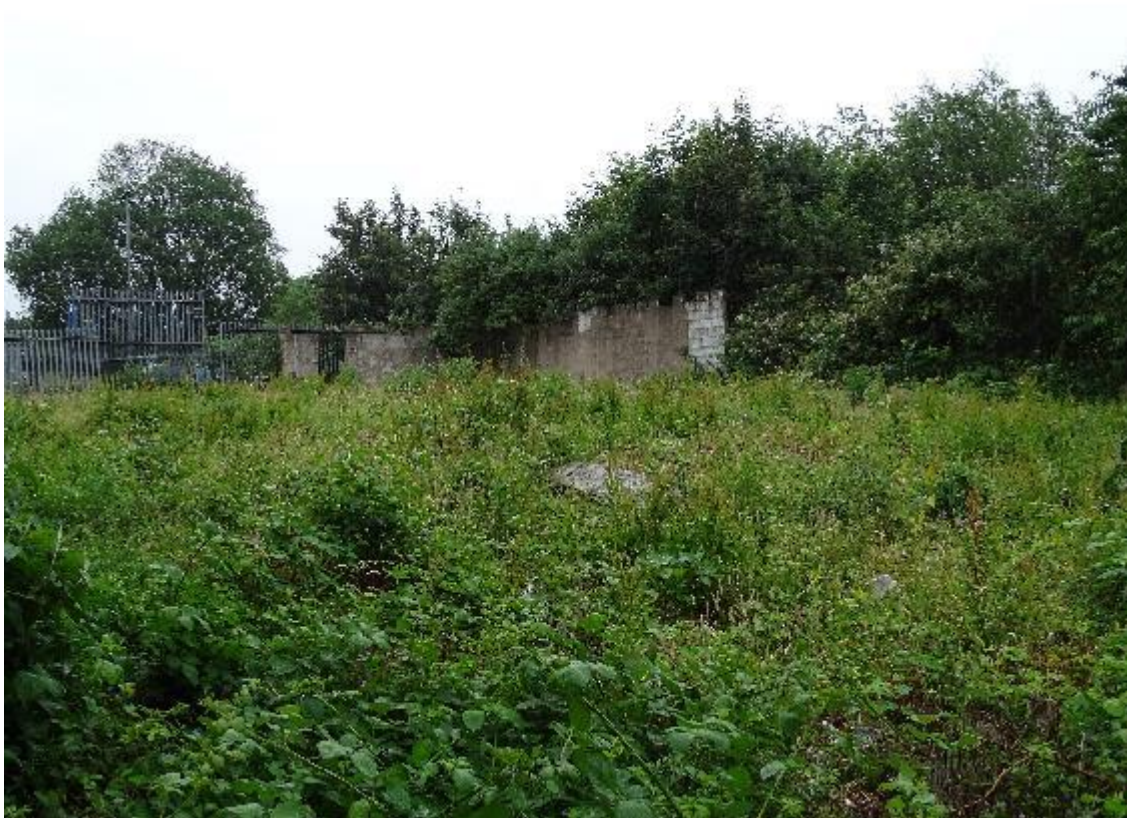
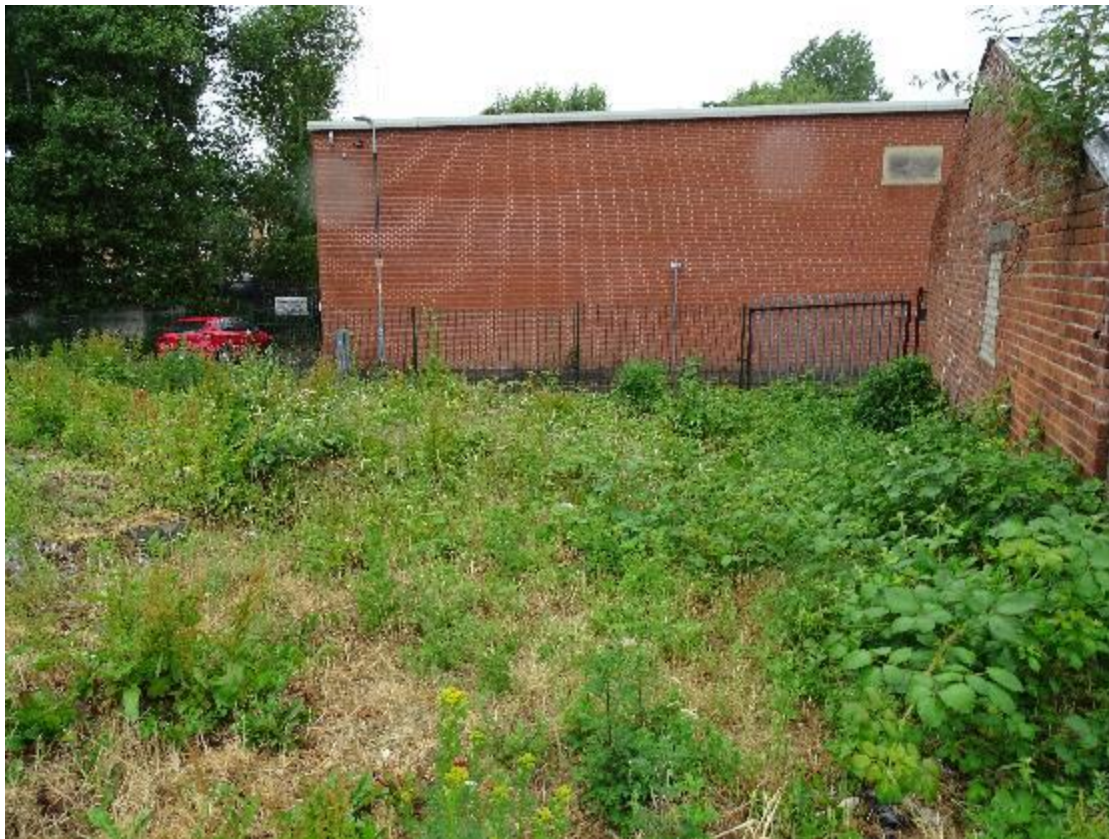
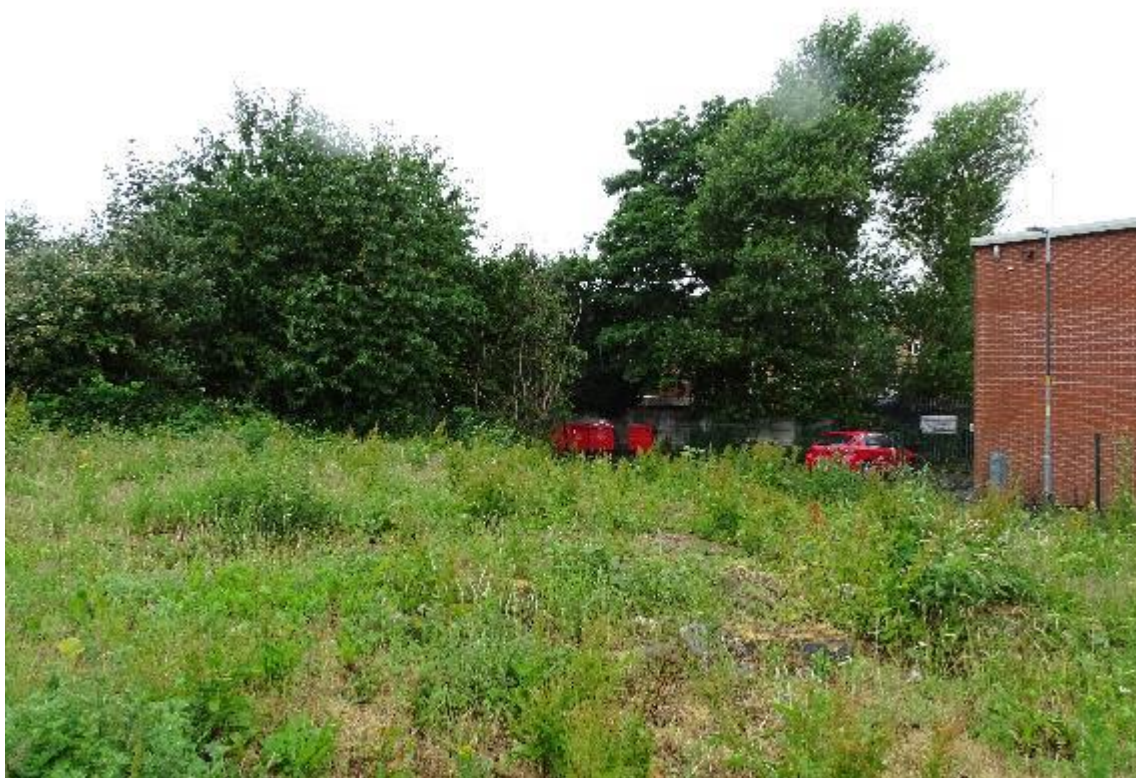
The historic uses of the site (smithy) and remains of buildings still present, particularly to the northern section present a possibility of contaminants being present with in the former building materials and made ground.

The overgrown rubble to the northern boundary

As such an intrusive investigation is recommended. However to aid this investigation it is suggested that surplus waste material on site is first removed to an appropriate licensed facility, including vegetation, and rubble. This will aid access to the subsurface in order to undertake the necessary soil samples.
