**Report Reference No: EL-01122**

**Mawlawi Kurdish Cultural Centre,  
Parsonage Street Lane, M15 5WD**

## **Asbestos Demolition Survey Report (Targeted – Office & Stores )**

Date 08/01/2023  
Elite Asbestos Solutions  
Suite 7 Ryfield House  
Highgate Rd  
Queensbury  
BD13 1DR

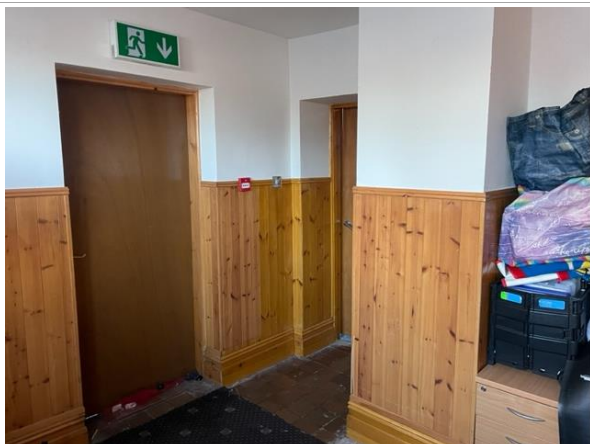
| Survey ID | EL-01 | | |

| Survey Sample Ref | Zone Level | Room/ Location | Element | Material Condition | Material Access | Material Extent Approx. | Cert. No/ Analytical Result | Material Assessment | Material & Type | Priority Assessment |
|---|---|---|---|---|---|---|---|---|---|---|
| EL-01 | Ground | Internal | Stores | N/A | N/A | N/A | NAD | 0 | NAD | N/A |

| Property & Building: | Stores - Walls / Ceiling / Floor & Voids | | |
| Asbestos Type(s): | NAD | 0 | |

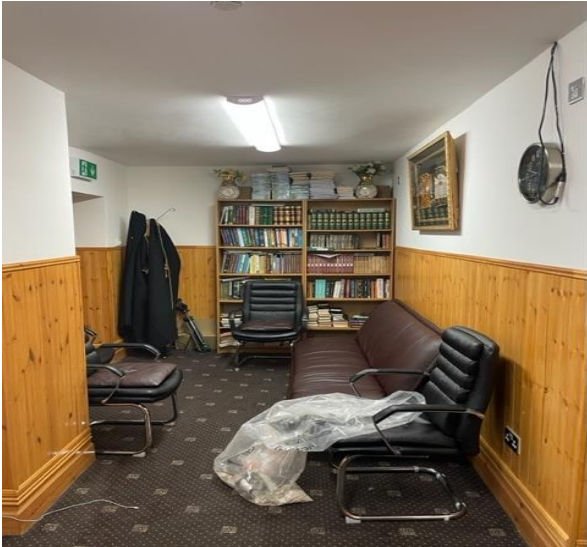
| Survey ID | EL-02 | | |

| Survey Sample Ref | Zone Level | Room/ Location | Element | Material Condition | Material Access | Material Extent Approx. | Cert. No/ Analytical Result | Material Assessment | Material & Type | Priority Assessment |
|---|---|---|---|---|---|---|---|---|---|---|
| EL-02 | Ground | Internal | Office | N/A | N/A | N/A | NAD | 0 | NAD | N/A |

| Property & Building: | Office | | |
| Item: | All - Walls / Ceiling / Floor & Voids | | |
| Asbestos Type(s): | NAD | 0 | |

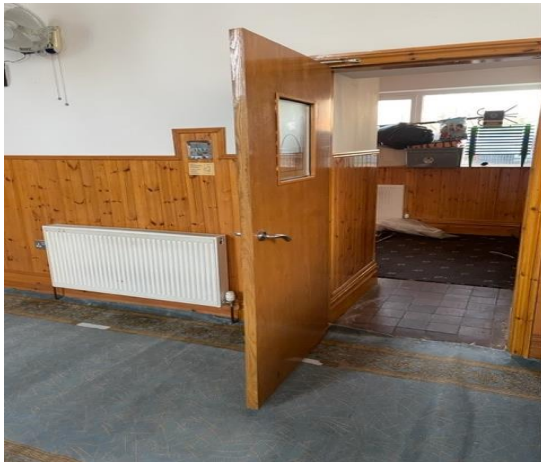
| Survey ID | EL-03 | | |

| Survey Sample Ref | Zone Level | Room/ Location | Element | Material Condition | Material Access | Material Extent Approx. | Cert. No/ Analytical Result | Material Assessment | Material & Type | Priority Assessment |
|---|---|---|---|---|---|---|---|---|---|---|
| EL-03 | Ground | Internal (Stores / Office) | Doors | N/A | N/A | N/A | NAD | 0 | NAD | N/A |

| Property & Building: | Office / Stores Doors | | |
| Item: | 2 X Doors | | |
| Asbestos Type(s): | NAD | | 0 |

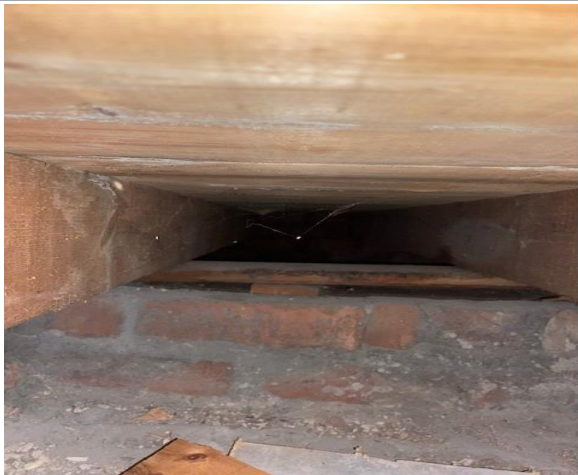
| Survey ID | EL-04 | | |

| Survey Sample Ref | Zone Level | Room/ Location | Element | Material Condition | Material Access | Material Extent Approx. | Cert. No/ Analytical Result | Material Assessment | Material & Type | Priority Assessment |
|---|---|---|---|---|---|---|---|---|---|---|
| EL-04 | Ground | Office | Under Floor Void | N/A | N/A | N/A | NAD | 0 | NAD | N/A |

| Property & Building: | Office | | |
| Item: | Floor Void | | |
| Asbestos Type(s): | NAD | | |

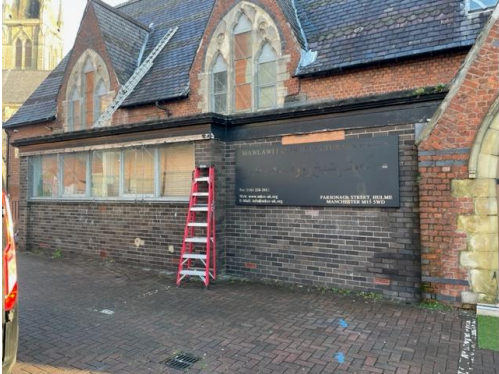
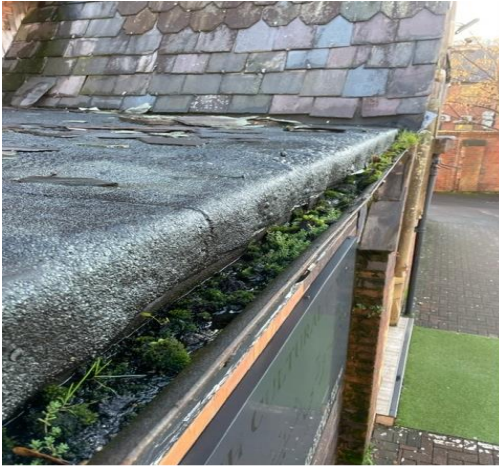
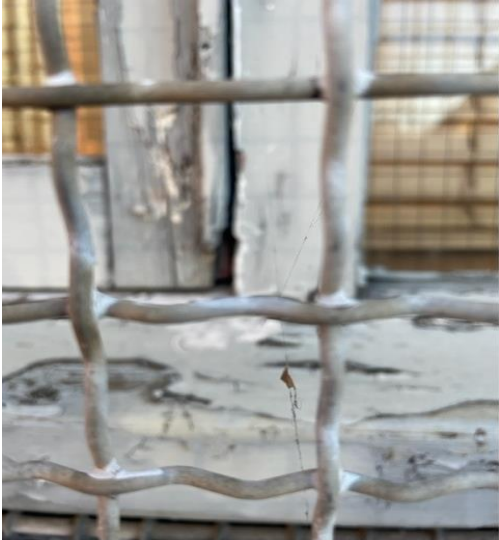
| Survey Sample Ref | Zone Level | Room/ Location | Element | Material Condition | Material Access | Material Extent Approx. | Cert. No/ Analytical Result | Material Assessment | Material & Type | Priority Assessment |
|---|---|---|---|---|---|---|---|---|---|---|
| EL-05 | Ground | External | Roof / Widows / Rainwater goods – ALL | N/A | N/A | N/A | Sample 001<br>(Bitumen Roof) | 0 | NAD | N/A |

| <b>Property &amp; Building:</b> | Office & Stores – External | | |
| <b>Item:</b> | All – Roof / Walls / Windows / Rainwater Goods & Doors | | |
| <b>Asbestos Type(s):</b> | NAD | 0 | |
| <b>Identification Method:</b> | Visual & Sample 001 | | |

| Sample No. | Client Sample No. | Sample Location | Sample Details | Asbestos Type(s) Present | Analysts Name |
|---|---|---|---|---|---|
| S001 | 001 | - | Roof Felt - Bituminous Product | NAD | Satya Tamerla |
