## STRUCTURAL CONDITION REPORT

Museum of Science and Industry  
Air and Space Hall  
Liverpool Road  
Manchester  
M3 4FP

Contract No: 11112  
Dated: March 2022

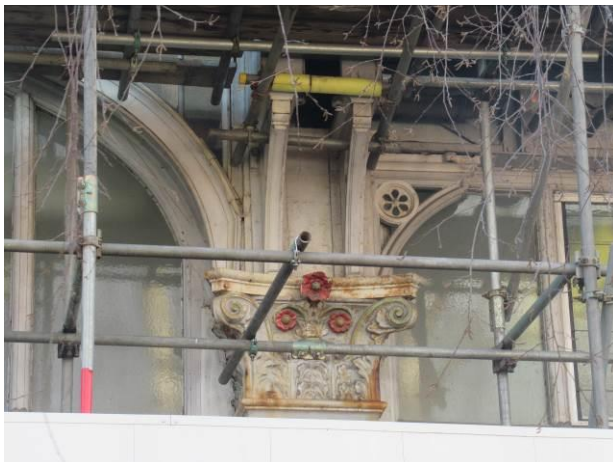
- 4.3 Loss of paint protection and surface corrosion was observed to the majority of the circular and square column heads. The upper columns heads were also noted to exhibit extensive pitting with rust staining affecting the majority of the external columns particularly around the joints and base of each column capital. The corrosion in these areas had led to a minor loss of section and definition of the ornate detailing works to the capitals of each column. This typically affected the floral decoration at the head of the capital and the rose motif projecting from the outside face of each column.

Corrosion and surface pitting to column capitals

1. Undertake the local clean, removal of flaking paintwork and repainting of corroded and pitted metalwork to the external façade of the structure. Remove all loose, delaminated metal work but consider a suitable paint protection, such as Carbomastic 15LT by Carboline, to seal the existing metalwork without the requirement to clean back to reliable metal.

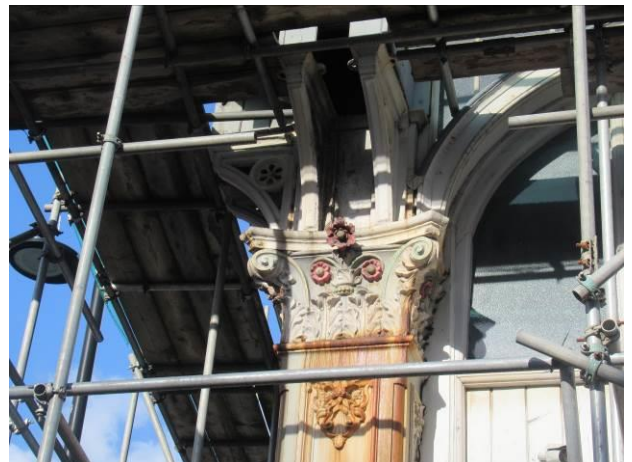
4.9 The capital of each column was generally in a reasonable condition with local defects recorded to each. Typically, the defects included rust staining to the lower portions and between the joints of the capital sections, surface corrosion and pitting of the capital was observed to the majority of columns and local fractures or loss of parts of the capital were observed in isolated cases. It was unclear from the survey if any of the column capitals were loose and at risk of falling from the building façade.

Rust staining and surface corrosion to column head and upper capital

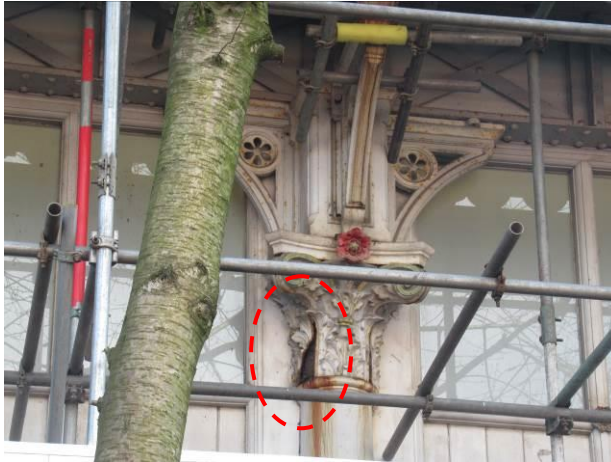
Isolated loss of part to column capital

- 6.11 The corrosion, loss of definition and loss of section to the decoration on the façade of the structure is considered decorative only however due to the listed nature of the structure consideration should be given to the protection and restoration of these elements. The wider corrosion to the external surface of the columns should be removed and a suitable paint specification applied to prevent further corrosion of the metalwork. The missing decorative crest at the head of the rear lefthand column should be replaced or sealed to prevent water ingress into the centre of the column.

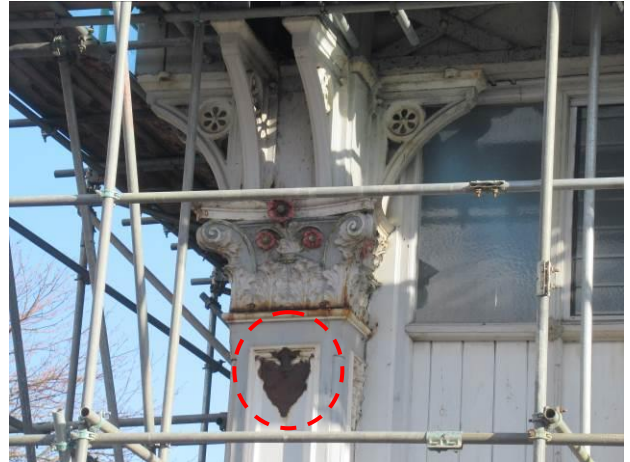
- 4.6 A decorative crest motif was observed to the base and head of each square column to the perimeter of the property. Typically, each crest was present to both the base and top of each column however the top motif to the rear lefthand corner column of the structure was missing and a void in the face of the column remained where the motif would have been. The surrounding metal work to the missing crest was rust stained where water ingress has occurred.

Missing decorative crest to the upper portion of the rear lefthand corner column

5. Ensure that all decorative motifs are adequately fixed to the existing columns and not currently loose. To allow the removal of the existing netting and timber framework to each internal column it is recommended that remedial fixings are introduced to all motifs on columns where water ingress is apparent.

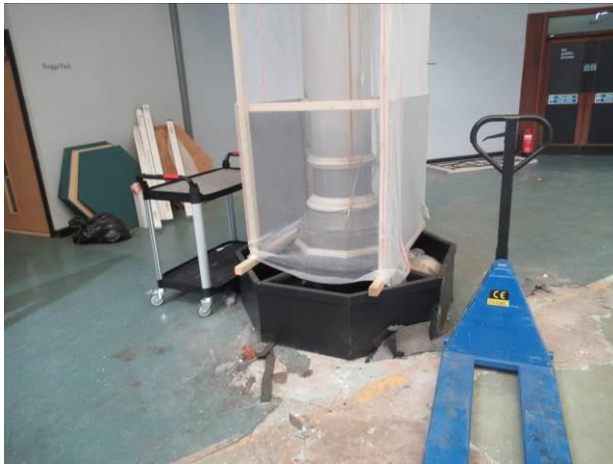
- 5.6 The majority of internal columns displayed minor rust staining to the upper portion of the column, around the capital and around the upper decorative motif of the columns. It is understood that the columns function as the rainwater pipes for the structure and had, since the initial construction, been internally lined with rainwater pipes. The water ingress to the structure had resulted in corrosion and delamination of the metal work around the joints and base of the capital. Two of the internal columns had a plastic sheeting installed around the head of the column which was understood to form an internal rain water hopper to collect water which was leaking through the building fabric. The hopper head was drained via a small pipe which discharged approximately 0.5m above ground level into a lined timber box out arrangement at the base of the column.

Local box out and tanking to the base of columns where water ingress has been historically observed

3. Undertake further investigations to the head of the columns shrouded in plastic guttering and any areas where the roof is leaking. Undertake remedial works as required to ensure the property is otherwise sealed from water ingress. Waterproofing and sealing works to architect specifications.

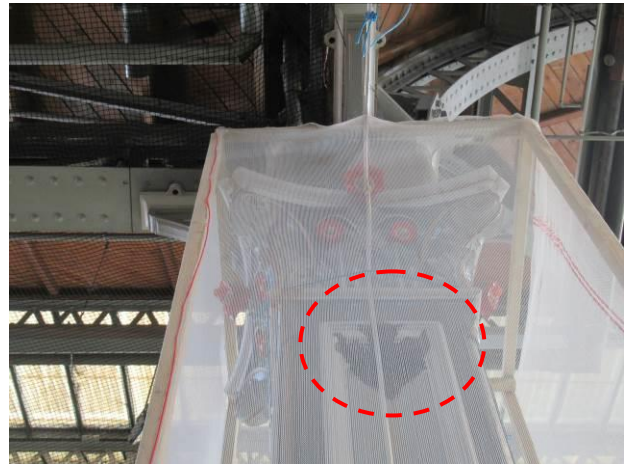
Missing upper crest motif to internal column

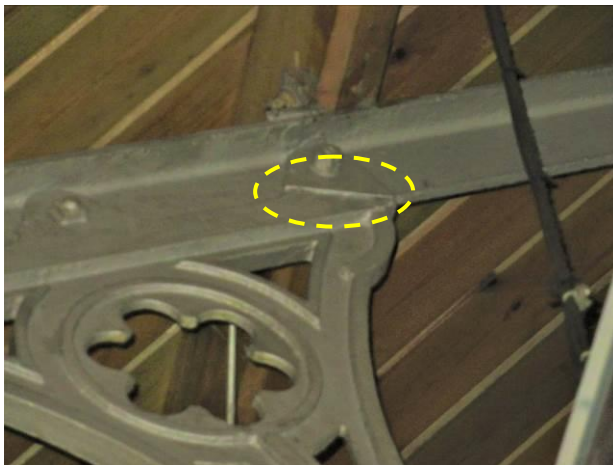
Metal fracture to lower bracket of aisle roof truss

- 6.9 The cause of the local fractures observed to the aisle truss connections to the north side of the structure could not be established, however the apparent long standing nature of the problem

and lack of further defect with the affected trusses suggests that the structure has reached an equilibrium and the remaining connections were suitable to support the roof structure.

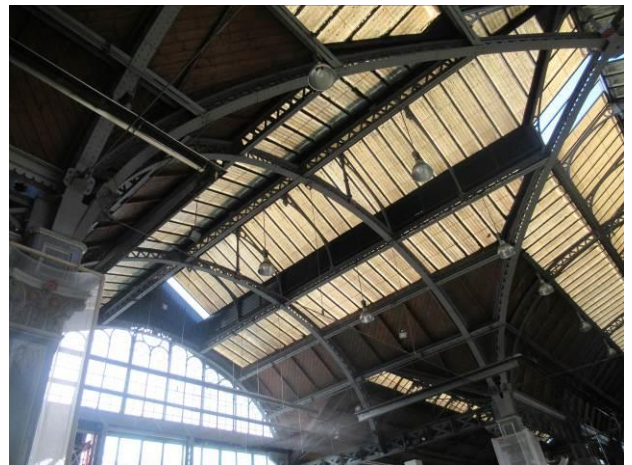
Central ties not installed across diagonal trusses

- 6.5 In addition to reducing the roof loading, agreement was reached to allow the installation of tie bars at the springing point of the arched trusses at the crossing point of the main aisles; however diagonal ties were not installed as the Heritage England Engineer contesting the installation of the ties, due to the listed nature of the structure argued that those installed to the aisles effectively formed a square of ties around the central area and as such the diagonally spanning ties were not required. At the time of our inspection, we noted that at least one of the tie bars could be seen to be slack; this is indicative of some movement of the structure since the installation of these ties.

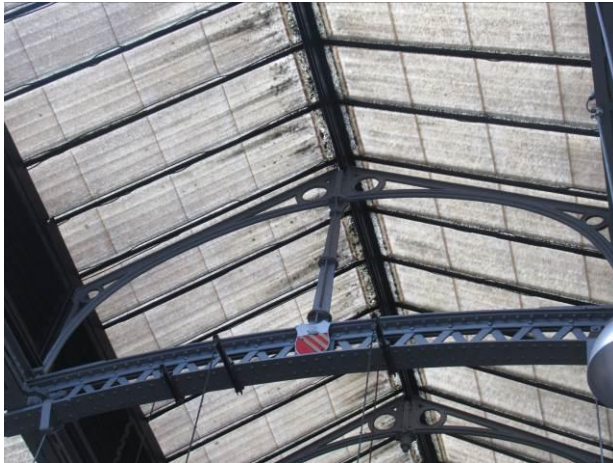
View on apex detail for centre aisle trusses, showing vertical member

- 6.10 The observed separation of the vertical member at the apex of the structure had occurred as a result of the general distortion of the structural frame. The separation did not appear to have imparted excessive stresses on the surrounding members which were typically free from visible defects. The separation of the apex was not considered to be of structural concern. The missing rivets observed to the majority of the apex prop connections may have occurred due to the distortion of the frame although it was unclear if these connections were present at the time of construction. Due to the perceived longstanding nature of the defect and should the building be free from further roof spread, the lack of second fixing at the head of the prop is not considered to be of structural concern although a second fixing could be introduced to improve the connection should the bolt holes of the two plates align.

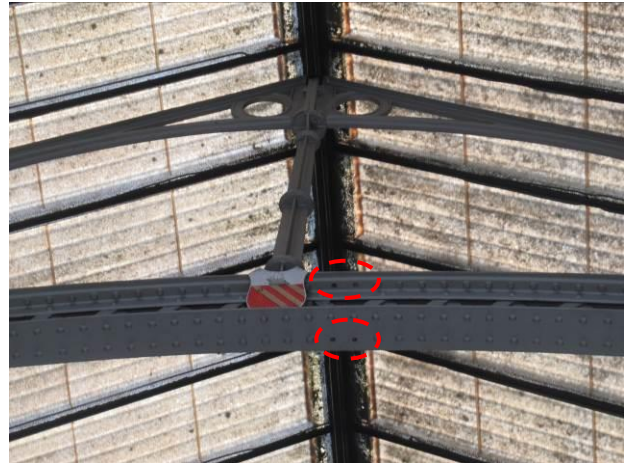
Missing rivets to the arched roof trusses.
