Eagle House, Manchester  
First Floor Photographic Survey  
May 2023

# 1.0 – First Floor Key Plan

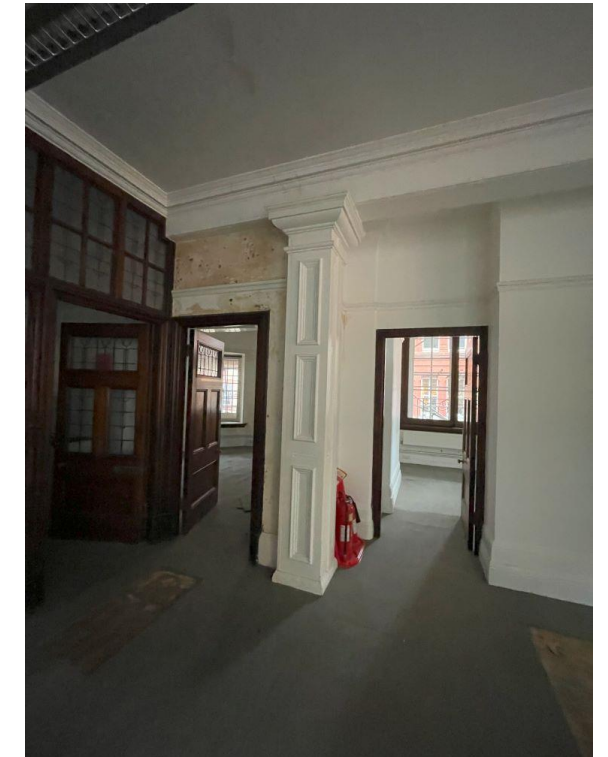
Photo 3

Partition shown to the right of the column in photo 3, photo 4 and 5 is new plasterboard partition installed as part of applications 075013/LO/2005/C1

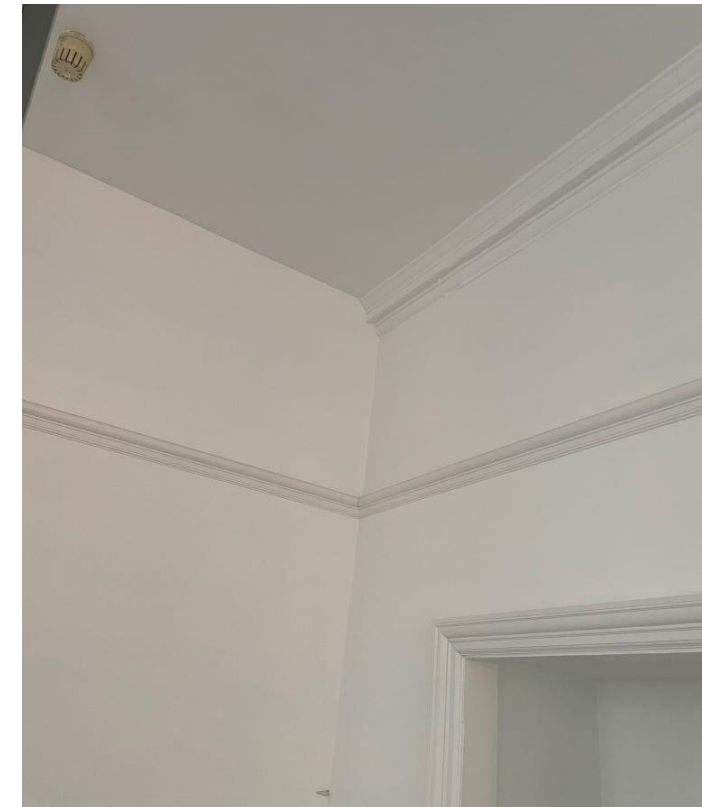
Photo 1 shows the junction between new partition to the front of toilets and original wall. Picture rail recreated, but cornicing absent from new partition. Photograph 5 shows door into toilets which is proposed to be relocated to adjacent wall

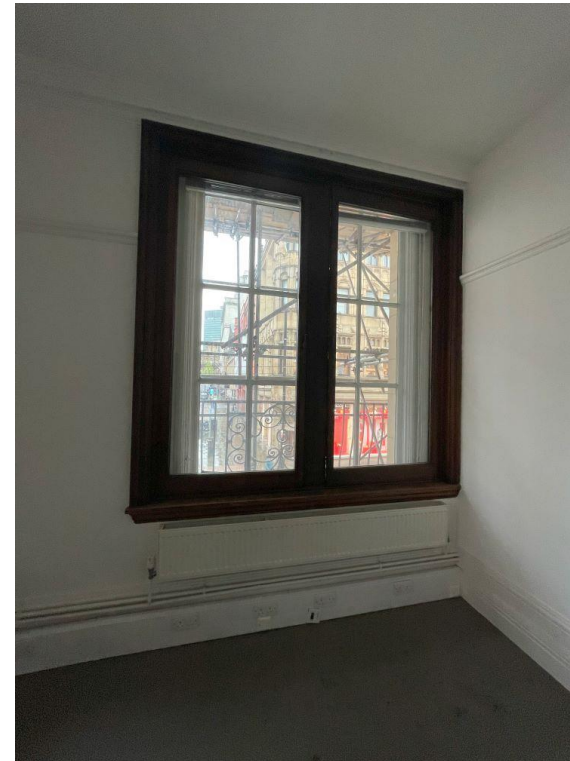
Photo 1

Photograph 1 and 2 show new partition to meeting room installed as part of planning application 075013/LO/2005/C1. This partition does not have cornicing which ties into the existing walls of the room

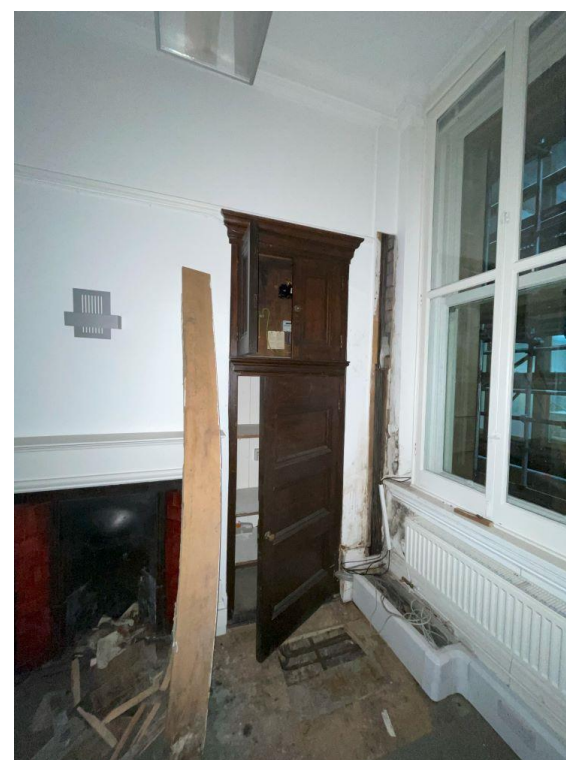
Photo 3

The timber and glazed screen to this room provide some historic character to this room along with the fireplace and timber store cupboard. There is some damage to the walls of this room. The cable management is not neatly contained as can be seen in photos 3 and 4. This will be improved as part of the works.
